WHEN DUNES MISBEHAVE

ROBERT H. BARRON
COASTAL MANAGEMENT CONSULTING
<beachmaker@aol.com>

The Coastal Engineering Community has become quite proficient working with the fluids of Wave, Wind and Weather, but with recent focus on construction of dunes, faces for the first time a fluid with an agenda. That is LIVING BEHAVIOR. The living dune ecosystem, can sometimes perform in unexpected ways, at times beneficial and occasionally harmful.

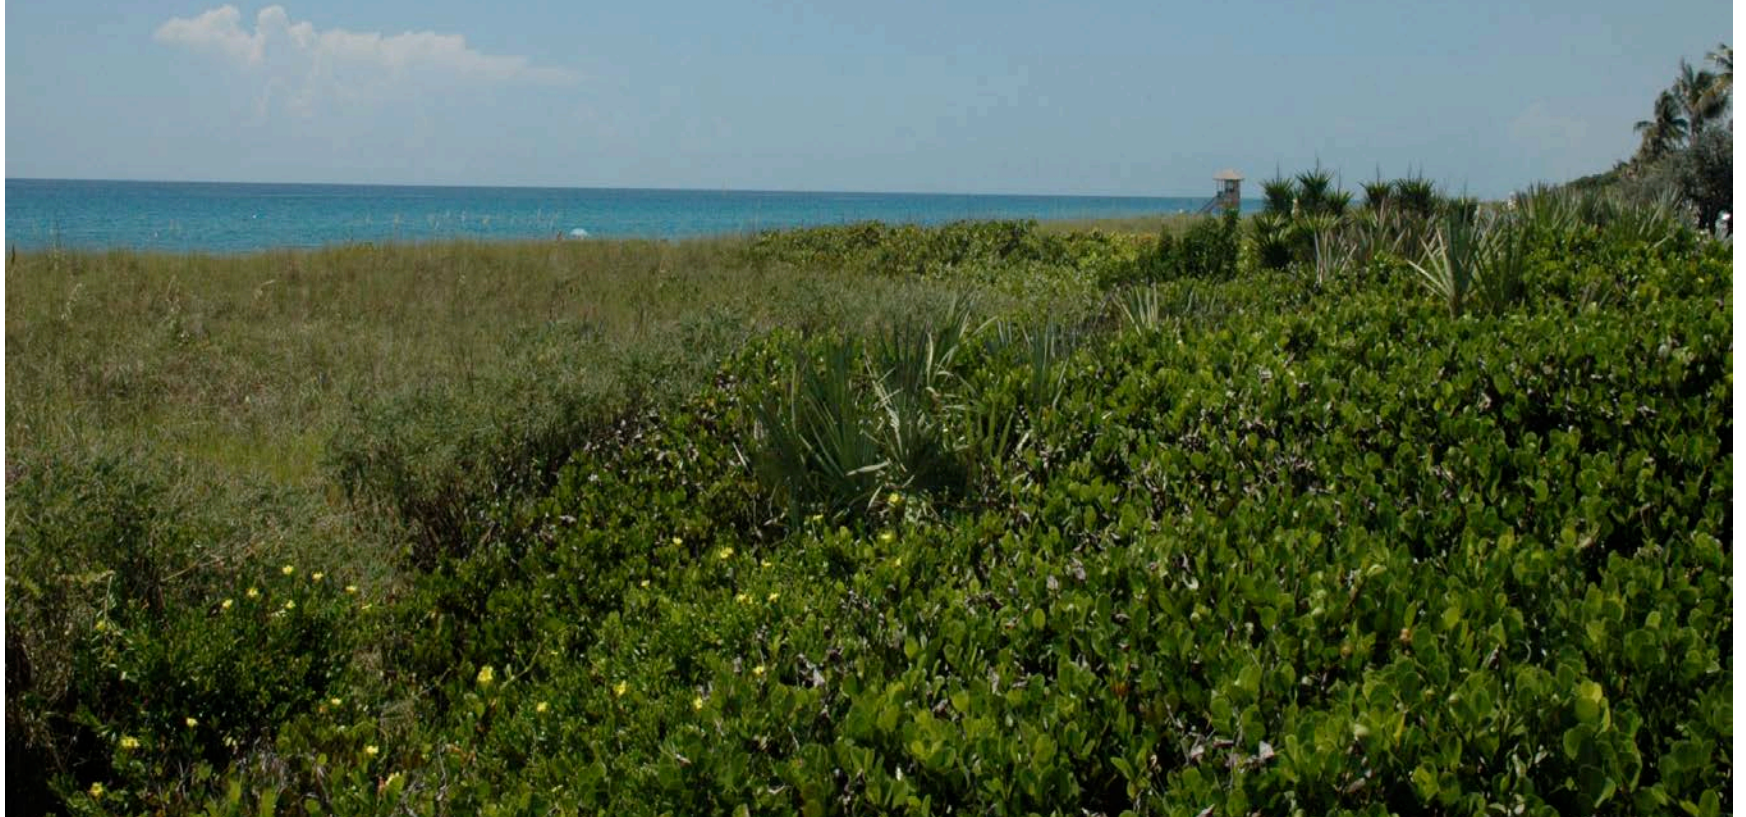
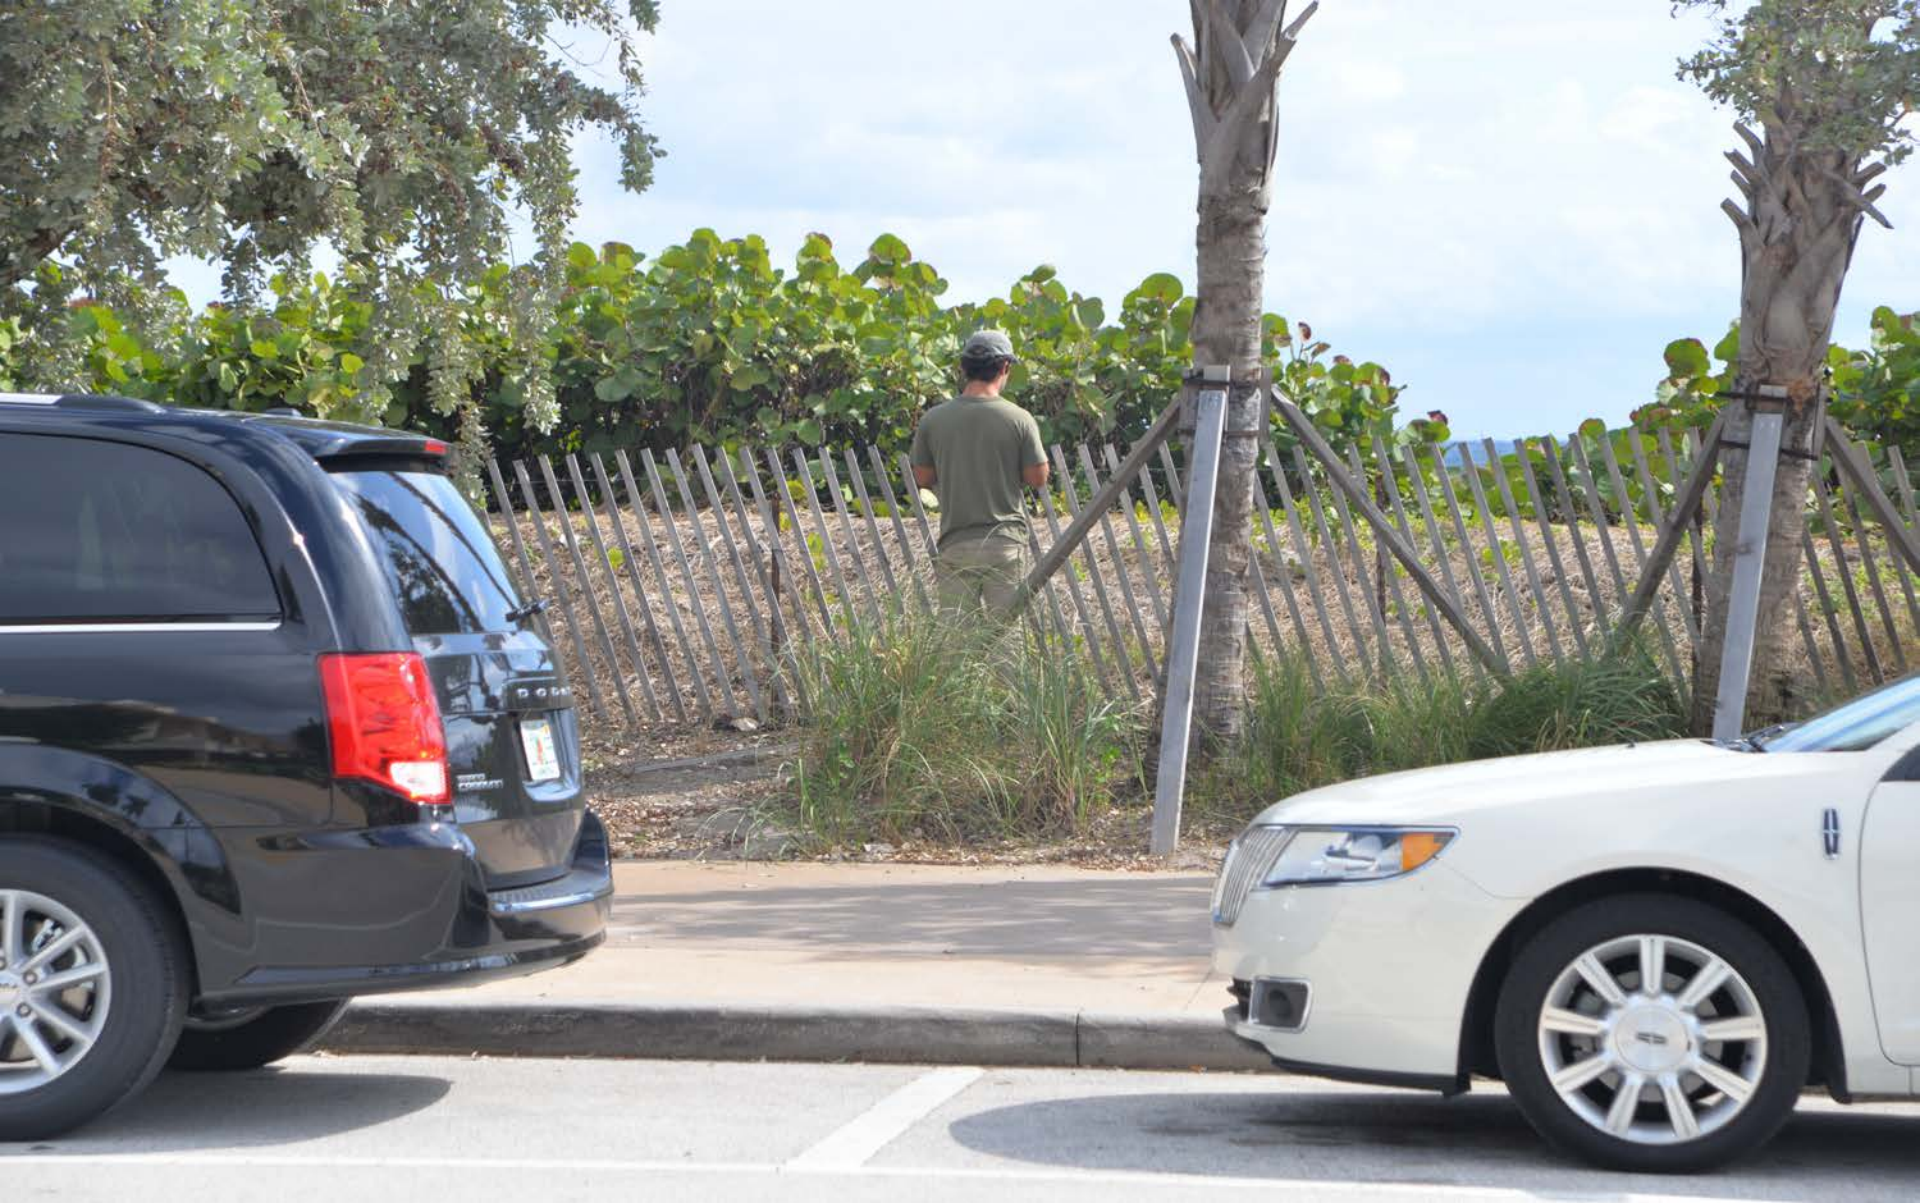
Forty years later, 165 foot wide pioneer and strand zone dune , which has captured as much sand as a complete nourishment project, with up to 14 vertical feet in spots.

Sand capture and vertical development has raised elevations by 14 feet in some places and blocked vista from street level. Permits acquired to cut and fill bumps and fill low areas within comprehensive dune enhancement program. Not yet carried out.

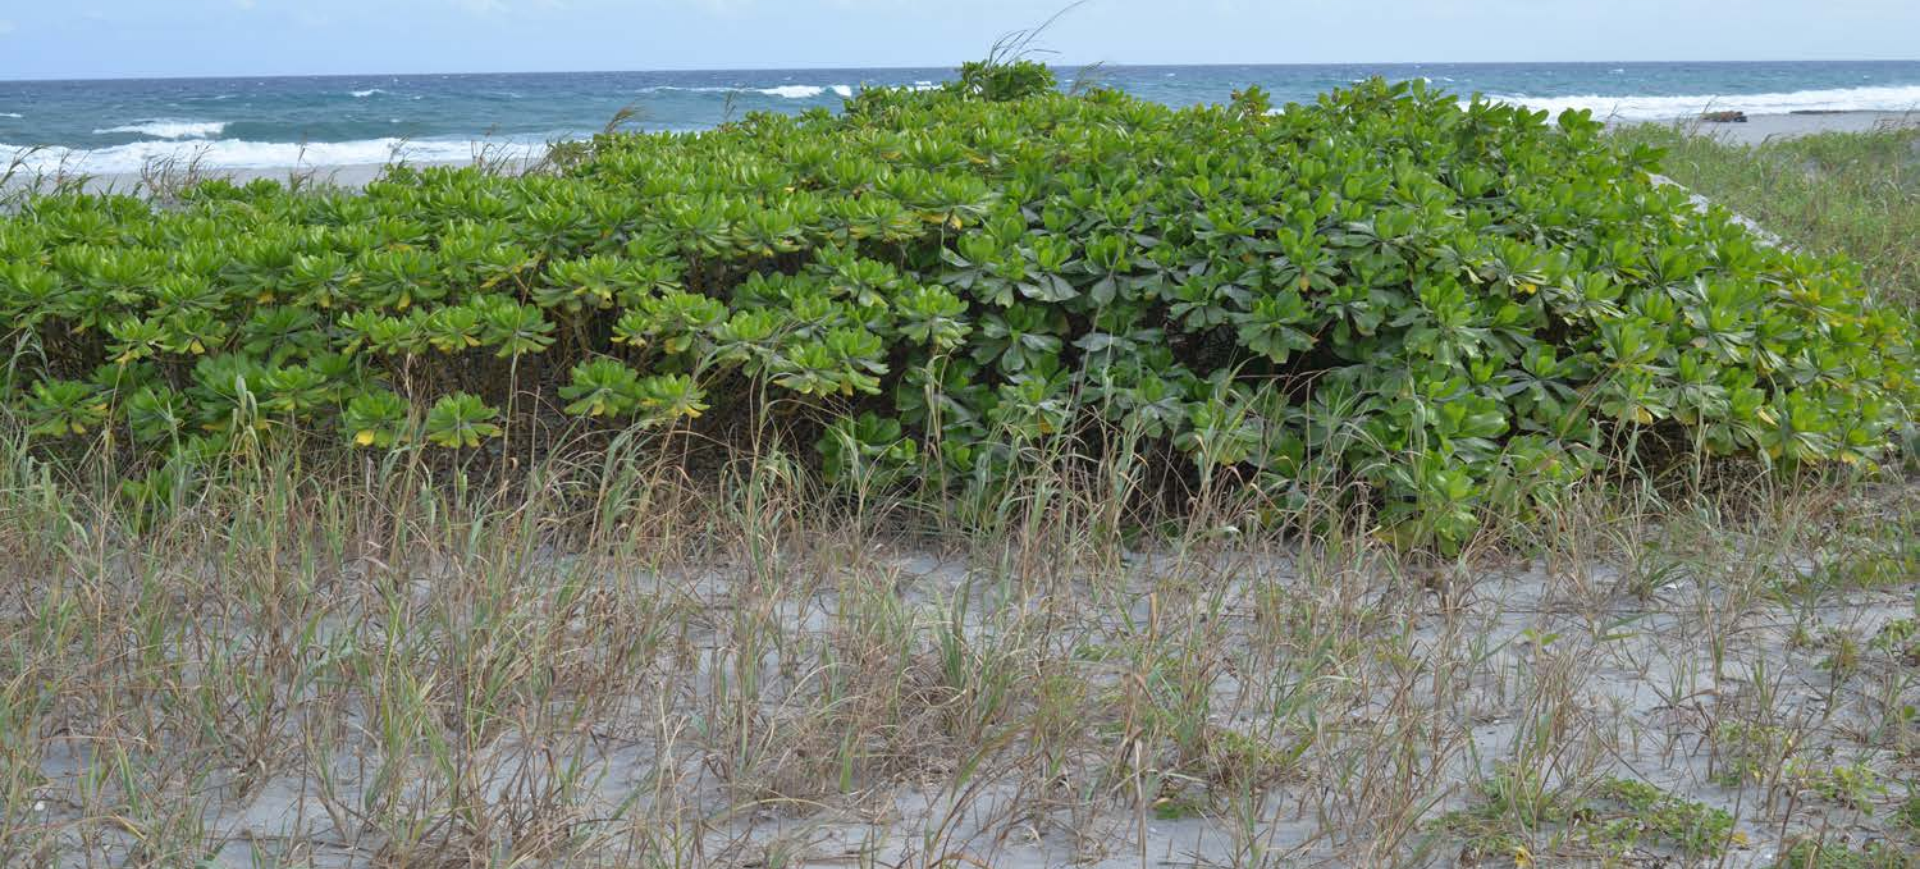
12/3/14 INSPECTION 500 FT. NORTH END Invasive exotic *Scaevola taccada*, 2 to 3 year old cluster. Cost to remove maybe \$150, this Cluster but \$30K to eradicate overall.

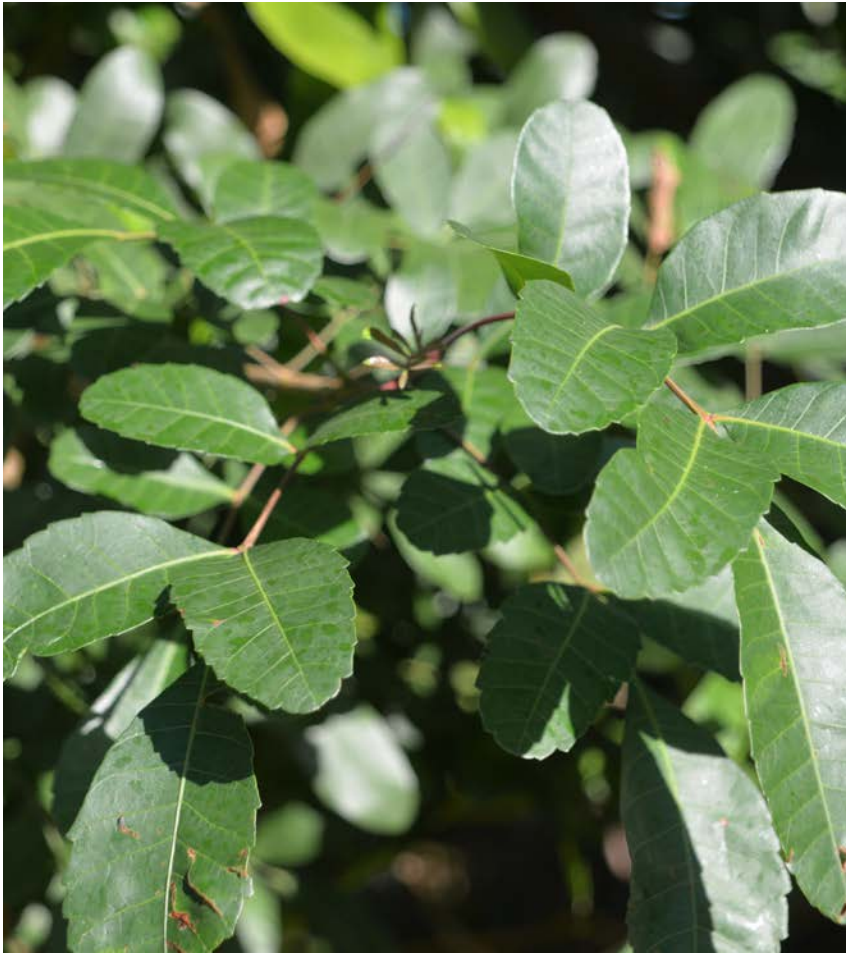
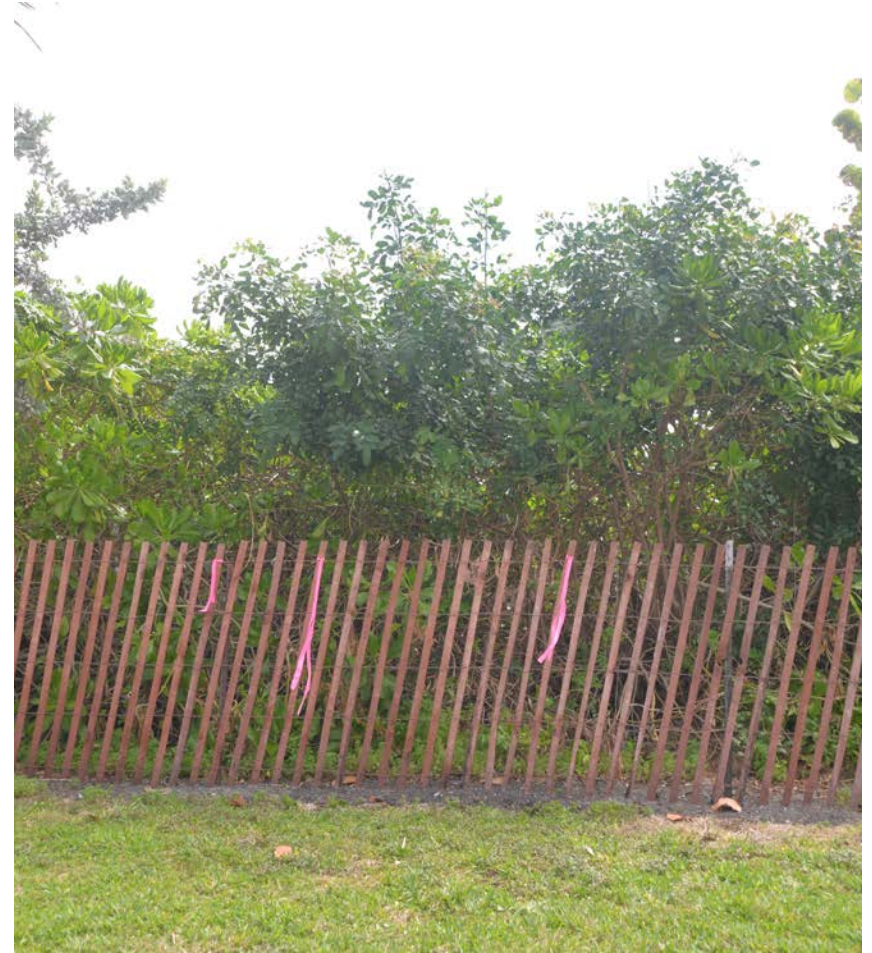
BRAZILIAN PEPPER, *Shinus terebinthifolia*, a sprawling shrub and heavy seeder, infests coastal and inland areas. Specimen across from the Marriot main entrance. FLEPPC Category 1 invasive exotic species.

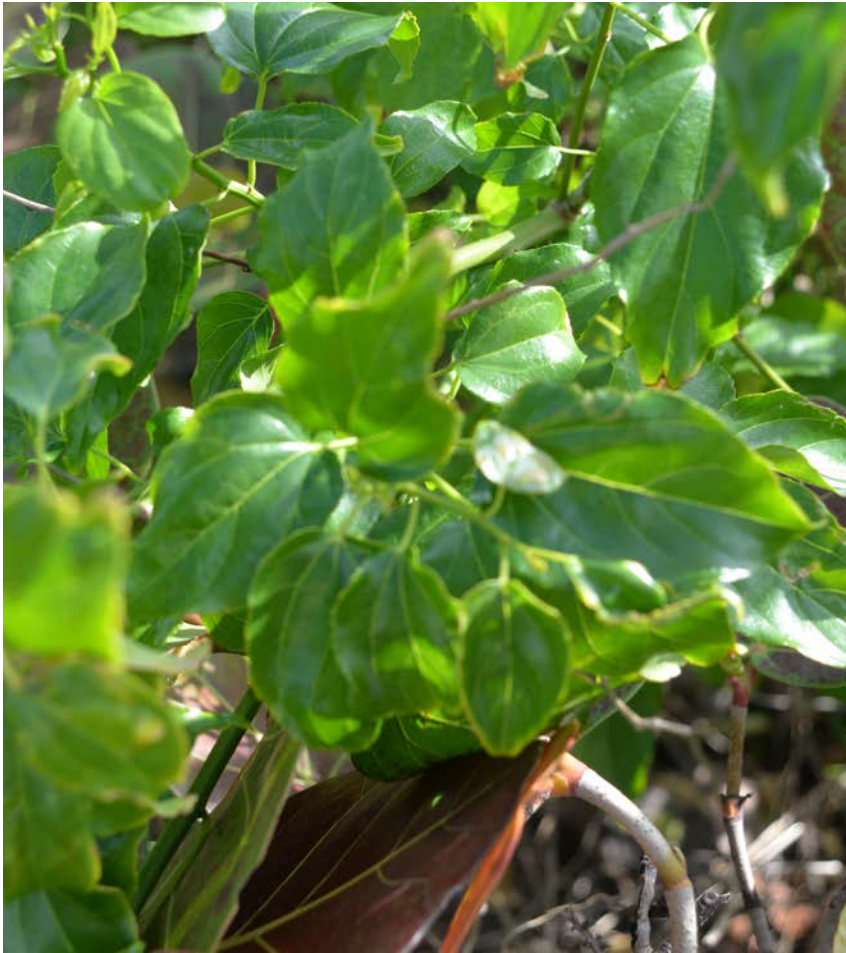
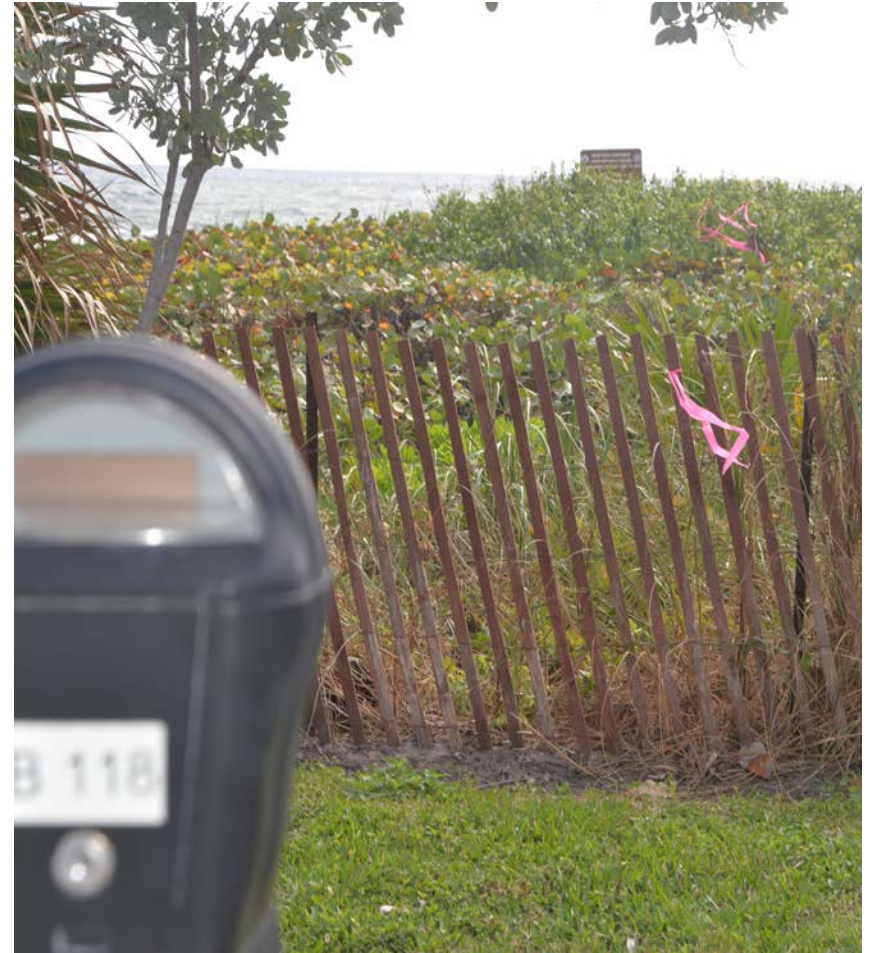
LATHER LEAF, *Colubrina Asiatica*. A profuse seeder, like most of the other invasives, overshadows and displaces natives with typically single plant masses. Specimen at meter B-119. FLEPPC Category I.

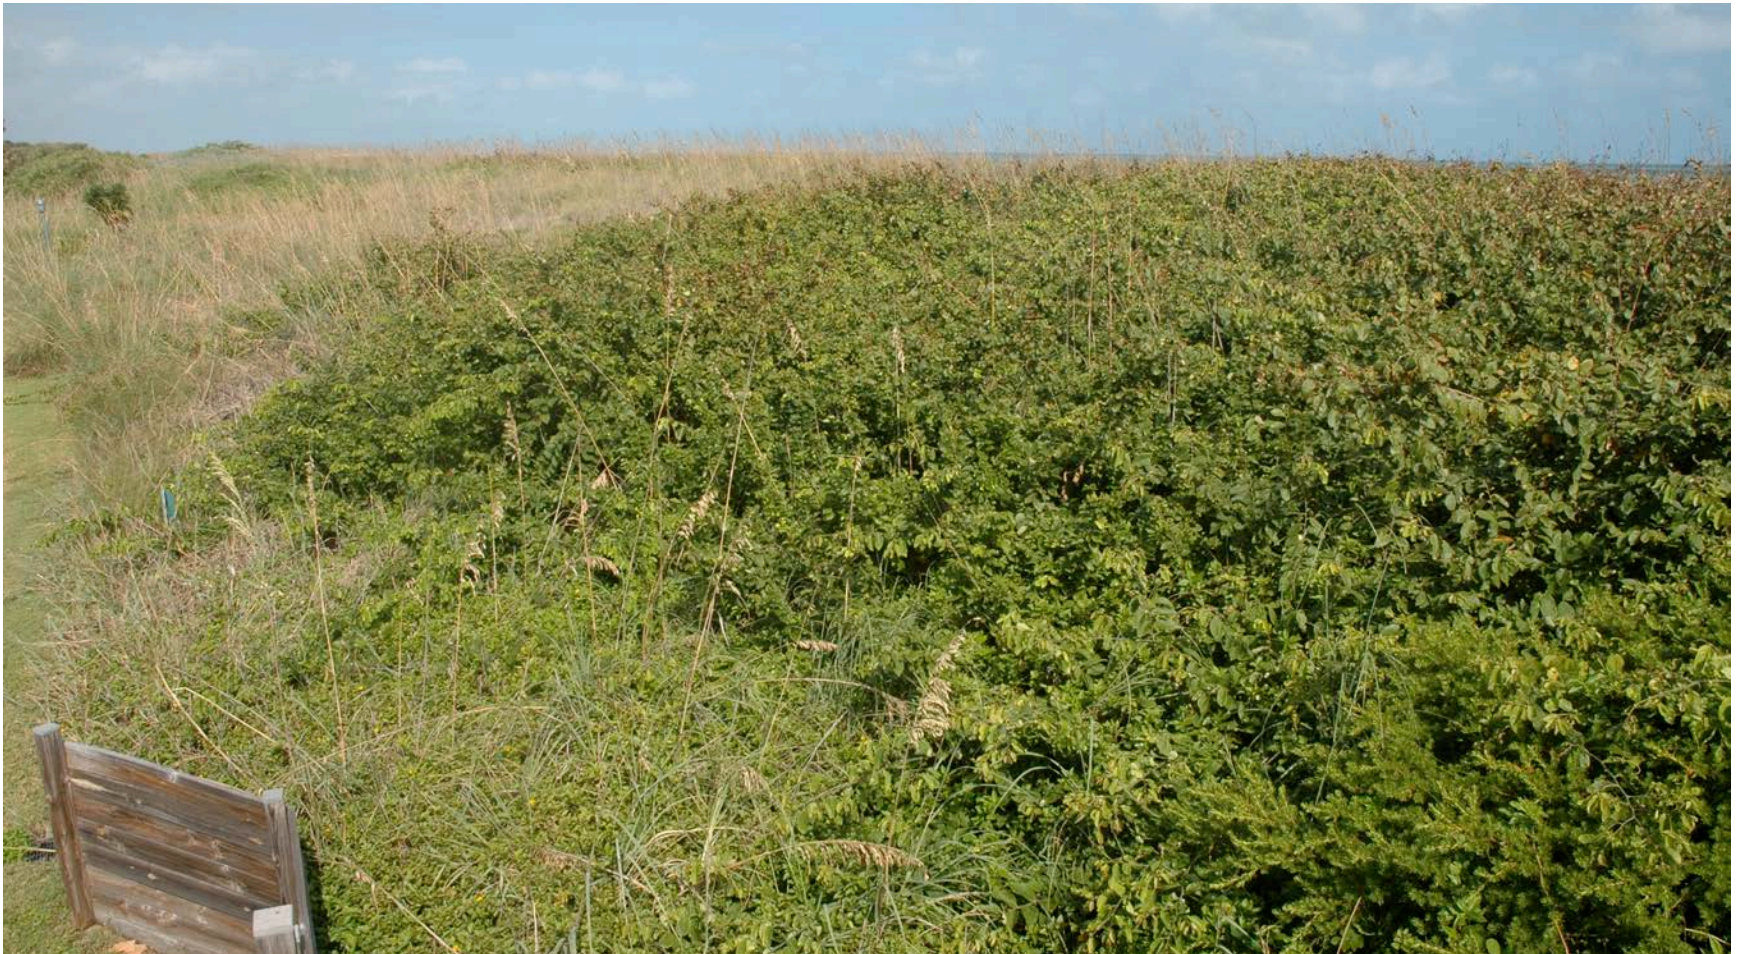
Storm wave
disbursed seed

Dalbergia ecastophylum (coin vine) infestation.

Contaminating over 500 square yards this two year old infestation is only three individual plants, largest of which had 26 leads radiating out as much as 36 feet with laterals out to fifteen feet. These completely overshadow the native dune grasses and strand species below. First noticed in August of 2009.

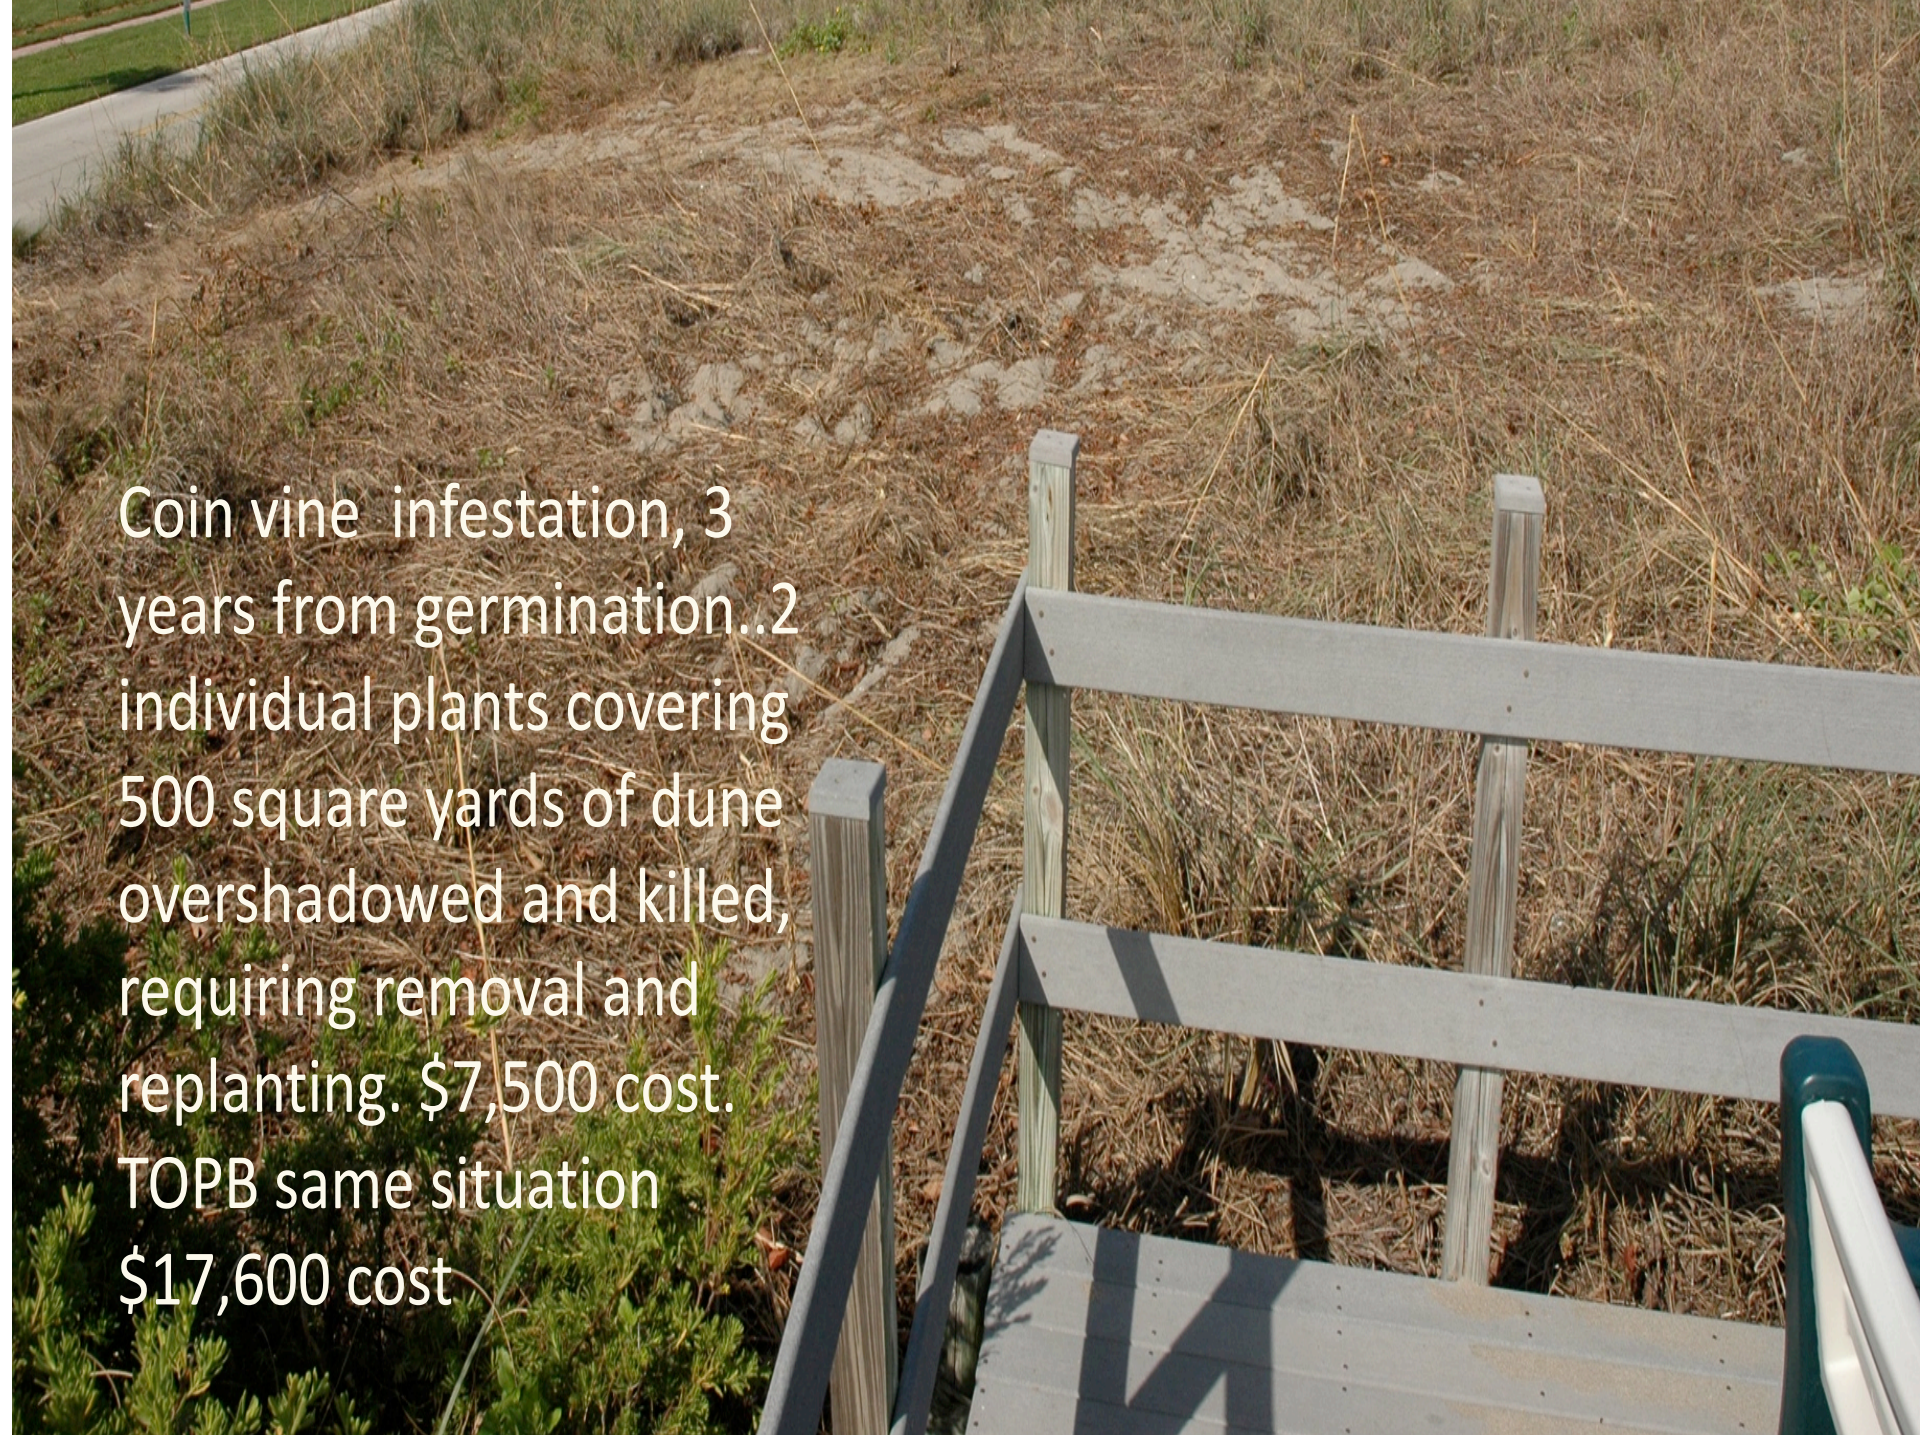
Coin vine infestation, 3
years from germination..2
individual plants covering
500 square yards of dune
overshadowed and killed,
requiring removal and
replanting. \$7,500 cost.
TOPB same situation
\$17,600 cost

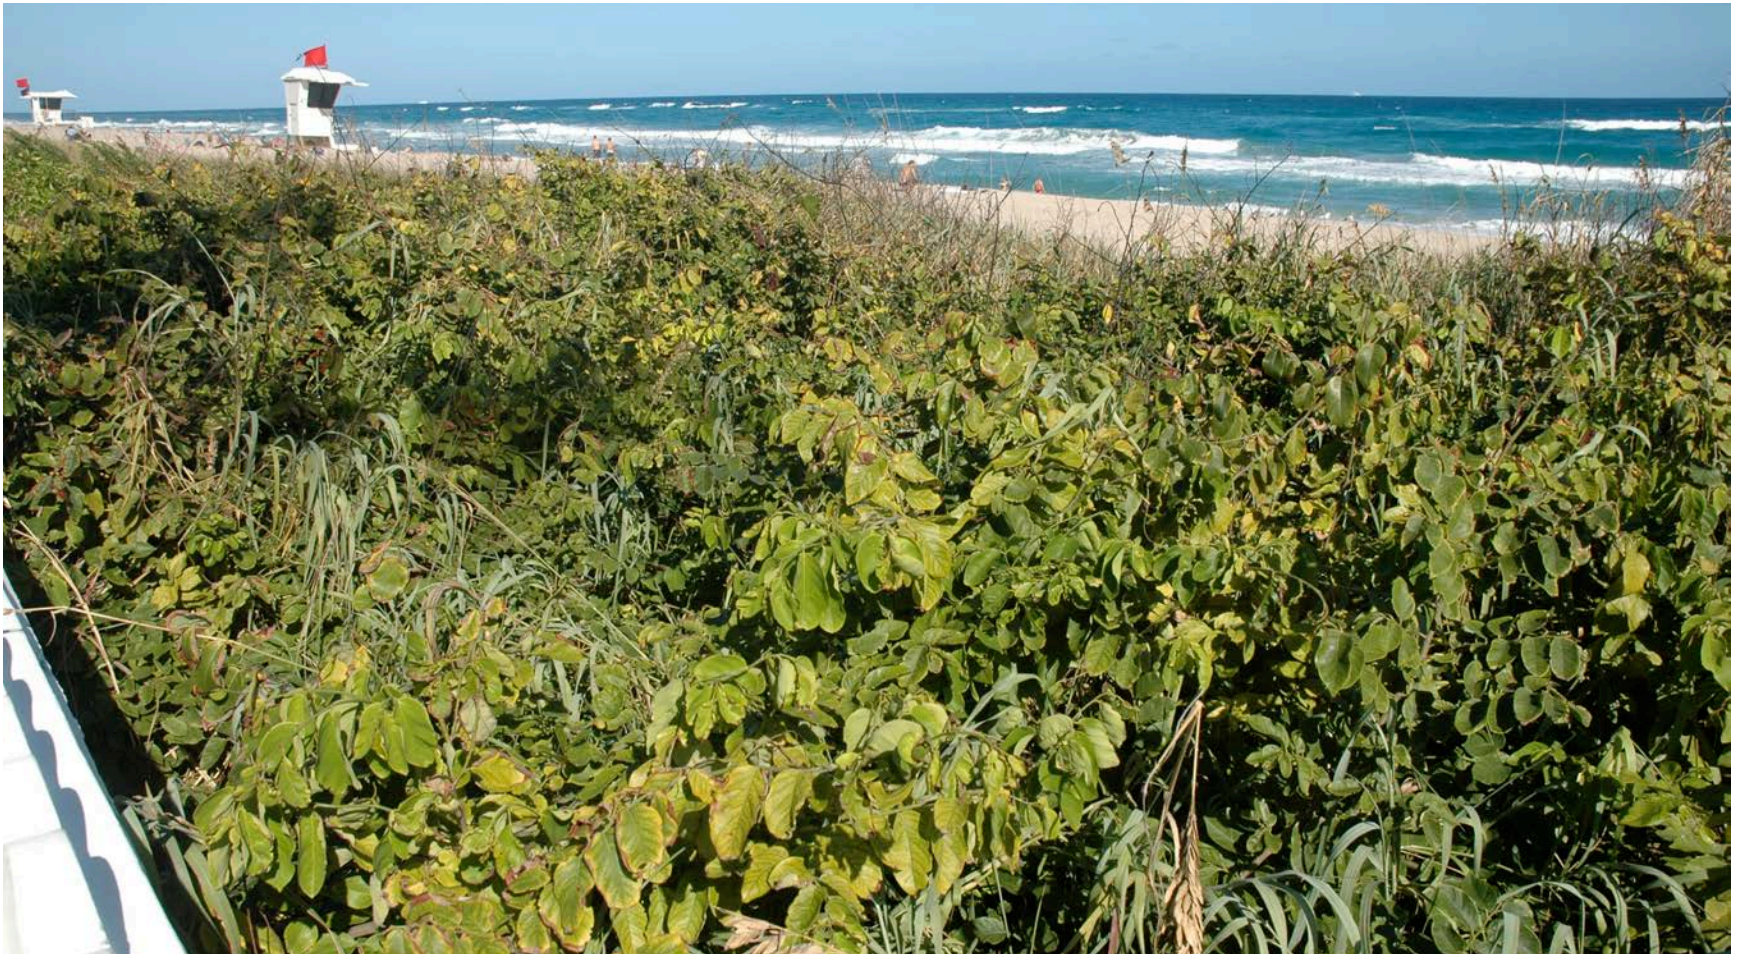
Coinvine killing Midtown dune.

Easy and cheap to control, but costly if allowed to establish.

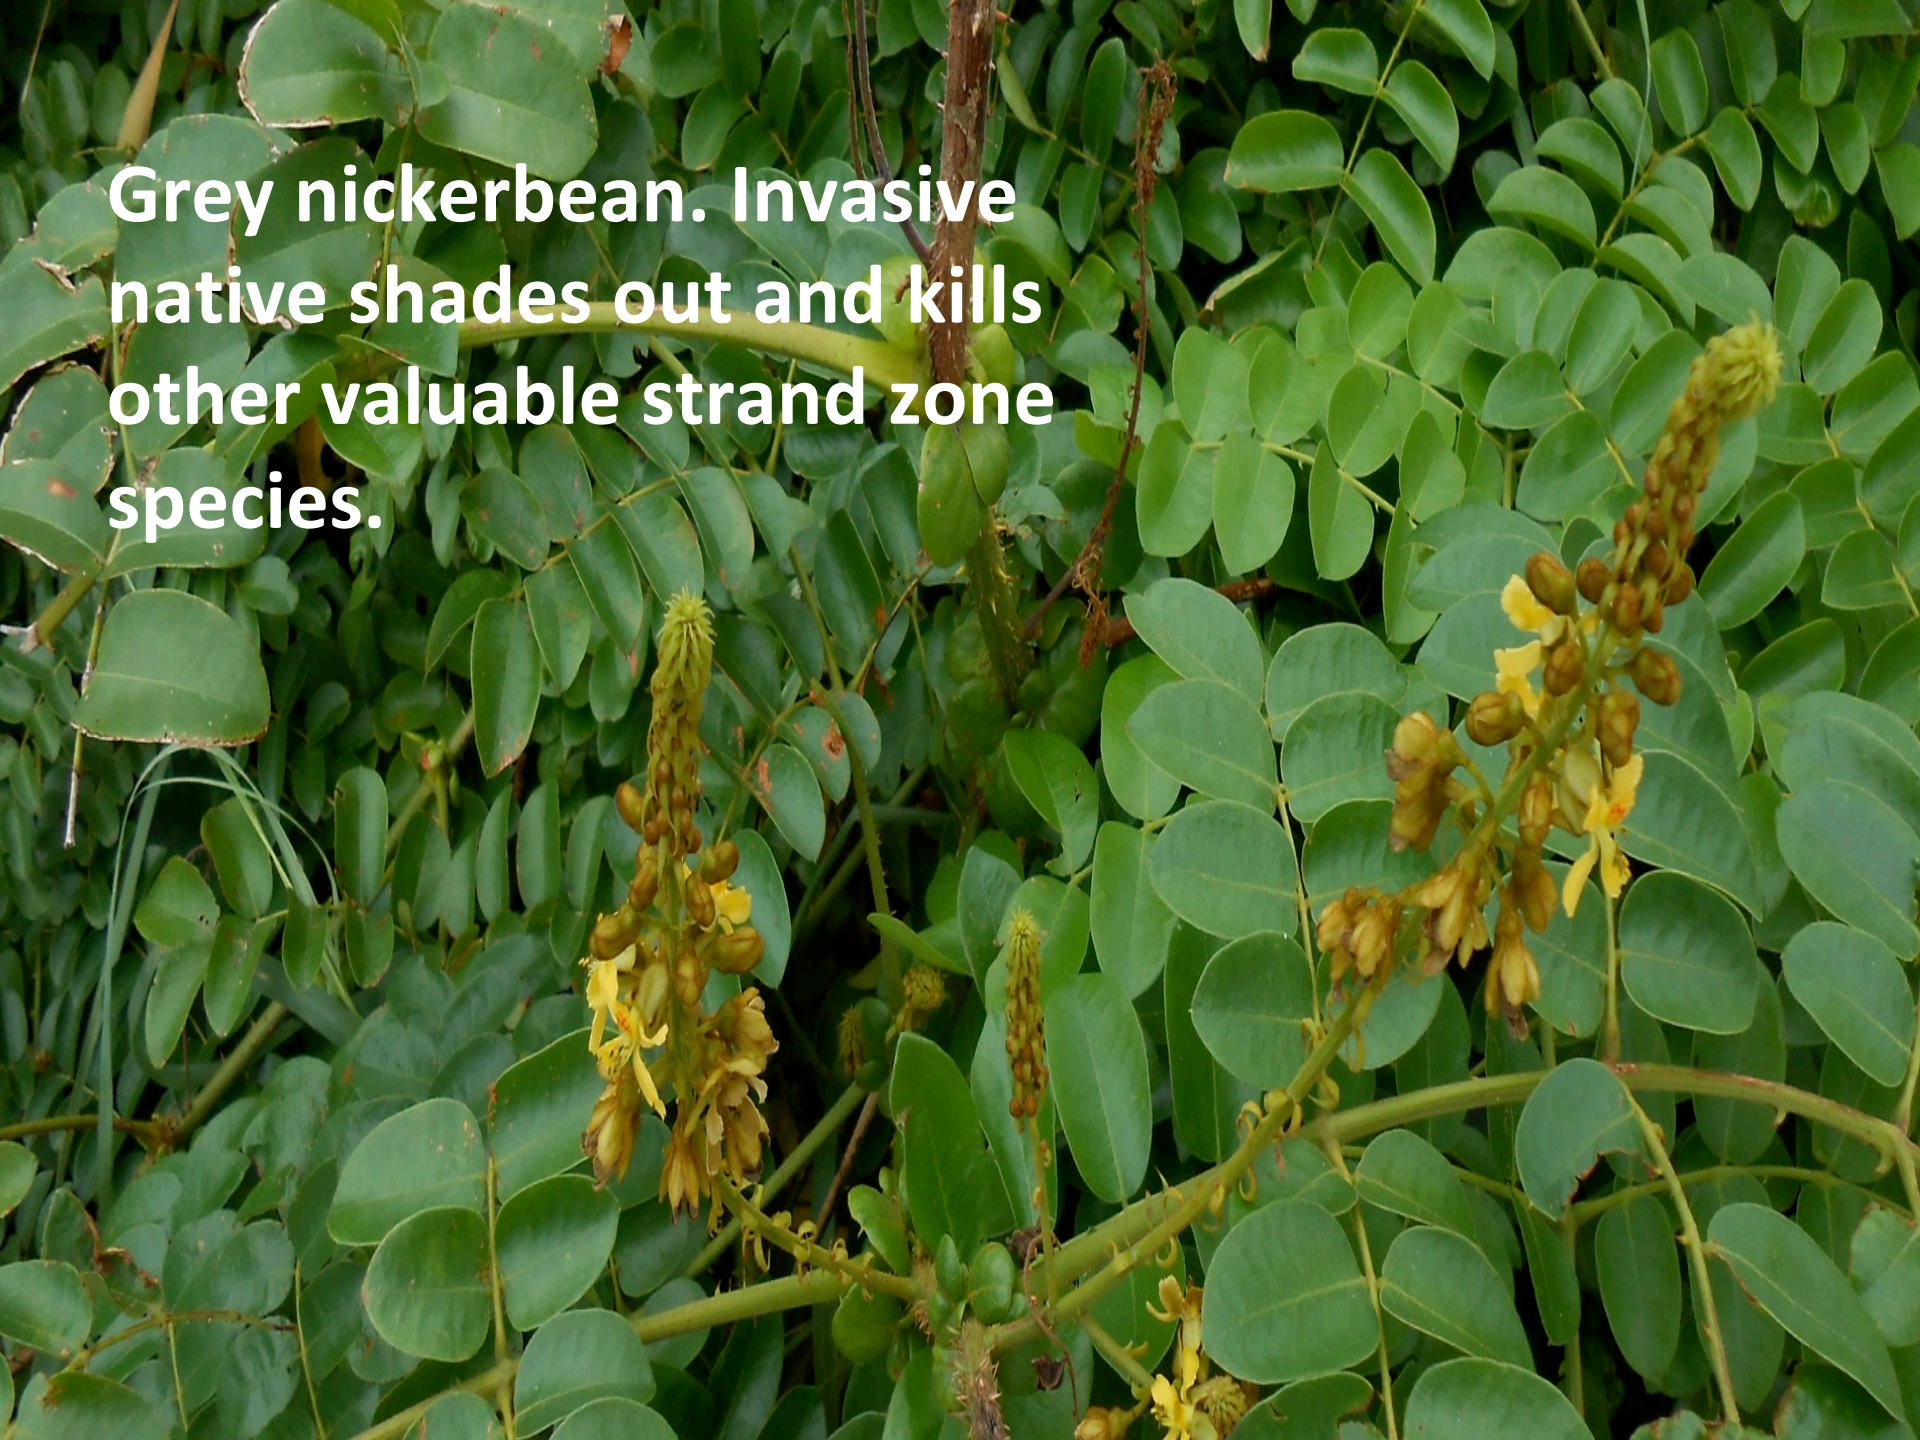
**Grey nickerbean. Invasive
native shades out and kills
other valuable strand zone
species.**

Replanting will cost minimum of
\$4/square yard.

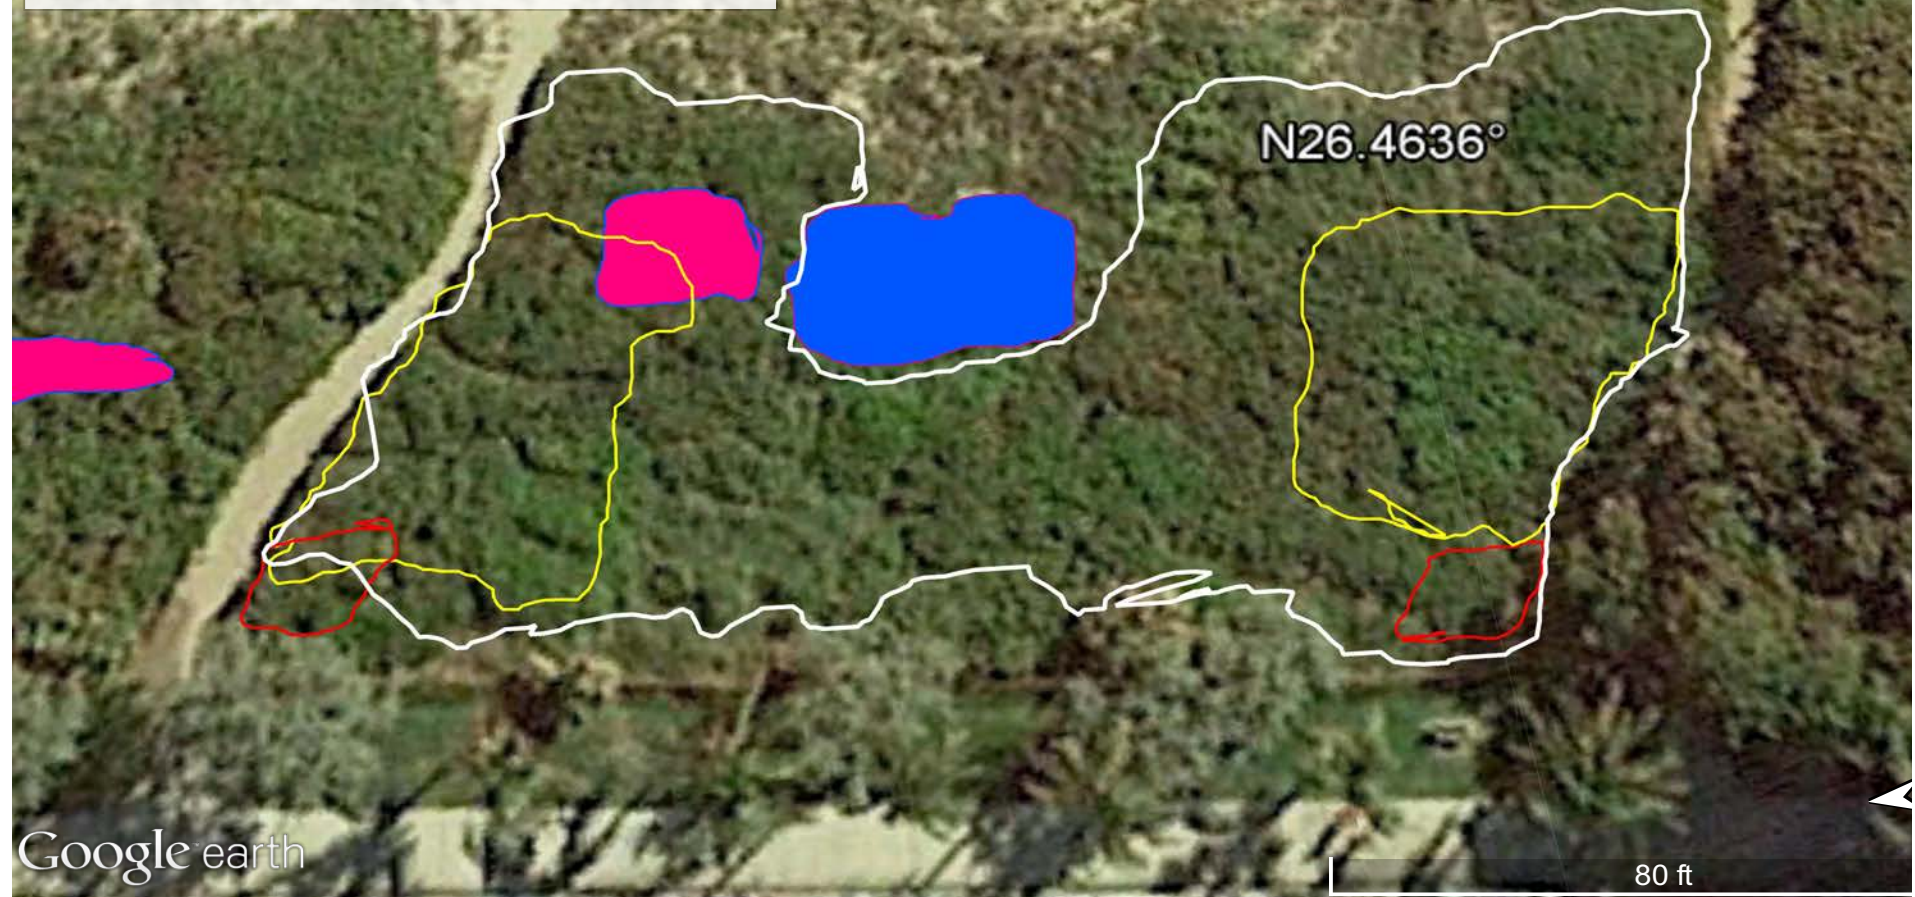
Section 17 Seagrape expansion since 1985

Red line is approximate footprint of seagrape clusters as installed to trap sand at access points 1982; about 300 sq ft.

Yellow is footprint at time of 2001 FDEP pruning permit; about 4,500 sq.ft.

White line is seagrape footprint at 2015 FDEP exotic removal permit; about 10,500 sq. ft.

35X increase since planting, 2.3X increase since pruning began. 7% /year, expansion since pruning began.

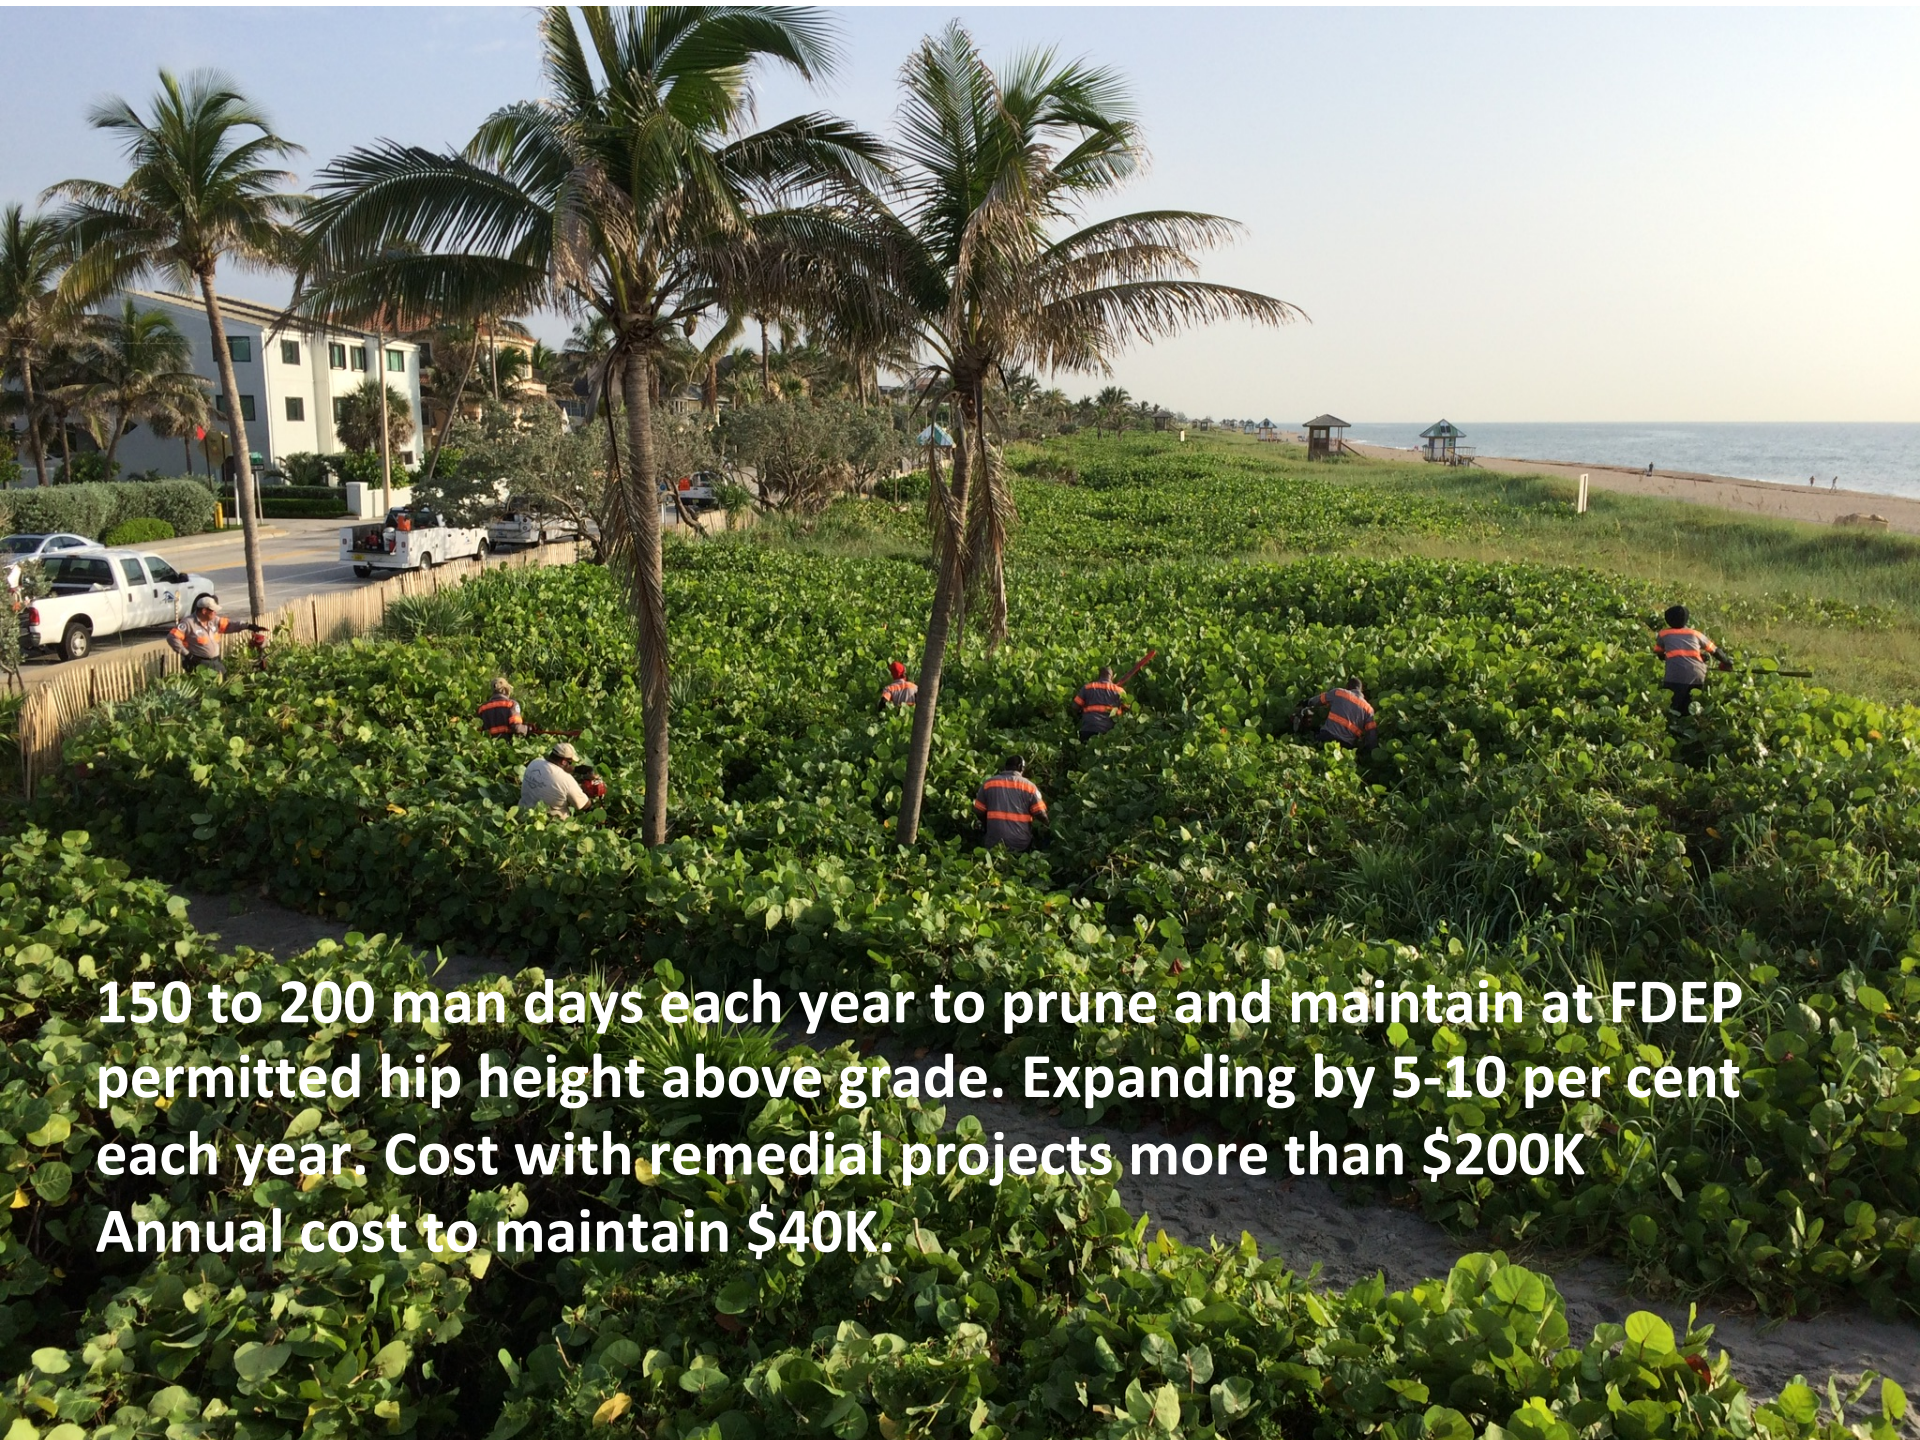
Seagrape shades and kills everything below.

150 to 200 man days each year to prune and maintain at FDEP permitted hip height above grade. Expanding by 5-10 per cent each year. Cost with remedial projects more than \$200K Annual cost to maintain \$40K.

March 2017, FDEP permitted
Coppicing, exotic removal,
species enhancements to SER
standards
