WHEN DUNES MISBEHAVE

ROBERT H. BARRON
COASTAL MANAGEMENT CONSULTING
<beachmaker@aol.com>

The Coastal Engineering Community has become quite proficient working with the fluids of Wave, Wind and Weather, but with recent focus on construction of dunes, faces for the first time a fluid with an agenda. That is LIVING BEHAVIOR. The living dune ecosystem, can sometimes perform in unexpected ways, at times beneficial and occasionally harmful.

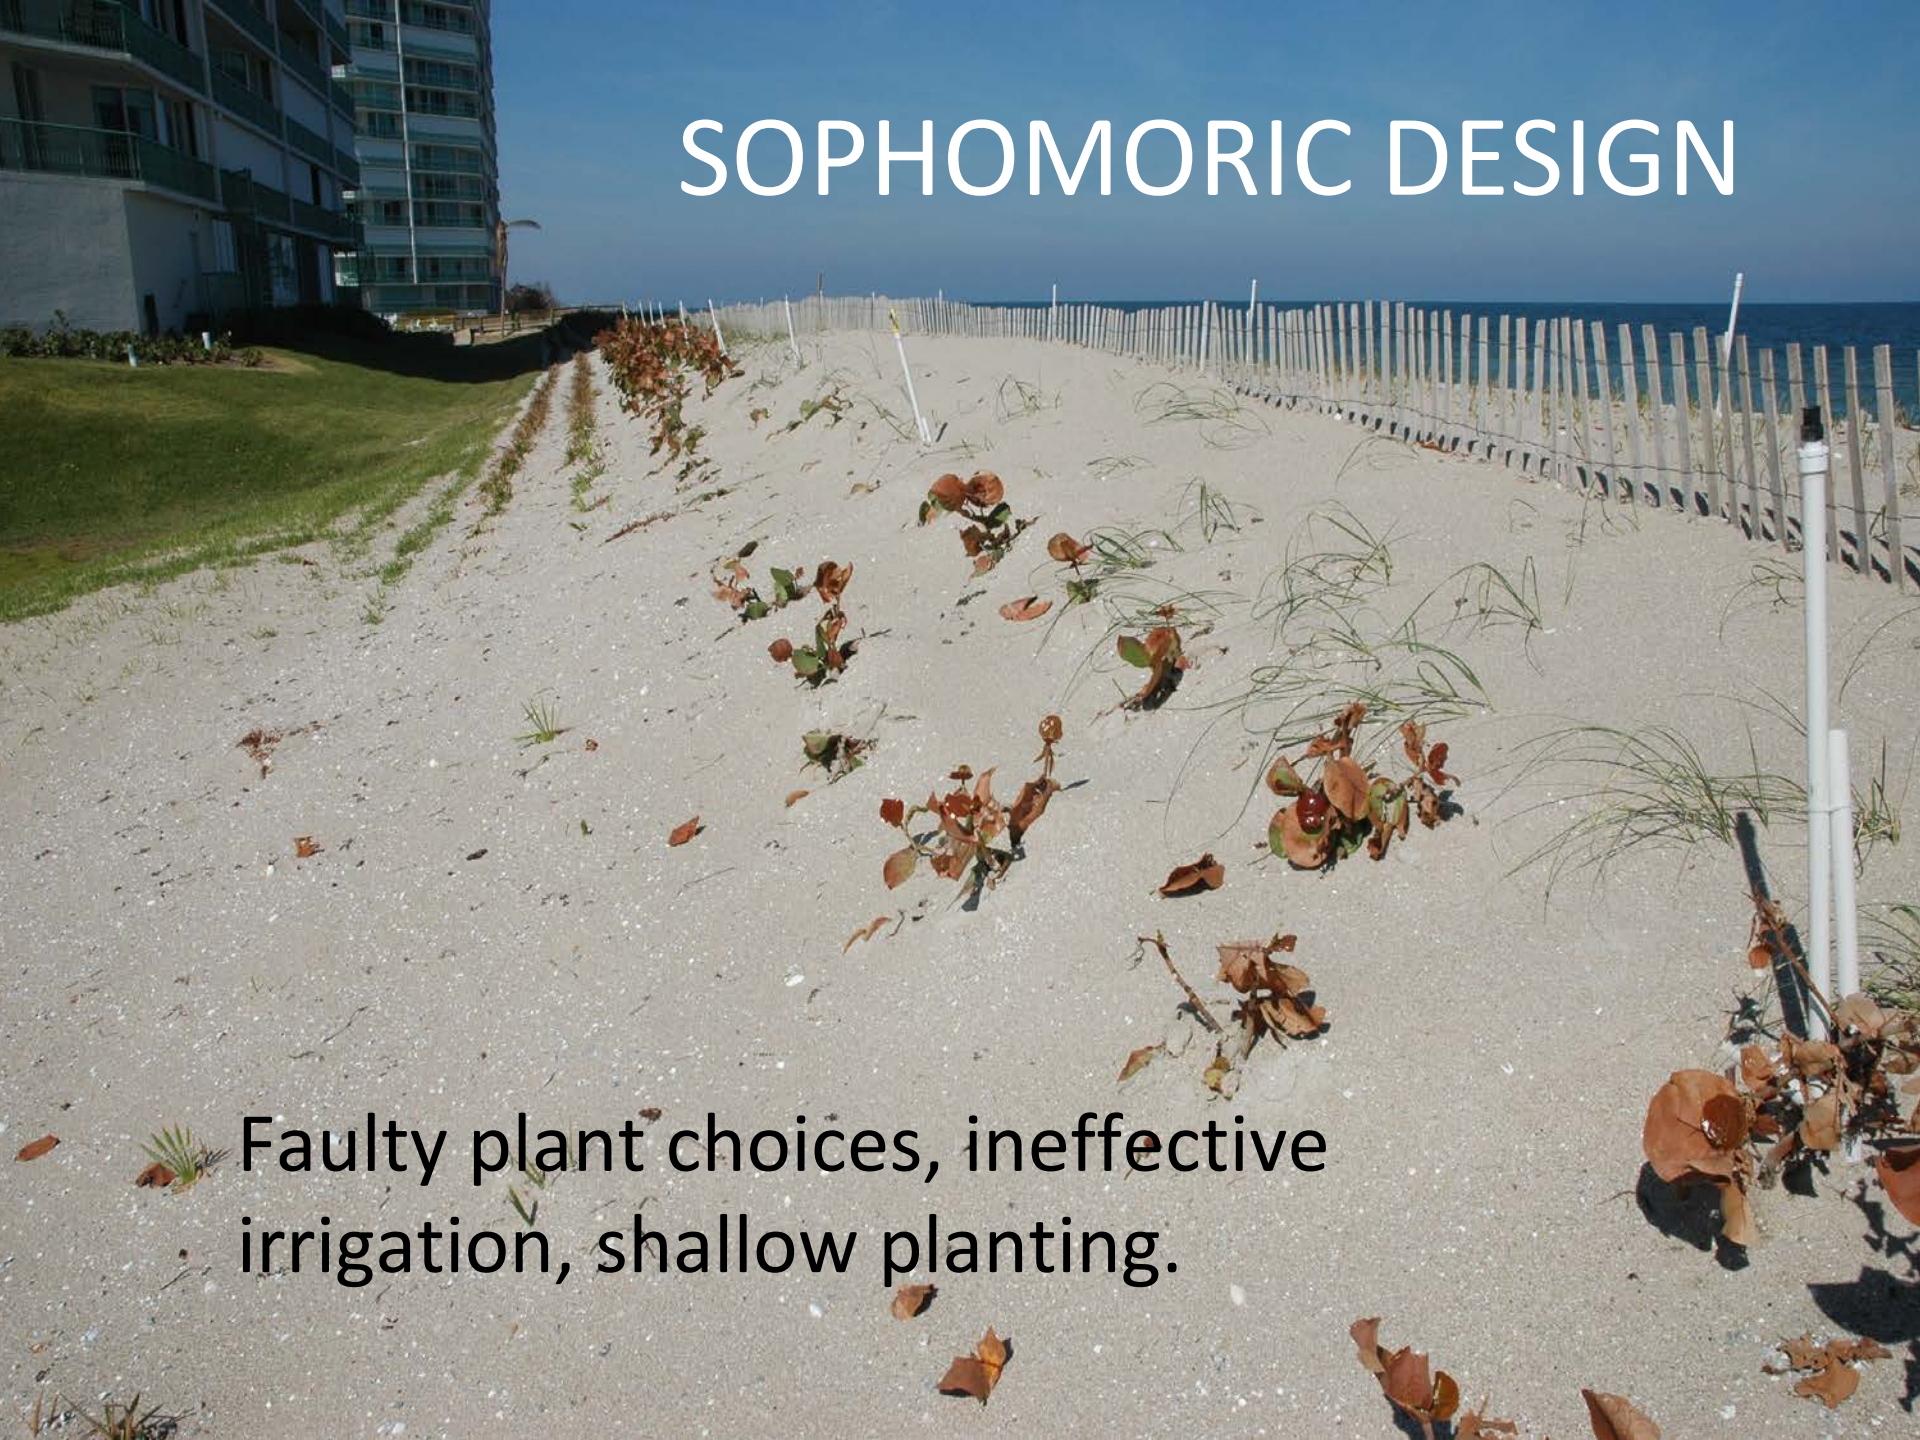
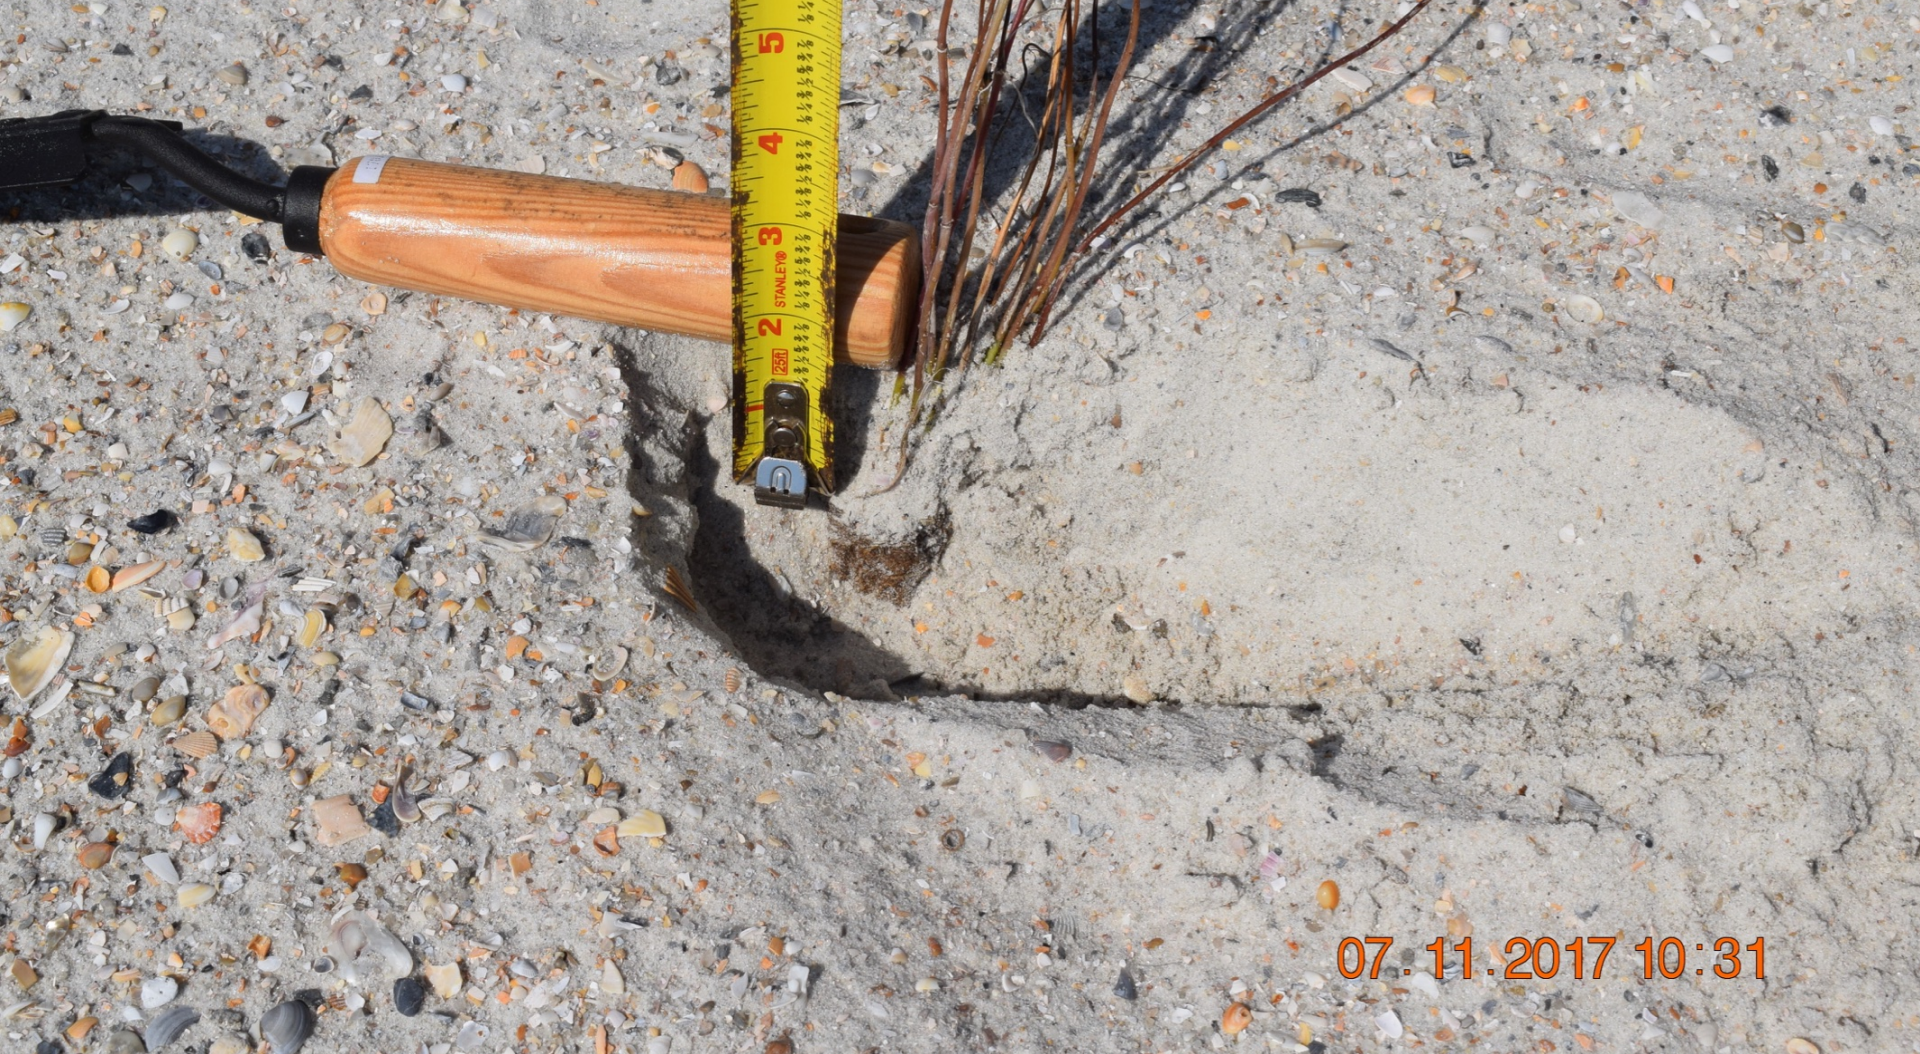
Faulty plant choices, ineffective irrigation, shallow planting.

Dune planting specifications typically call for planting depths of 6 inches to get plants into zone of constant moisture. Most projects fail to achieve this, yet still get paid.
THE RESULT IS POOR PLANT SURVIVAL AND FAILURE TO THRIVE.

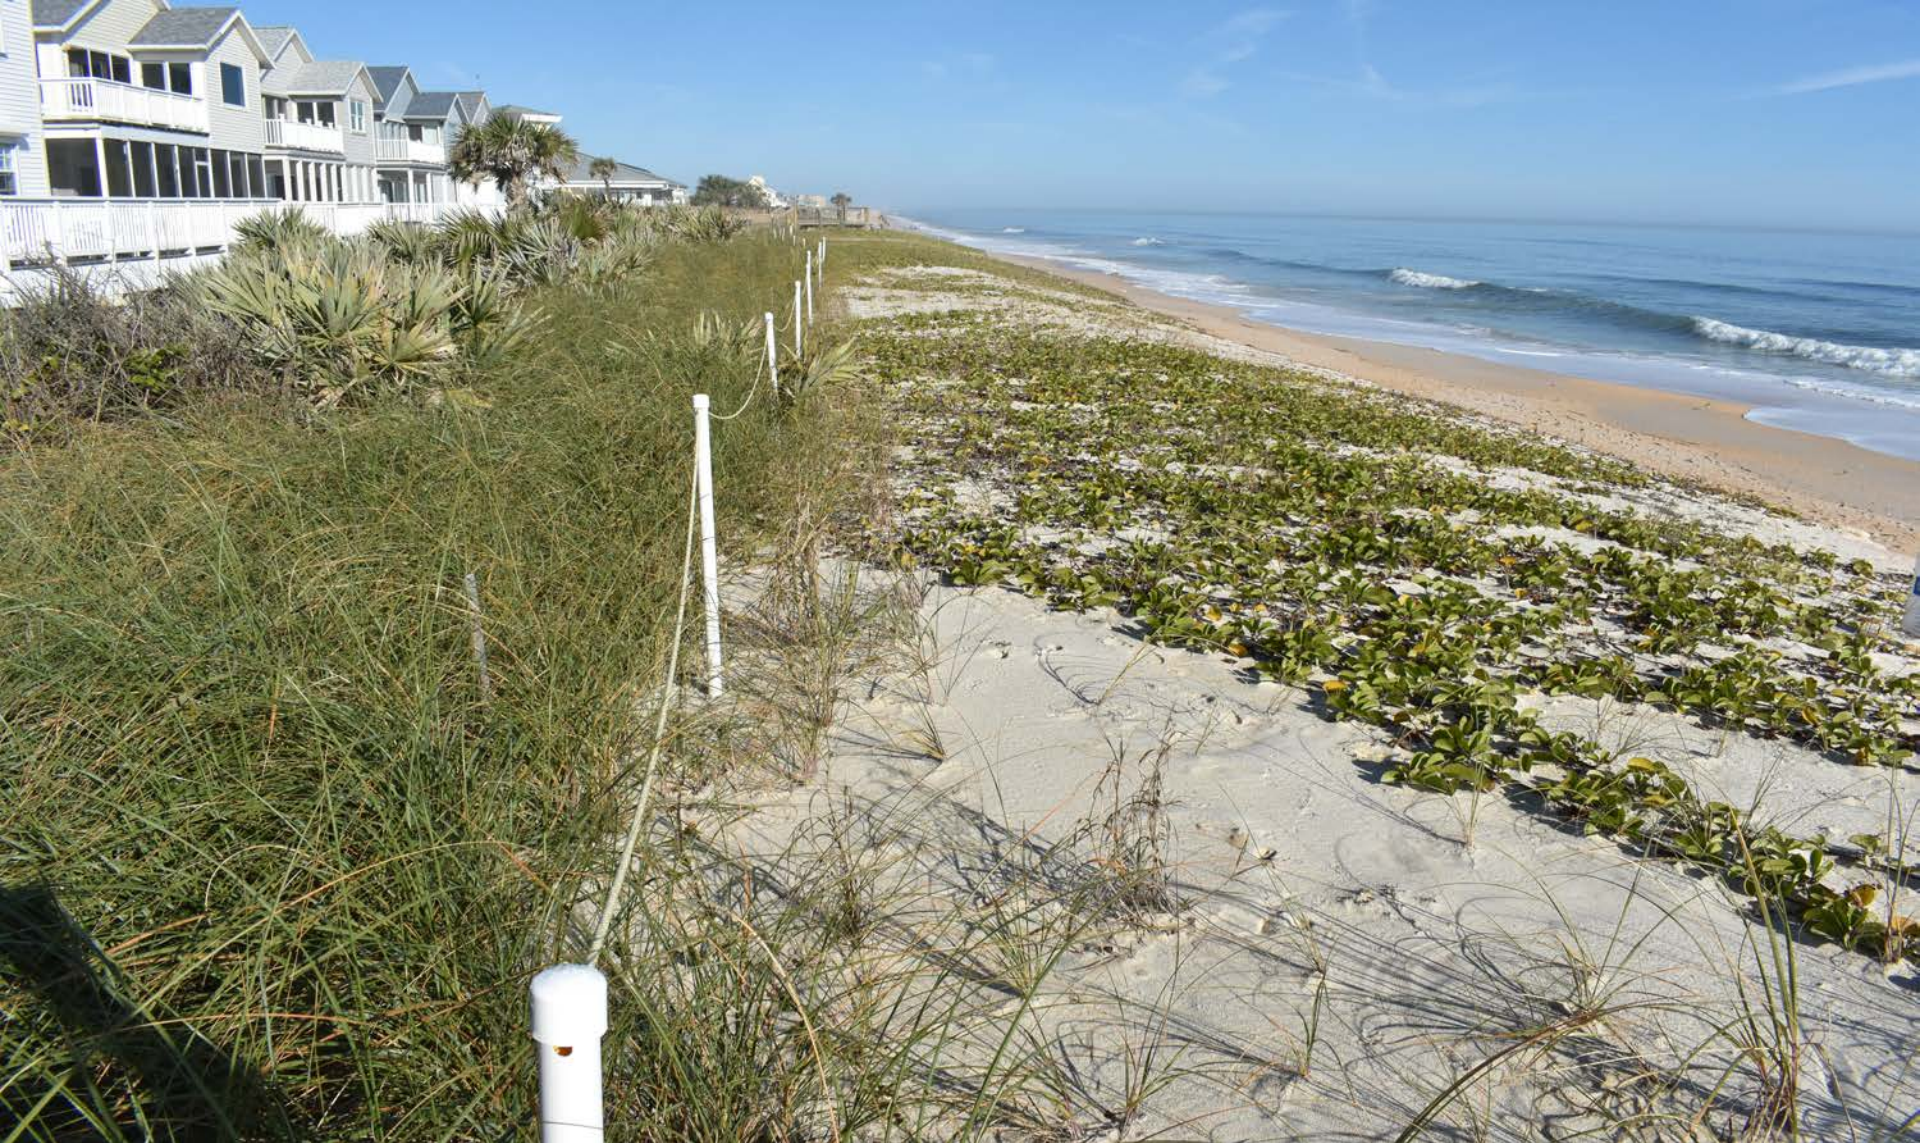
Left of rope..private work to spec..

Right of rope. Public project..not so much.

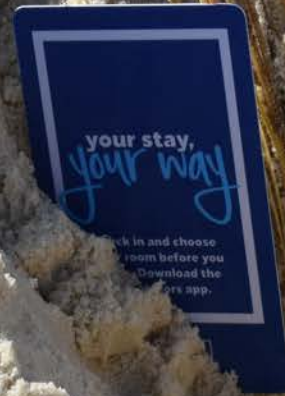
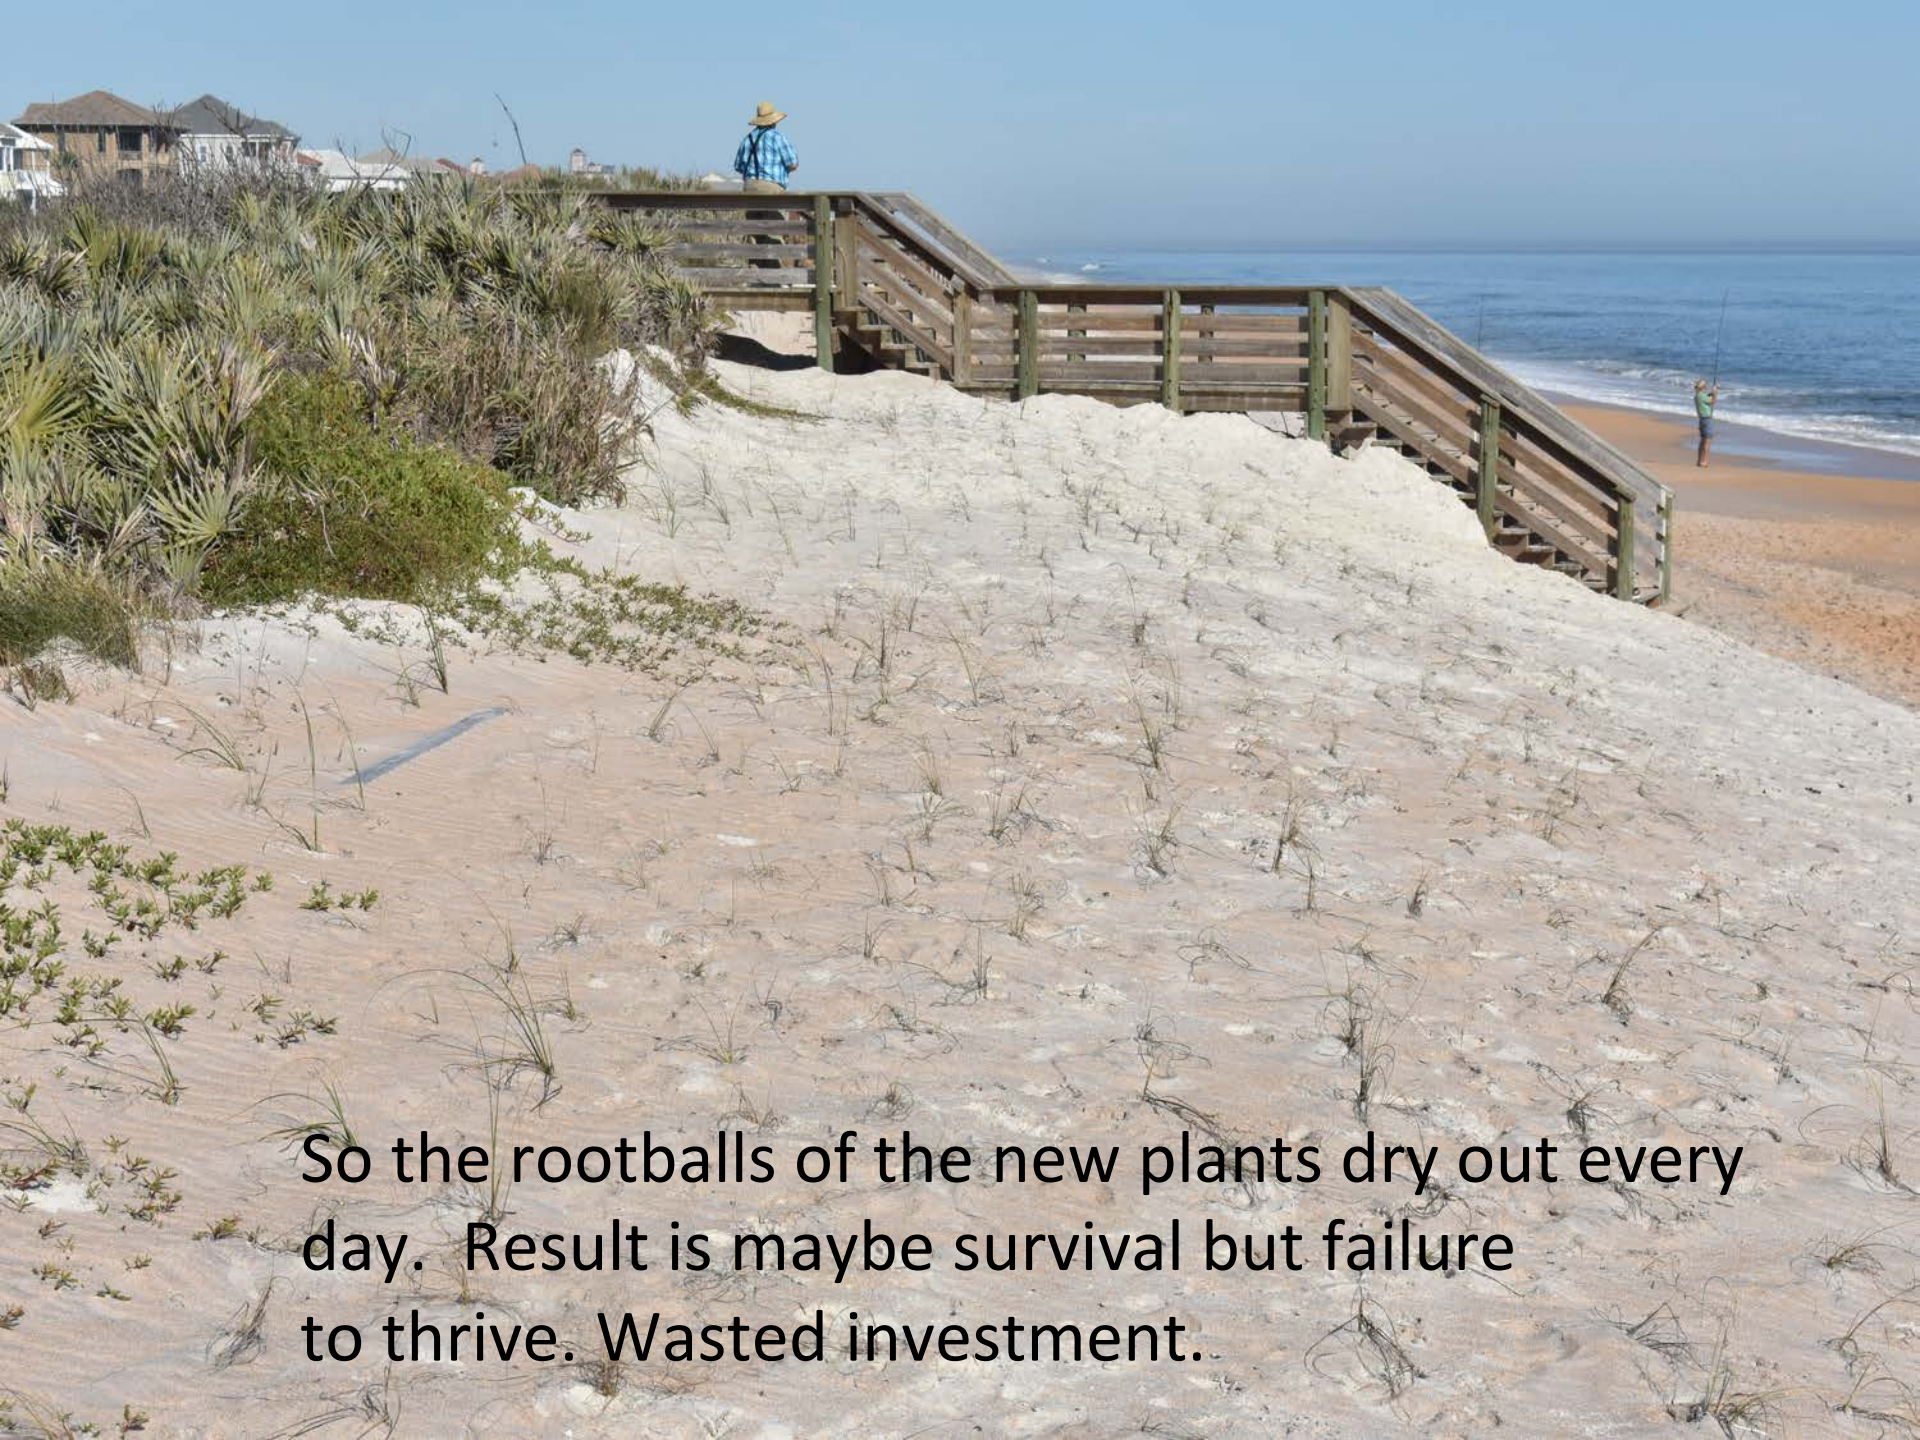
Spec was top of
root ball to 6 inches
below grade. Most
plants measured at
2 to 4 inches.

So the rootballs of the new plants dry out every day. Result is maybe survival but failure to thrive. Wasted investment.
