Town of Palm Beach, FL Lake Worth Inlet Sand Transfer Plant Integrity Assessment

FSBPA 36th National Conference on Beach Preservation Technology
February 1-3, 2023

Integrity Assessment

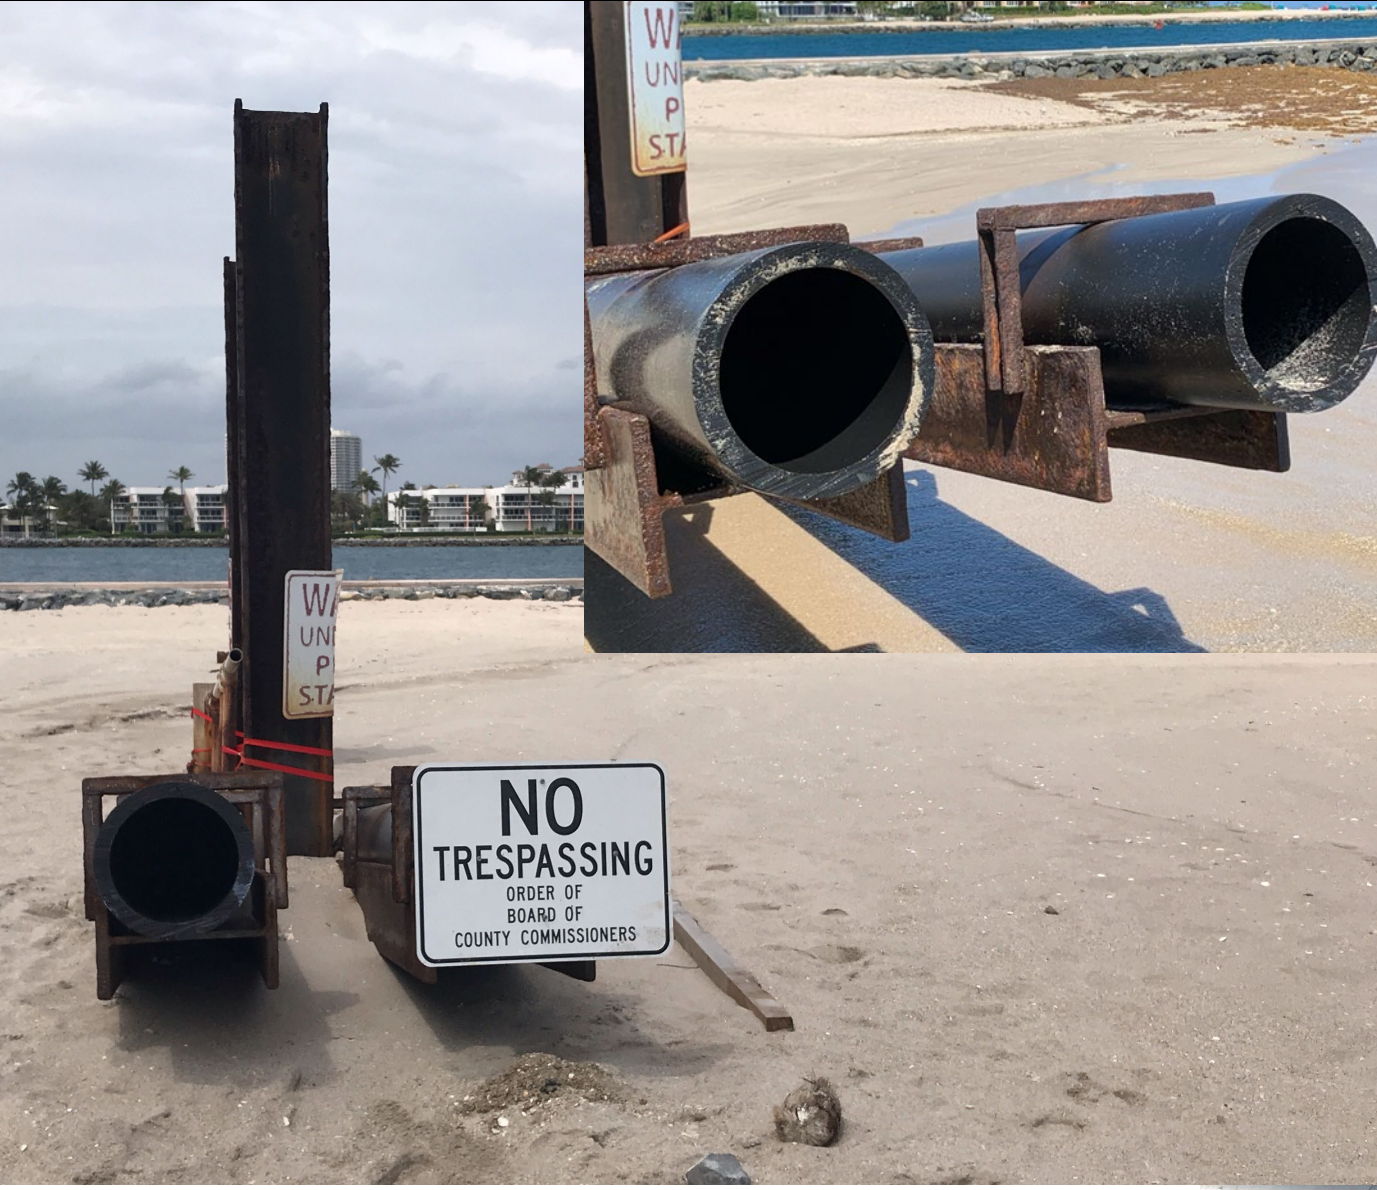
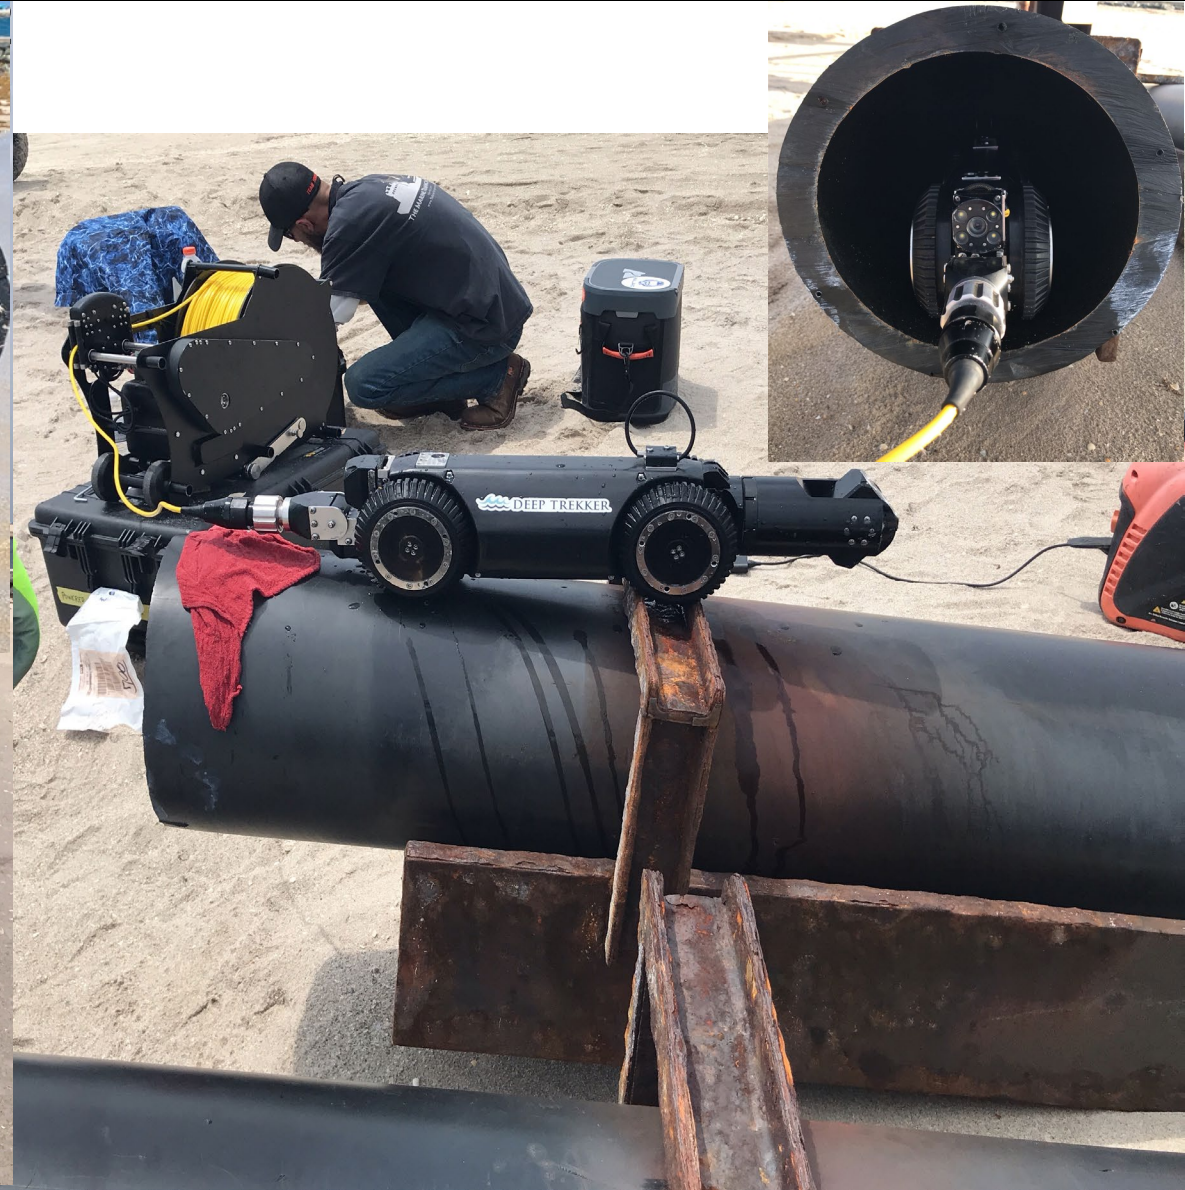
Functional Line

Distance Documented = ~1,400 linear feet
(Straight line as measured by crawler)
Maximum Documented Pipeline Angle = $<20^\circ$

Non-Functional Line

Distance Documented = ~90 linear feet
Maximum Documented Pipeline Angle = $>40^\circ$

11 Coarse shell and sand encountered
at ~80 feet

- The excess slope (>40-degree decline) in the non-functional discharge line as it transitions back up to the beach south of the Inlet may be the functionality issue with this asset. Remedial measures may be available to bring this line back into service without complete replacement, but additional investigations are necessary to further define the challenges.

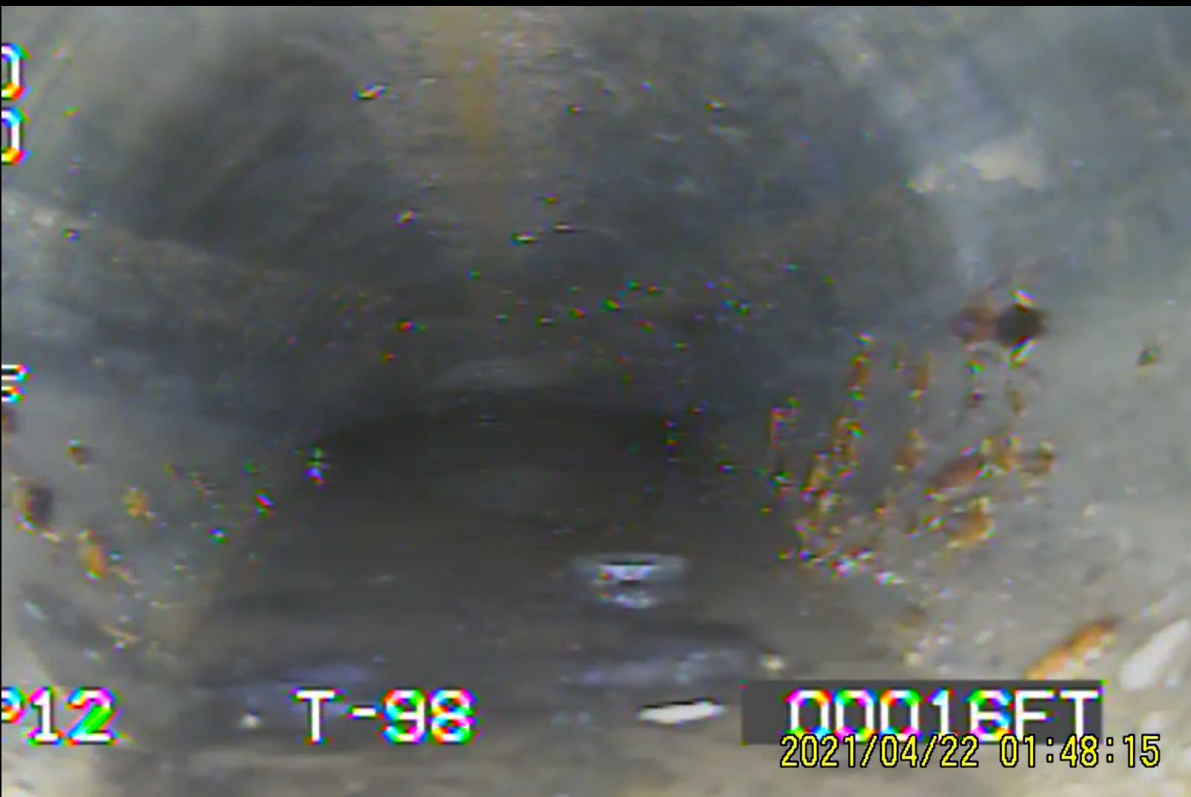
Non-Functional Line
Distance Documented = ~370 linear feet
(Straight line as measured by crawler)

- ~35 LF a steep downward angle and banking left turn was difficult to transit without crawler rollover.
- ~ 260 LF, deposits of sand and shell occur with a wave pattern.
- Forward progression stopped at ~370 LF. Pipe cross-sectional area of sediment coverage is approximately 40-50%.
