# TAYLOR ENGINEERING, INC.

## Embassy Suites St. Augustine Beach, Florida Shoreline Protection and Seawall Replacement

J.B. Brumfield, P.E. February 7, 2024

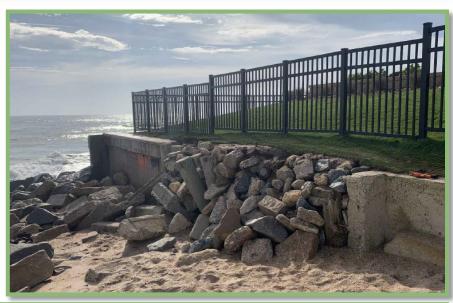
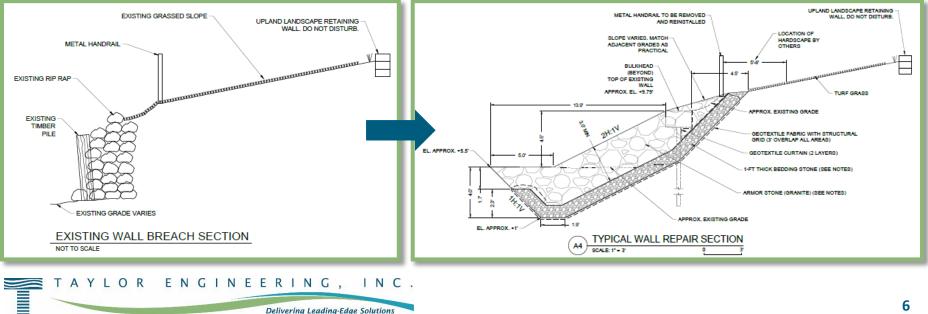
- Gap in wall on northern corner
  - Plugged with old rubble and other debris
  - Causing depressions from fill loss
- Significant issue for flooding

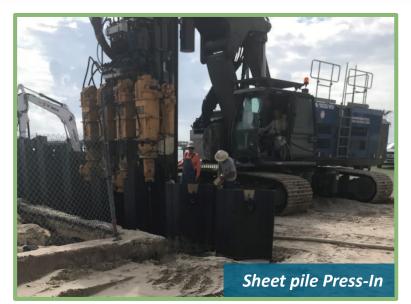
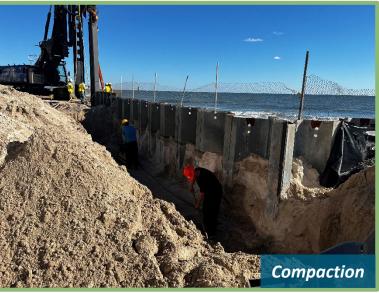
- Silent press-in equipment
  - No vibration
- Buried debris up to 16 ft deep

- Excavation to remove debris
- Compaction program to mitigate consolidation
- S.S. mesh reinforcement in walkway slab
