Honeymoon Island Erosion Control Project Performance during 2016 Tropical Season

Presented by:
Brett D. Moore, P.E., D.C.E.
Humiston & Moore Engineers

Florida Shore and Beach
Preservation Association

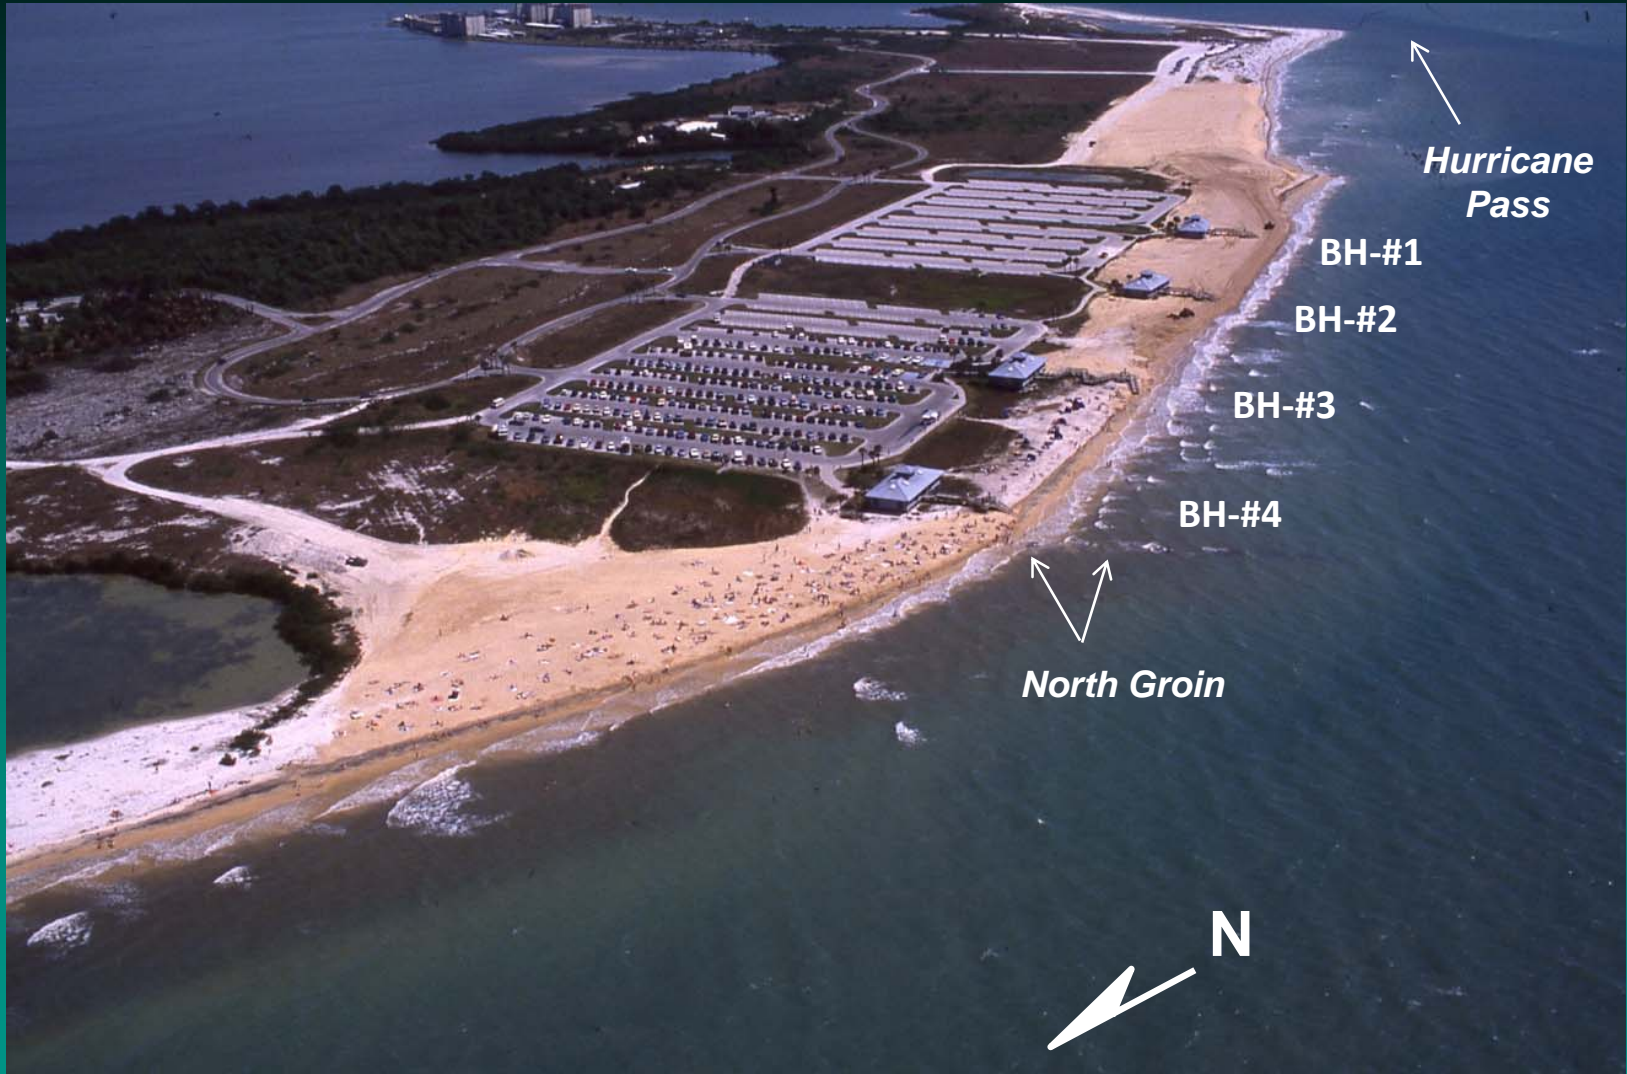
Honeymoon Island 1991

1989-1991

- Shoreline receded
- Walkways shortened

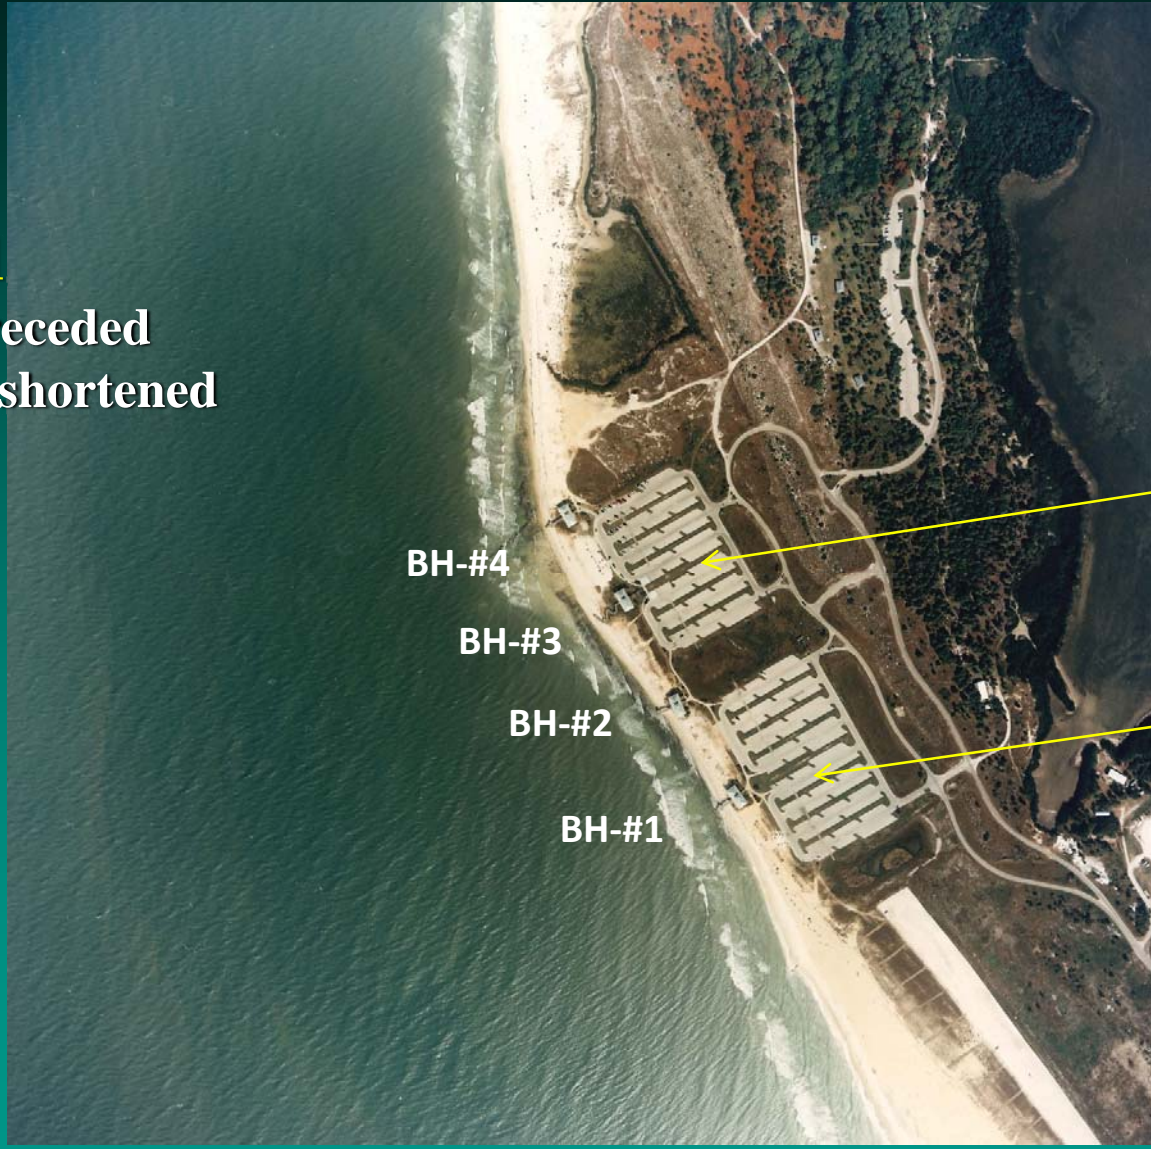
Honeymoon Island 1995

1991-1995

- Shoreline Recession at Parking Lots and South
- BH-#1 Relocated
- BH-#2 Relocated

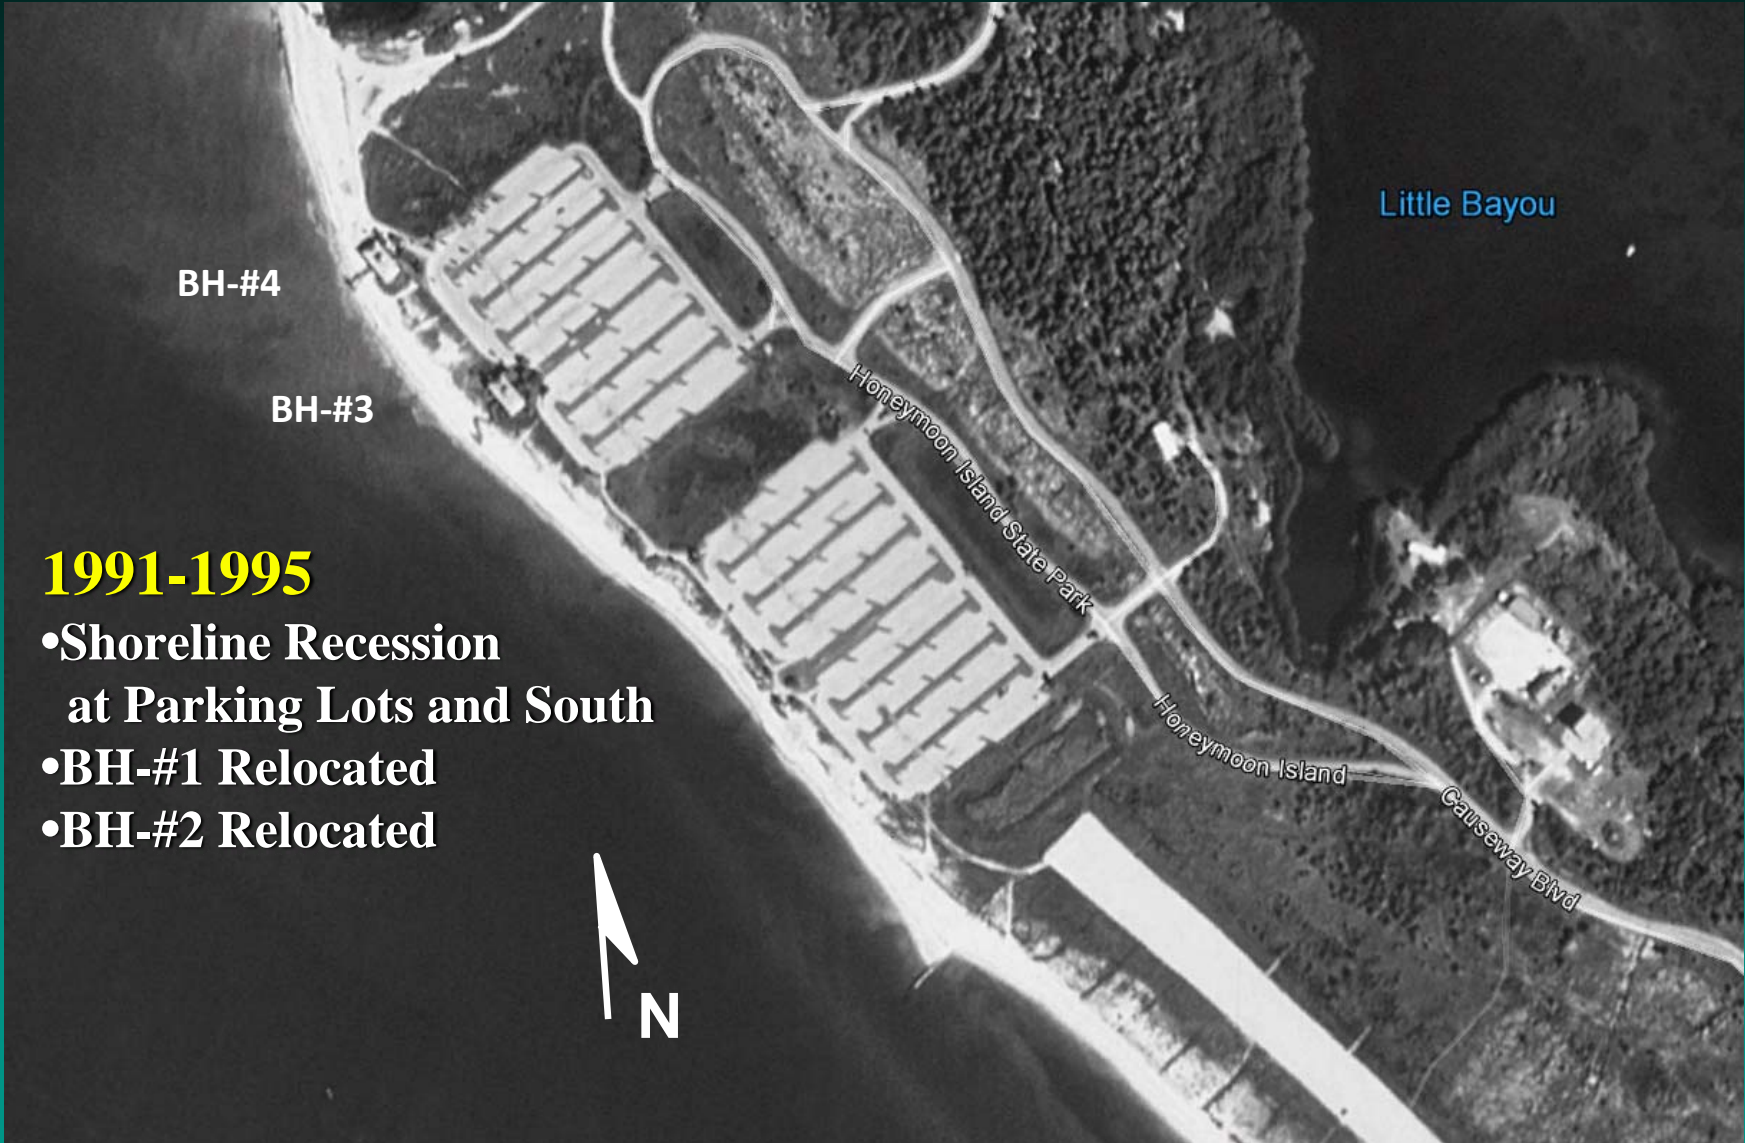
Honeymoon Island 2004

1995-2004

- Continued Shoreline Recession at Parking Lots and Adjacent Areas
- BH-#3 Rubble Shoreline
- BH-#4 Rubble & Concrete Shoreline

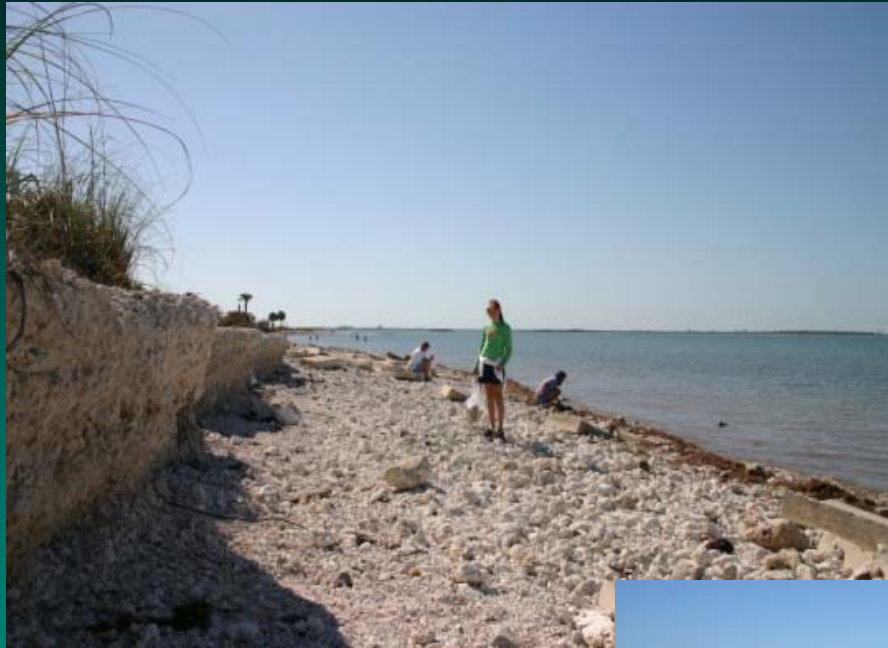
Honeymoon Island 2004

1995-2004

- Parking Lots – Vulnerable
- Mostly rubble beach.

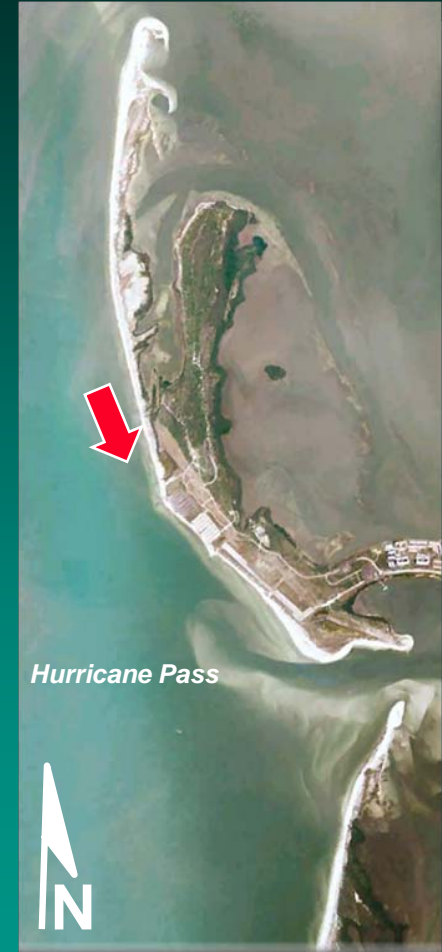
- Concrete debris for shoreline protection near BH-#3.

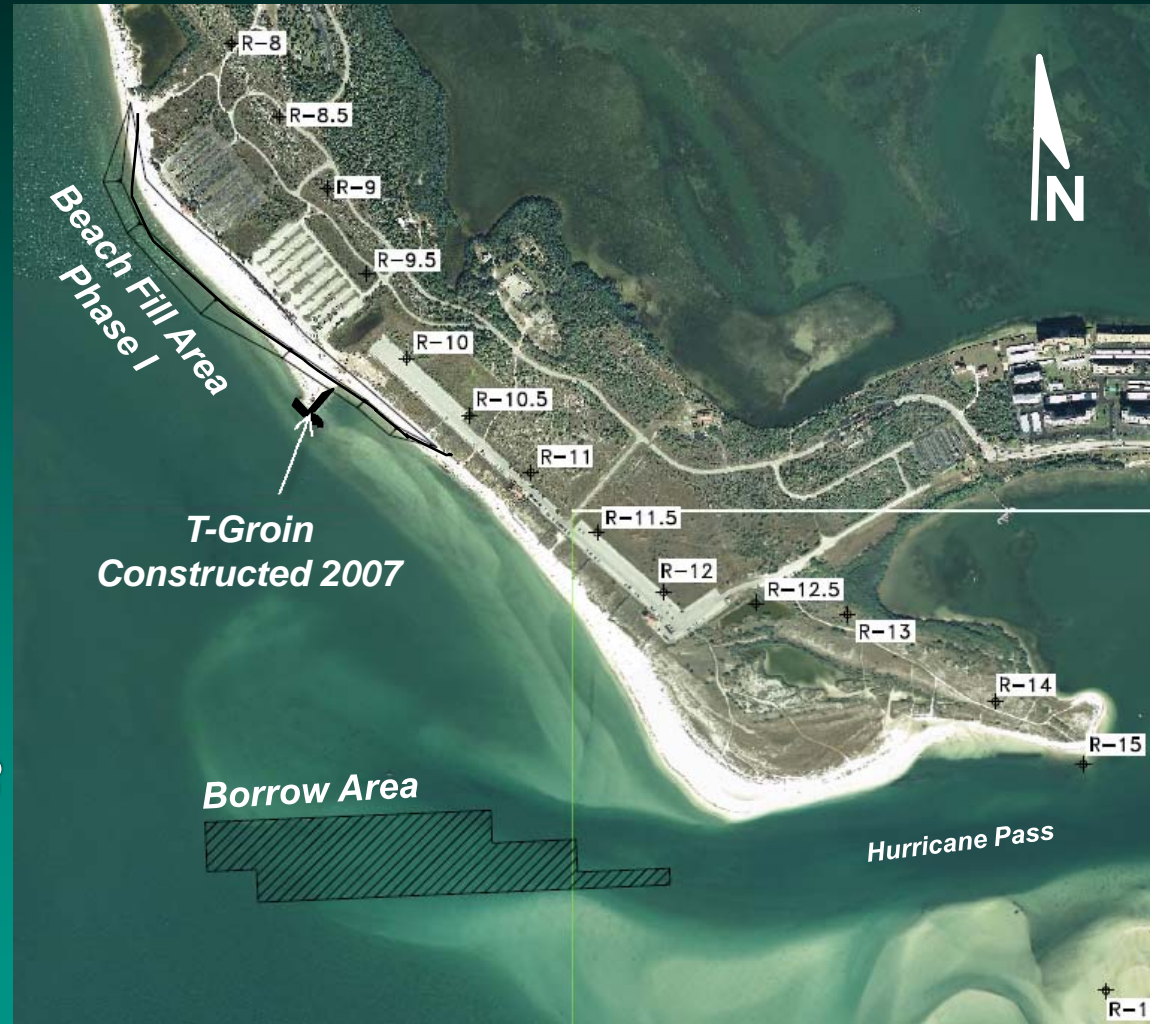
Honeymoon Island Phase I Project

- *150,000 CY placed between R-8 to R-10.5*

- *T-groin Constructed*
- *One T-groin, fill, monitor*

- *Construction from Aug. 2007 to Jan 2008*

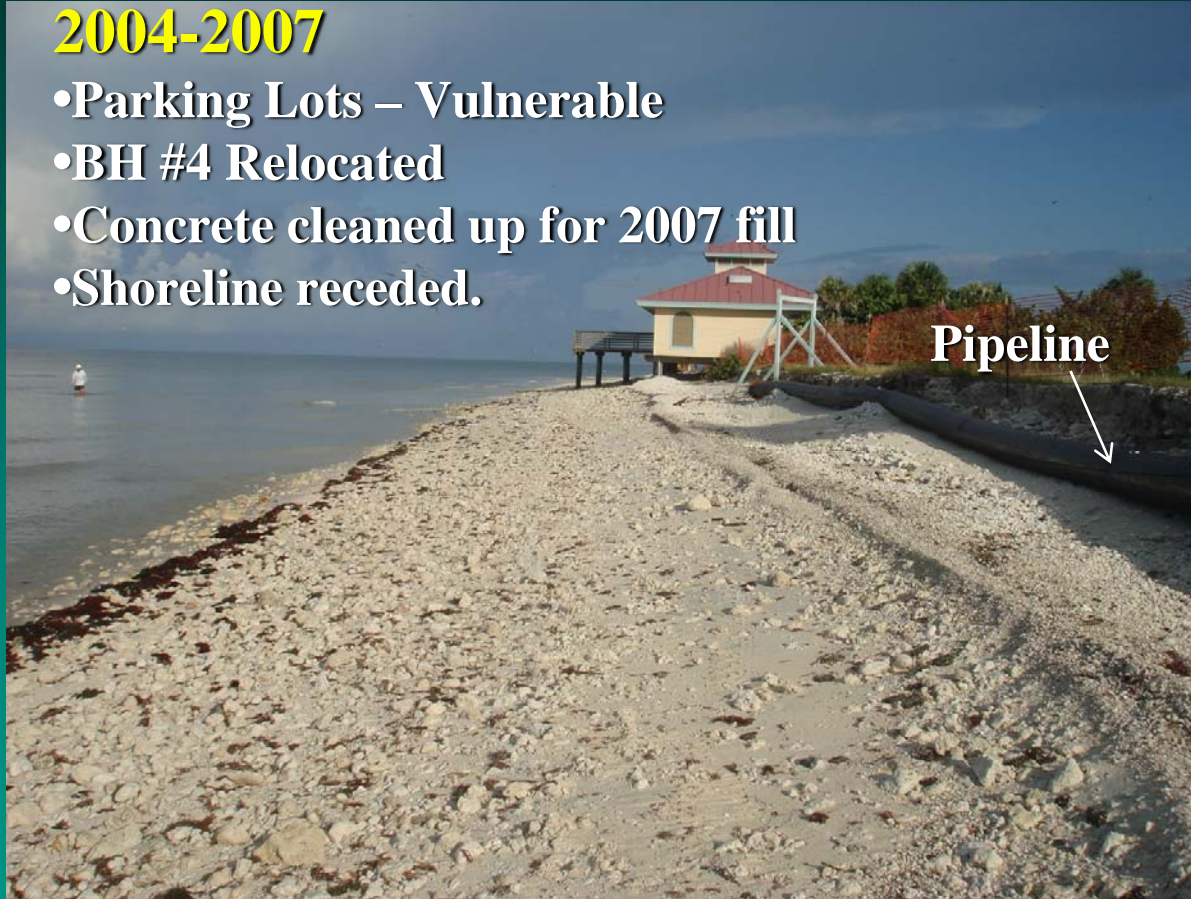
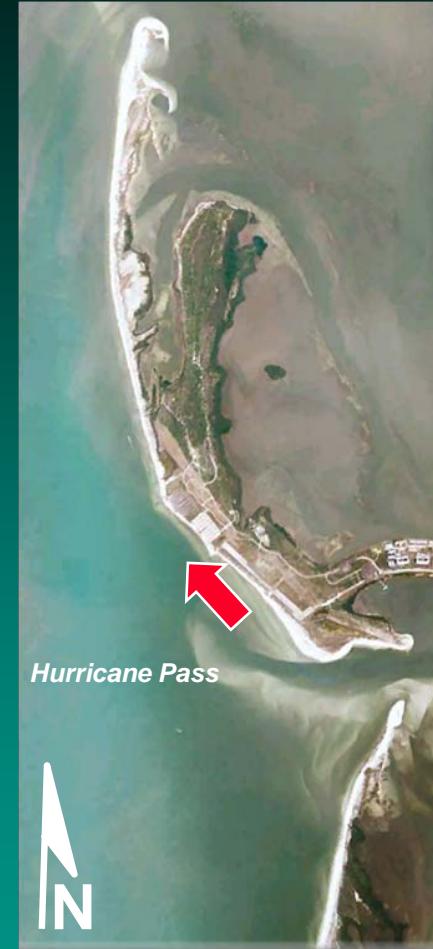
Honeymoon Island 09-11-2007

2004-2007

- Parking Lots – Vulnerable
- BH #4 Relocated
- Concrete cleaned up for 2007 fill
- Shoreline receded.

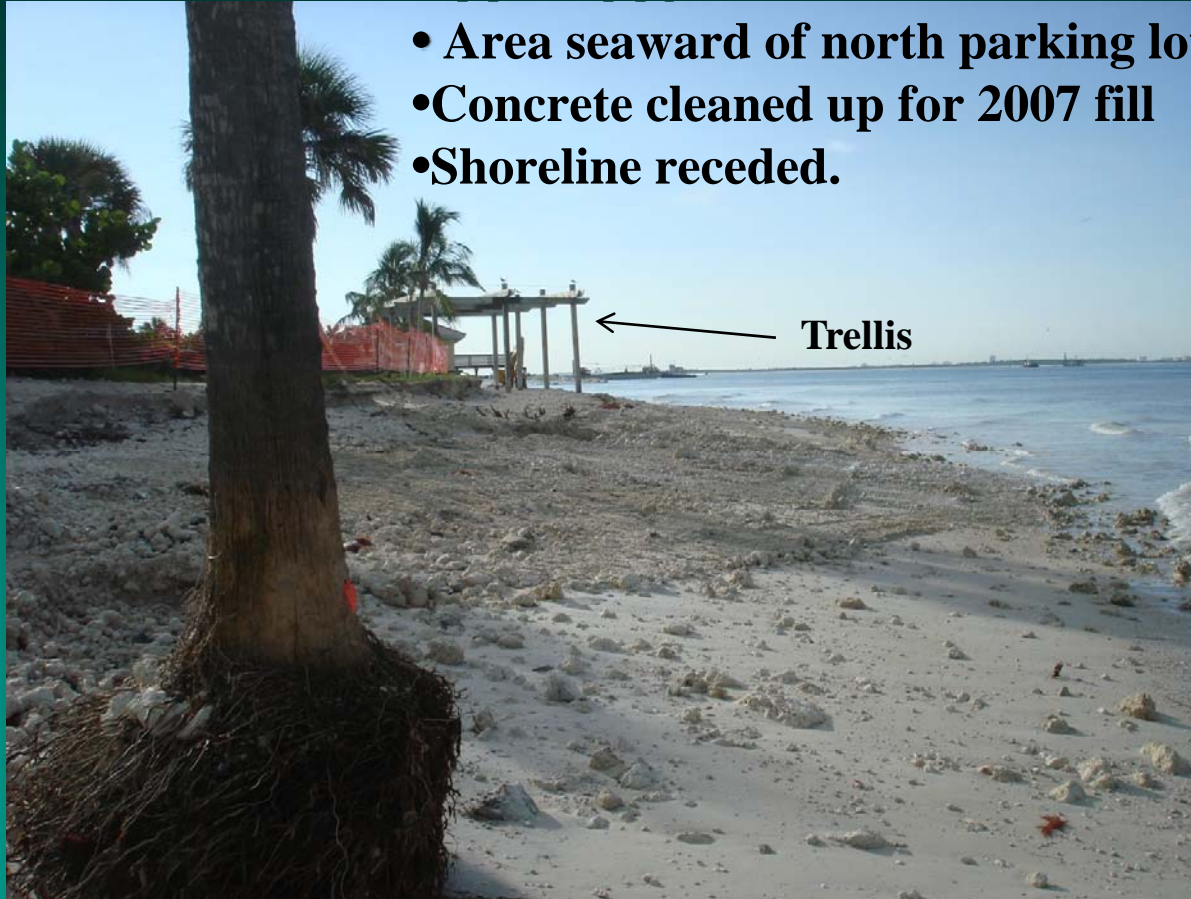
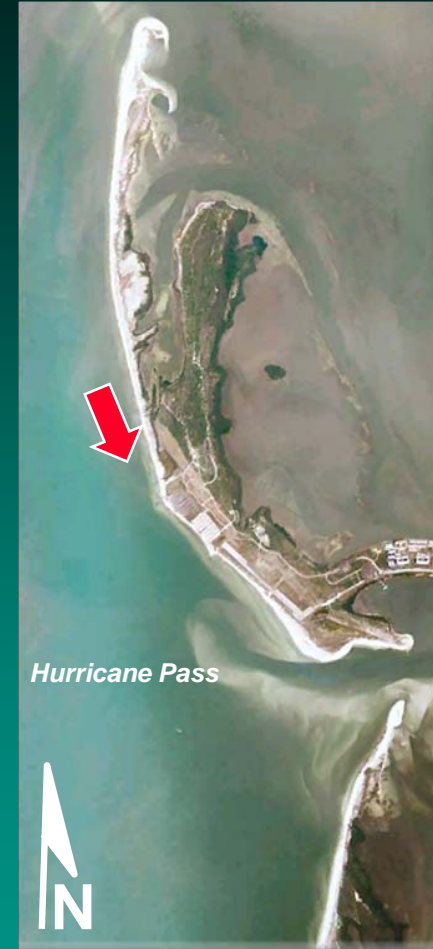
Honeymoon Island 09-11-2007

2004-2007

- Area seaward of north parking lot
- Concrete cleaned up for 2007 fill
- Shoreline receded.

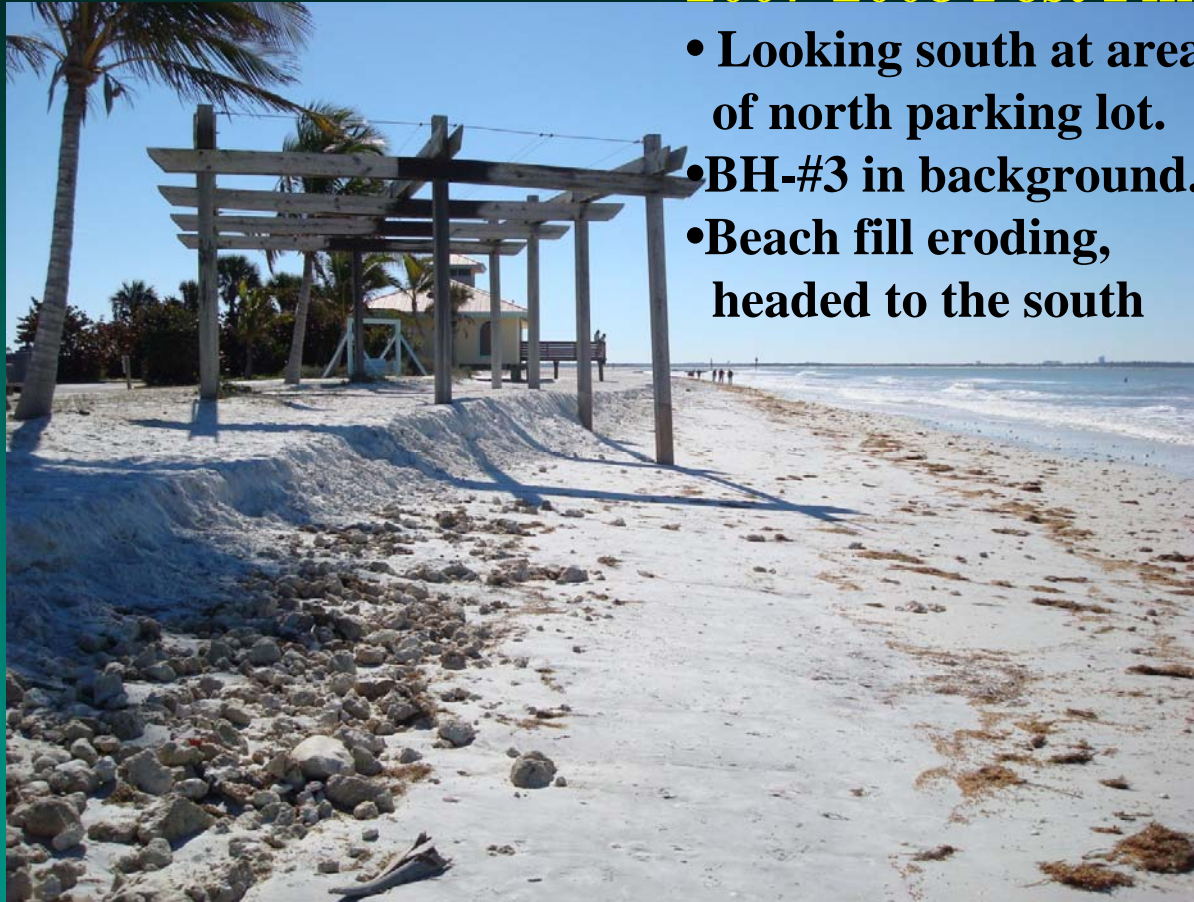
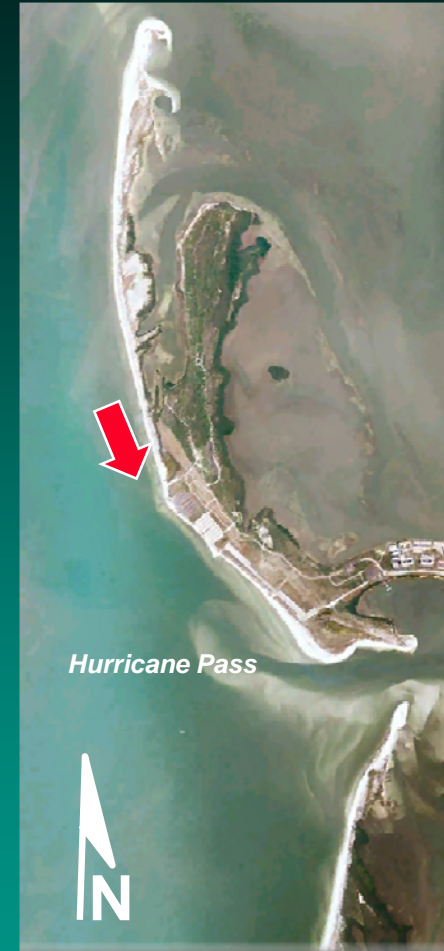
Honeymoon Island 03-09-2008

2007-2008 Post Fill

- Looking south at area of north parking lot.
- BH-#3 in background.
- Beach fill eroding, headed to the south

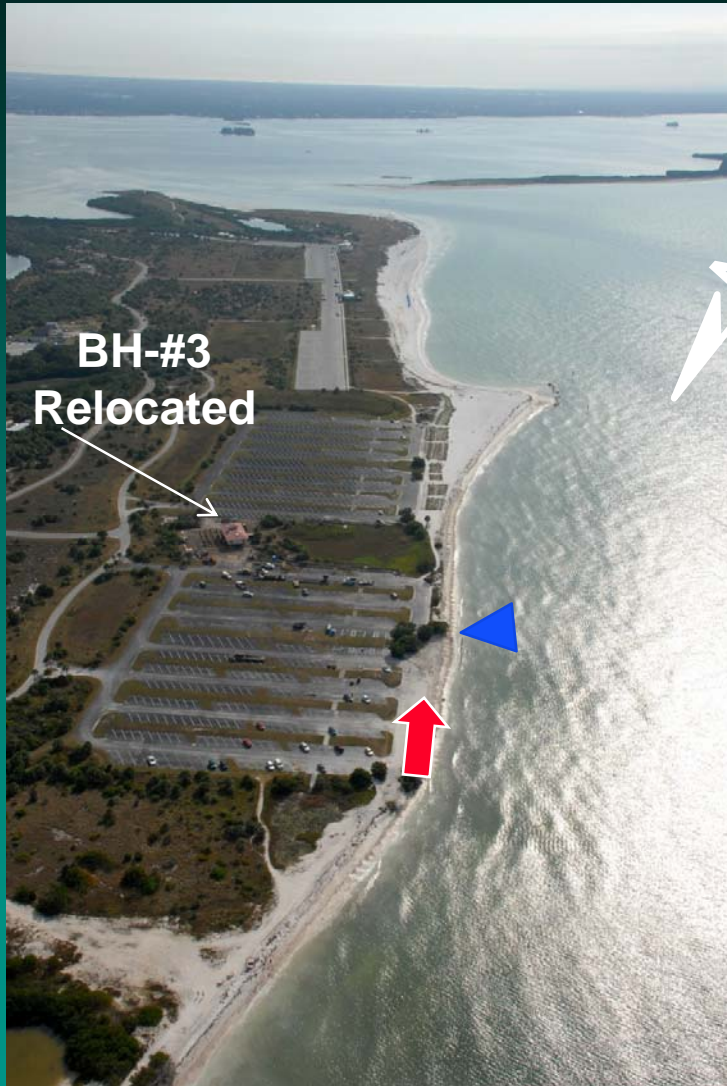
Honeymoon Island 12-01-2009

2009 Post Fill

- Looking south at BH-#3 center of north parking lot just prior to relocation.
- North Parking Lot sustaining damage.
- Shoreline continues to recede.

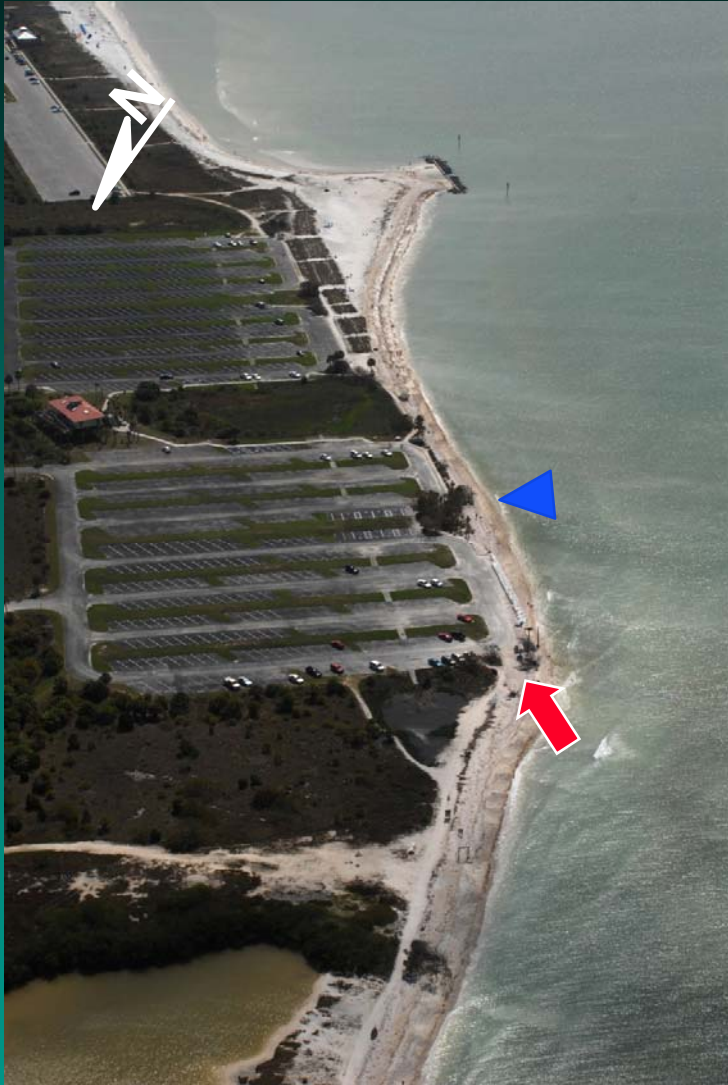
Honeymoon Island 03-02-2011

2010 - 2011

- Looking south at north lot.
- Temporary 1-ton sandbags.
- Shoreline continues to recede.

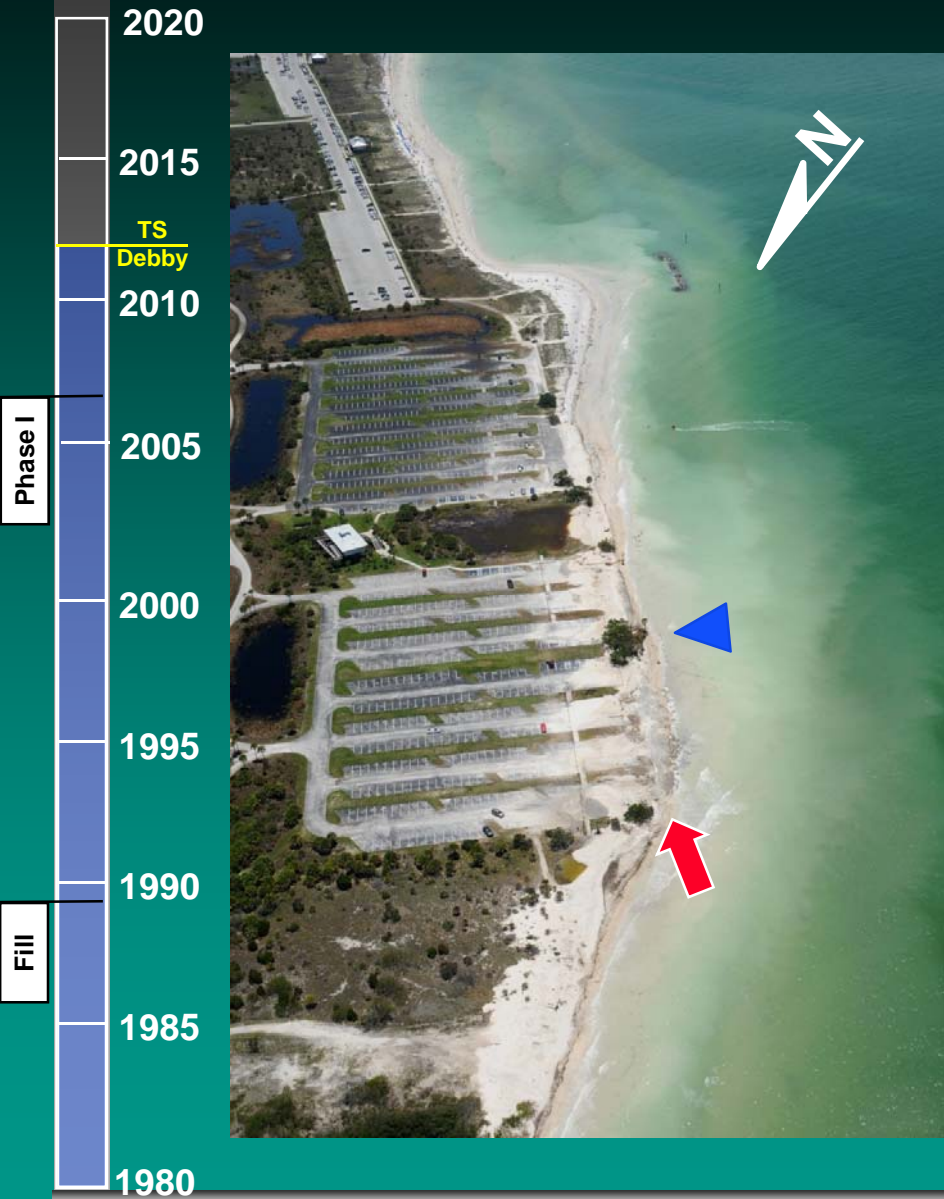
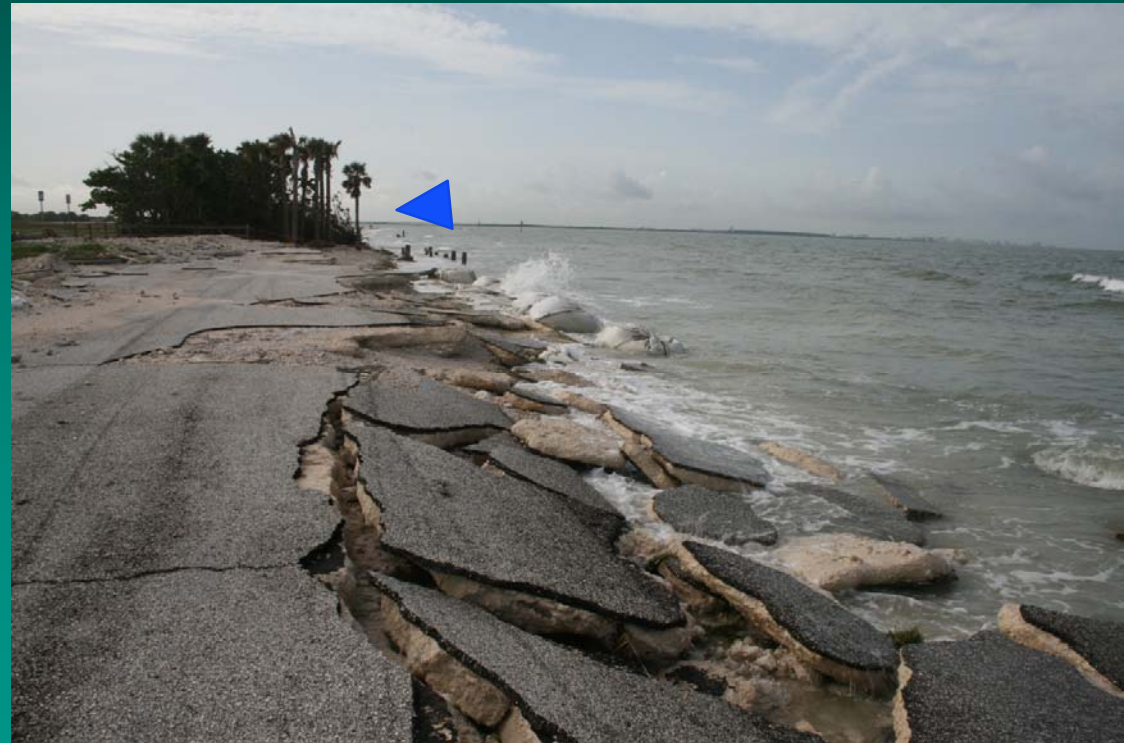
Honeymoon Island 07-01-2012

2011 – 2012 Post TS Debby

- Looking south at north lot.
- Temporary sandbags gone .
- Shoreline continues to recede.
- Parking lot failing.

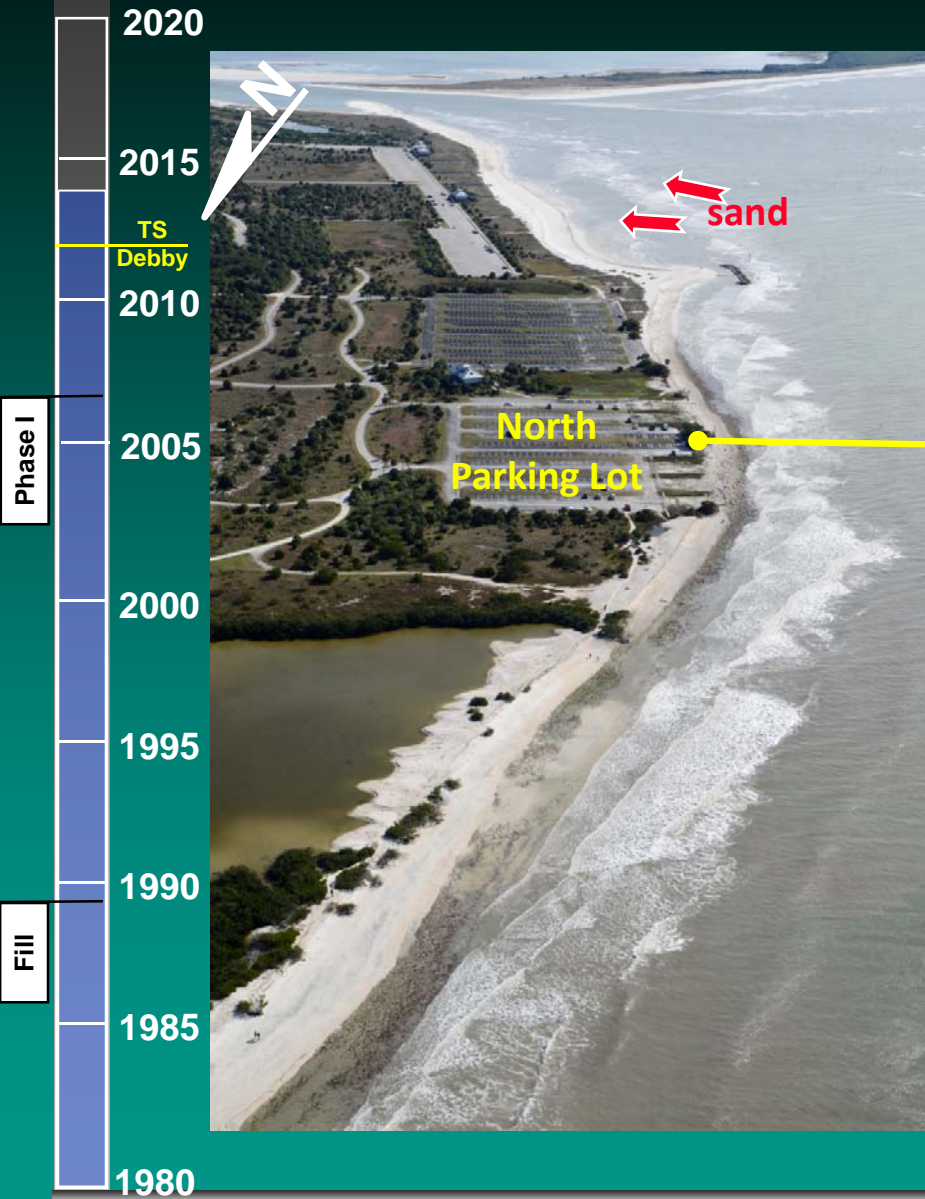
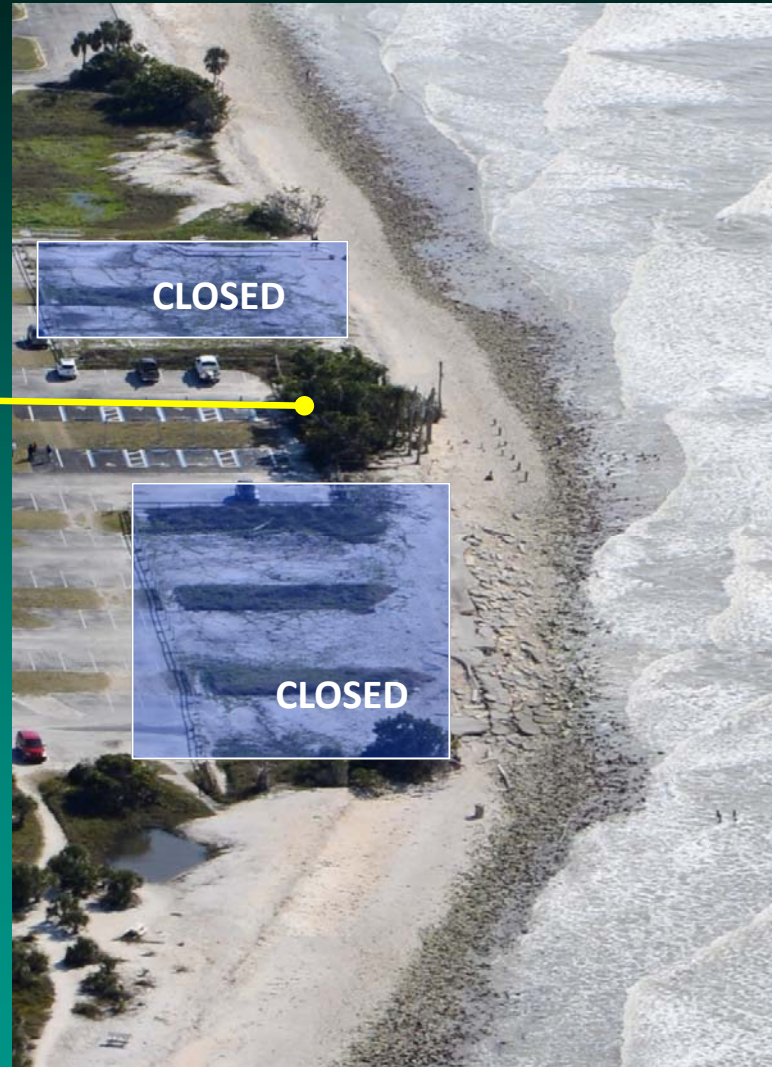
Honeymoon Island 01-03-2014

2012 – 2014

- Continued Recession,
- Damage,
- No beach in north area.

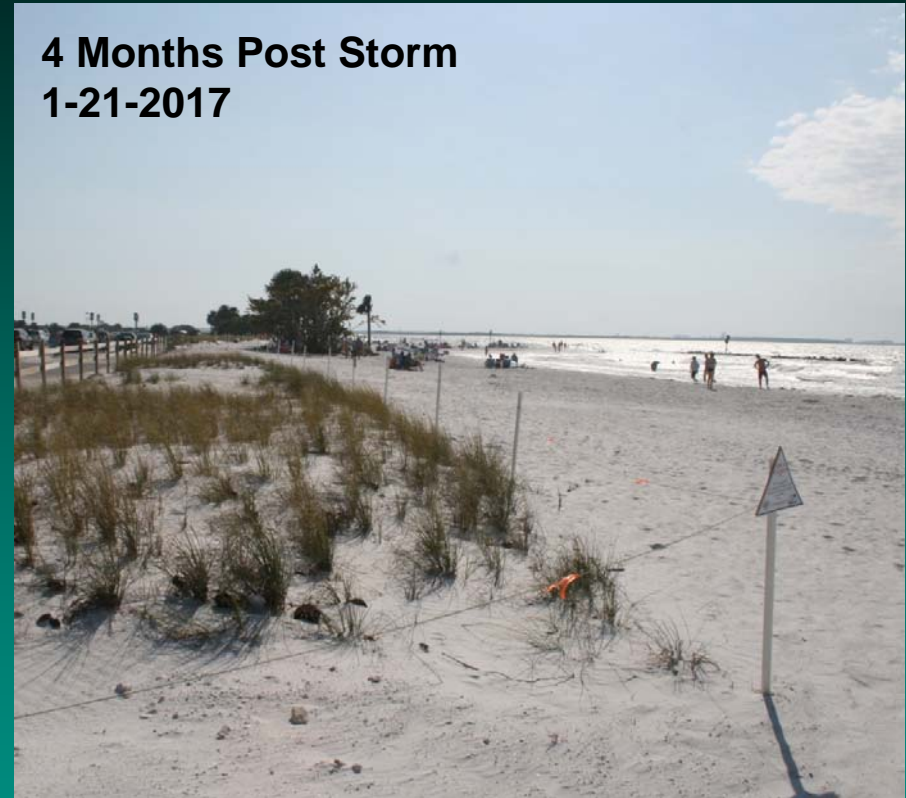
**4 Months Post Storm
1-21-2017**

Area of Dune Construction
