NATIONAL CONFERENCE ON
BEACH PRESERVATION TECHNOLOGY
FEBRUARY 8, 2018

INLET STABILIZATION AT STUMP PASS CHARLOTTE COUNTY, FL

VADIM ALYMOV, PH.D.
MICHAEL POFF, P.E.

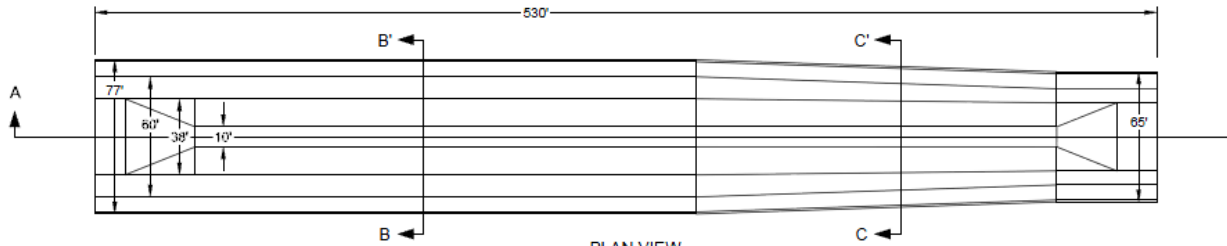
SECTION A-A'
SCALE: H: 1" = 60' / V: 1" = 6'

TERMINAL GROIN DESIGN

- NOTES:
1. STONE SIZES EXAGGERATED FOR ILLUSTRATIVE PURPOSES ONLY.
 2. REFER TO TECHNICAL SPECIFICATIONS FOR ROCK SIZE, DENSITY, AND GRADATION.
 3. CEC CONDUCTED JET PROBE SURVEY OF FOOTPRINT OF TERMINAL GROIN ON NOV. 4, 2015. NO ROCK LAYERS WERE DETECTED. PROBES EXTENDED 10 FEET BELOW EXISTING GRADE.

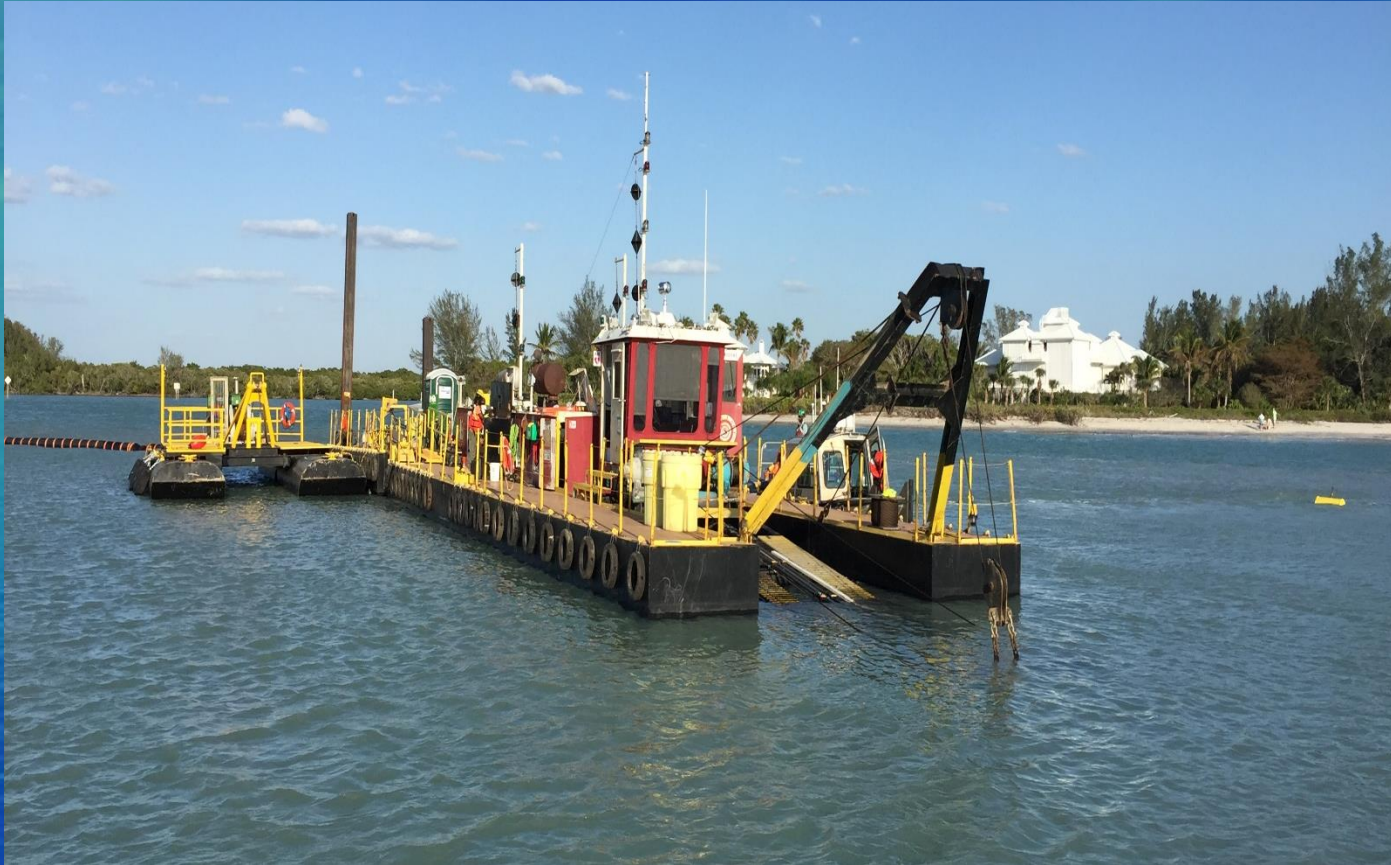
Great Lakes Dredge and Dock's Dredge 'Commodore'

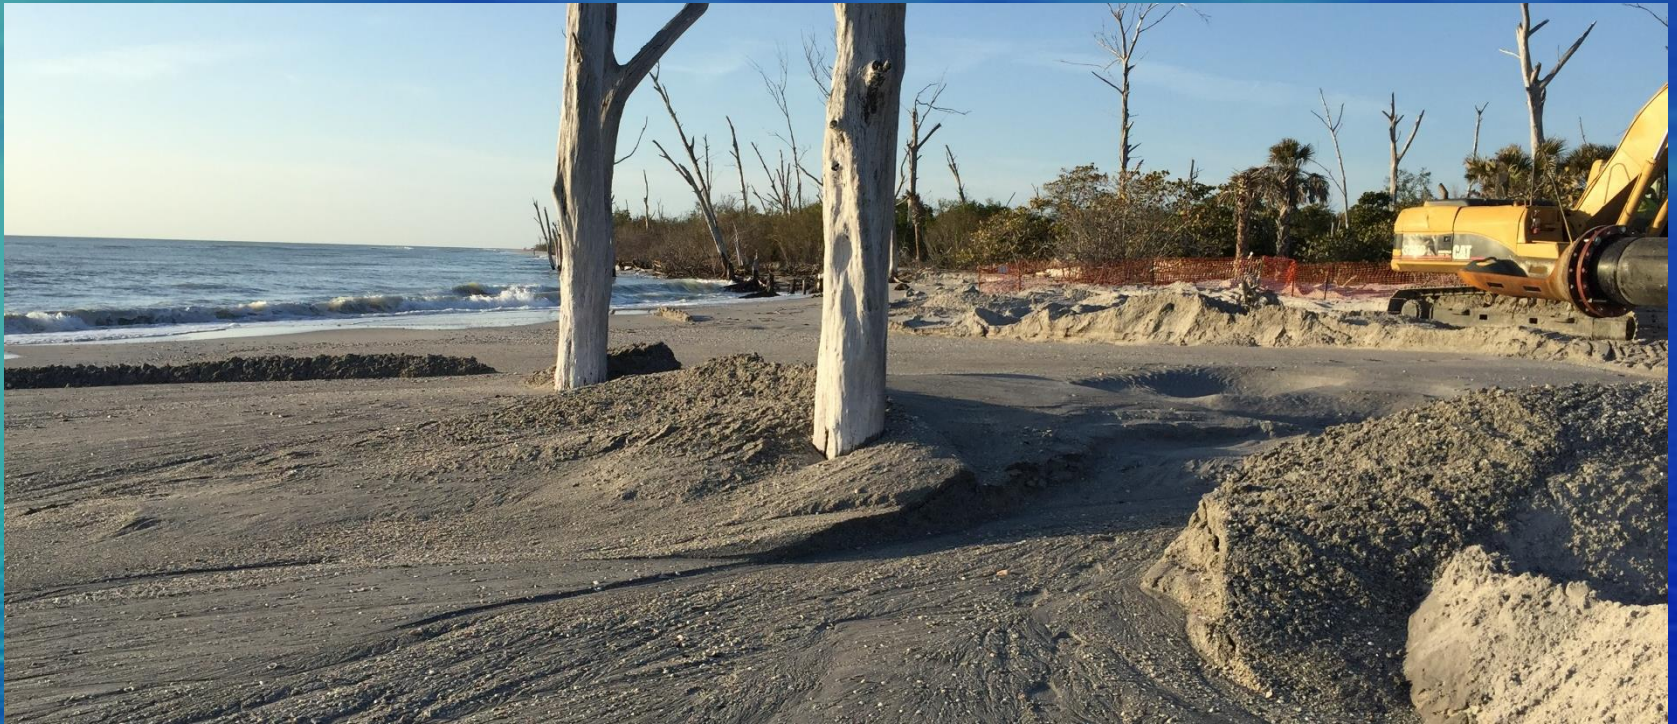
View looking North at Starting Point of Beach Fill

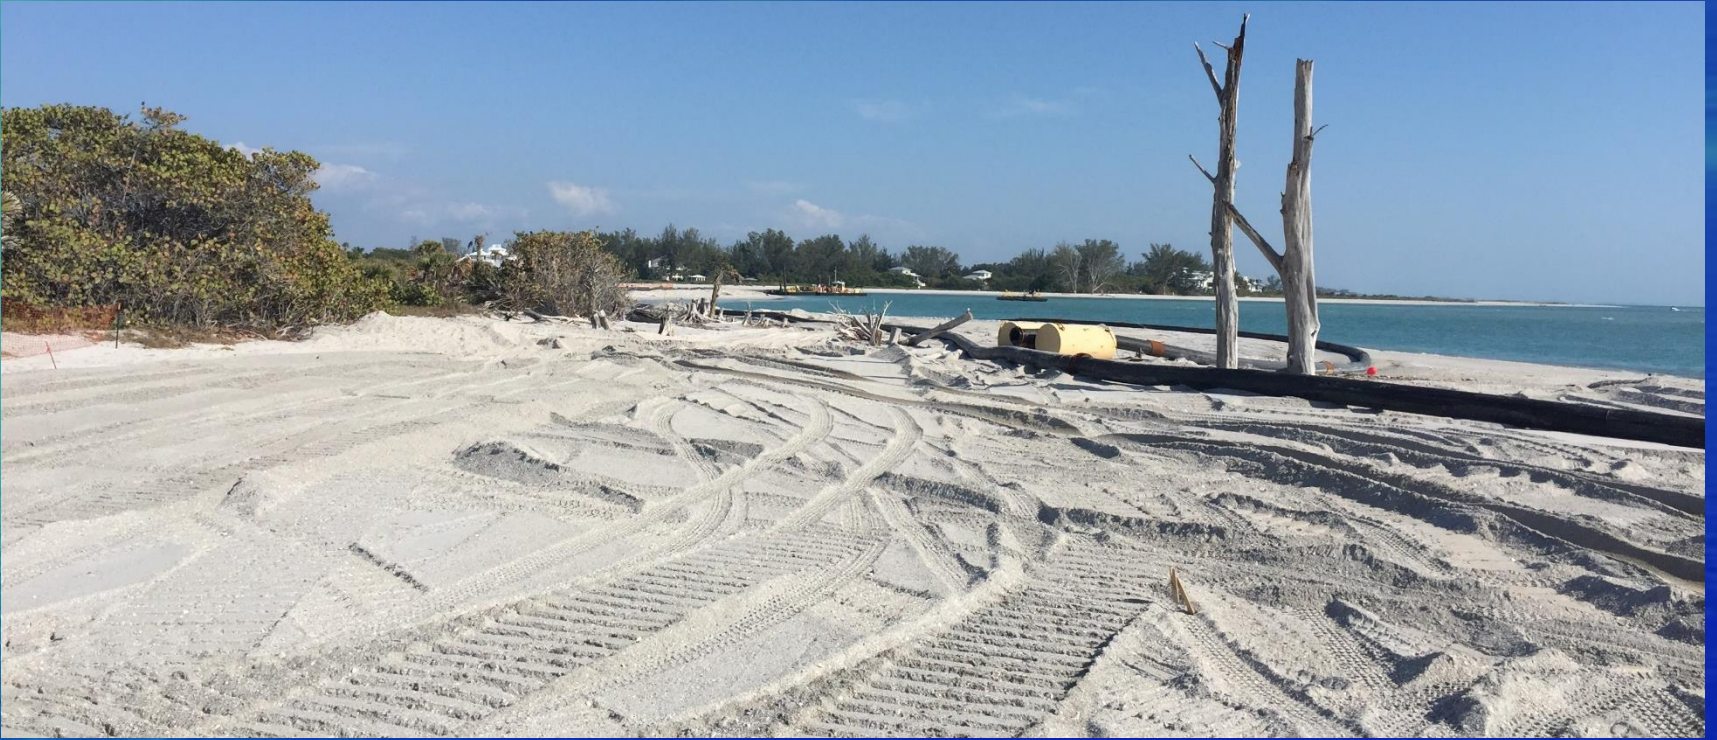
Beach fill looking South toward Stump Pass

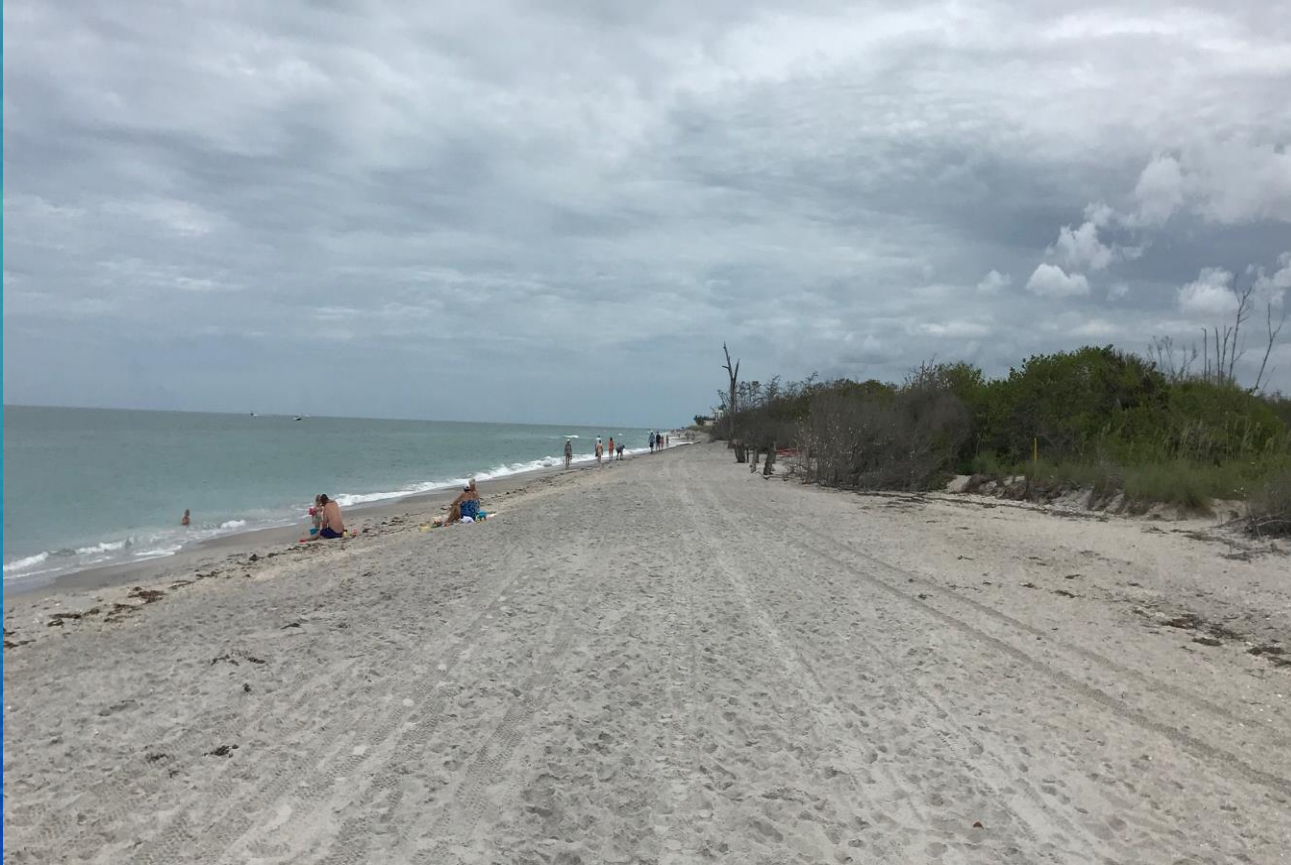
The New Beach Fill on Manasota Key (View North)

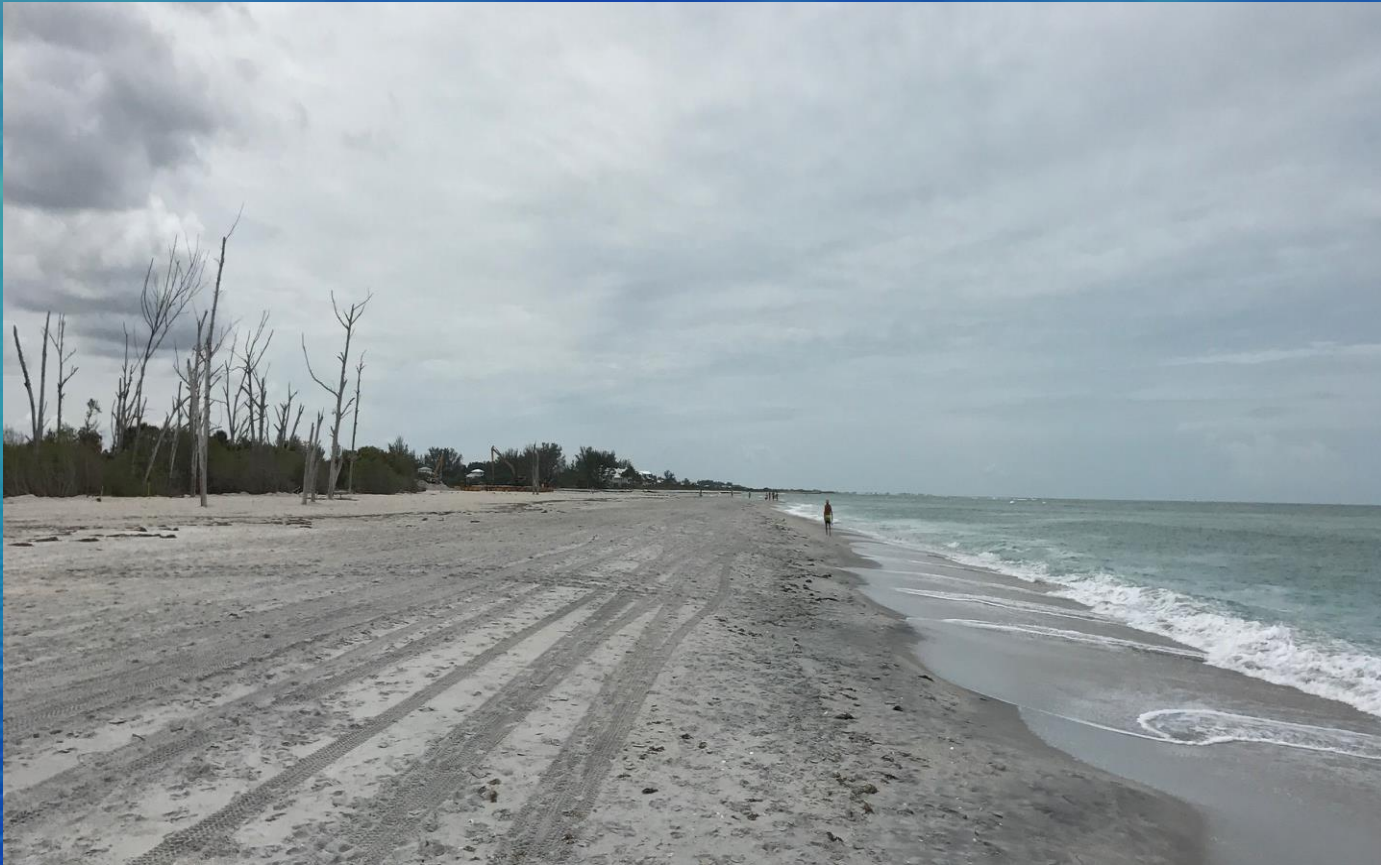
The New Beach Fill on Manasota Key (View South)

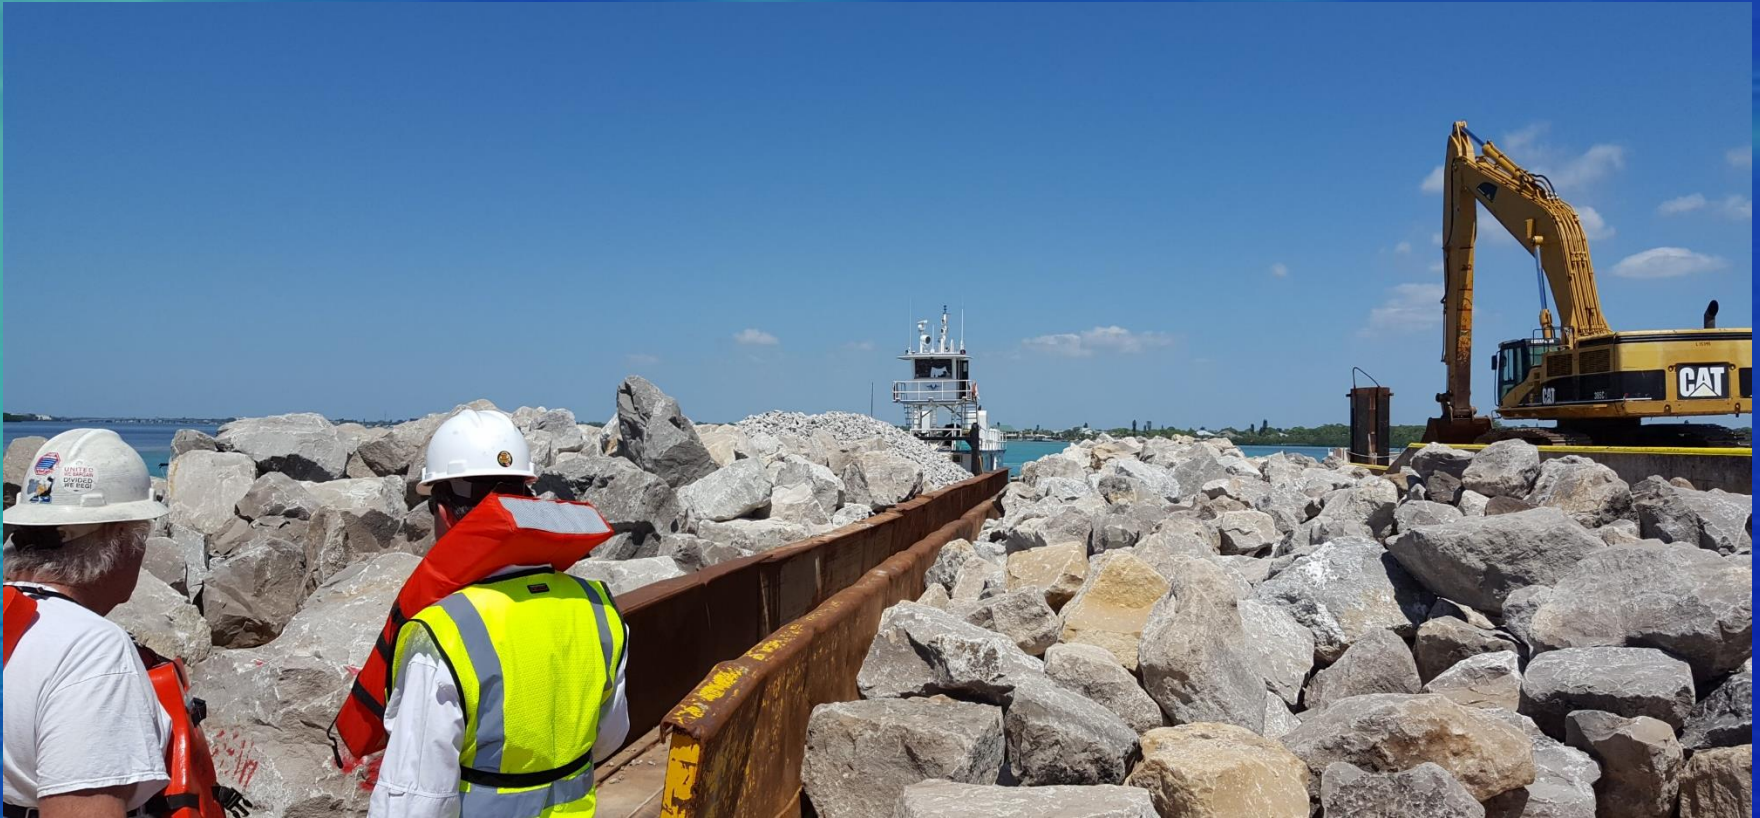
Barges from Missouri Arrive with High Quality
165+ lbs/cf Bedding, Core, and Armor Stone

- 23,000 CY from Terminal Groin Excavation Placed on UBF
- 2,630 Tons of 12" Bedding Stone
- 7,420 Tons of 18"-36" Core Stone
- 4,840 Tons of 2-3 Ton Armor Stone
- Total = Approximately 15,000 Tons of Rock

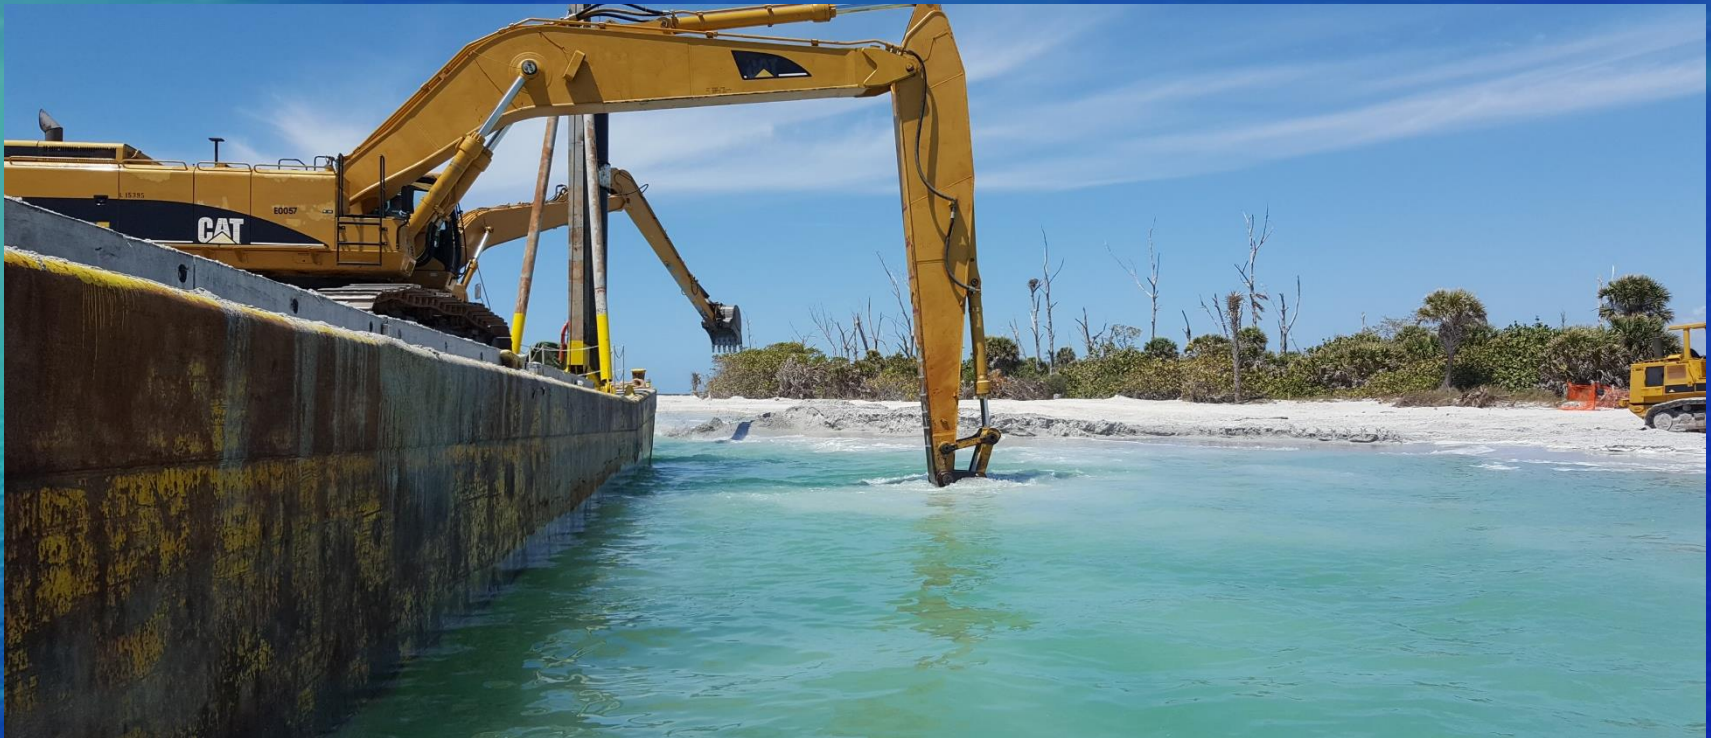
Excavating First Section of Terminal Groin

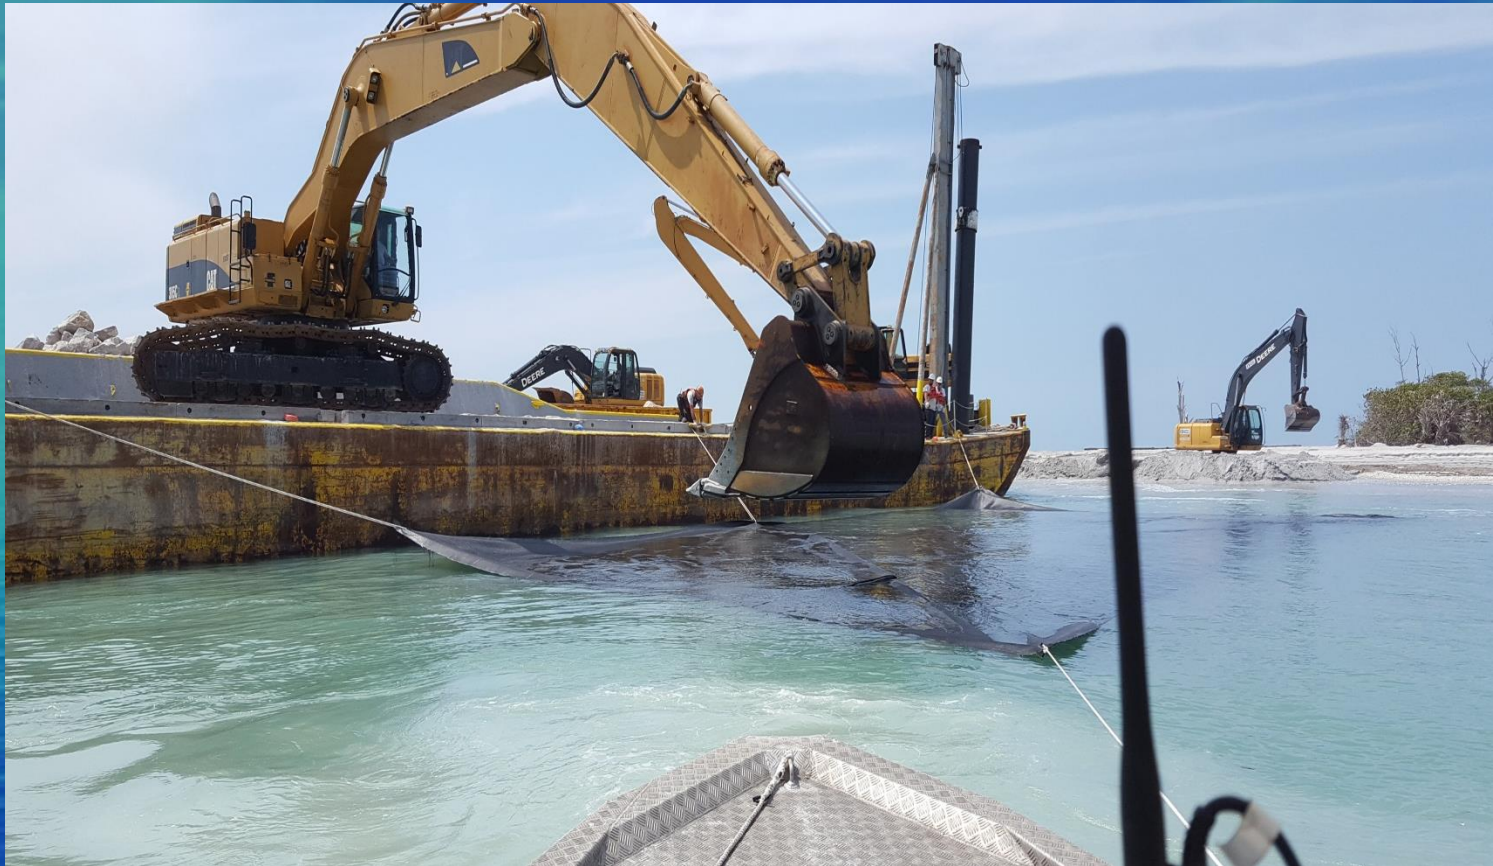
Stretching out Geotextile Fabric and Placing Bedding Stone to Sink into Place as Foundation of Groin

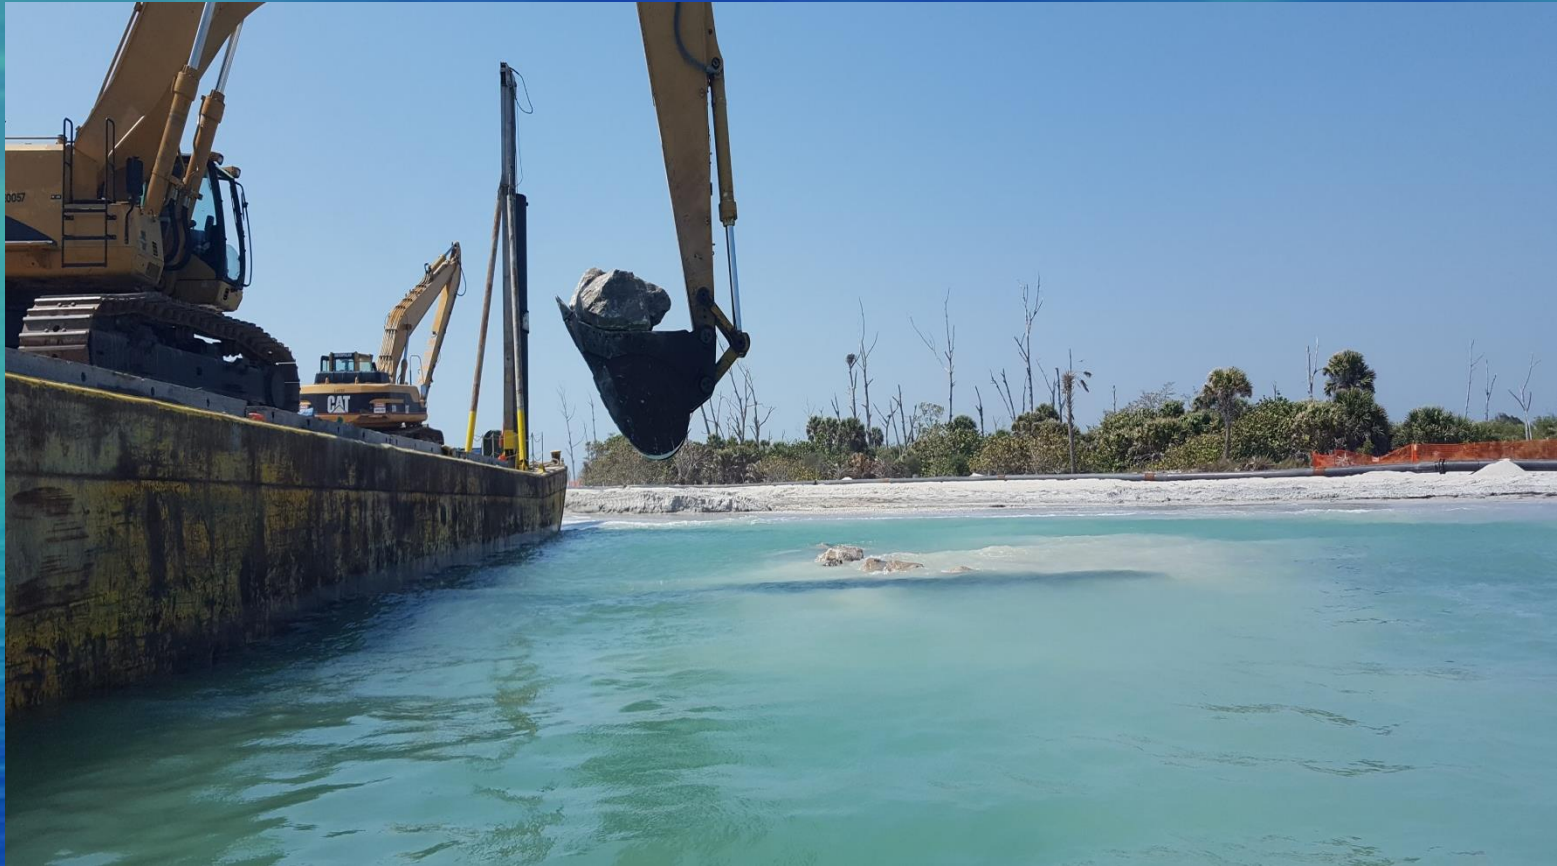
Armor Stone Being Placed on Groin

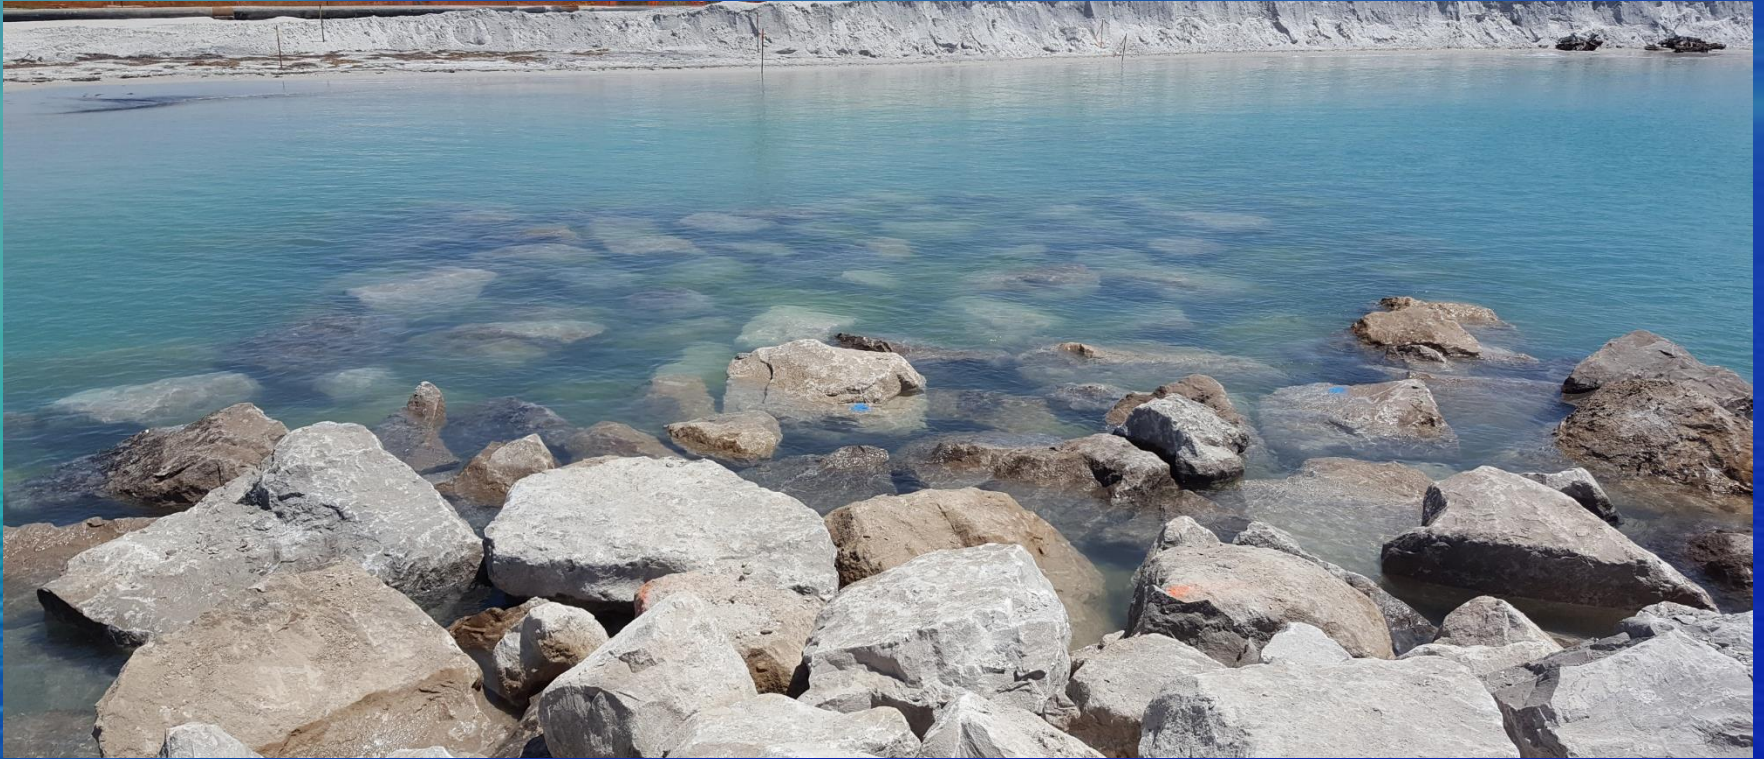
Groin Sloping up from Landward Toe & Seaward Progress

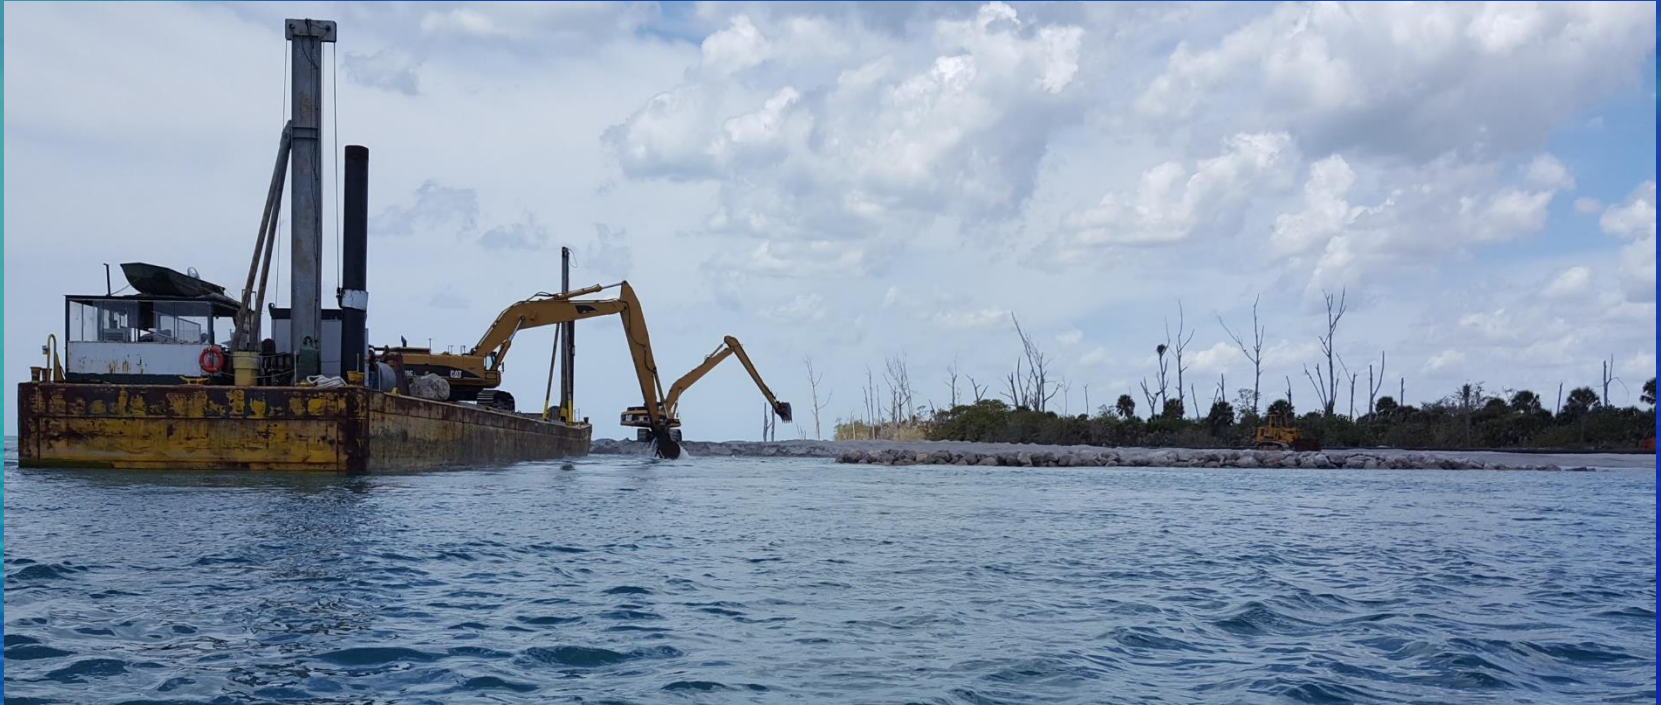
Excavating Next Section of Groin

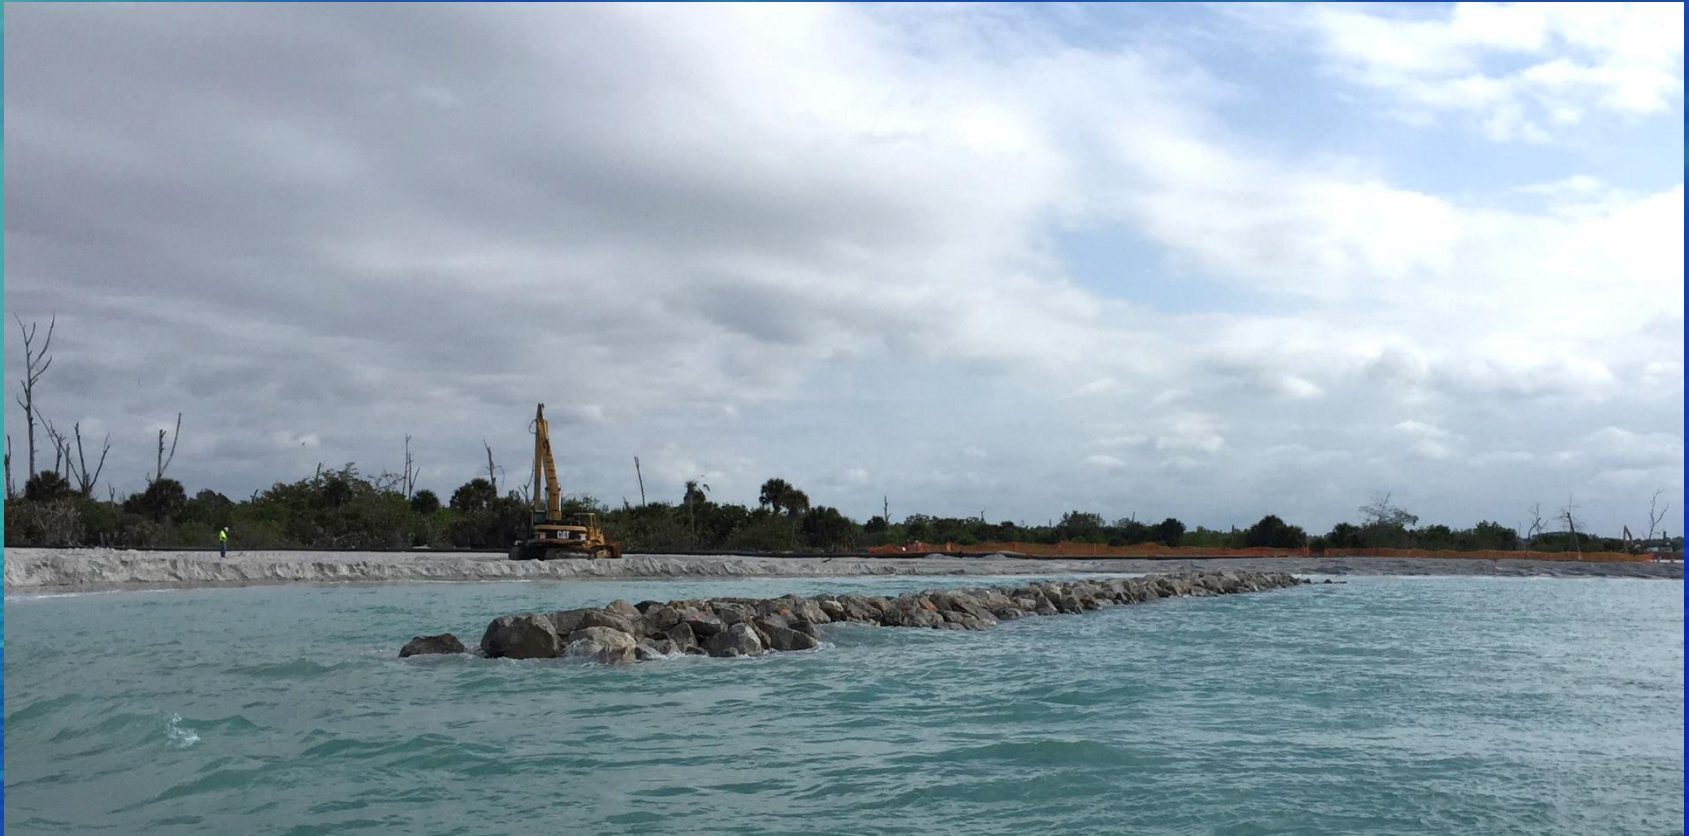
Beach Fill Placement Advancing

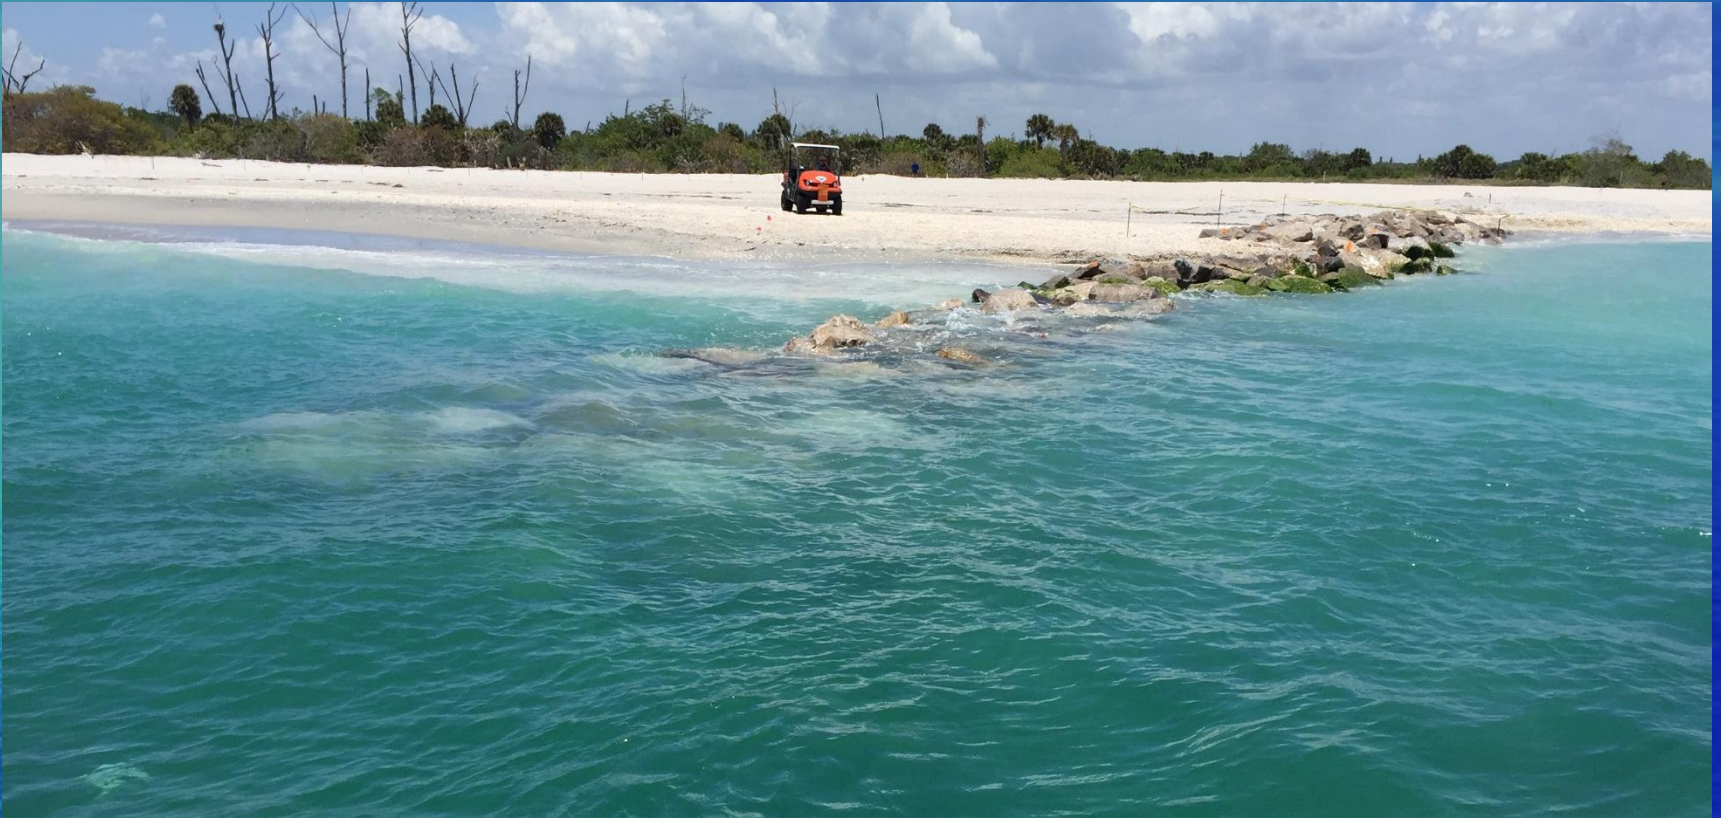
Beach Fill Placement Complete to Groin
