# BEACH SCRAPING: Benefits of an Interim Shore Protection Measure

National Conference on  
Beach Preservation Technology  
February 7-9, 2018  
Panama City Beach, FL

Zachary Bedell, E.I.T.  
Olsen Associates, Inc.

# Hilton Head Island, South Carolina

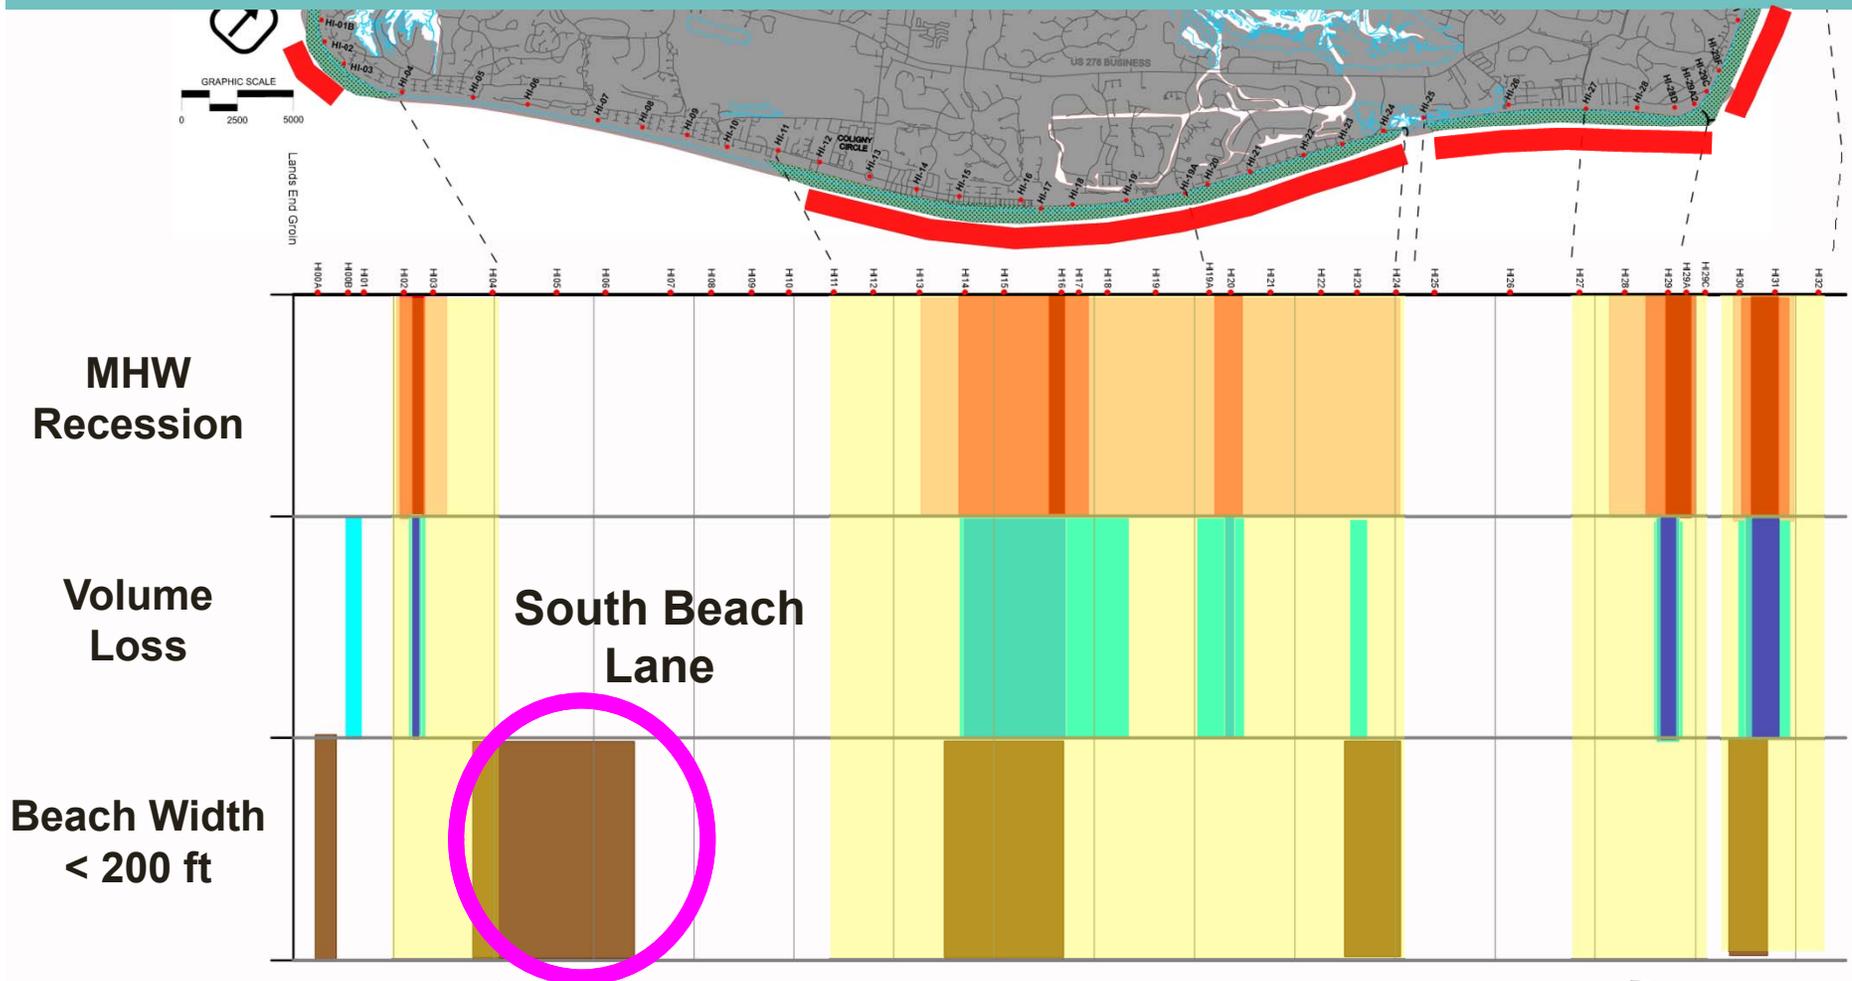
# Change Mar. 2007 - Feb. 2016

Yellow indicates areas of sand placement

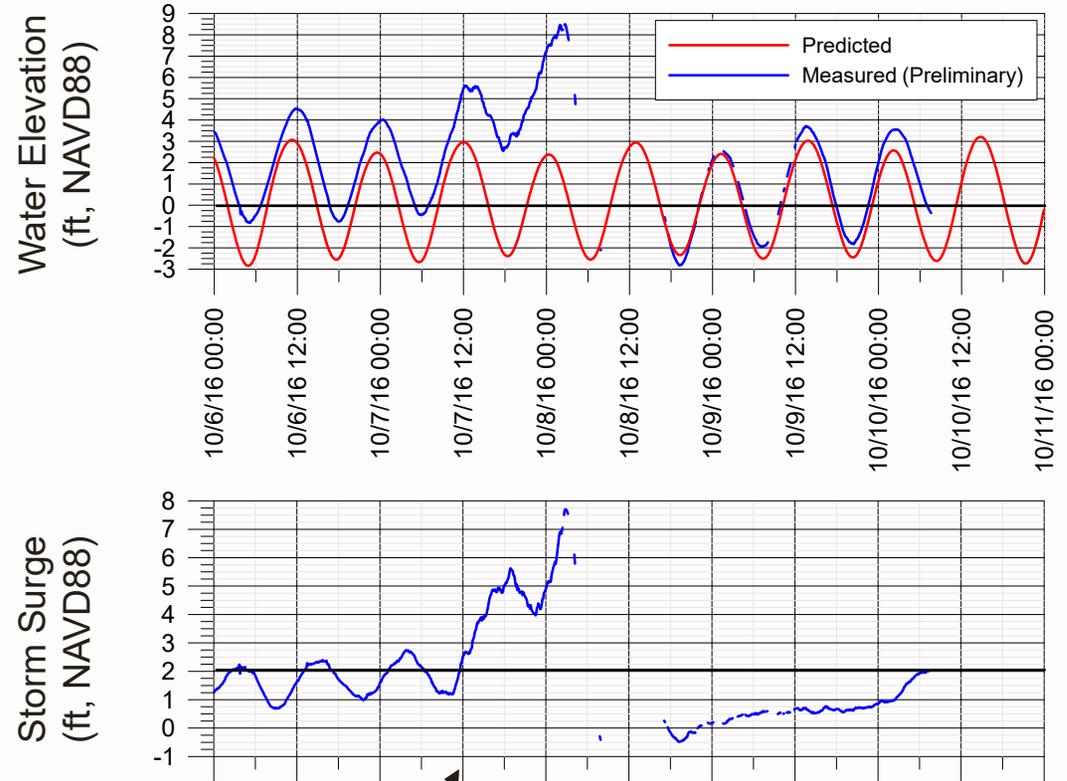
SAVANNAH RIVER ENTRANCE, FORT PULASKI, GA NOAA Station: 8670870

7 October 2016

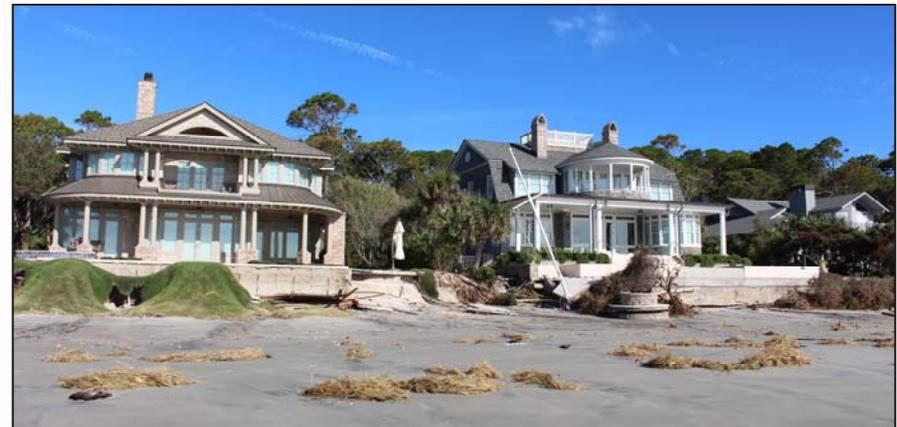
South Beach Lane

- **Extensive Coastal Flooding (WL >10 ft NAVD88)**
- **Extensive Frontal Dune Loss**
- **Primary Dune breached** (most severe along non-nourished areas)
- **Upper beach loss ~750 kcy along 16 miles**
  - Average: ~ -9 cy/ft
  - Range: ~ -4 to -17 cy/ft

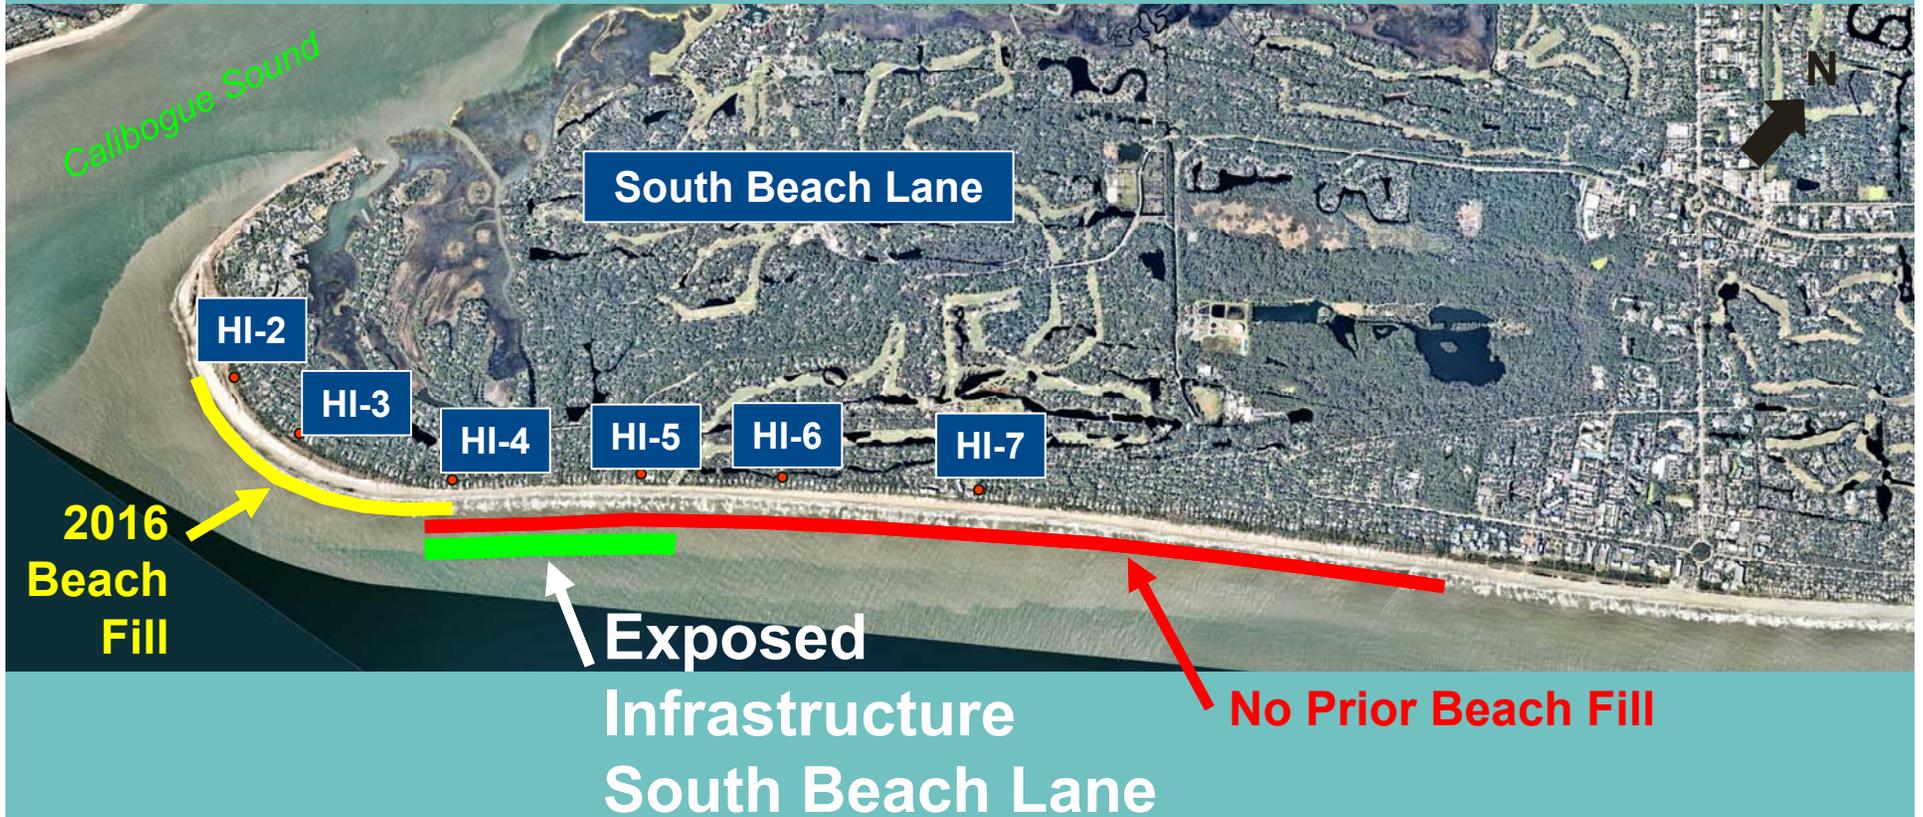
# South Island Impacts

**South Beach Lane Shoreline**  
**Stable to Accretional (1985 to Pre-Matthew)**

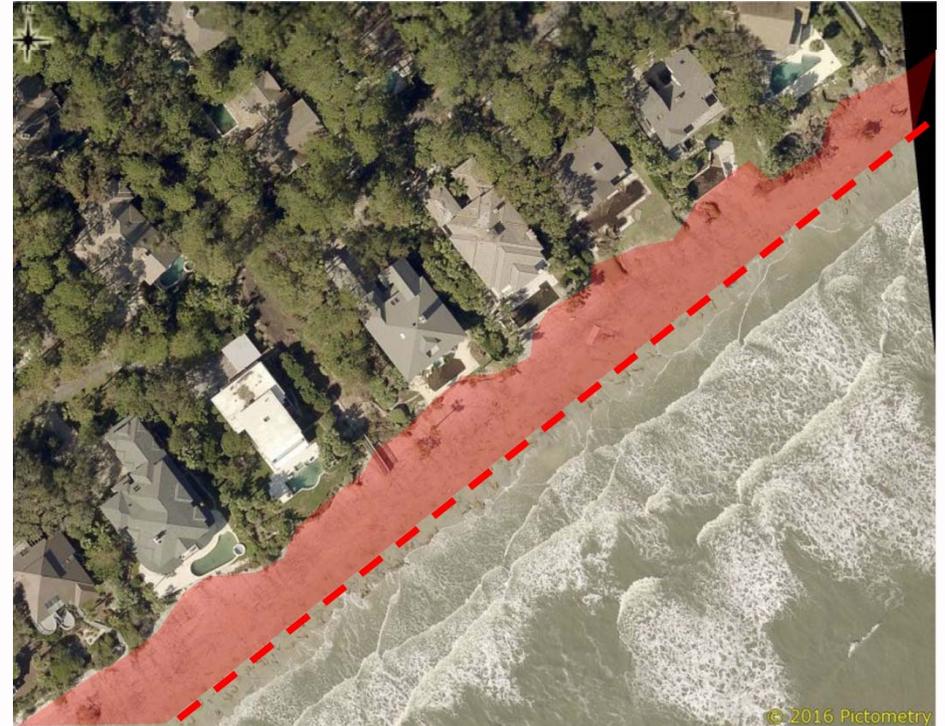
**October 2016  
(Immediate Post-Matthew)**

**60-120 feet of dune and vegetation  
loss (typical)**

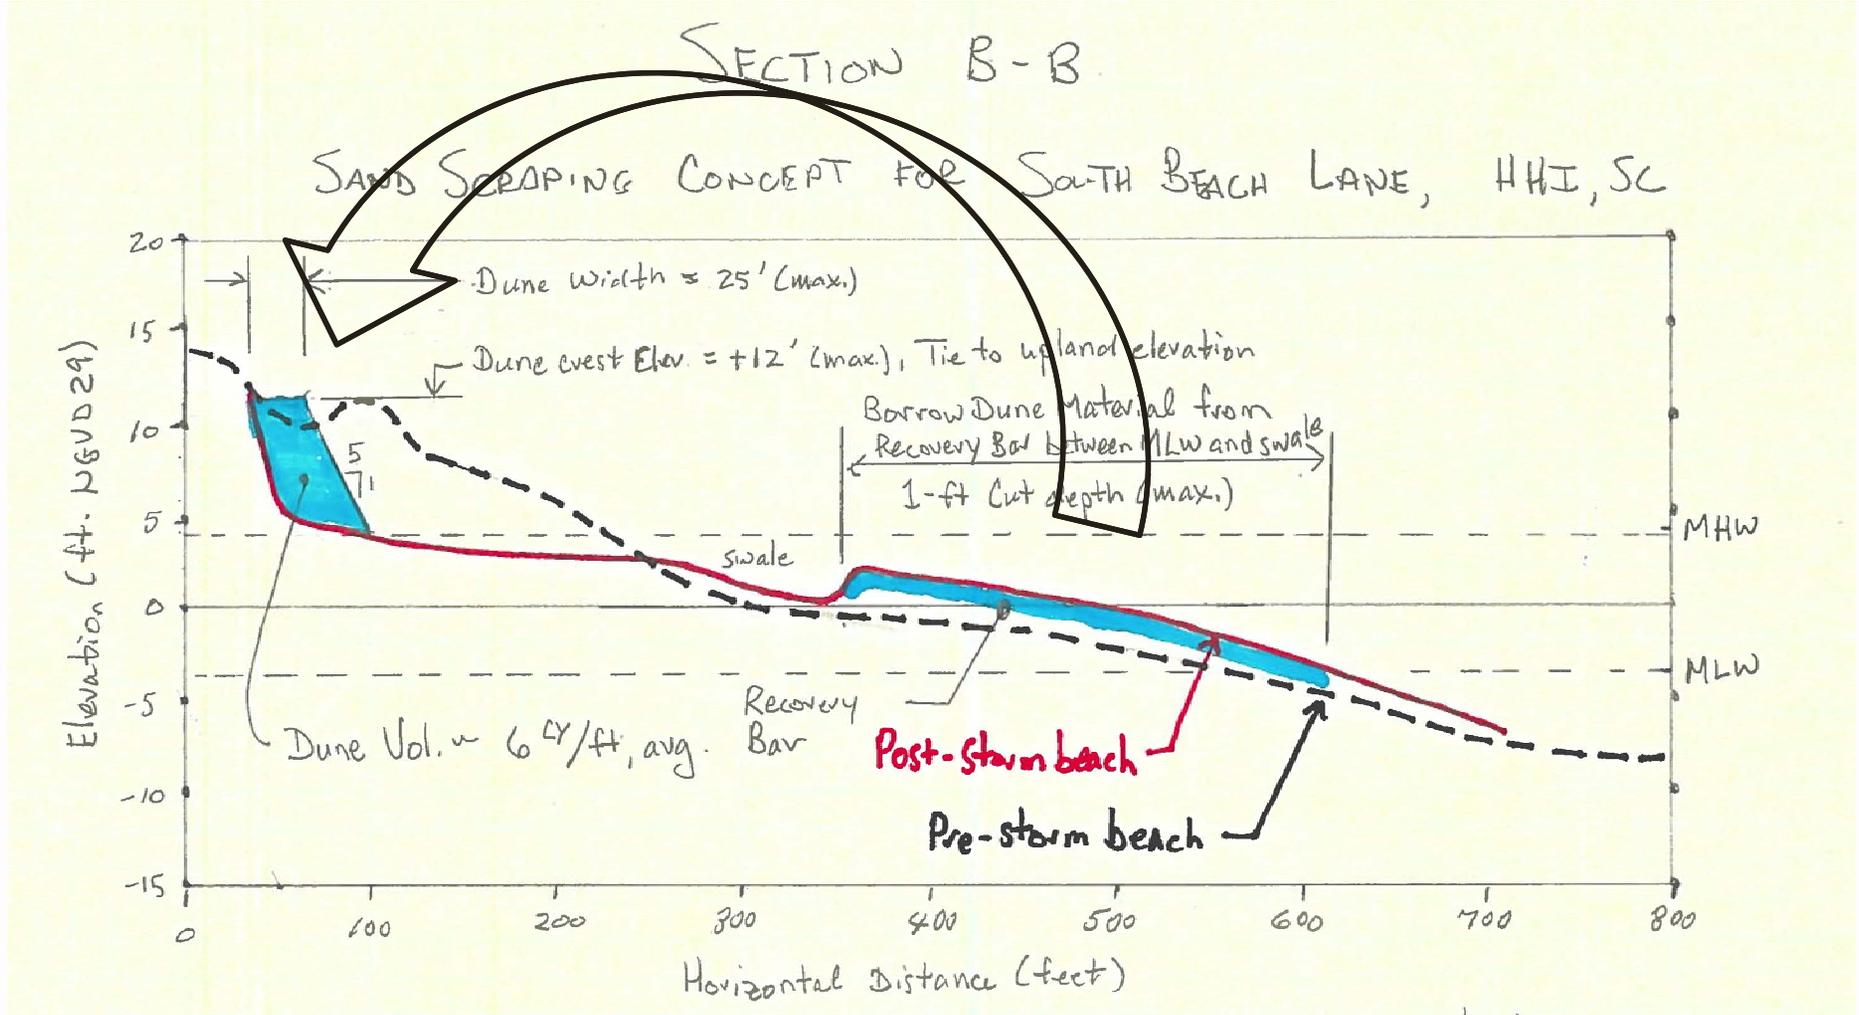
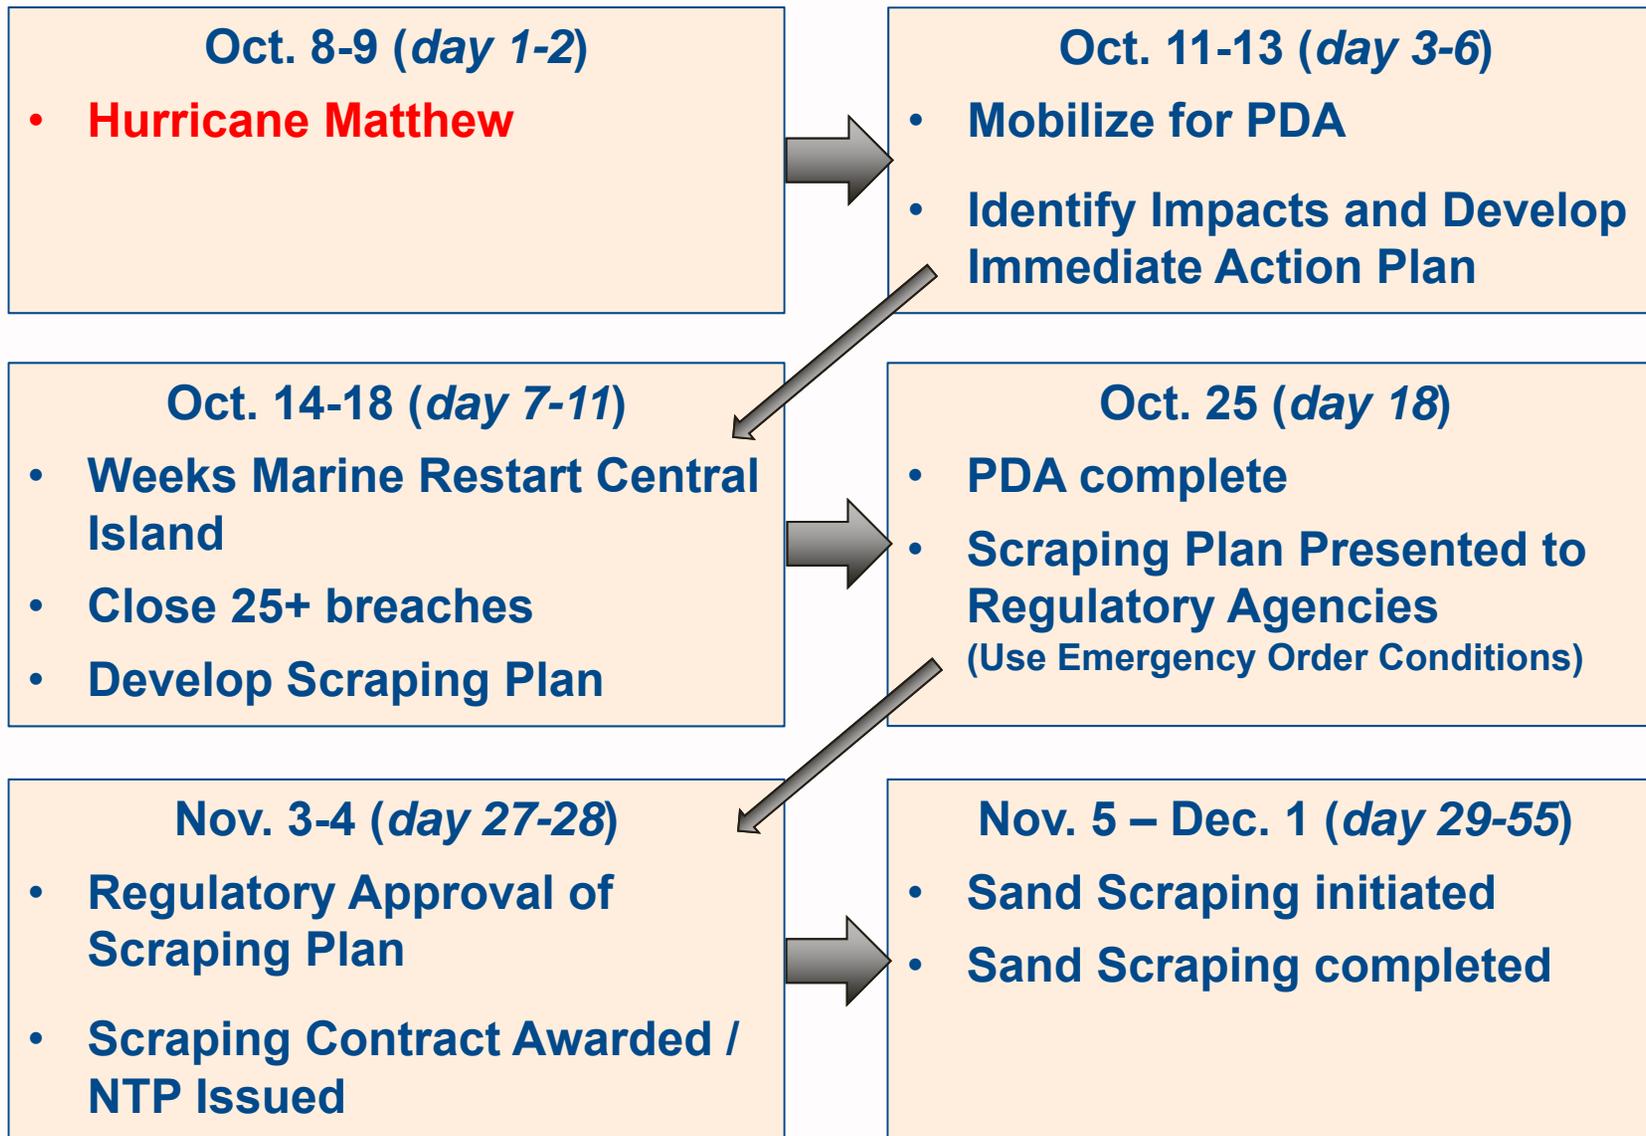
# Sand Scraping Details

- **3,400 feet of shoreline**
- **21,700 cubic yards (~6.4 cy/ft, on average)**
- **Equipment: 2-3, Cat D6 – D8**
- **Project Cost:**
  - Mobilization = \$ 24,100.00
  - Payment Surveys (Before/After) = \$ 12,400.00
  - In-Place Sand = \$ 141,167.00
  - Total = \$ 177,667.00 (\$ 8.18 / cy)
- **Qualified as FEMA Category B Emergency Action**

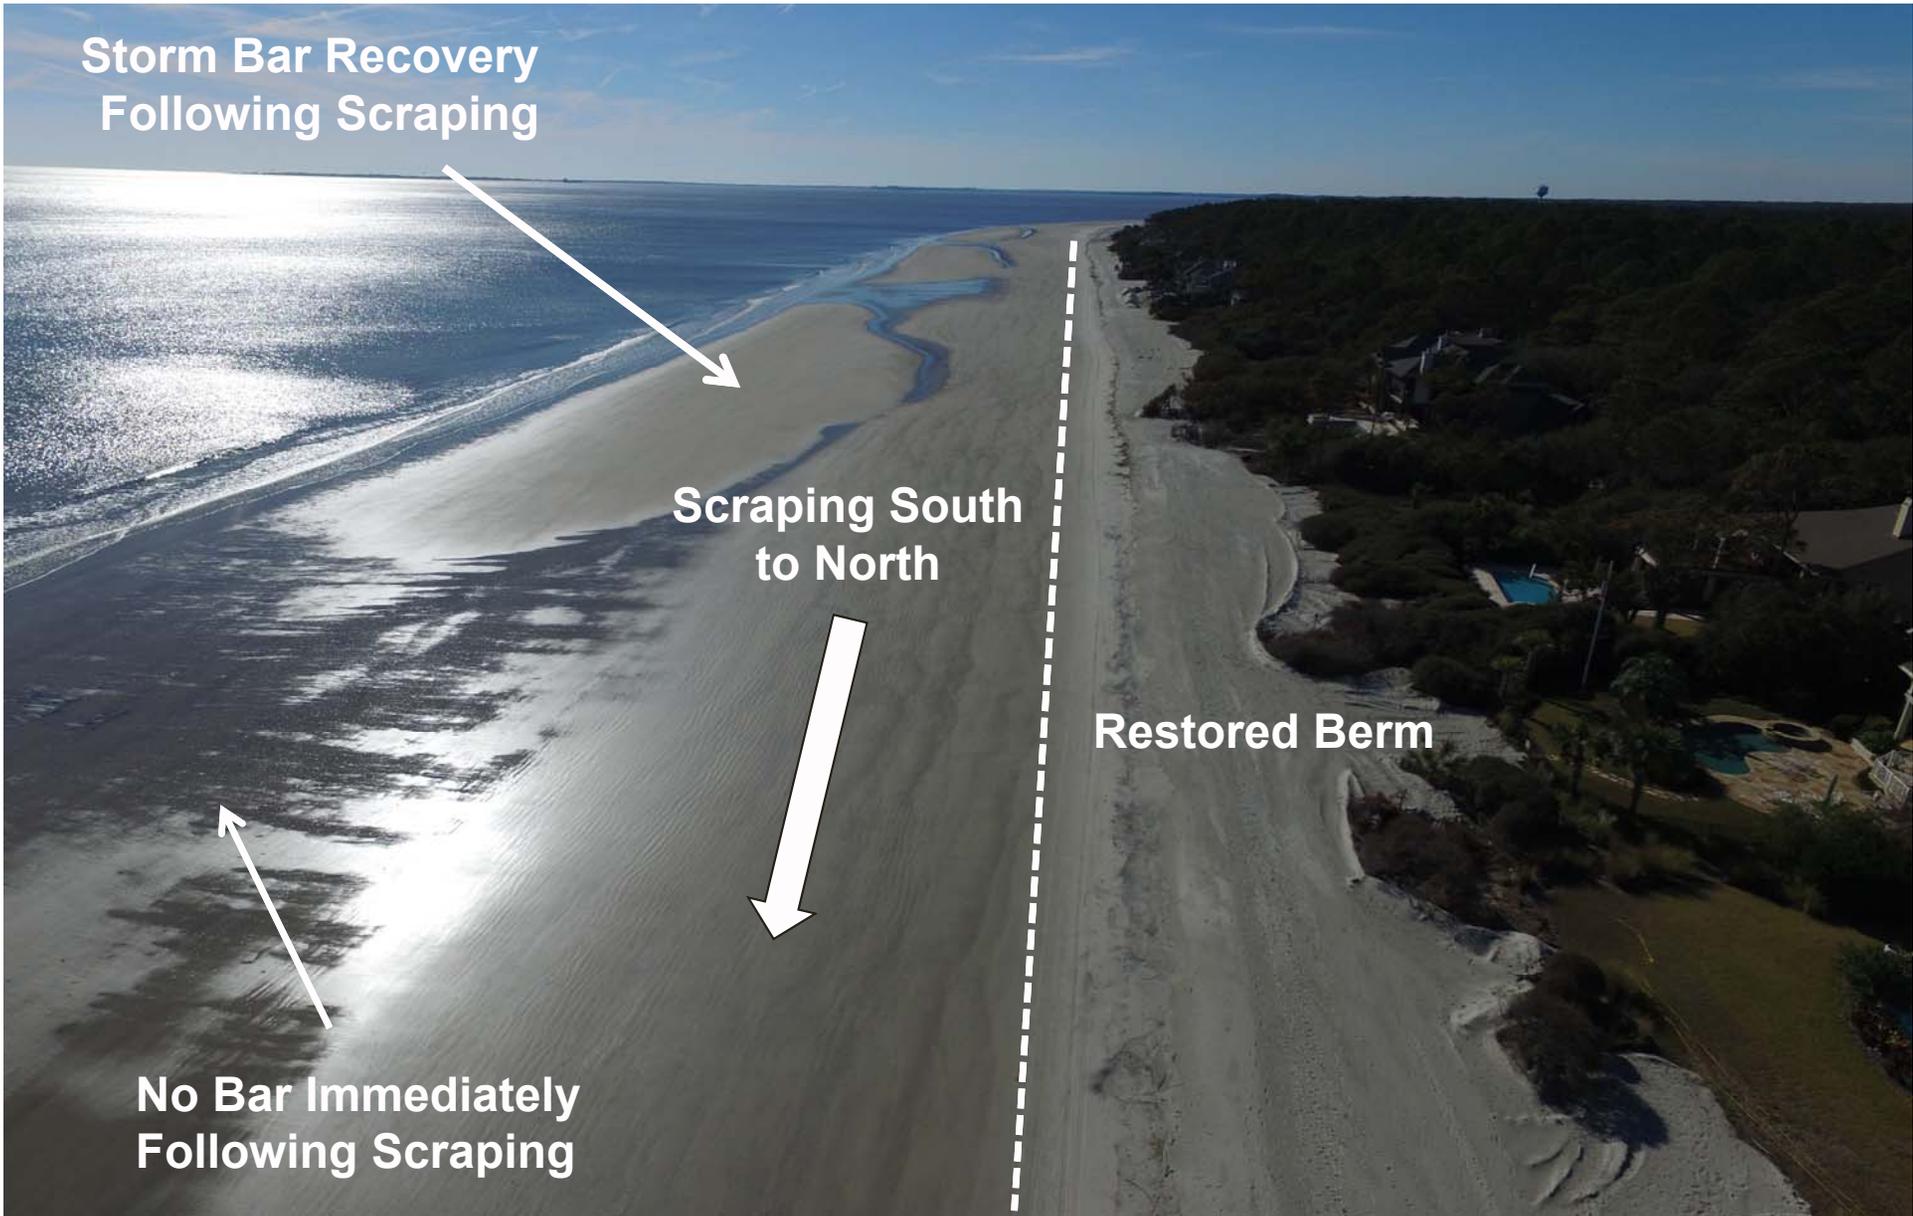
Storm Bar Recovery  
Following Scraping

Scraping South  
to North

Restored Berm

No Bar Immediately  
Following Scraping

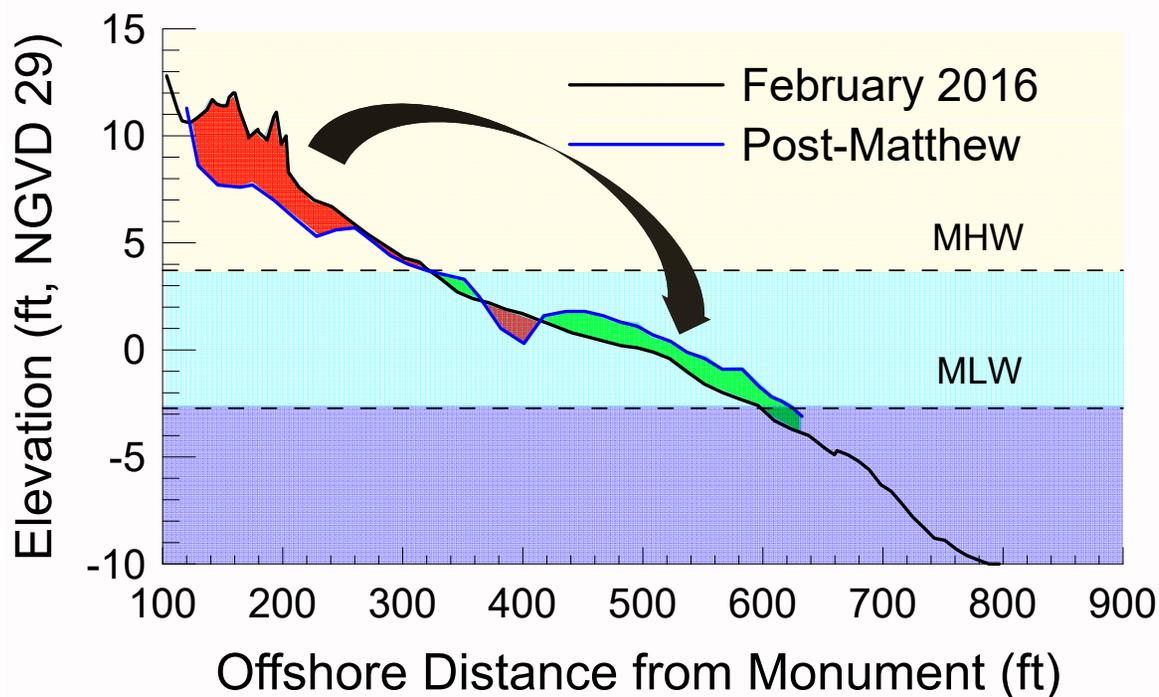
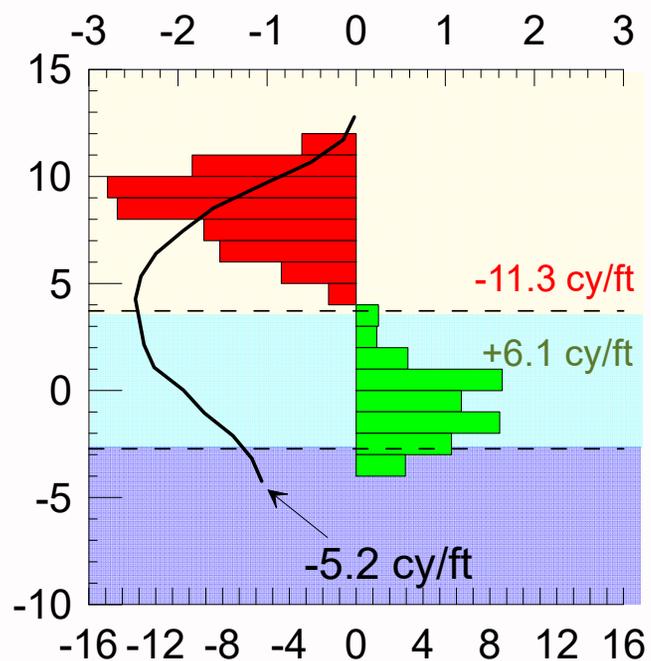
**HI-05**

Sectional Volume Change  
(bars, cy/ft)

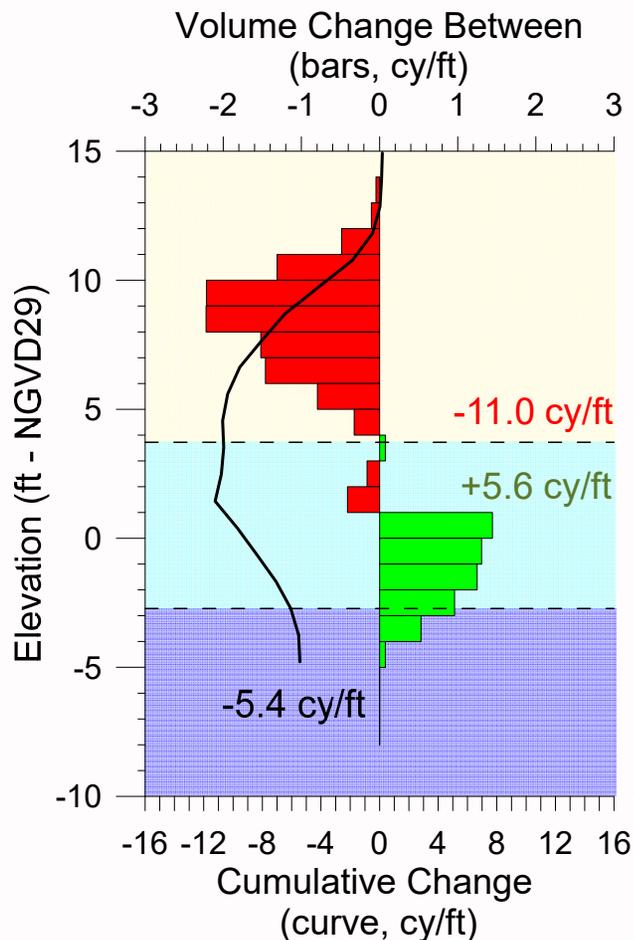
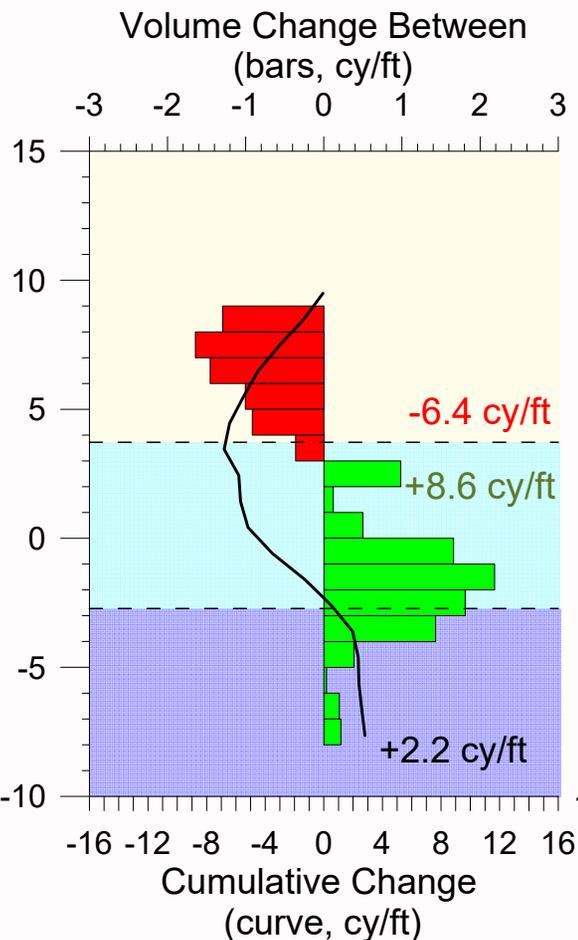
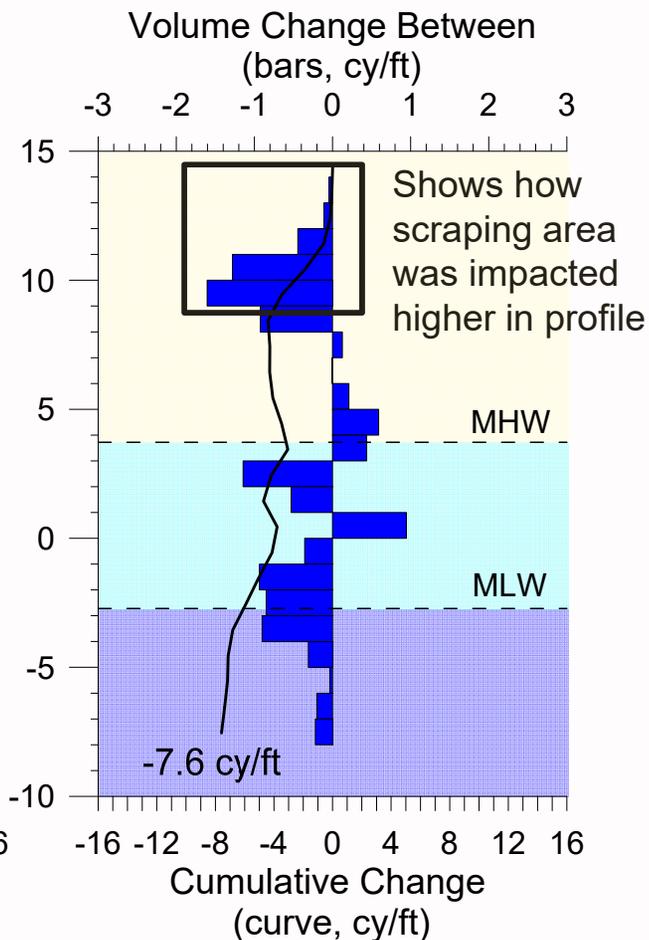
## Scraping Area

## Control Area

## Difference

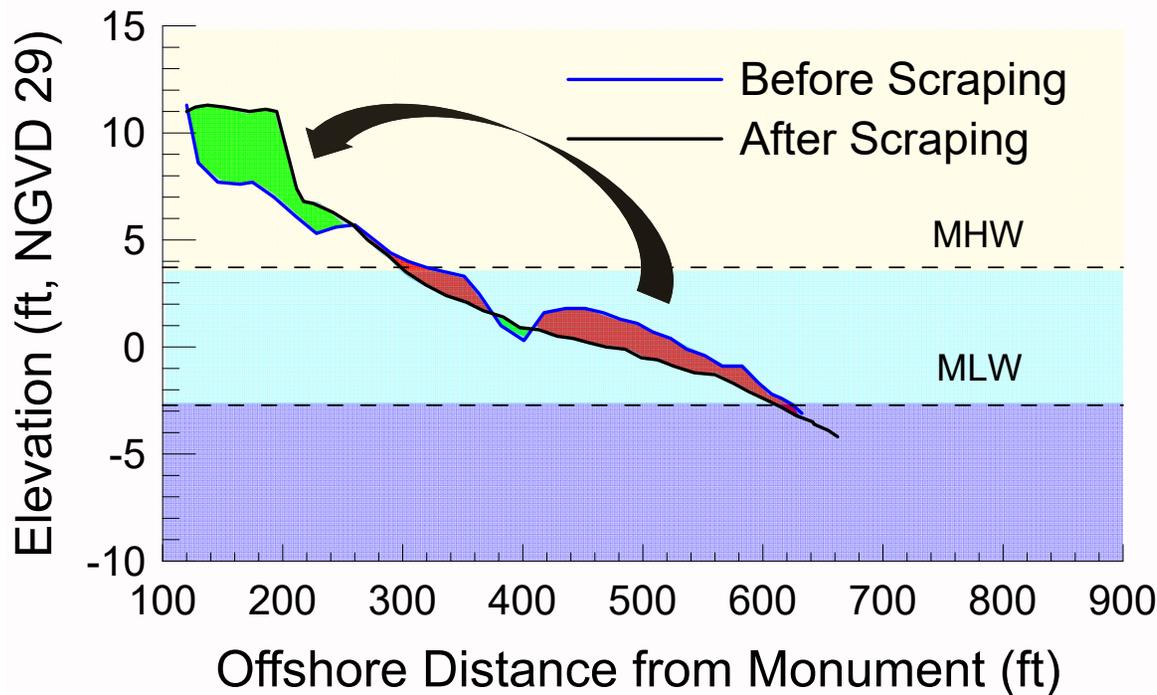
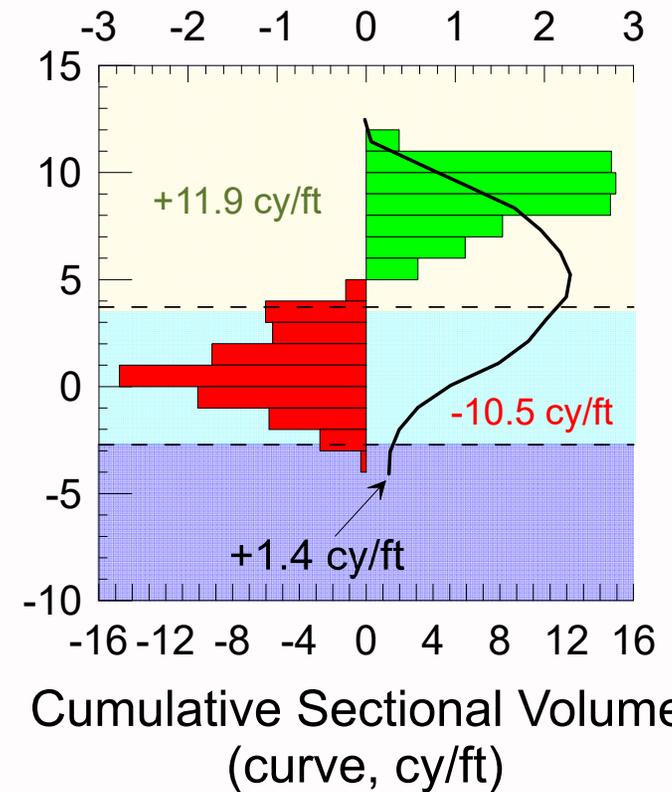
**HI-05**

Sectional Volume Change  
(bars, cy/ft)

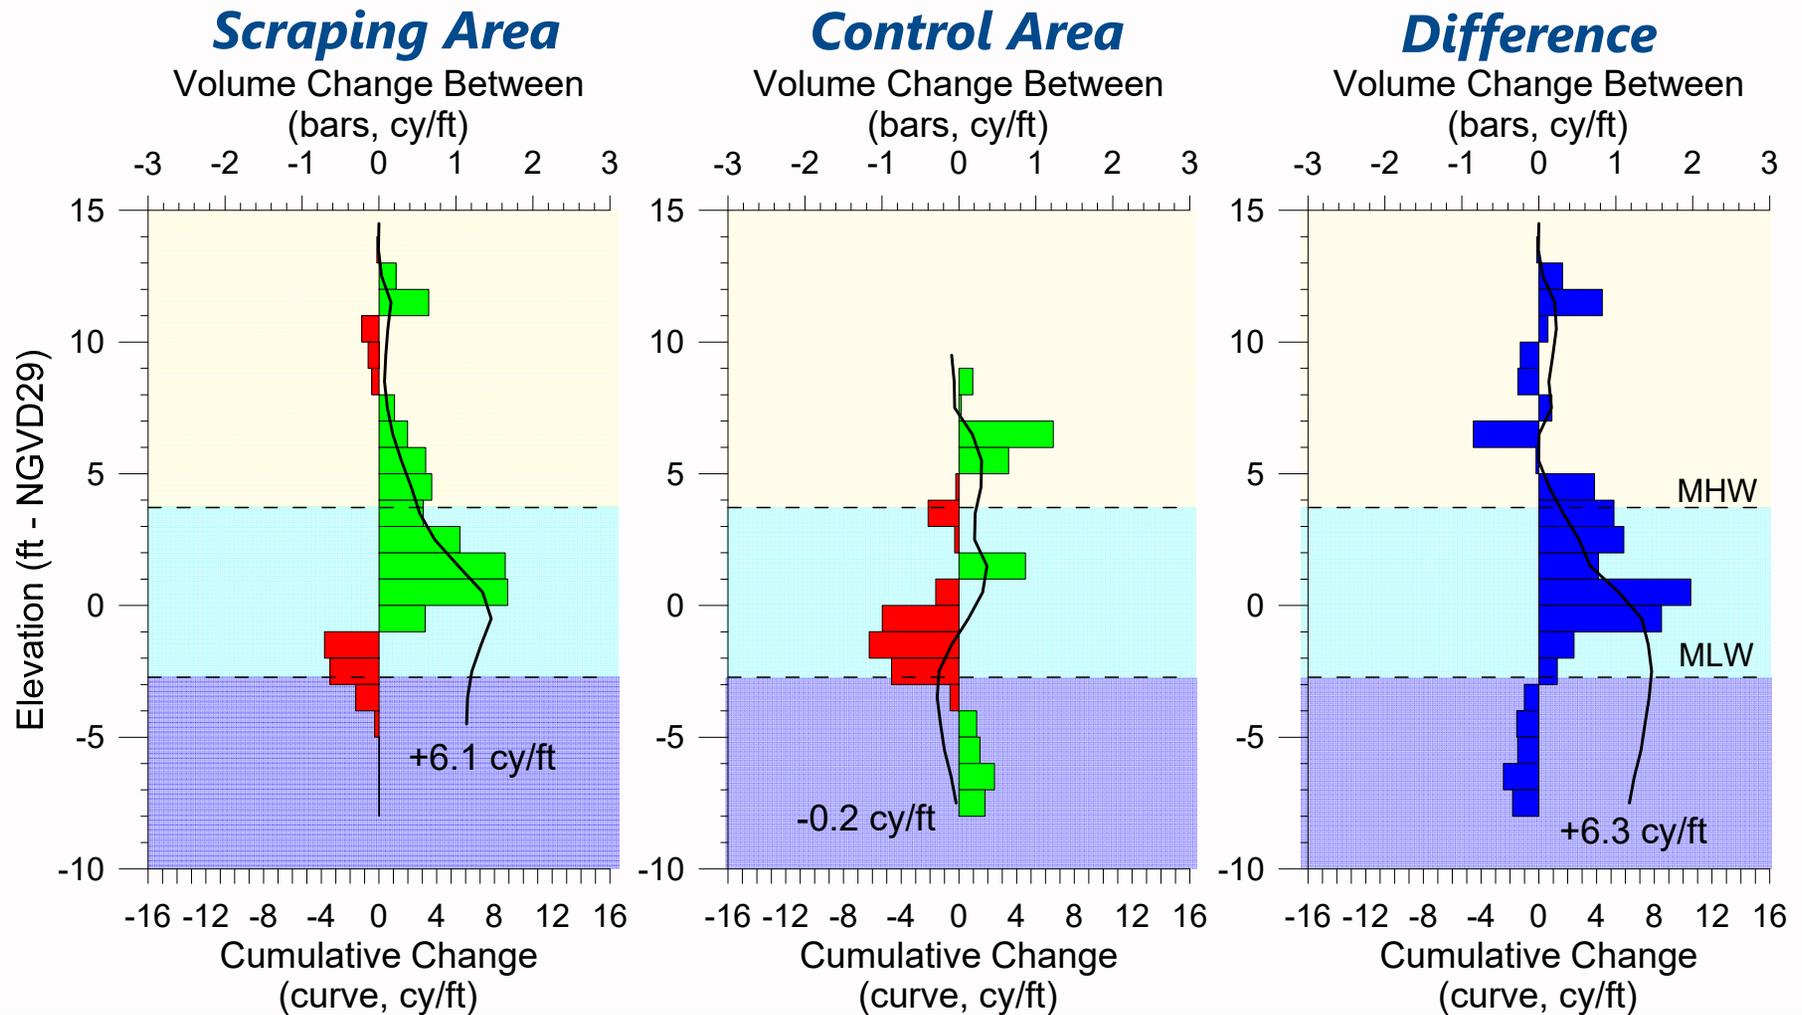
# Post Scraping (0-6 months)

Nov. 2016 – May 2017

- **Did scraping enhance or diminish post-storm beach recovery?**
  - **Yes – dune likely would not have recovered above +8 ft**
  - **Bar recovered within 6 months following scraping**
  - **Beach behavior along scraped and non-scraped areas similar beyond 6 months**
- **Was scraping an effective interim shore protection measure?**
  - **Yes – There was no additional damage to infrastructure**
- **What if scraping was not performed?**
  - **No decisive answer, but appears to have mitigated Irma impacts to infrastructure exposed by Matthew**

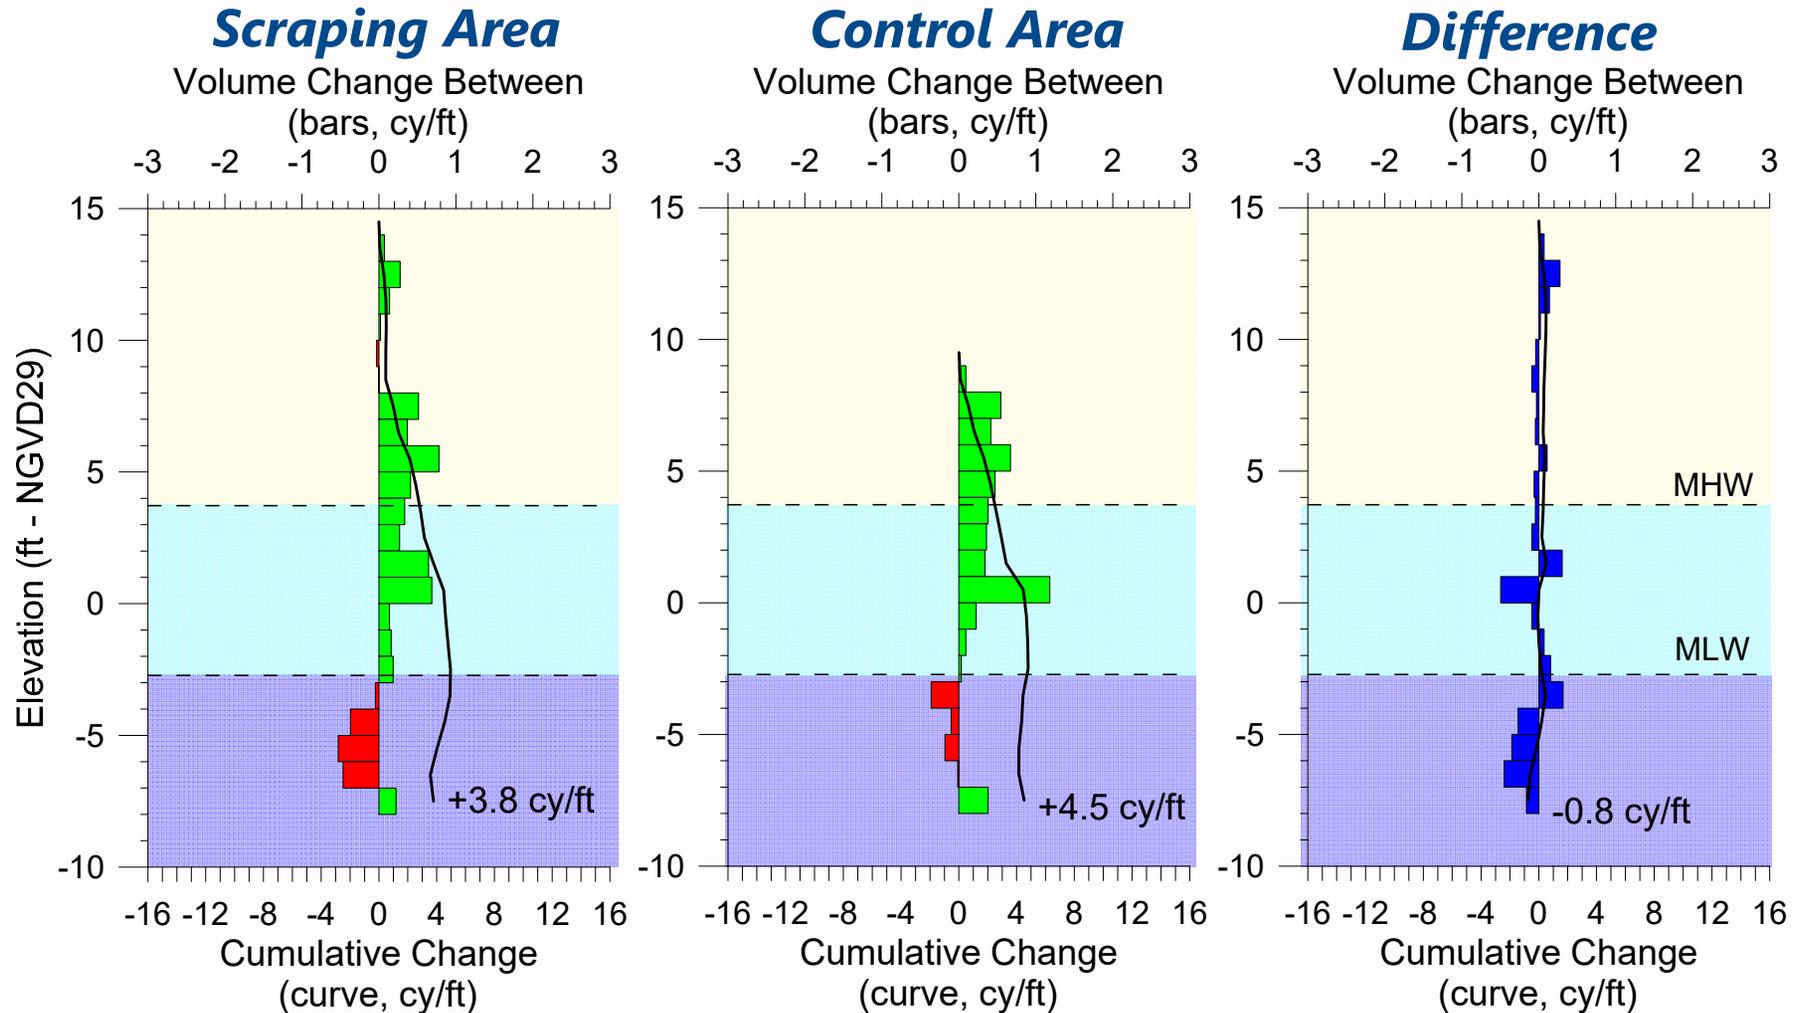
# Post Scraping (6-9 months)

May 2017 – Aug. 2017

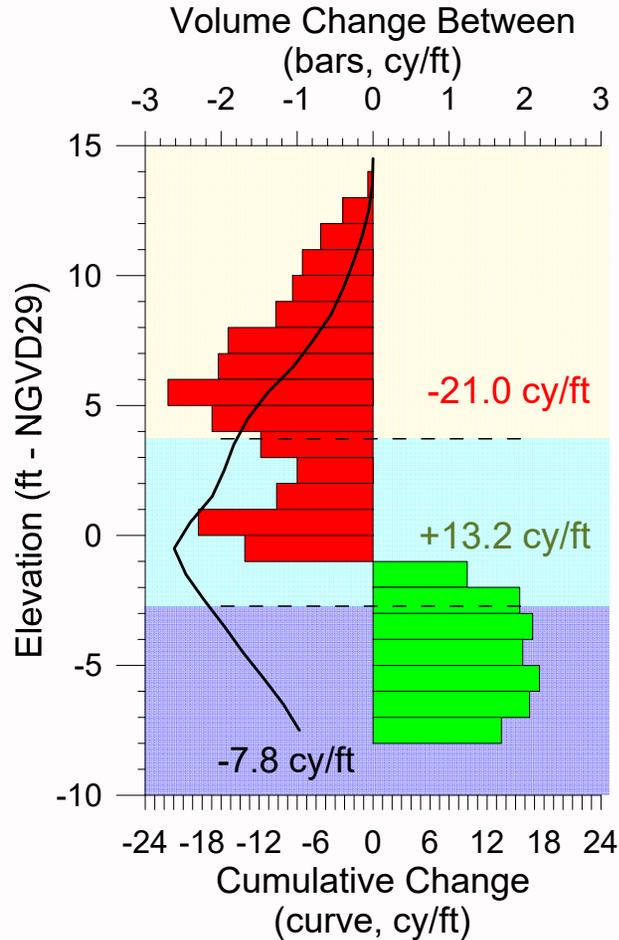
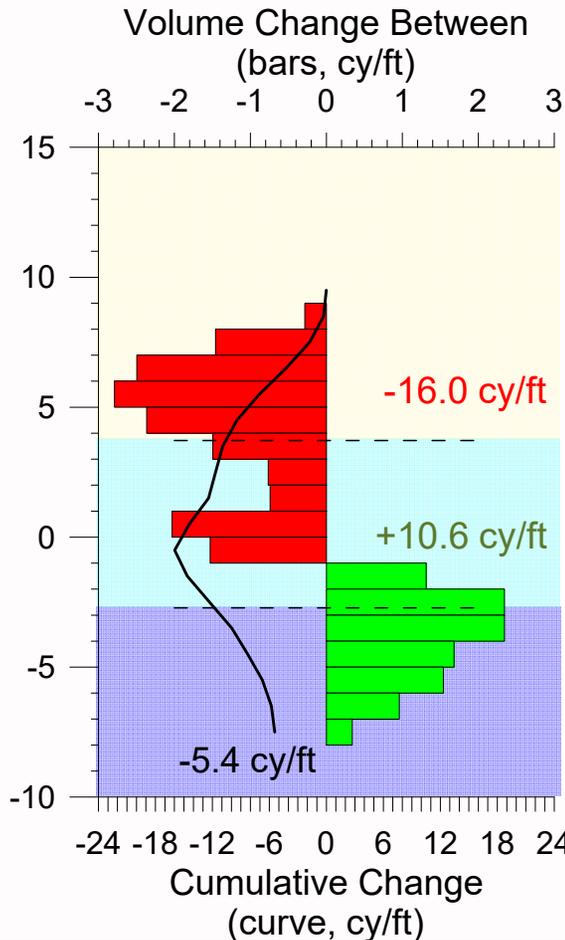
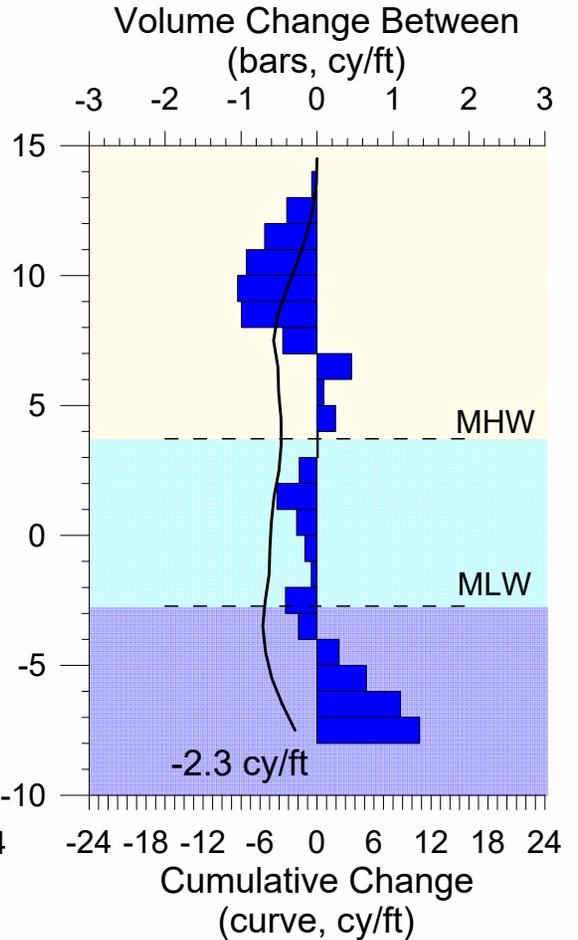
## Scraping Area

## Control Area

## Difference
