POST-STORM RECONSTRUCTION USING RESILIENT STRUCTURE IN COASTAL AREAS

FLORIDA SHORE AND BEACH PRESERVATION ASSOCIATION

TECH CONFERENCE, FEBRUARY 2018

I-Dock: A Resilient Coastal Structure

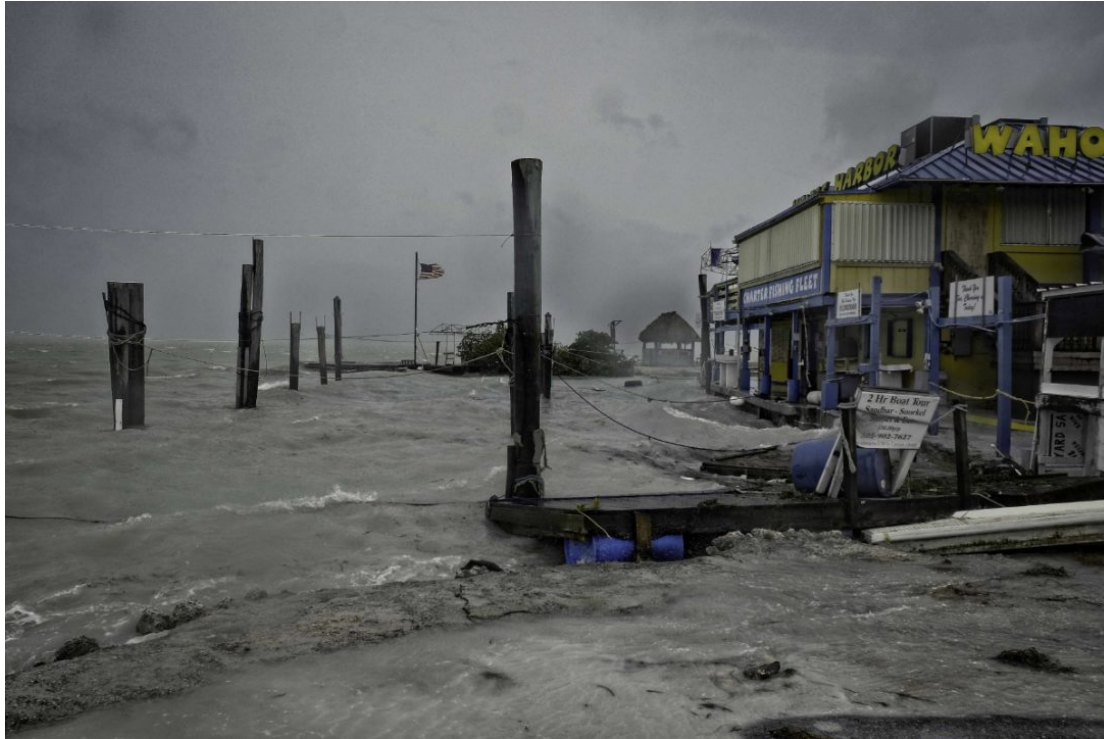
Dock Damaged by Hurricane Irma in Islamorada, FL.

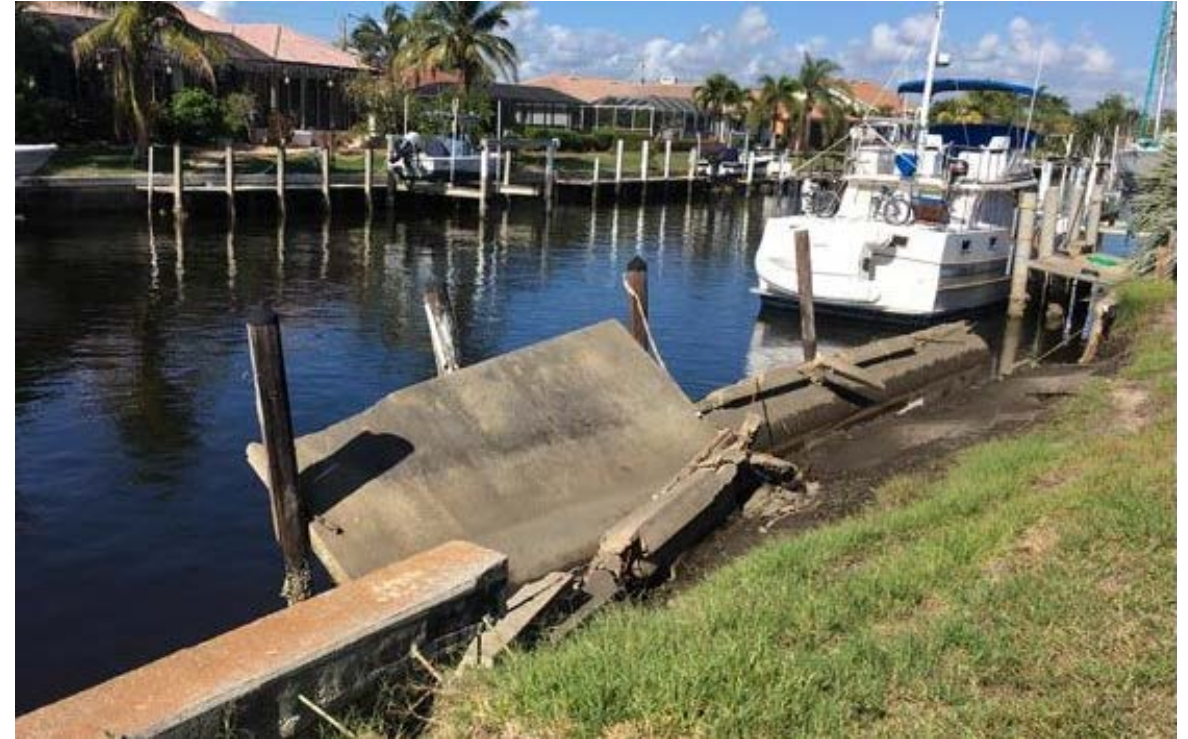
Collapsed Seawall due to Hurricane Irma in Punta Gorda, FL.

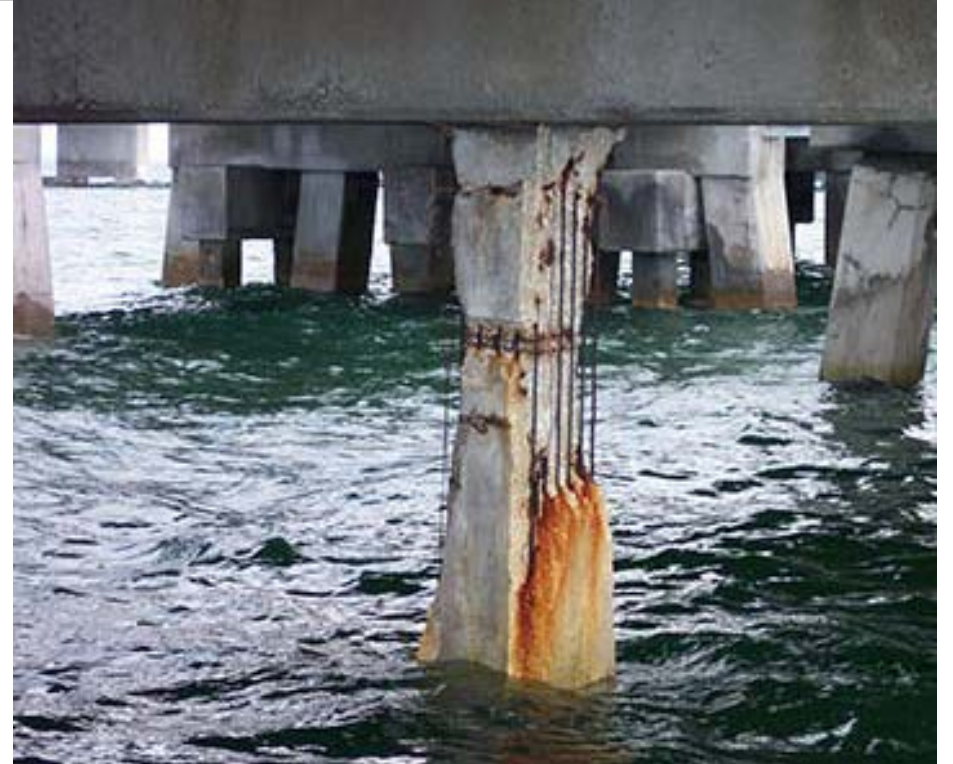
Bridge Piling with Damage Caused by Reinforcement Corrosion.

- Failure mechanism for structures exposed to aggressive environments is often corrosion of steel reinforcement
- Chlorides from seawater penetrate concrete and reach steel
 - Through cracks
 - Through concrete porosity
- Corrosion is accelerated by carbonation of concrete that lowers the pH

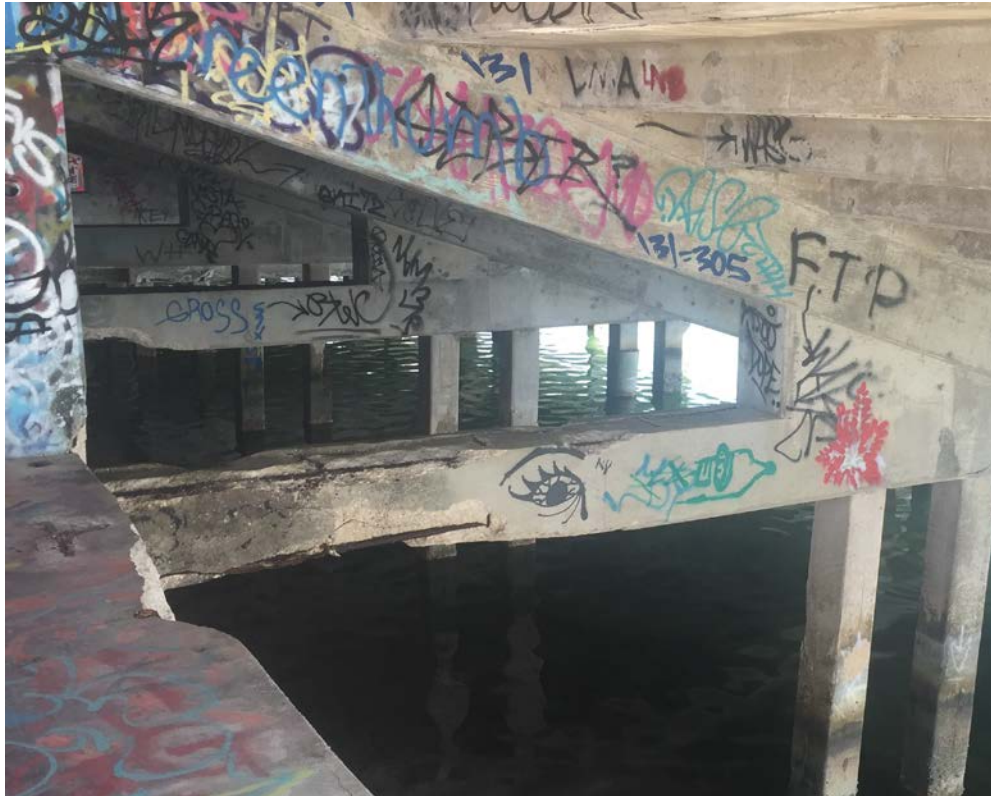
Miami Marine Stadium, beam with spall and corroded reinforcement.

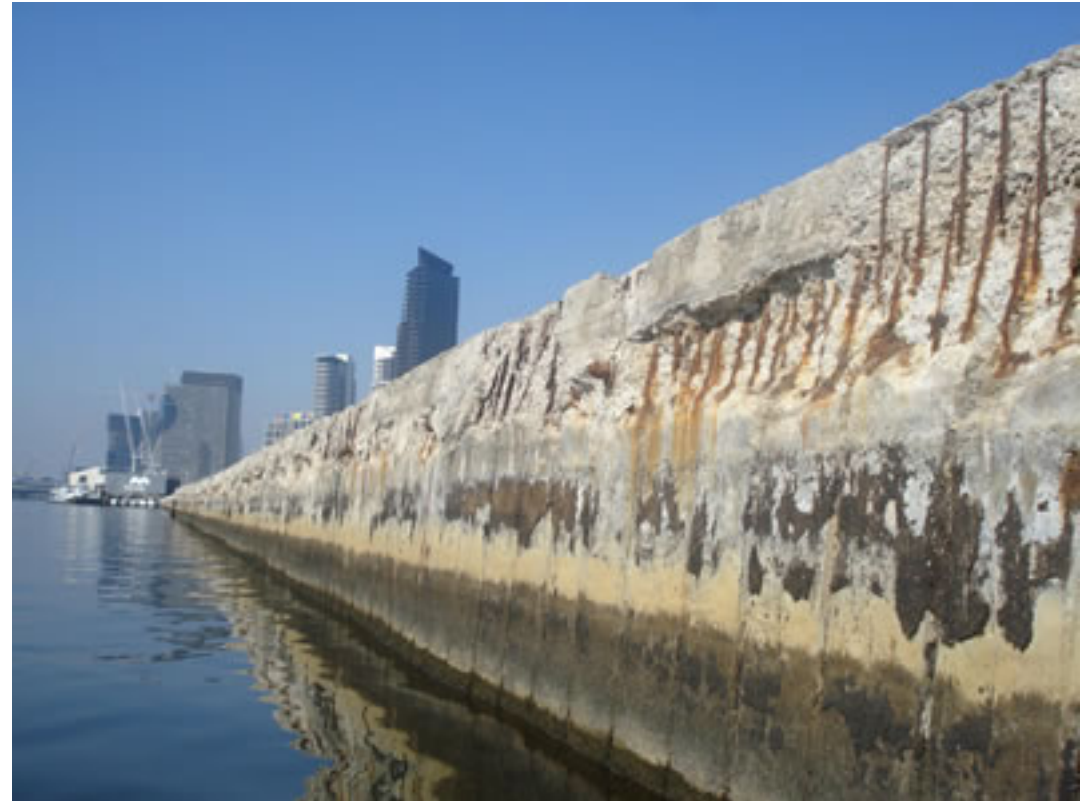
Bulkhead cap with reinforcement corrosion.
Picture from Duoguard.

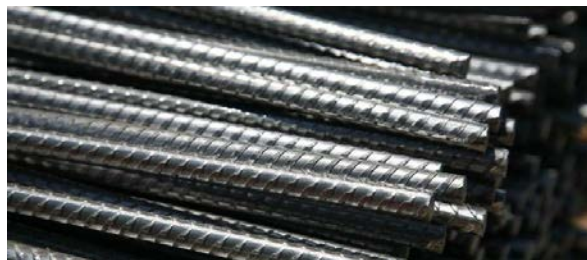
Stainless Steel Rebars

- Admixtures
- Increase Concrete Cover
- Alter Concrete Mix
- Membranes & Overlays
- Epoxy coated or Stainless Steel
- Cathodic Protection

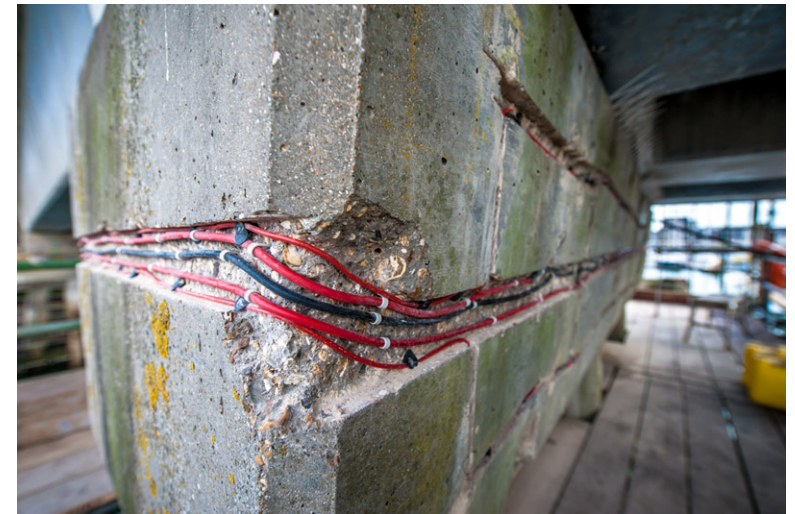
Cathodic Protection

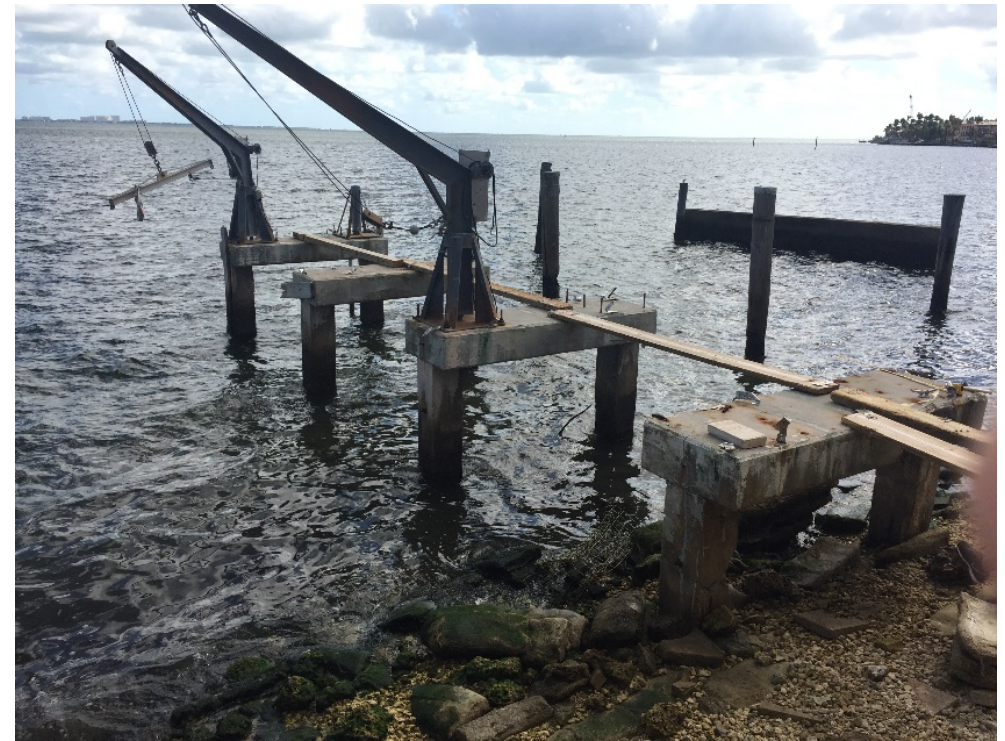
After Hurricane Irma – Current Conditions

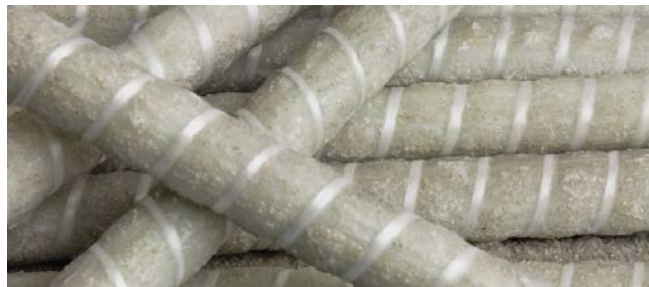
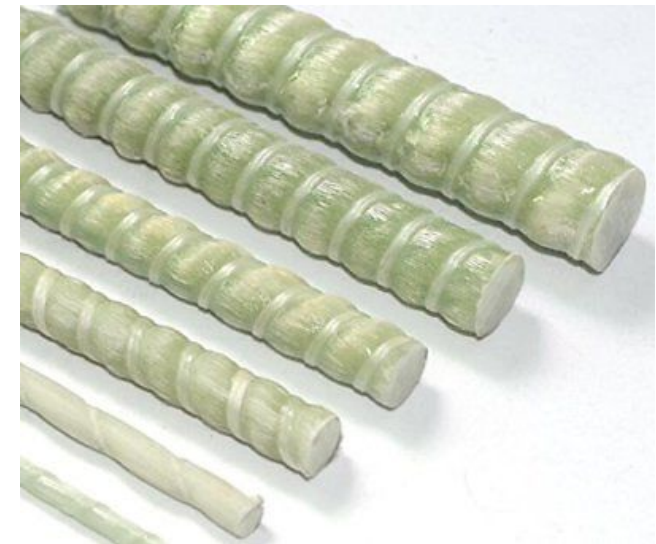
Seabar™

- ❑ SEABAR™: non-corrosive reinforcement with superior performance in chloride-contaminated environments
- ❑ SEABAR™ includes Glass Fiber Reinforced Polymers (GFRP), Carbon Fiber Reinforced Polymers (CFRP) and Basalt Fiber Reinforced Polymers (BFRP) bars.

- Non-corrosive
- High strength-to-weight ratio
- Ease of application & installation
- ¼ the weight of steel
- Transparent to magnetic fields and radar frequencies
- Electrically and thermally non-conductive

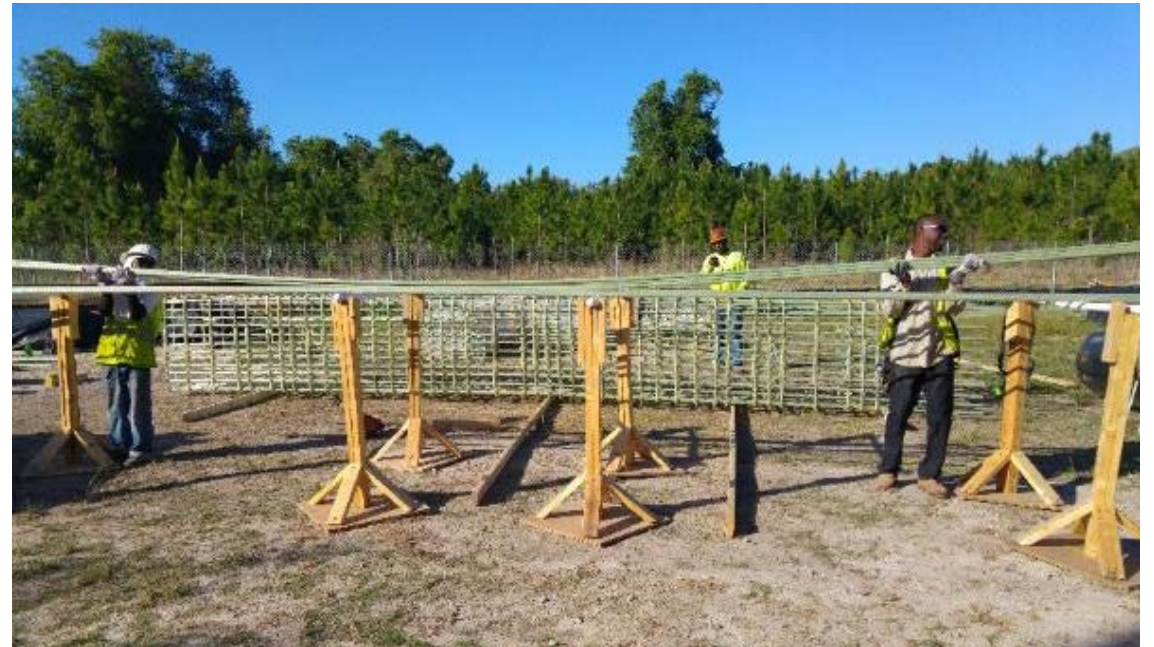
Construction Crew Lifting Reinforcement Cage.

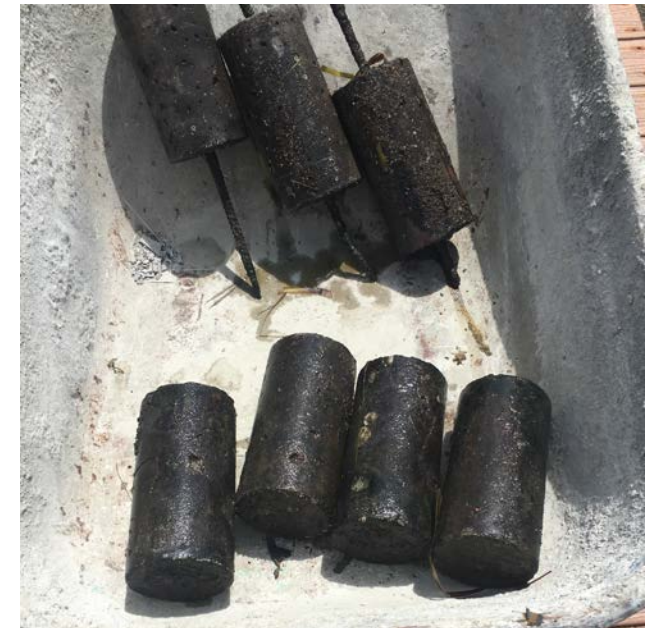
Seacrete™ specimens

□ Seacrete™: Sustainable concrete using seawater, salt-contaminated aggregates, and non-corrosive reinforcement

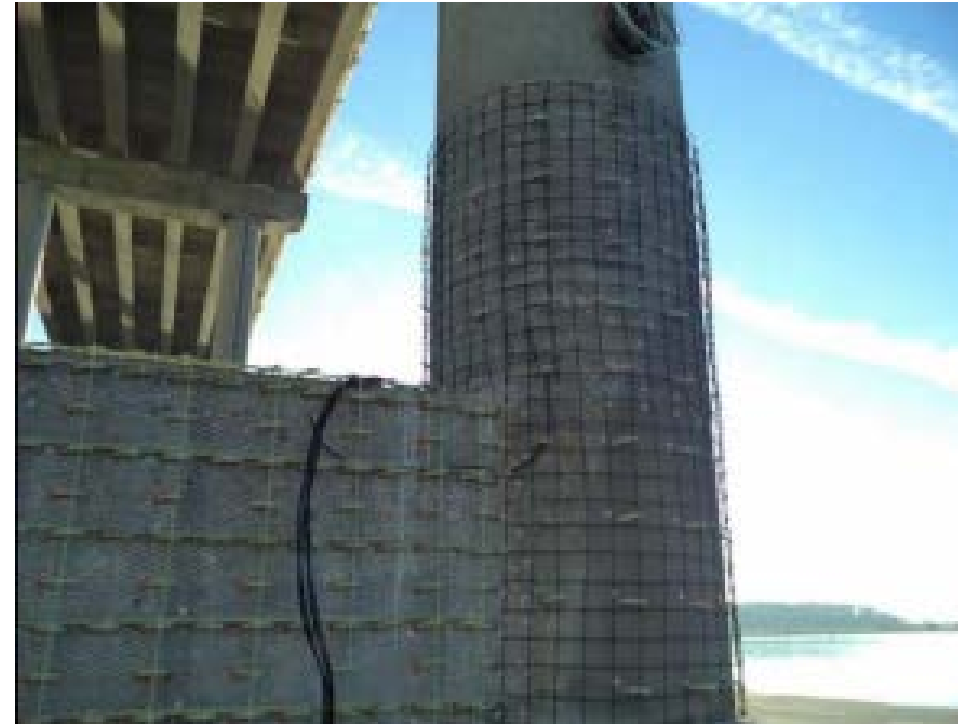
FDOT Bridge Substructure Rehabilitation

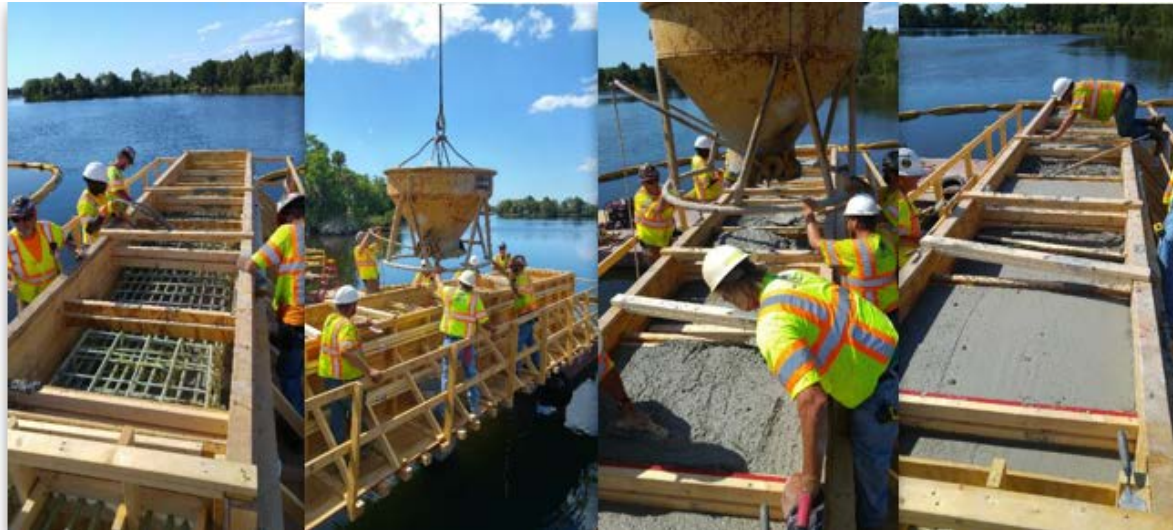
FDOT Bridge Rehabilitation project. GFRP and CFRP Used in Concrete Deck

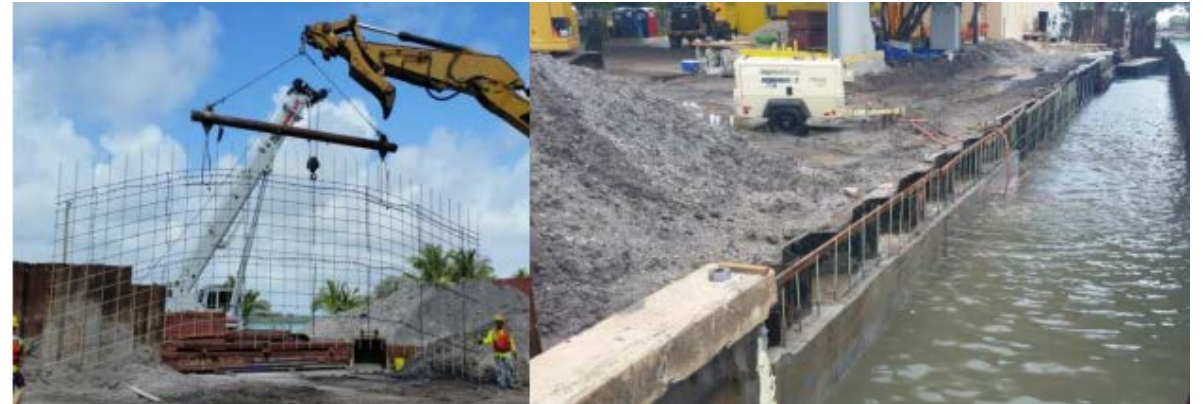
FDOT Bulkhead Rehabilitation Project. GFRP Used in Concrete Cap and Fascia Panels
