# The Impact of Hurricane Michael on the Coast of Northwest Florida

Ralph Clark, P.E.

Division of Water Resource Management

February 8, 2019

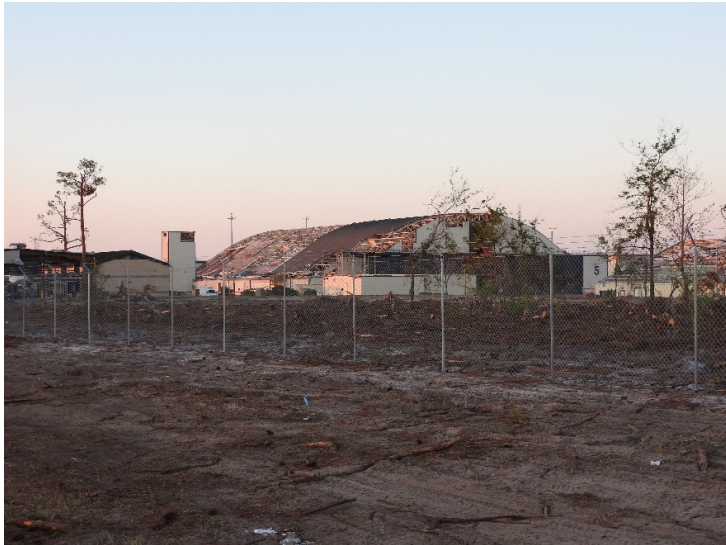
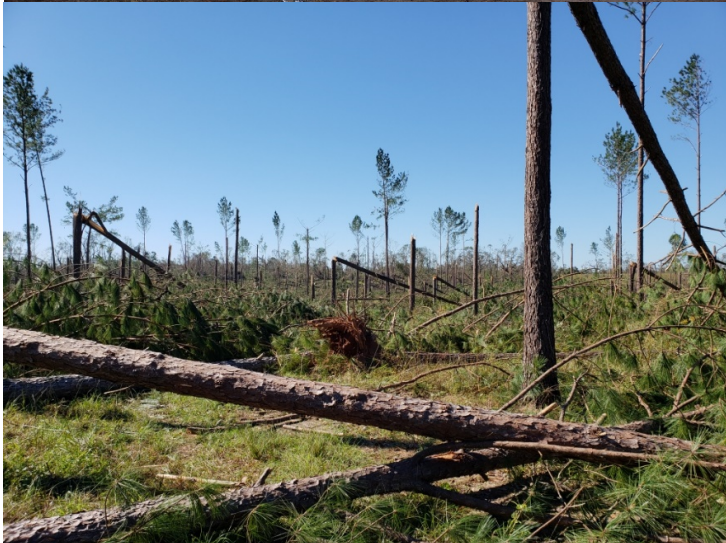
# Severe Inland Wind Damages

- **Tyndall Air Force Base sustained major damages to all major structures**
- **Major disaster declared for Bay, Gulf, Calhoun, Holmes, Jackson, Gadsden, Franklin, Leon, and Wakulla Counties**
- **Major disaster to the forests of north Florida**
- **Entered Georgia as a Category 3 – first major hurricane to hit Georgia since 1898**

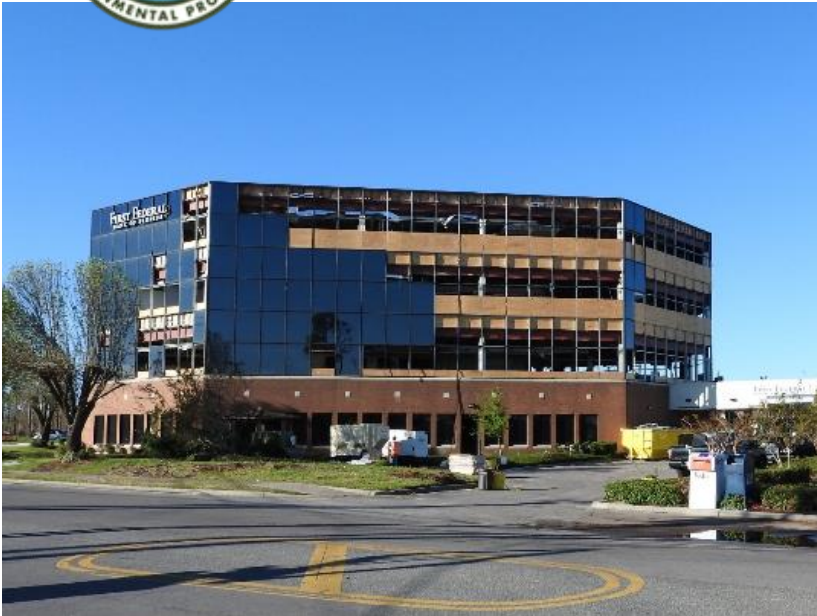
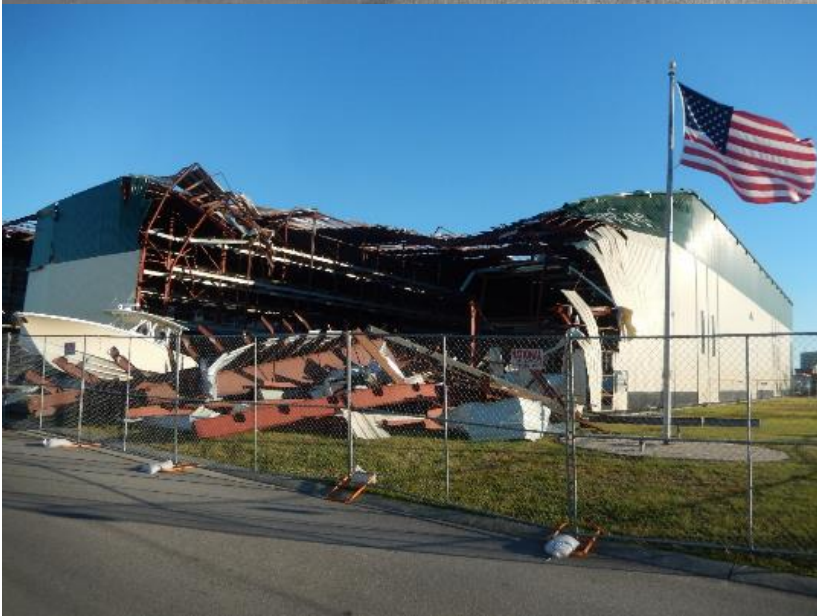
# Wind Damages in Panama City

- **Severe wind damages in Panama City and eastern Panama City Beach**
- **All major damage along Panama City Beaches was due to the wind**
- **466 major structures damaged including 6 destroyed along Panama City Beach**

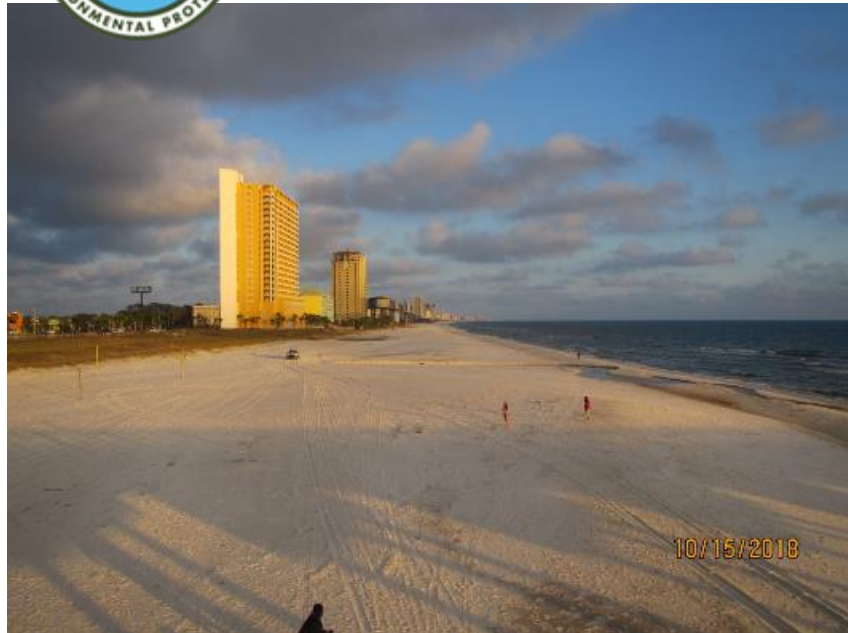
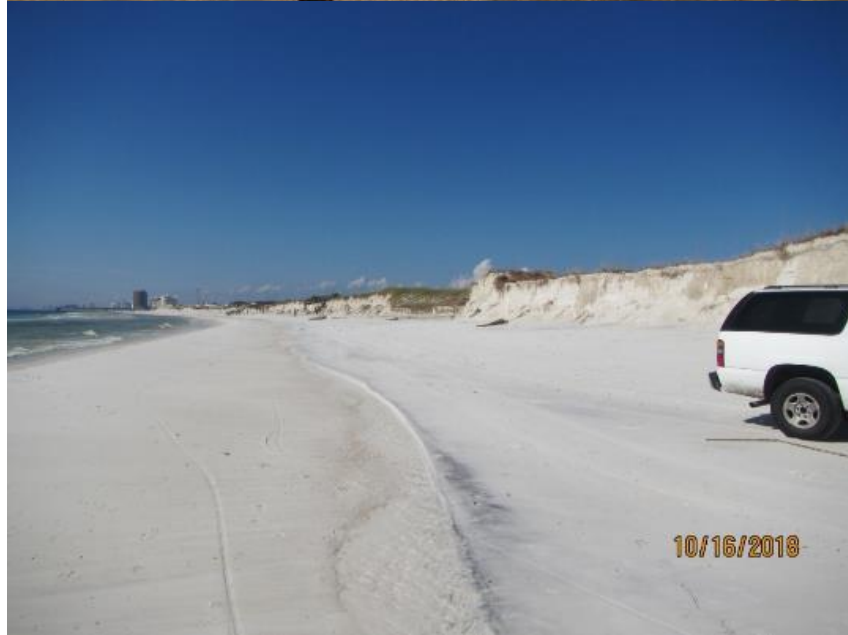
# Erosion: Panama City Beaches

- **Shore Protection Project (R0-R92) – 546,000 cy eroded**
- **The project protected Panama City Beaches from all surge, wave, and erosion damages**
- **In contract, pre-project damages from Hurricane Opal were 471 buildings and numerous seawalls**
- **Outside of the SPP, St. Andrews State Park sustained major dune erosion**

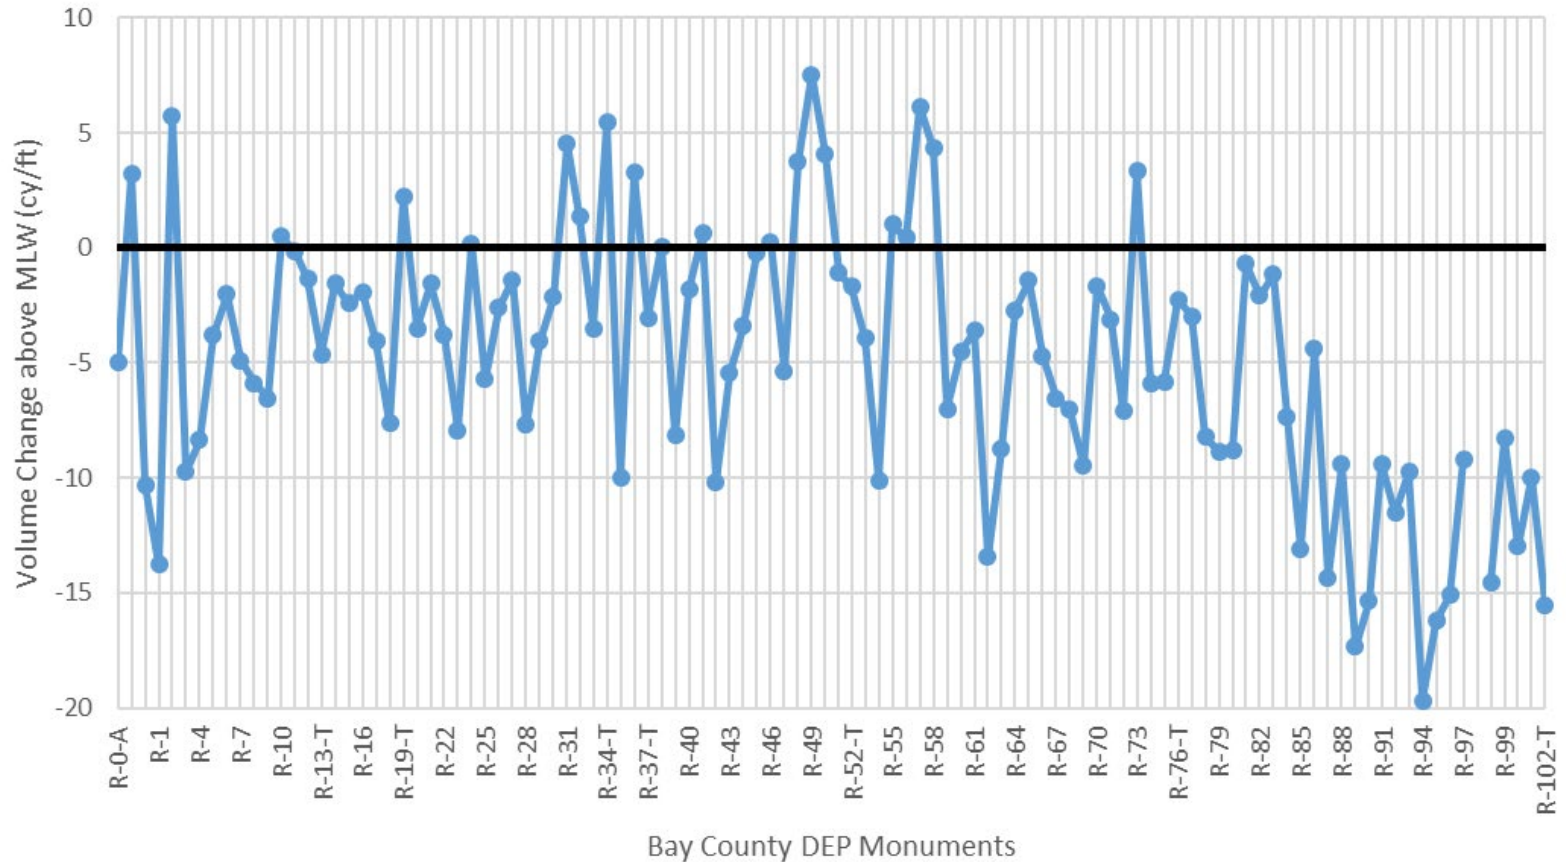
# Panama City Beach Erosion

Panama City Beach Volume Change After Hurricane Michael  
May 2018 to October 2018

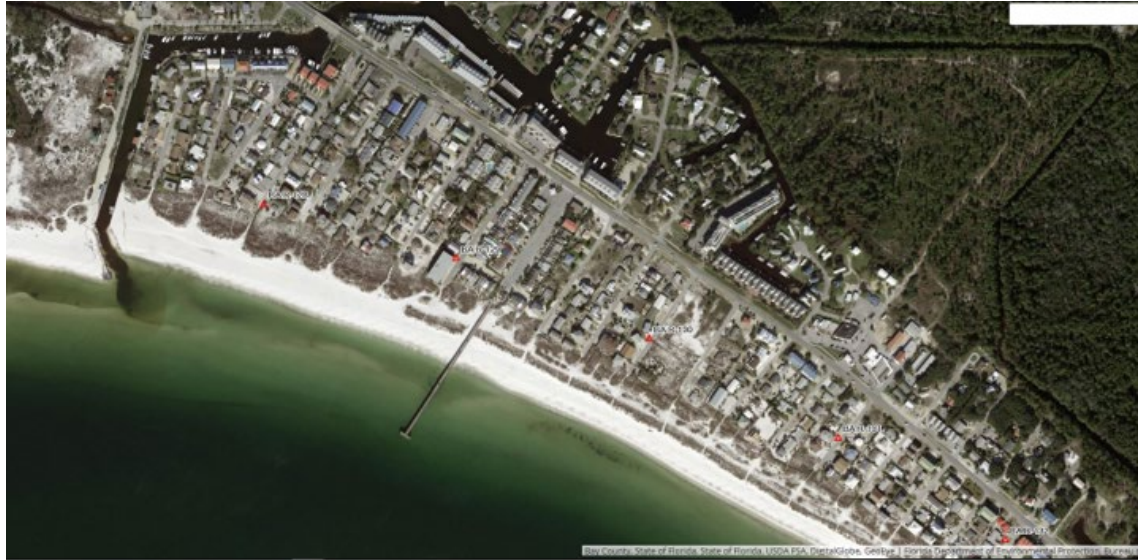
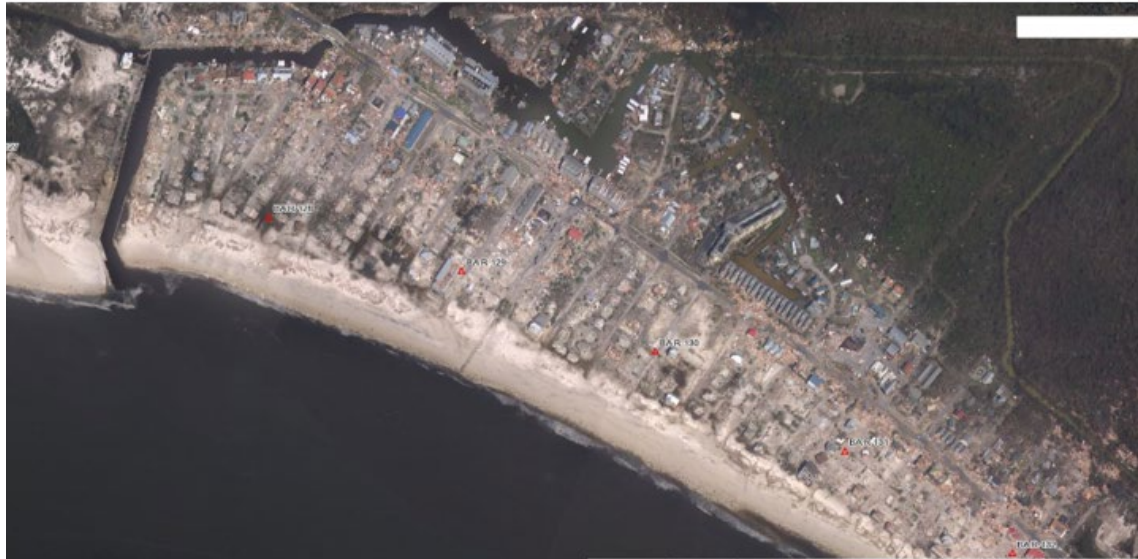
# Ground Zero: Mexico Beach

- Sustained the greatest damage from the storm surge, waves, and winds exceeding coastal building standards
- 99% of development seaward of US98 sustained major damage, including 80% of buildings destroyed
- 1,102 buildings with major damage, including 595 destroyed within Coastal Building Zone

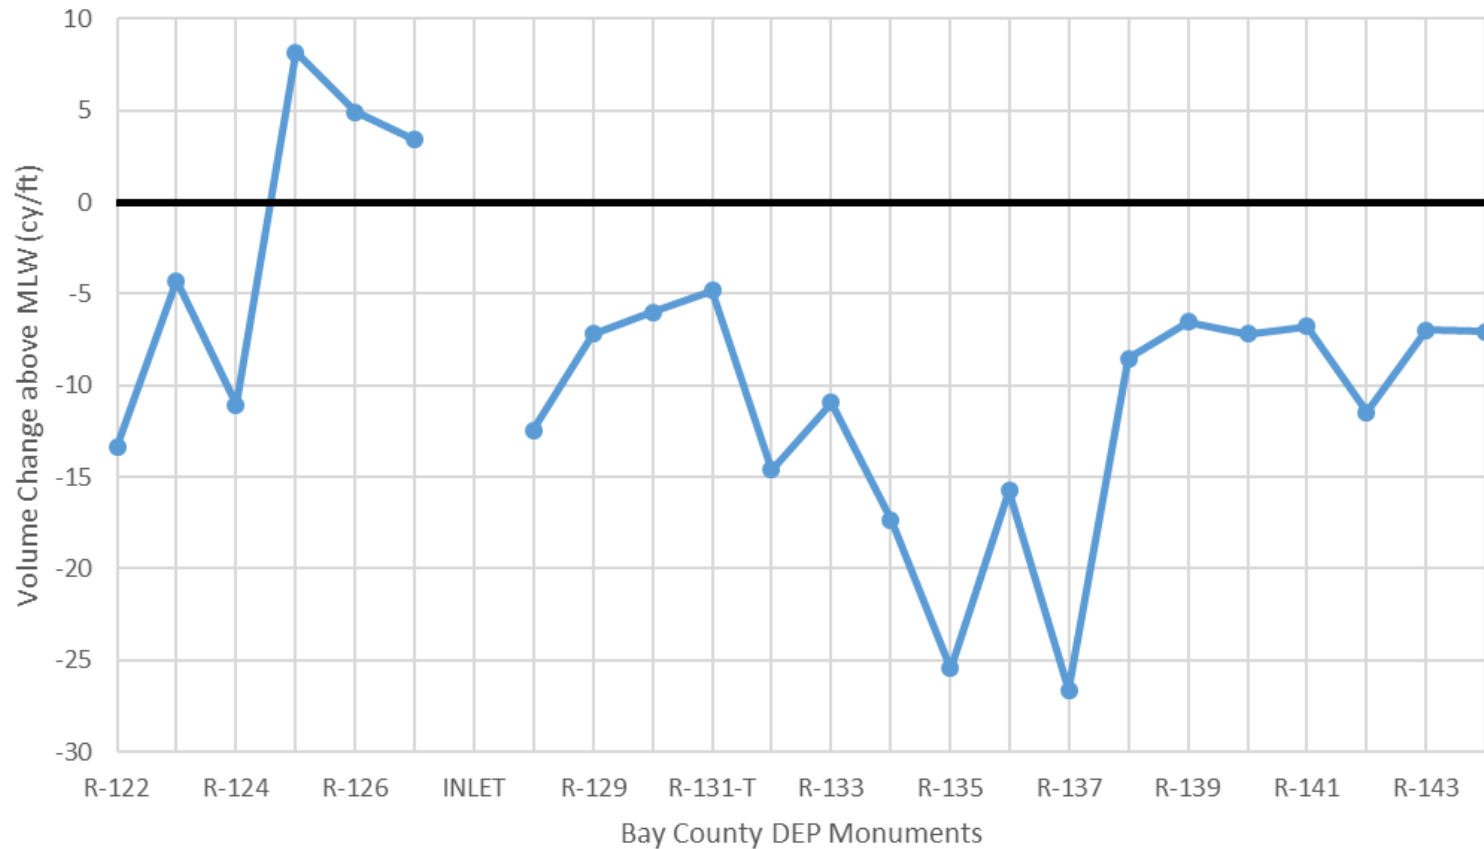
# Mexico Beach Erosion

- **100-year storm surge only +12.2 ft NAVD. Surge gauge on pier piling measured +15.6 NAVD (280 year event)**
- **High water marks were measured by USGS between +17.6 ft and +21.2 ft NAVD**
- **Wave uprush to +30 ft NAVD exacerbated the flooding**
- **Inlet to county line (R128-R144) – 190,000 cy lost above MLW or -11.6 cy/ft**

Mexico Beach Volume Change Above MLW After Hurricane Michael  
October 2016 to October 2018

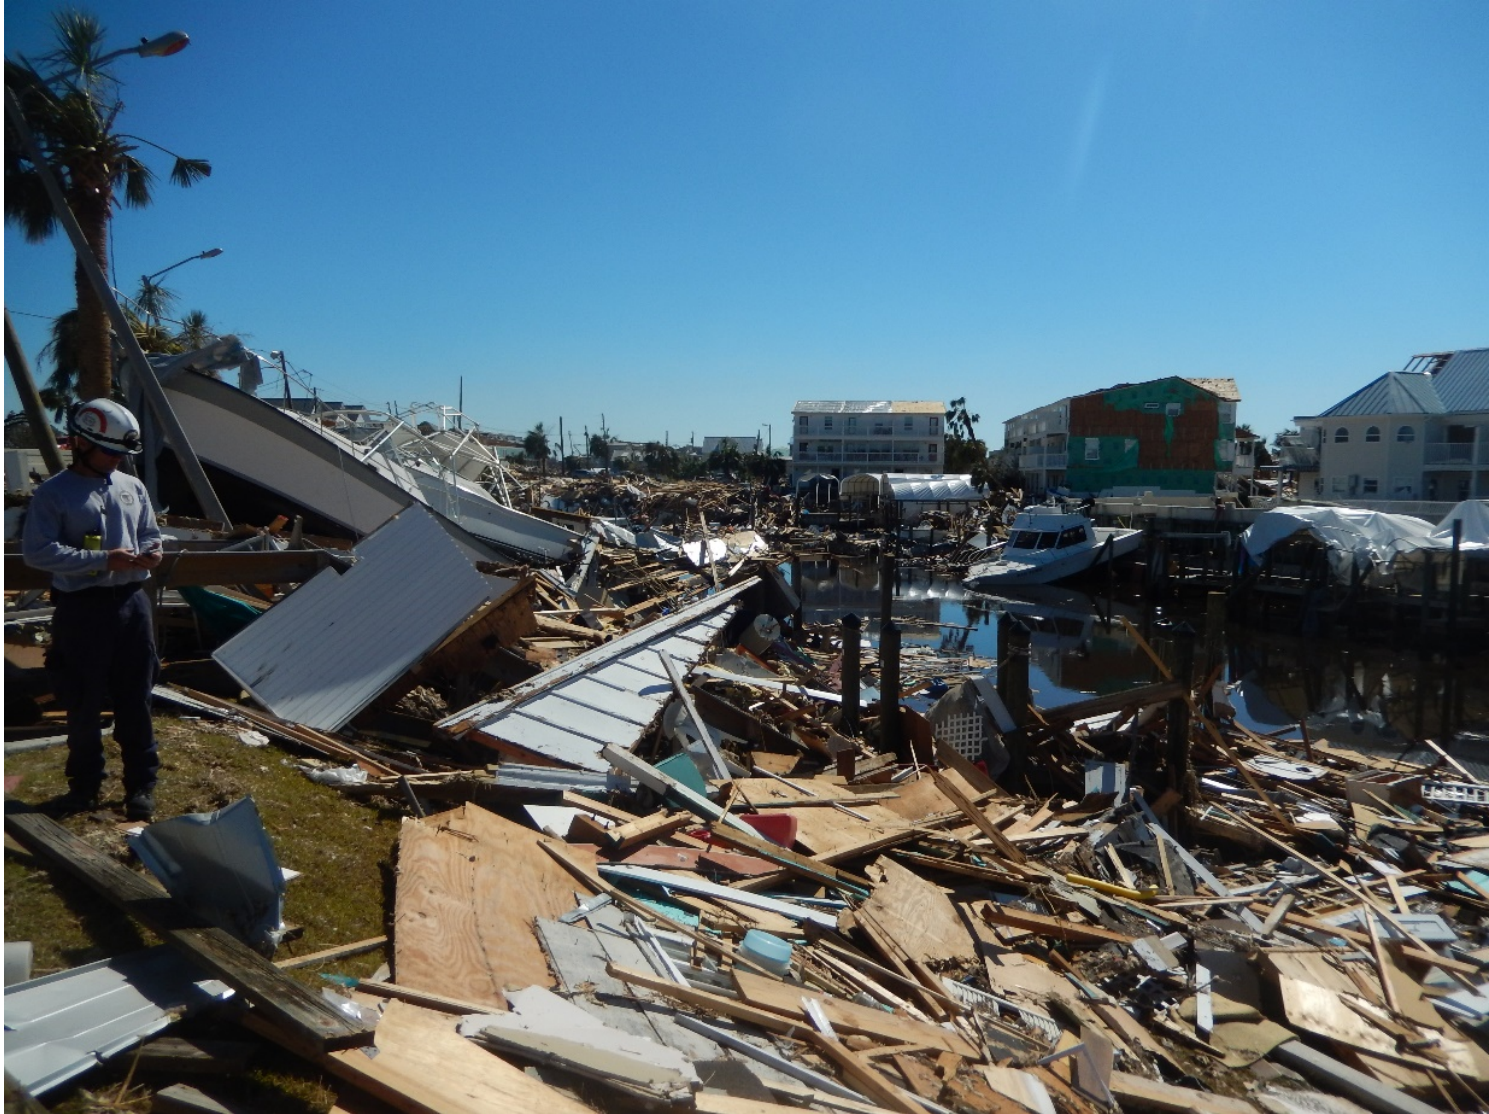
# Mexico Beach Canal Debris

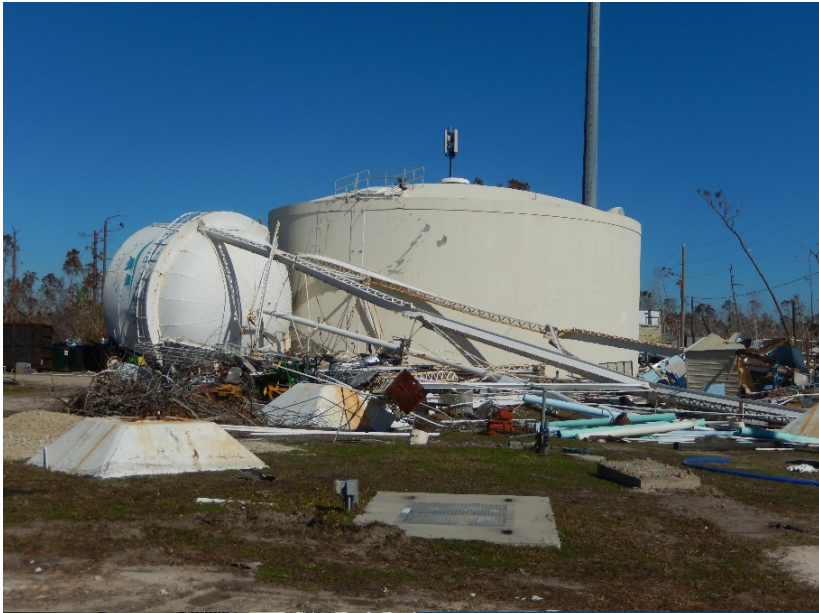
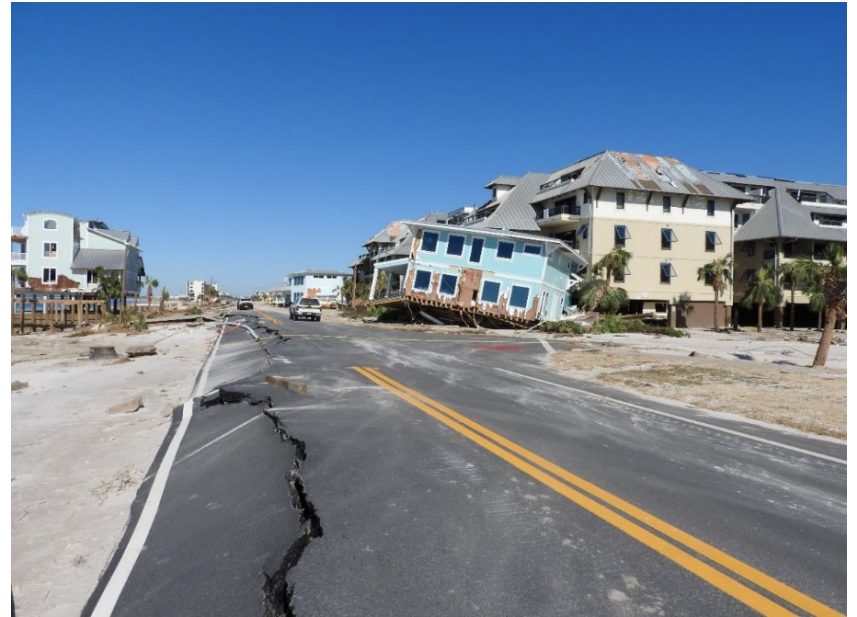
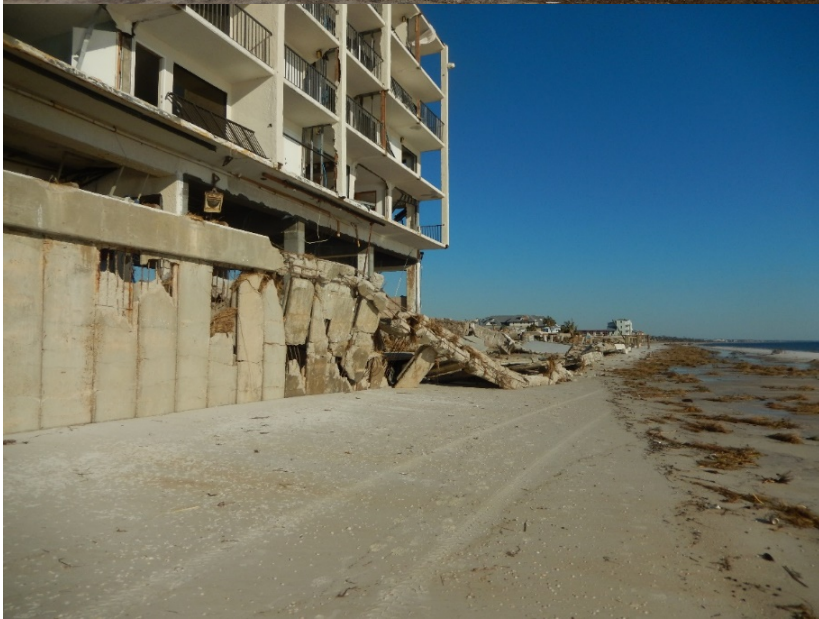
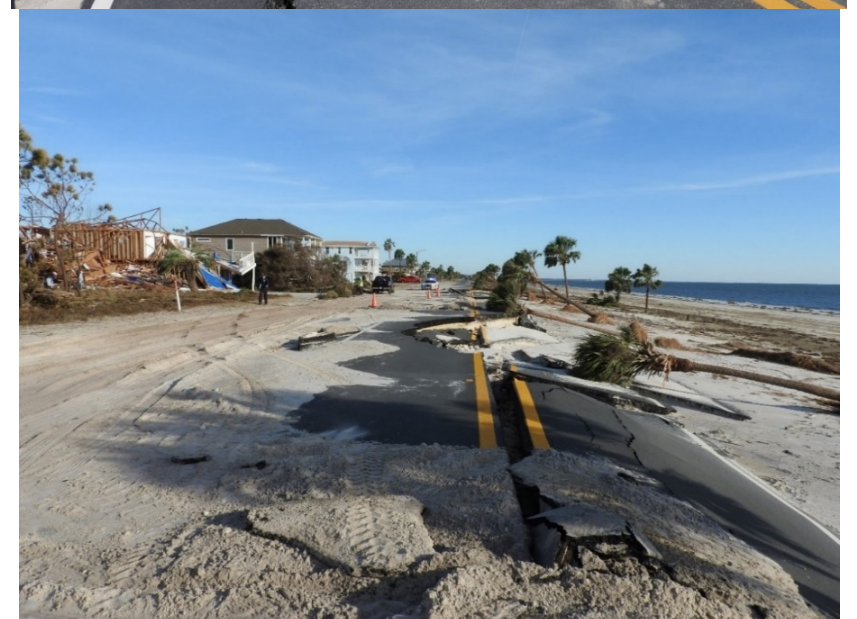
# Mexico Beach Damage

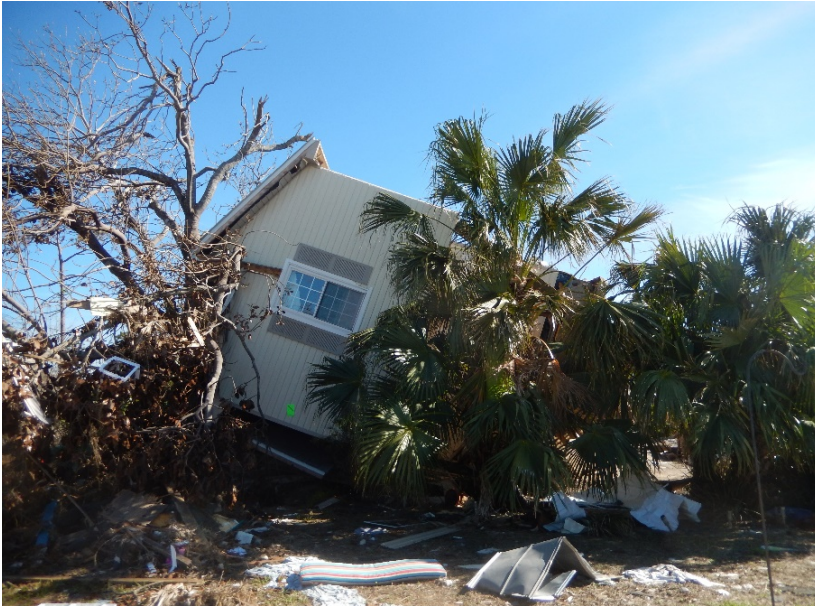
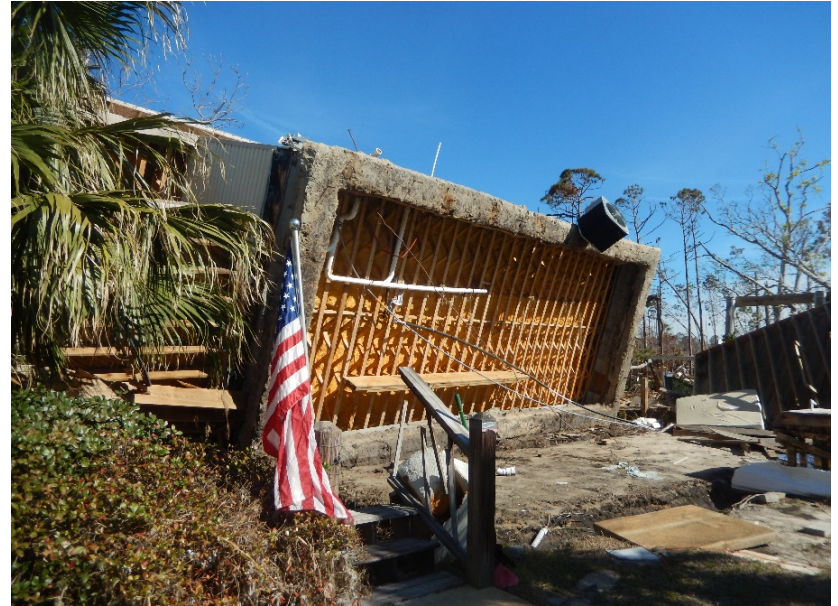
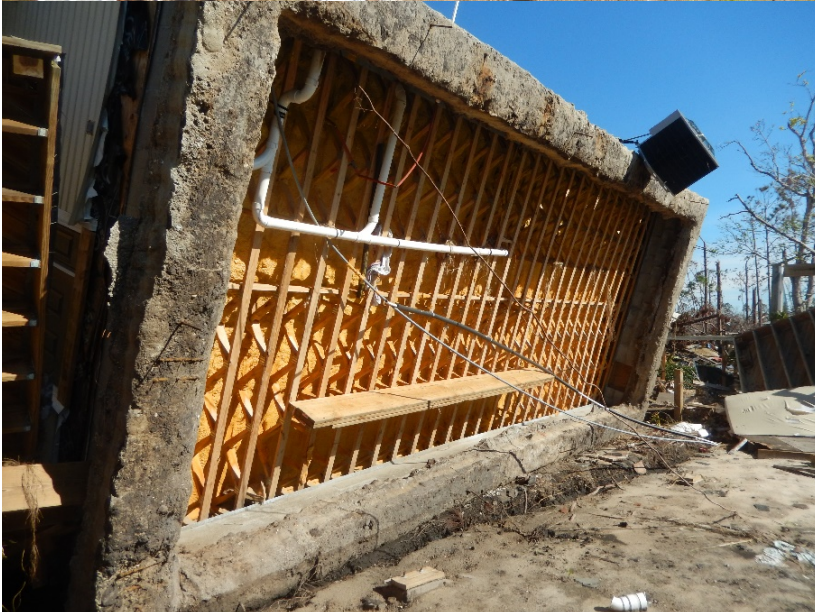
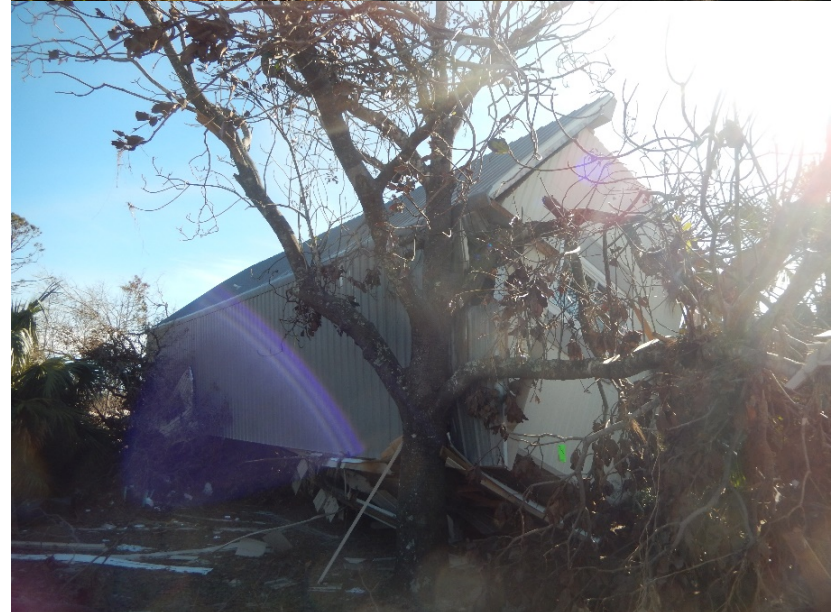
# House Rolled by Surge and Wind

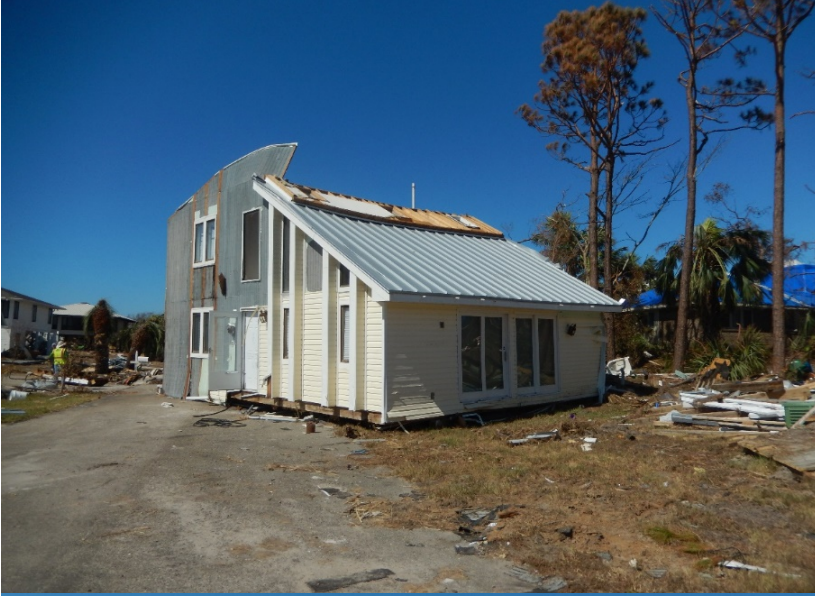
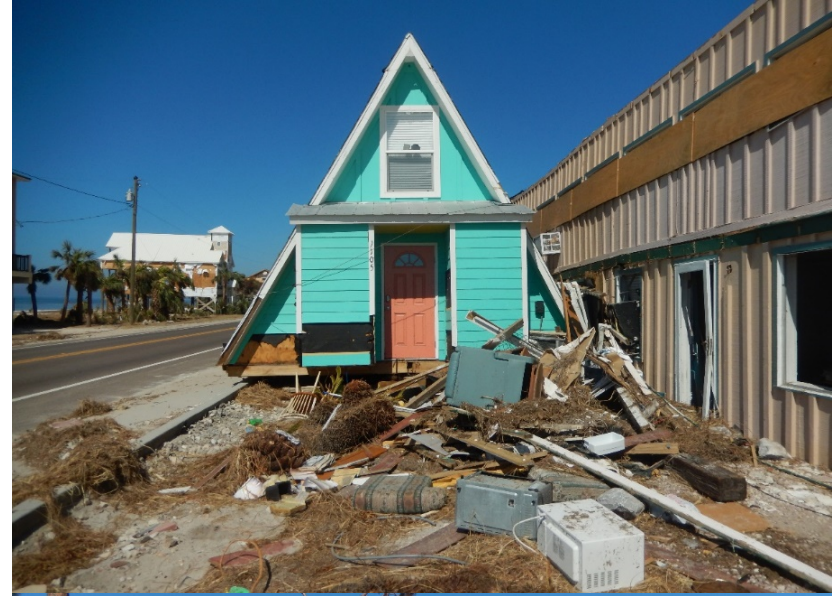
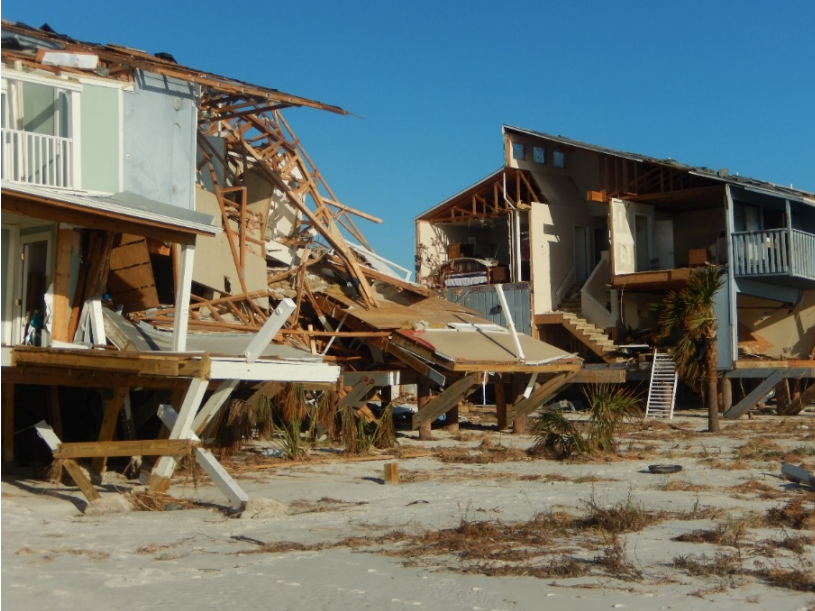
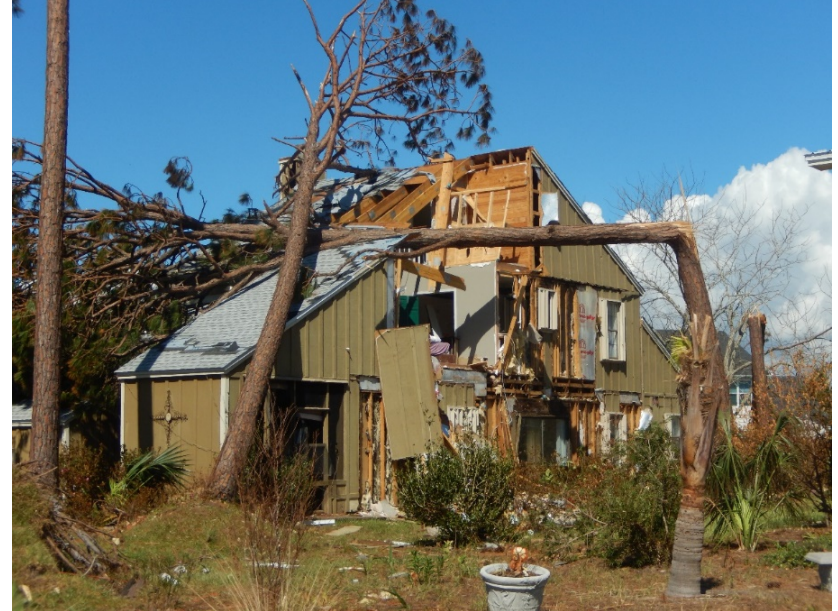
# Beacon Hill Damage

- Peak surge +21.2 ft NAVD at north county line
- Extreme impacts along Beach Hill from surge, waves, and wind
- Major beach and dune erosion along Beacon Hill and St. Joseph Peninsula
- Barrier breach at Eagle Harbor
- Road destroyed at Stump Hole
- 660 ft of Cape San Blas lost to erosion
- Major damage to 984 buildings county-wide in Coastal Building Zone, including 176 destroyed

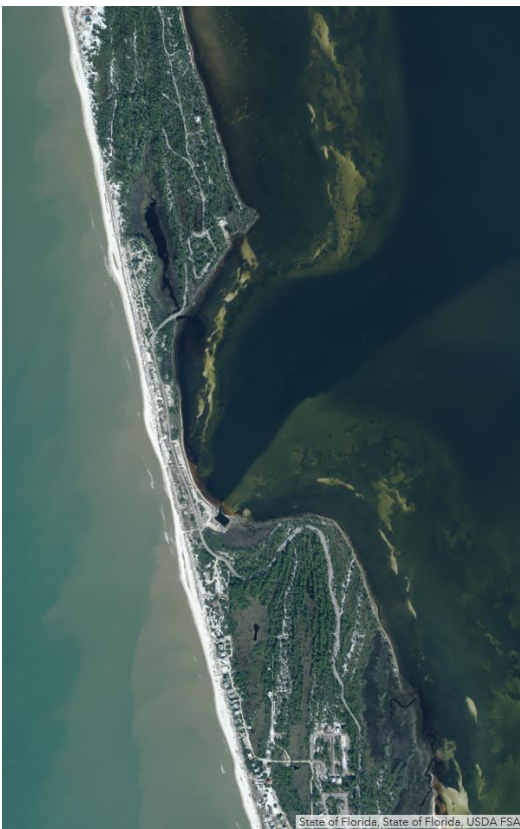
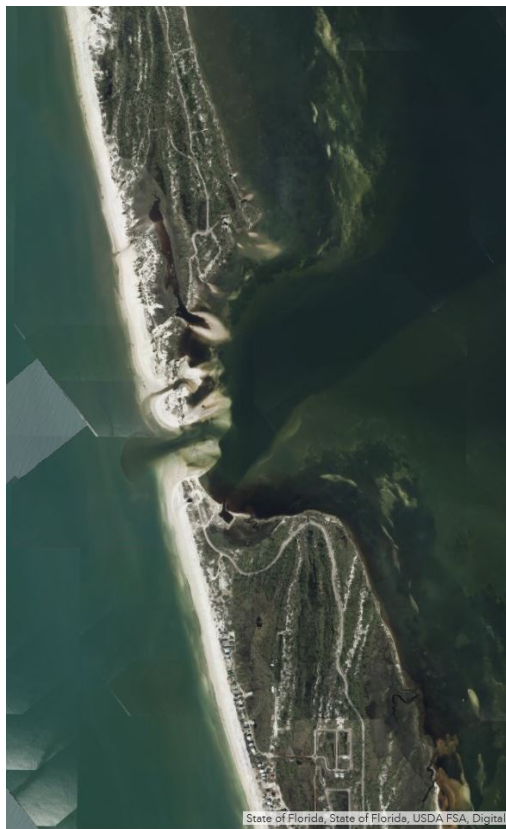
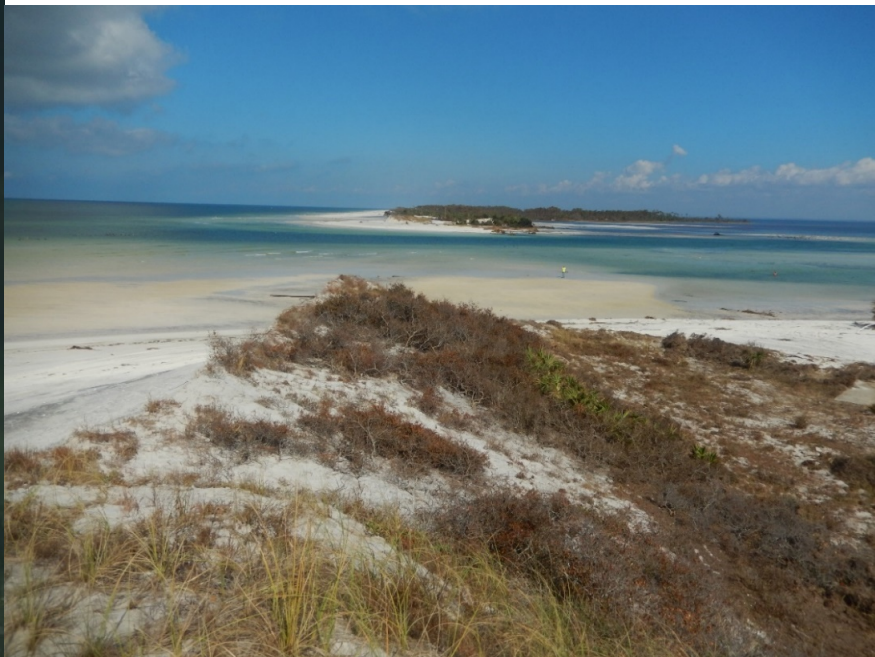
# Barrier Breach at Eagle Harbor

- **Approx. 288,700 yd<sup>3</sup> of erosion**
- **Approx. 116,500 yd<sup>3</sup> of accretion**
- **Approx. 172,200 yd<sup>3</sup> of overall loss**

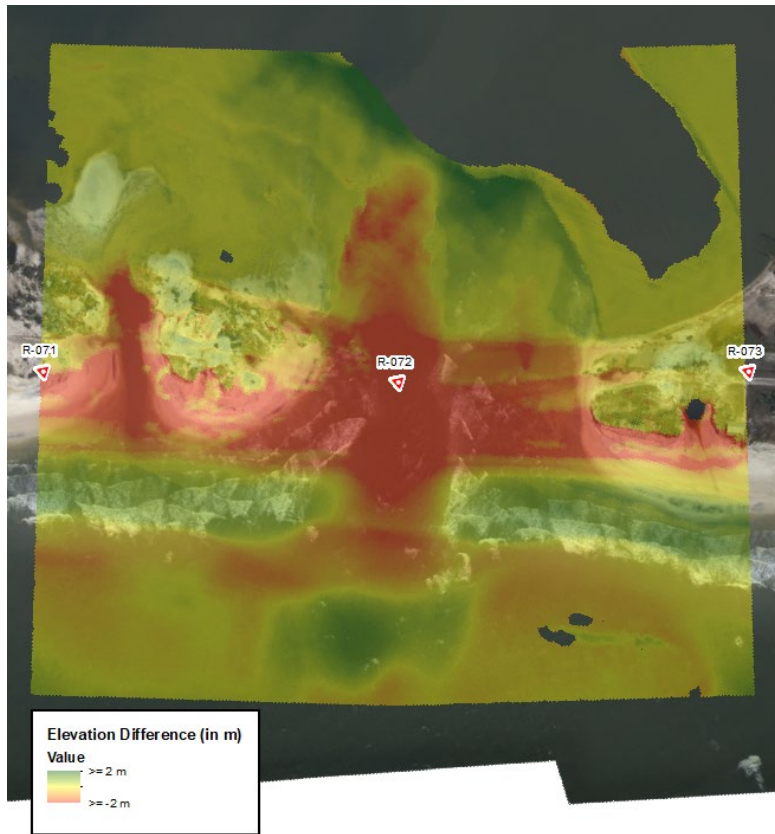
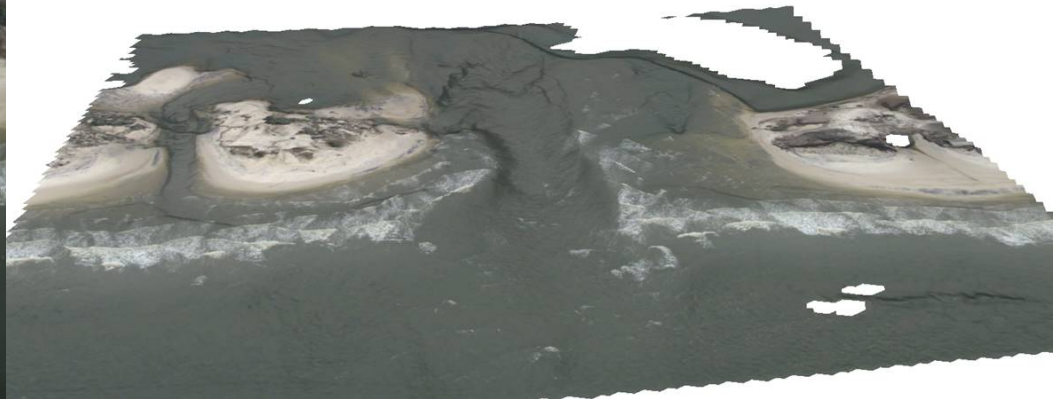
# Barrier Breach at Eagle Harbor

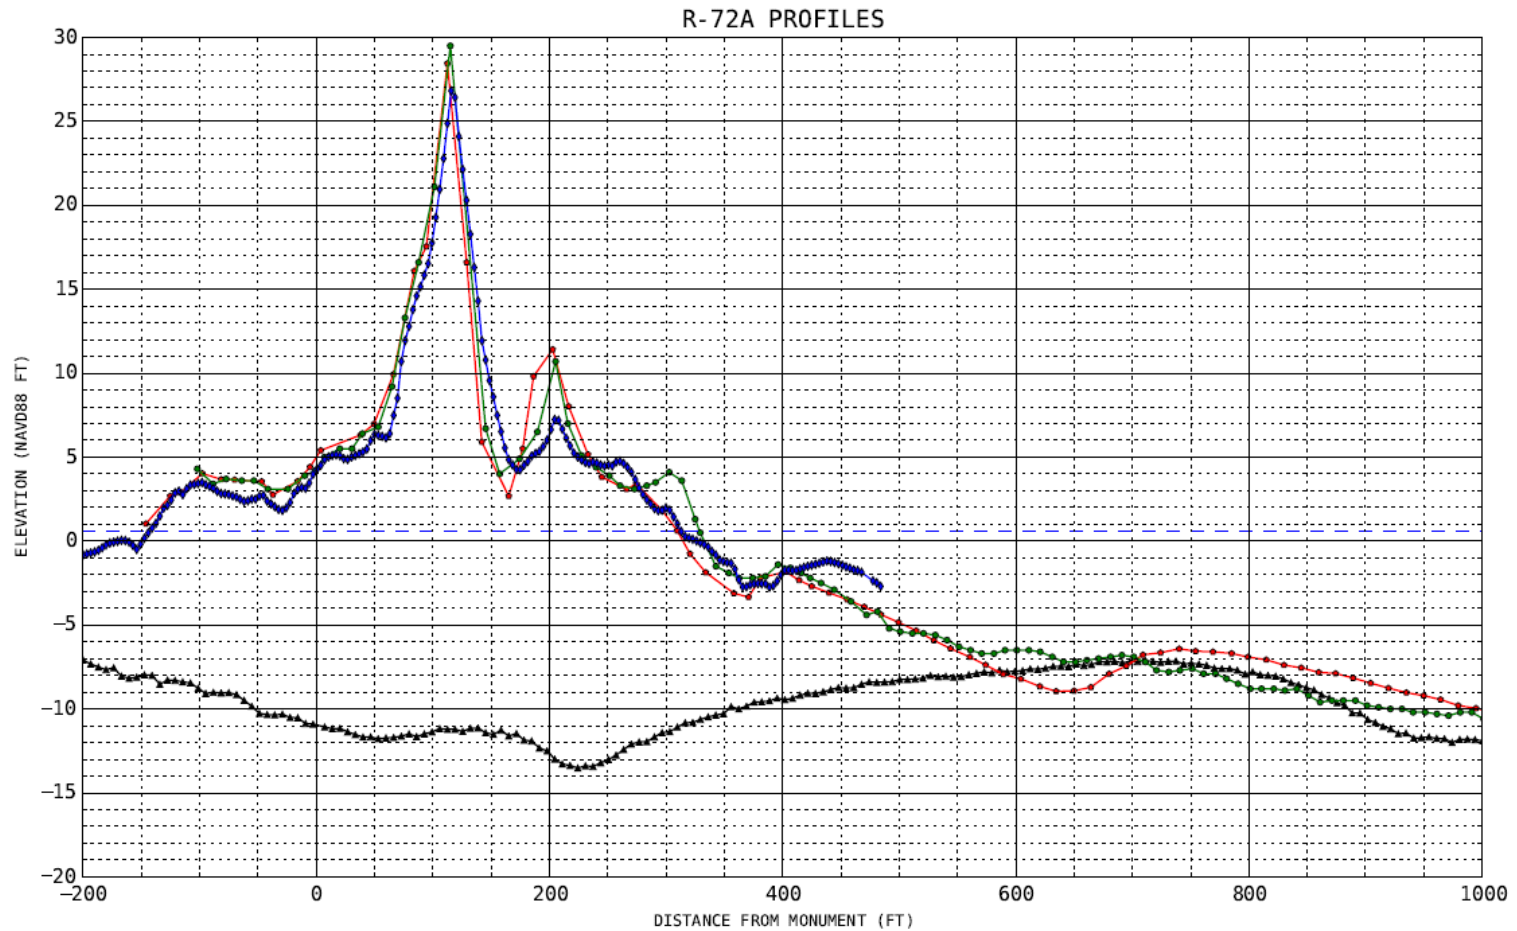
RANGE: R-72A  
EST DATE: JUN1983  
SURVEY DATE: 00NOV18  
AZIMUTH: 255.0

# Eroded Profile Across Breach

- ▲— 2018-NOV POST-MICHAEL BY USACE-DEM
- 2014-AUG 60-MONTHS BY PRI
- 2011-AUG 24-MONTHS BY PRI
- ◆— 2010-JAN MONITORING BY USACE-DEM
- - - MHW CONTOUR (0.6 FT)

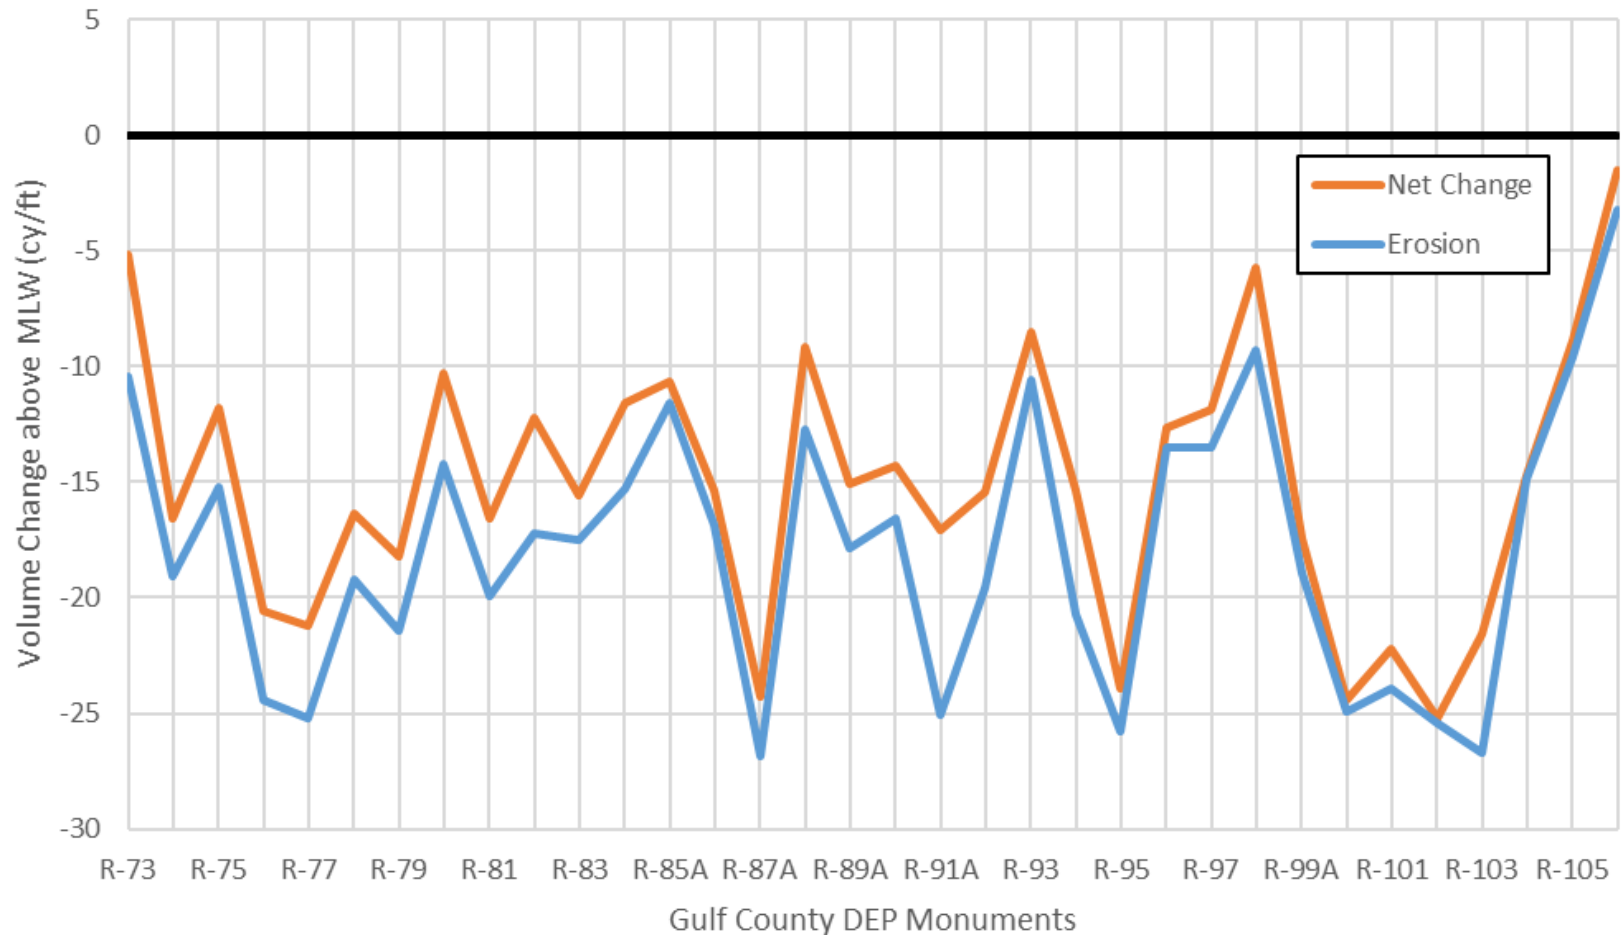
# St. Joseph Peninsula Erosion

St. Joseph Peninsula Volume Change After Hurricane Michael  
May 2017 or June 2018 to October 2018

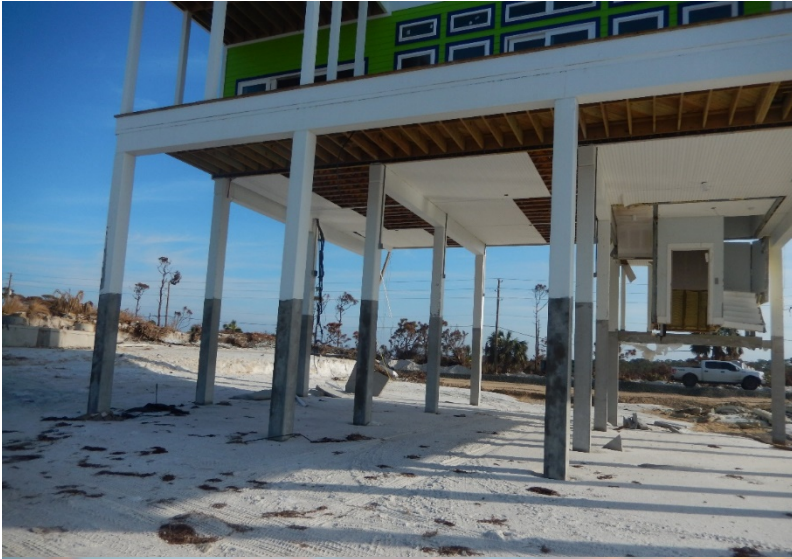
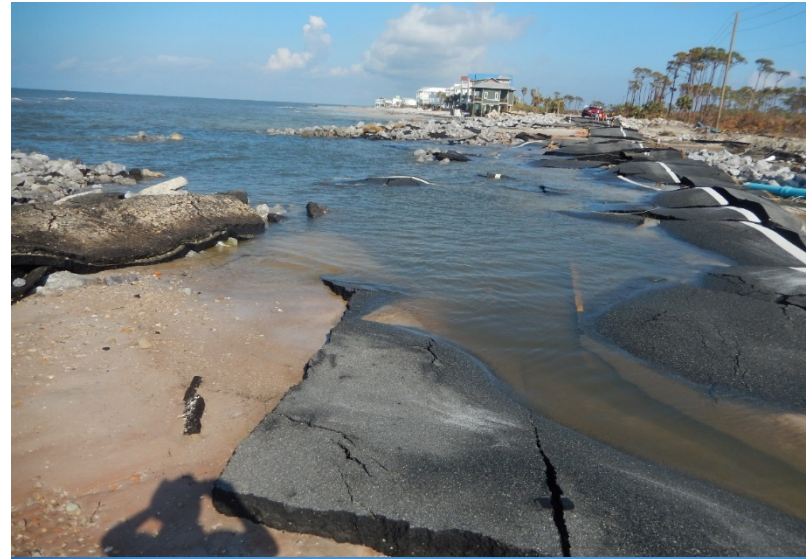
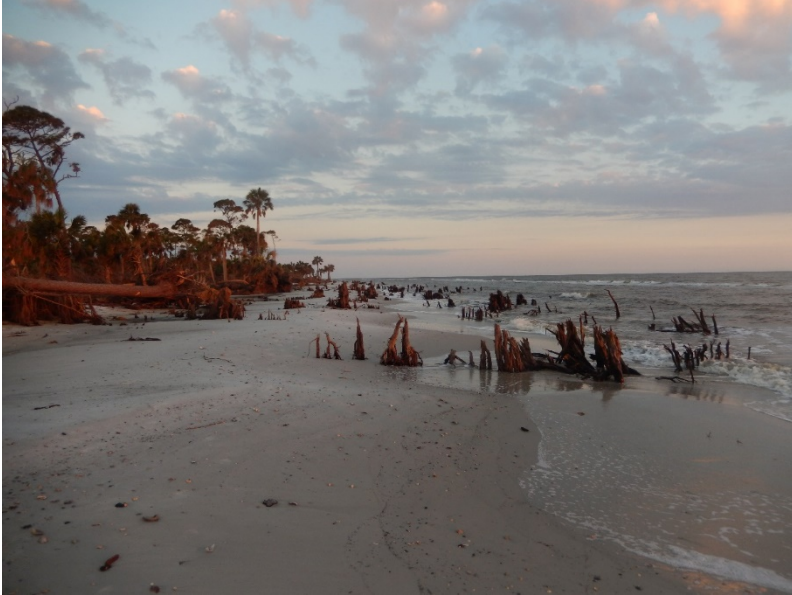
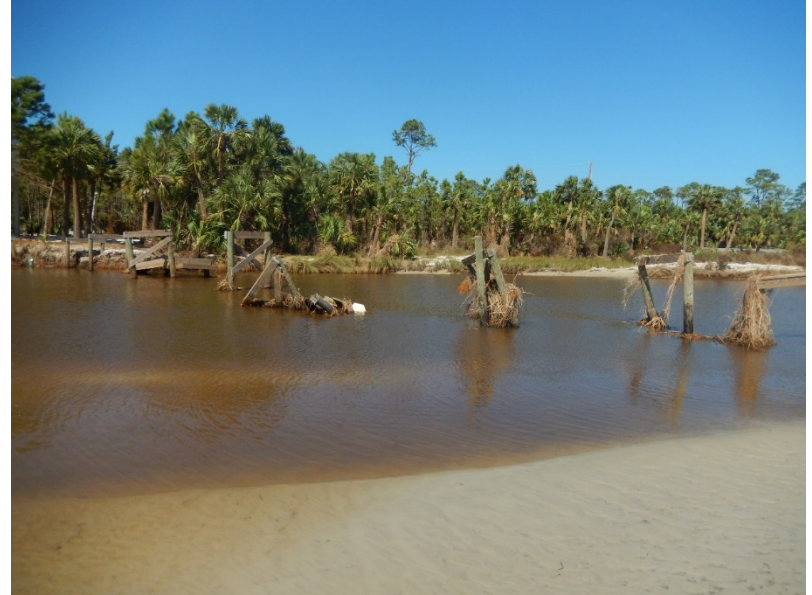
# Stump Hole, Cape San Blas, Money Bayou
