# The Impact of Hurricane Michael on the Coast of Northwest Florida

Ralph Clark, P.E.

Division of Water Resource Management

February 8, 2019

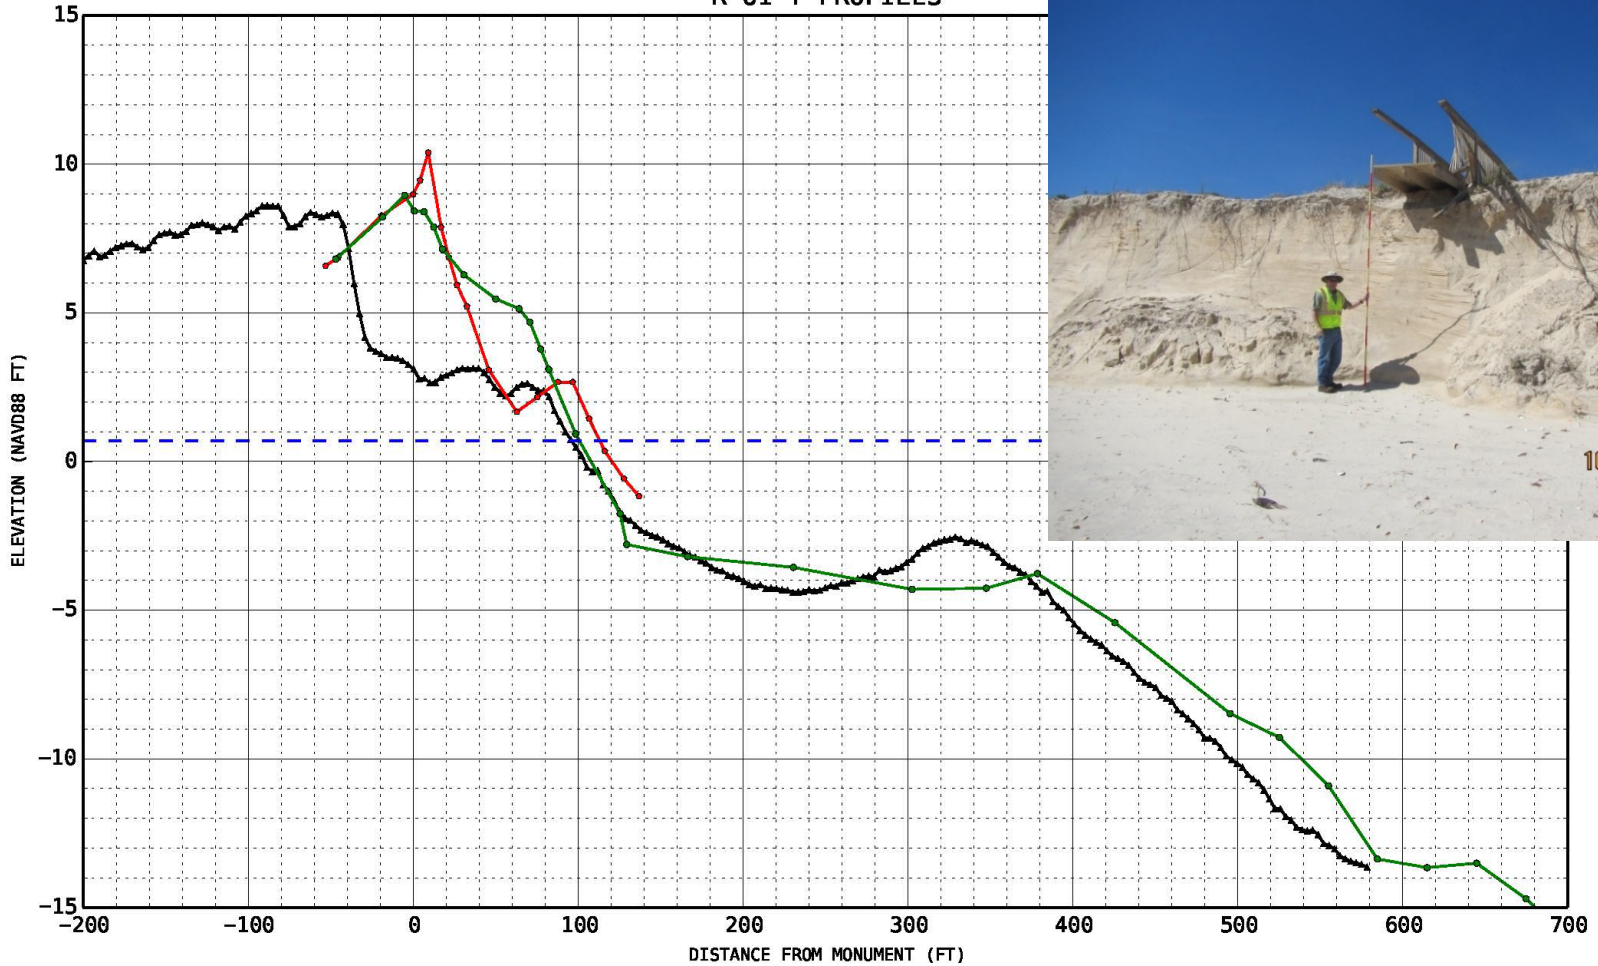
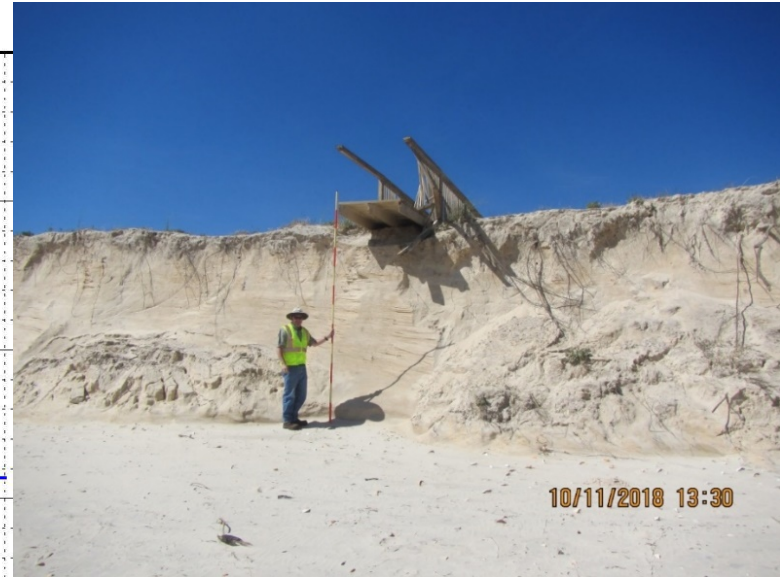
RANGE: R-61-T  
 EST DATE: FEB1980  
 SURVEY DATE: 31OCT18  
 AZIMUTH: 150.0

R-61-T PROFILES

- 2018-OCT MONITORING BY USACE-LIDAR
- 2017-FEB MONITORING BY DEP
- 2008-OCT MONITORING BY DEP
- - - MHW CONTOUR (0.7 FT)

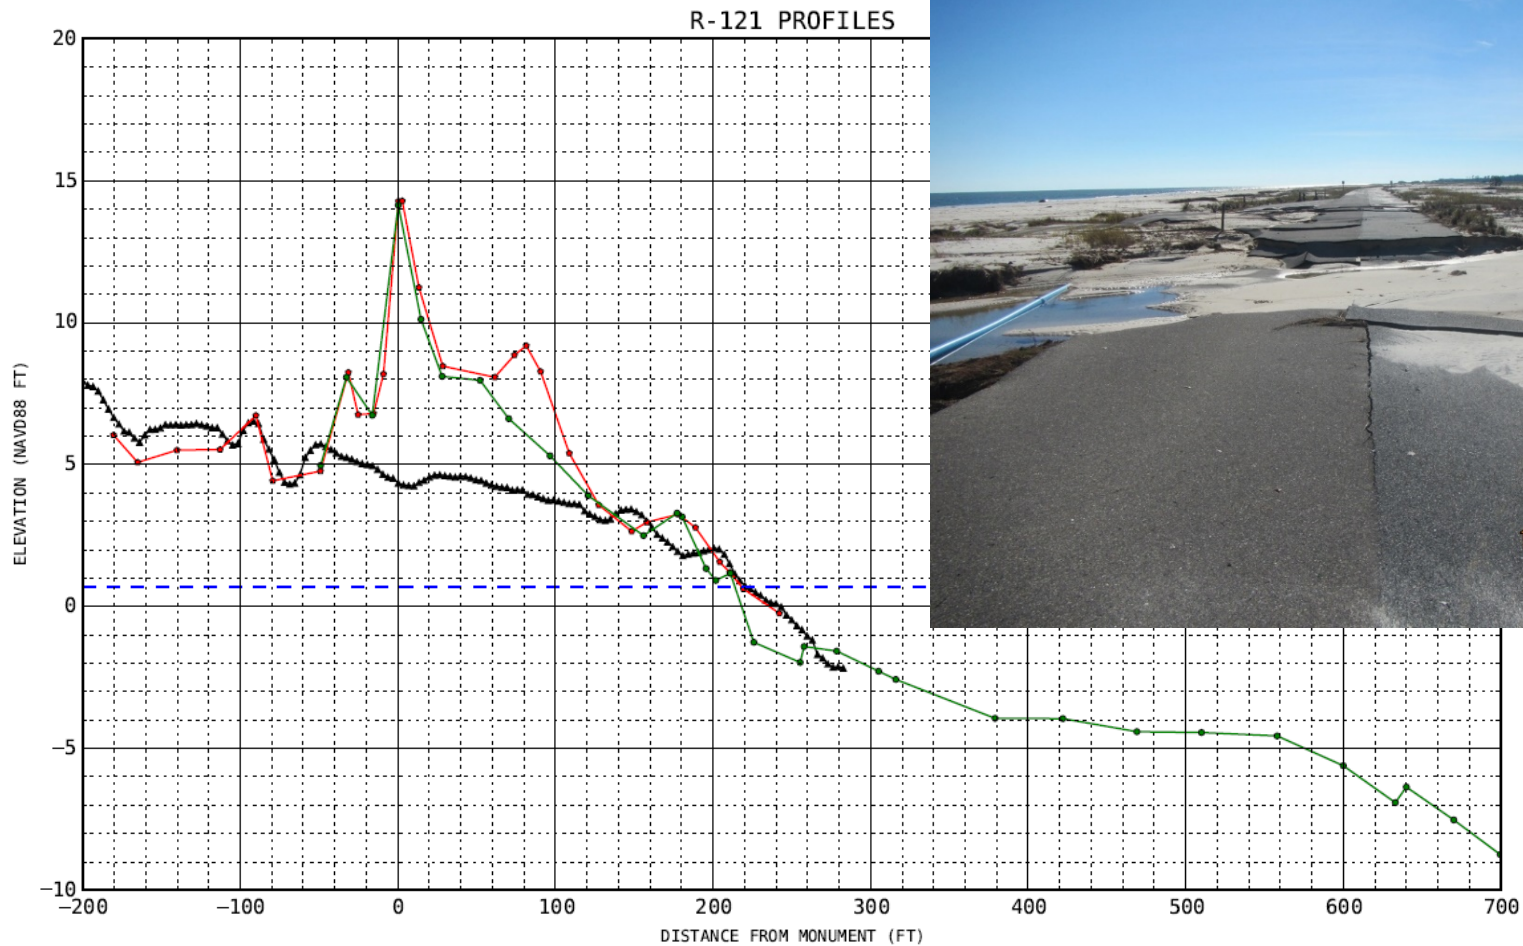
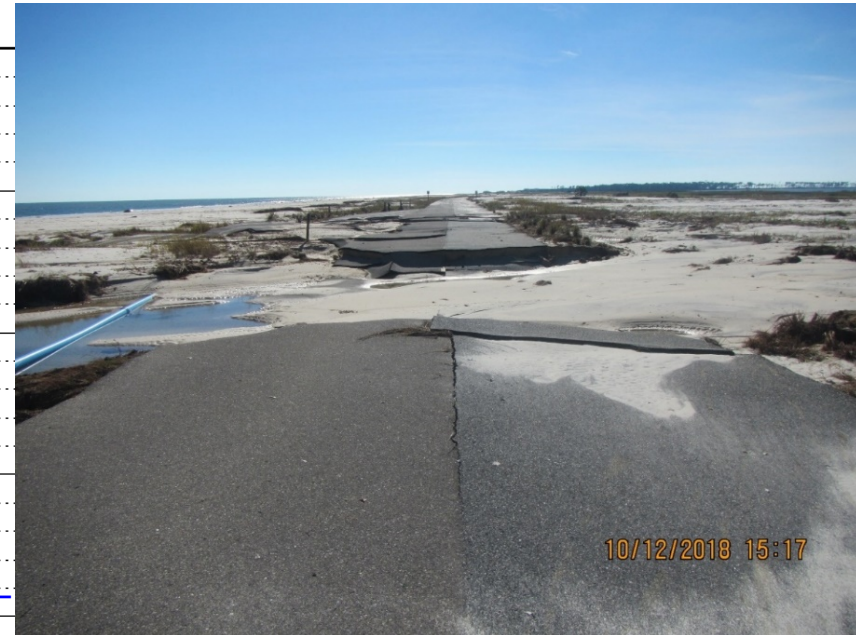
RANGE: R-121  
EST DATE: JUL1996  
SURVEY DATE: 31OCT18  
AZIMUTH: 140.0

# St. George Island State Park

- 2018-OCT MONITORING BY USACE-LIDAR
- 2017-FEB MONITORING BY DEP
- 2008-OCT MONITORING BY DEP
- - - MHW CONTOUR (0.7 FT)

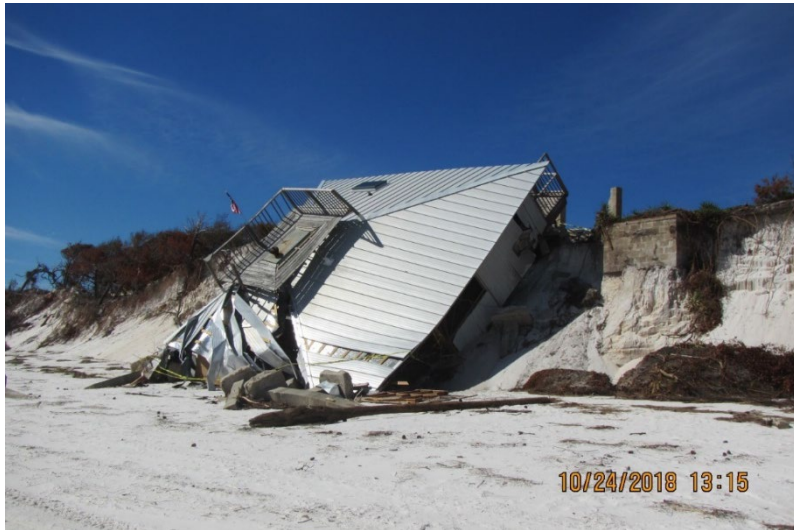
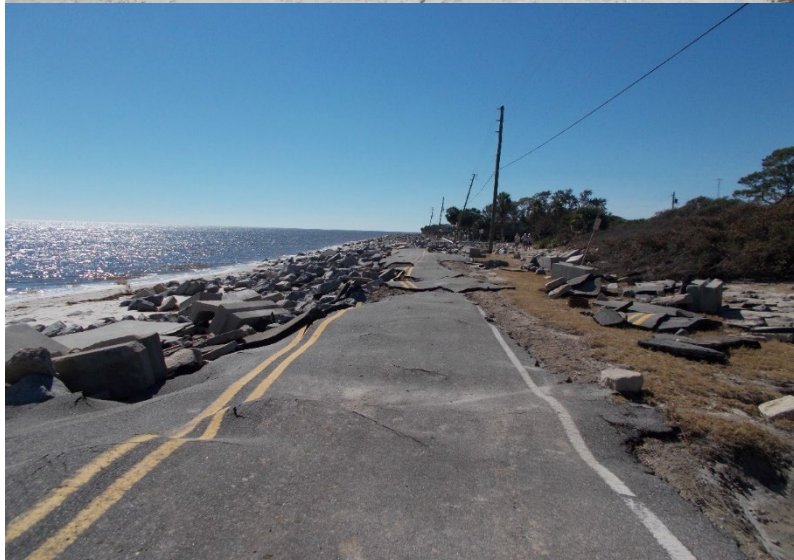
# Eastern Franklin County Impacts

- Dog Island – major damage to 25 buildings, including 12 destroyed
- Worse impact than Elena, Kate, or Dennis
- Alligator Point to Bald Point – major damage to 44 SFDs, including 5 destroyed
- 3,000 ft road destroyed and over 4,500 ft of armoring damaged
