2020 National Conference on Beach Preservation Technology

CSA assessed the current condition of the **Osborne Tire Reef (OTR)** using multibeam, side-scan, towed video, and diver surveys to create high resolution underwater maps

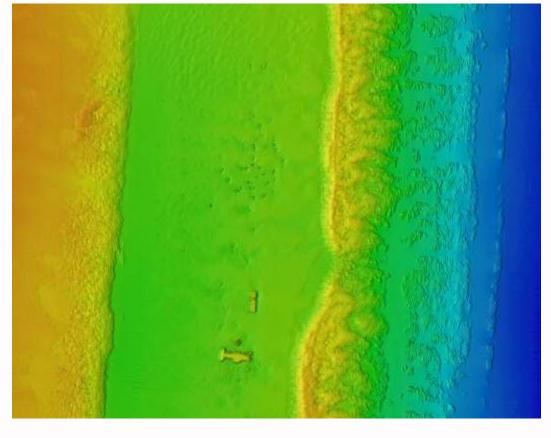
- Multibeam original OTR extent
- Expanded area tires outside OTR
- R2 Sonic 2024 Multibeam echo sounder
 - o 450 kHz
 - Applanix POS MV Wavemaster: real time motion-corrected location data
 - Micro X SV Base X2 sound velocity profiler used to refine soundings in post-processing

- Oriented North-South
- Spaced at 40 m
- 300 m buffer area around OTR
- Extended buffer: 1000 m N, 500 m E & S
- Multibeam critical first step:
 - Instrumental in determining depth and location of hardbottom features
 - Easily located larger shipwrecks, manmade structures
 - Provided framework of survey area to build on with finer-scale sampling
 - Lower resolution not diagnostic for tires

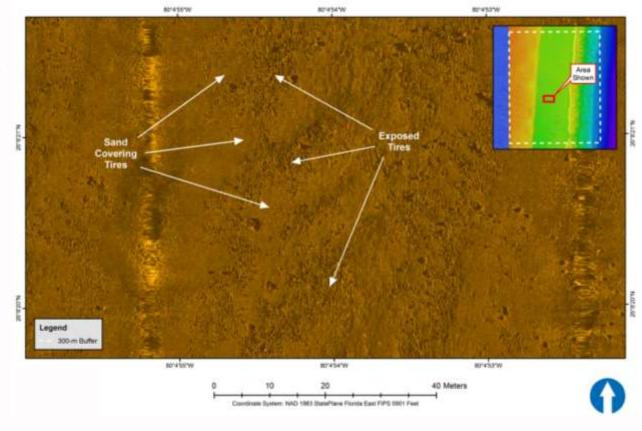
Side-scan Sonar Survey

- Side-scan sonar data recorded simultaneously with multibeam
- Dual-frequency Klein 3900 side-scan sonar
 - o 445 kHz
 - Slant range 150 m
 - Imaged at 100% overlap
- High resolution

Side-scan data = most valuable due to high resolution (~8 cm), necessary to effectively image tires

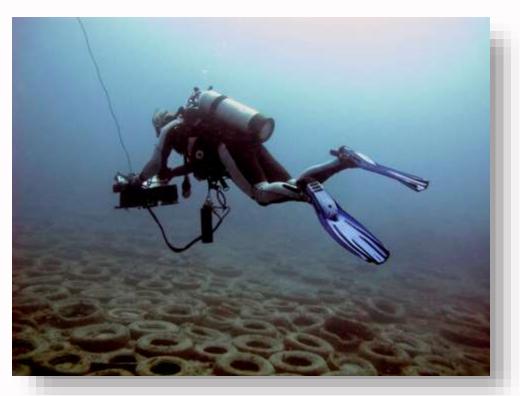
Shark Navigator on OTR

The Shark Navigator: submersible display, continuous GPS location and interface for diver data entry

- Geographic data from side scan preprogrammed
- Pre-plotted targets of interest and transects assessed by divers
- Annotated map in-situ to refine ground truth results
- Collected geographic locations of additional objects of interest

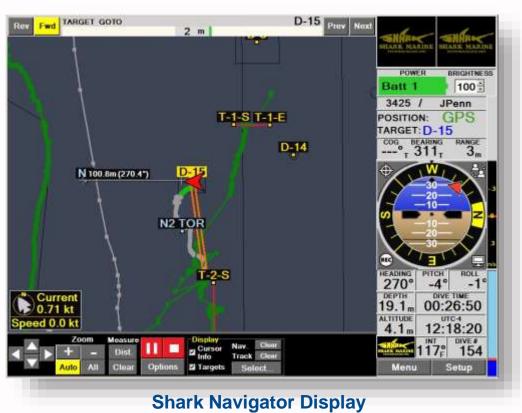
Diver Mapping – Underwater GPS

The Shark Navigator: submersible display, continuous GPS location and interface for diver data entry

- Geographic data from side scan preprogrammed
- Pre-plotted targets of interest and transects assessed by divers
- Annotated map in-situ to refine ground truth results
- Collected geographic locations of additional objects of interest

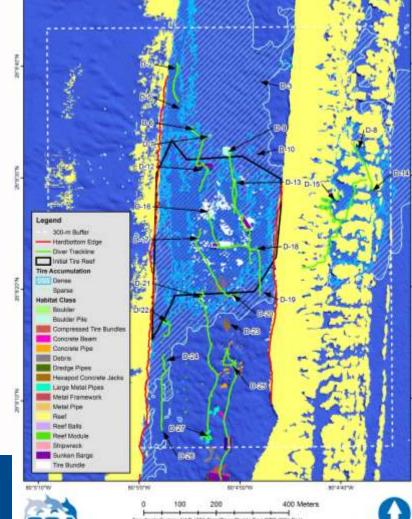
Final GIS mapping products:

- Large number of habitat classes encompassing important data points
- Geographic extent of tires
- Diver-verified tire densities
- Large geographic dataset of man-made debris, artificial reefs, and shipwrecks

The geophysical survey found tire accumulations much further from the original tire reef than expected.

Survey team mapped tires, artificial reefs and quantified tire density within the extensive area.
