PRACTICAL CONSIDERATIONS AND RESPONSES TO AGEING COASTAL STRUCTURES

Douglas W. Mann, P.E., D.CE.

APTIM - Lead Coastal Engineer

January 2021

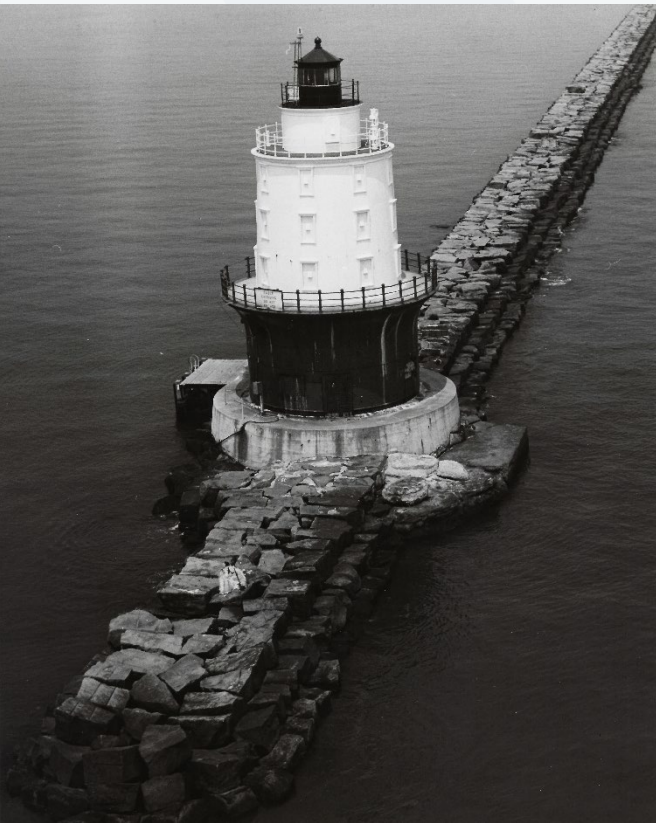
Coastal structures must be monitored and maintained over the long term to insure their performance (after Pope, 1992). While they can usually be designed for say 50 years, the practical life of these structures can be much longer, or shorter.

Delaware Bay breakwater at age ~100 years.

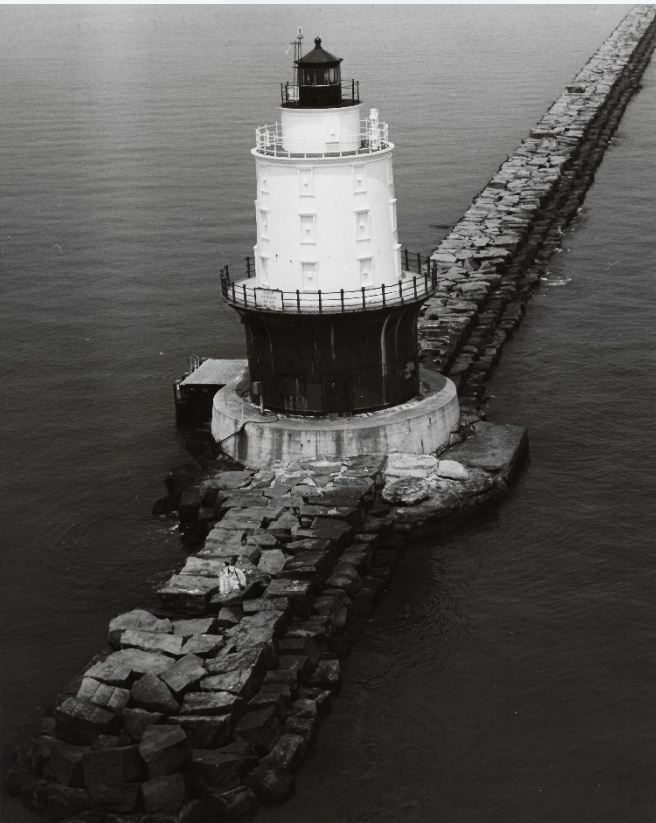
Delaware Bay breakwater at age ~100 years.

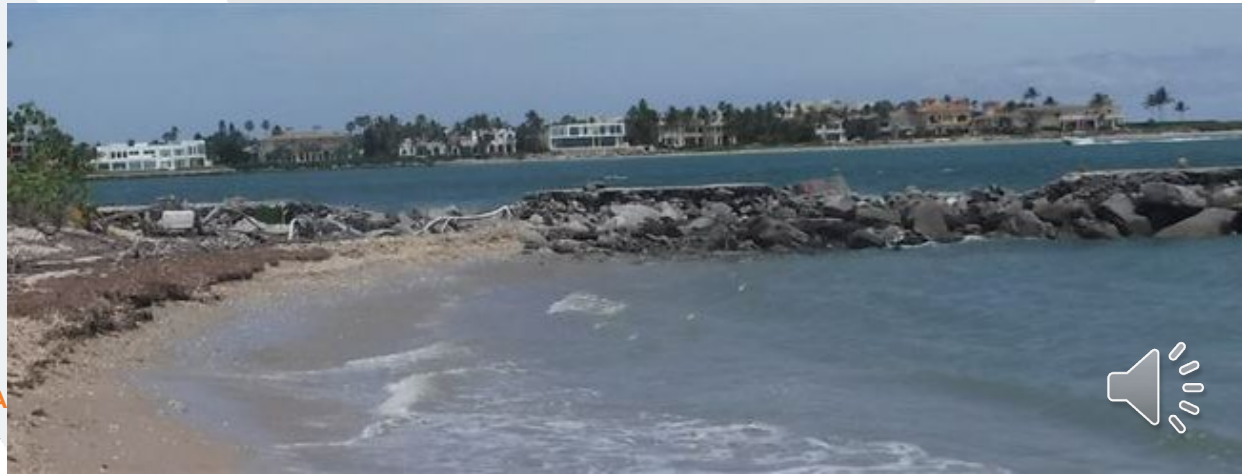
Section of a Florida jetty at age 38 years

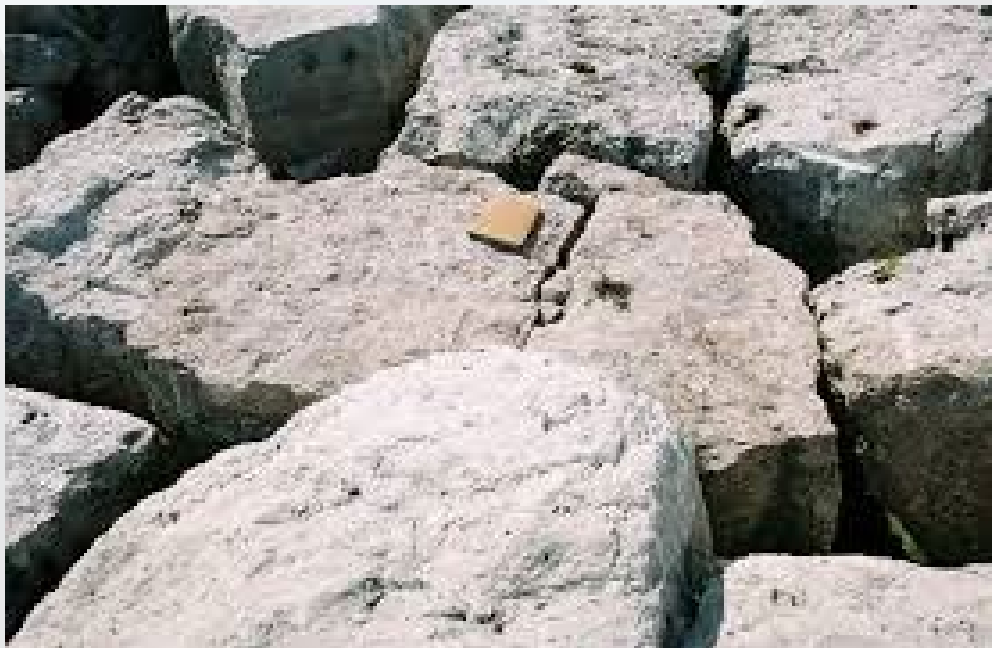
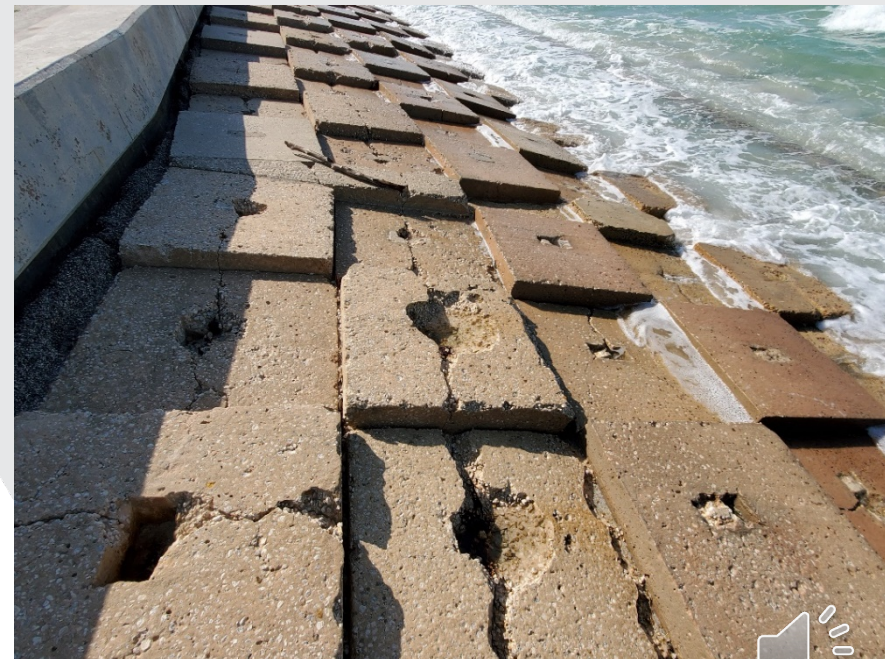
Observations should focus on both the performance of the total structure and the performance of individual armor stones or units (after Pope, 1992).

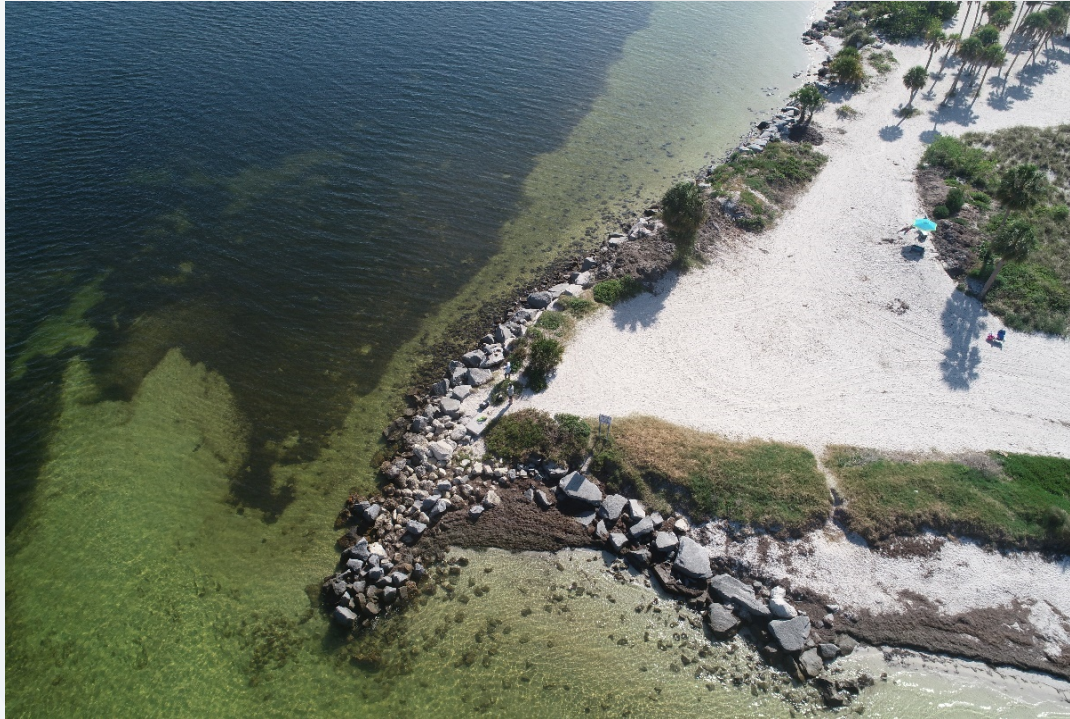
Fred Howard Park, Pinellas County, FL

Qualitative stone size identification.

Evidence of stone displacement.

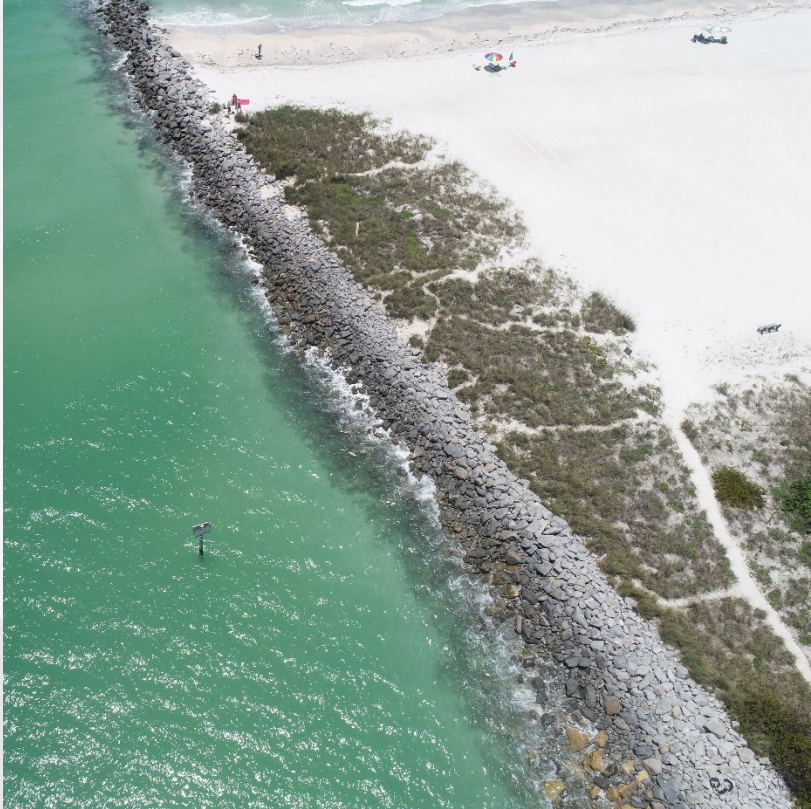
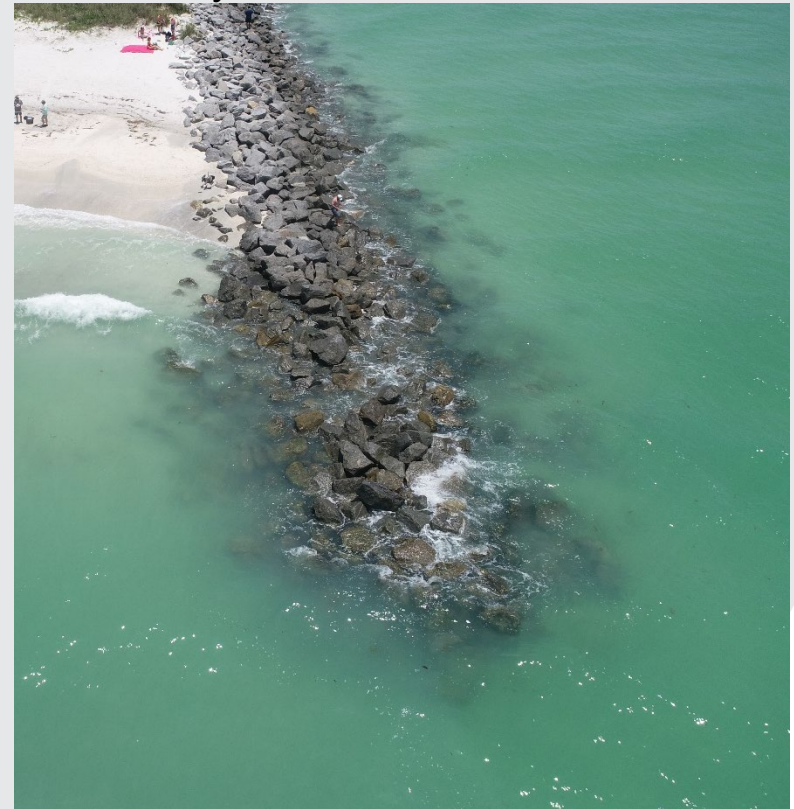
North Jetty at Blind Pass, Pinellas County

Visualization of toe stone uniformity across large spatial distances.

Identification of specific areas that may warrant u/w inspection.

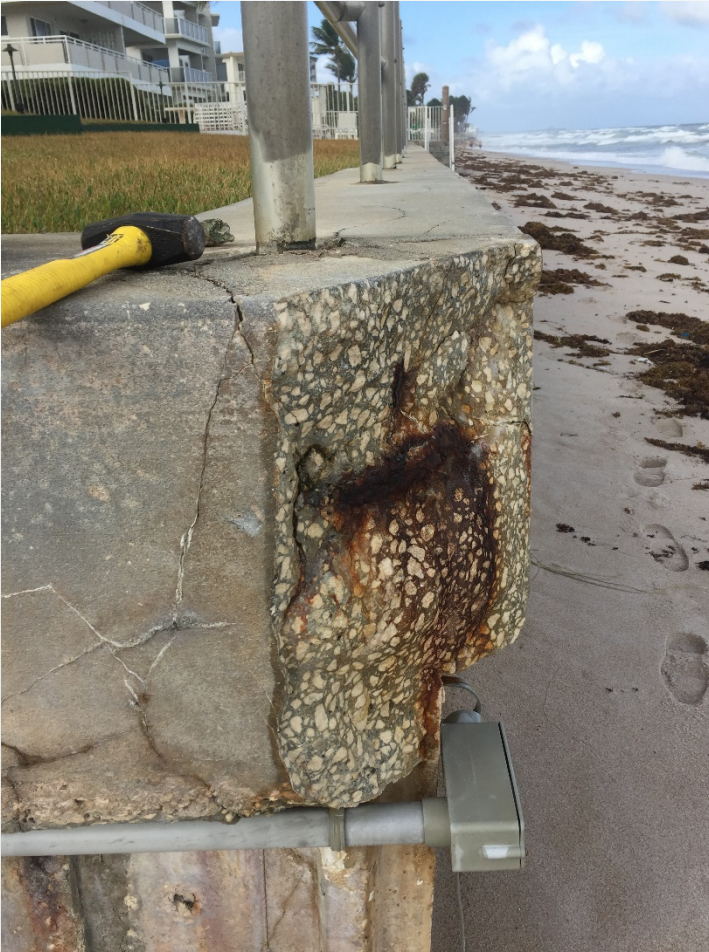
South Florida Seawall

This results in a finite design life.

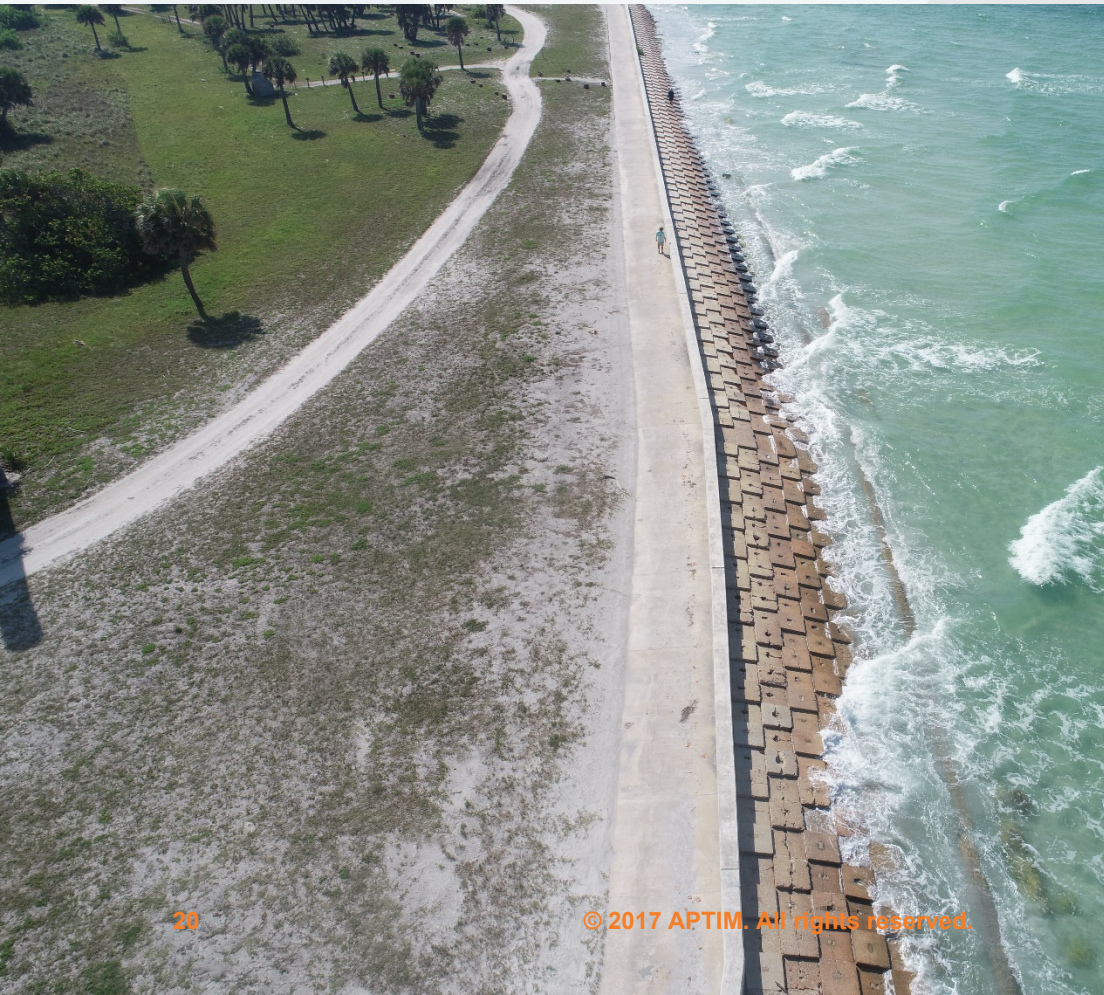
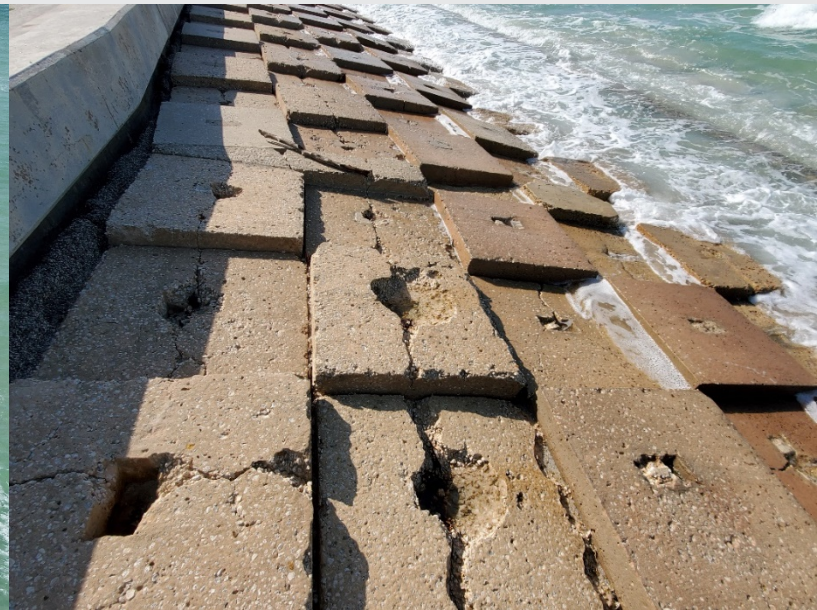
Mullet Key, Pinellas County 2020

This requires research or knowledge of the historical technology in order to repair or replace them effectively.

Jachowski, R. 1964. "Interlocking Precast Concrete Block Seawall". International Conference on Coastal Engineering, pp. 504-517.
