Innovative Stormwater Solutions in Coastal Areas

2023 FSBPA Tech Conference

February 2, 2023

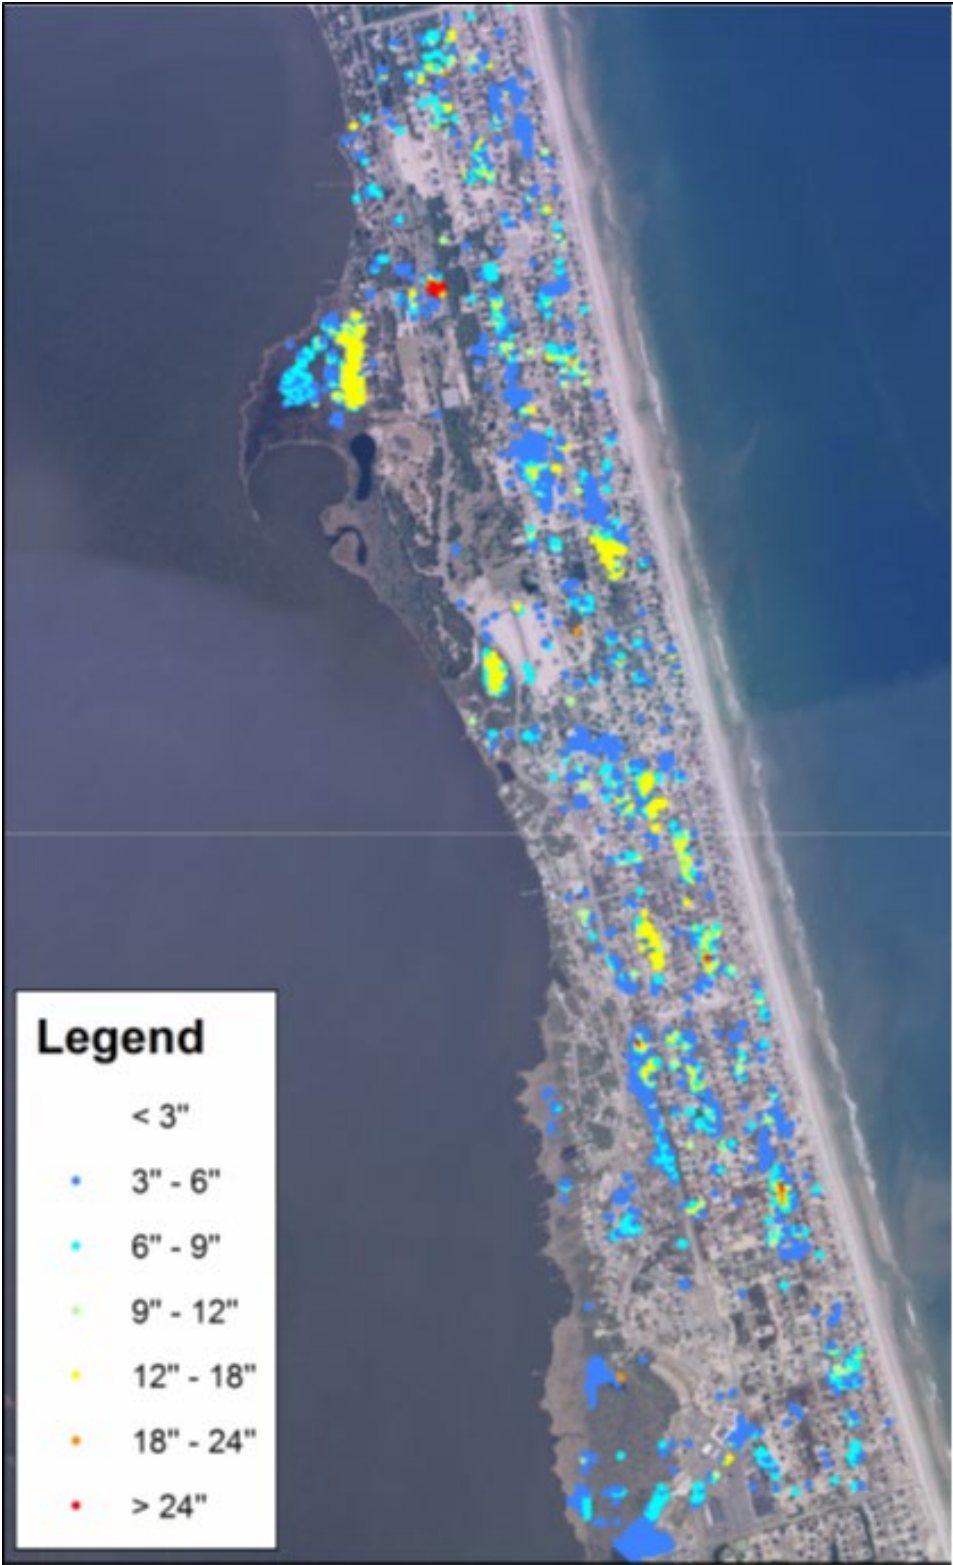
Flooding during an 8" rainfall event
