Use of UAV-flown LiDAR and Georadar to Assess the Geomorphological Impact of Hurricane Ian Along the Southwest Florida Coast

*36th National Conference on Beach Preservation Technology
Michael Savarese¹, Dhruvkumar Bhatt¹, Christopher Daly¹, Felix Jose¹, Rachel Rotz¹, & Ilya Buynevich²*

February 1, 2023

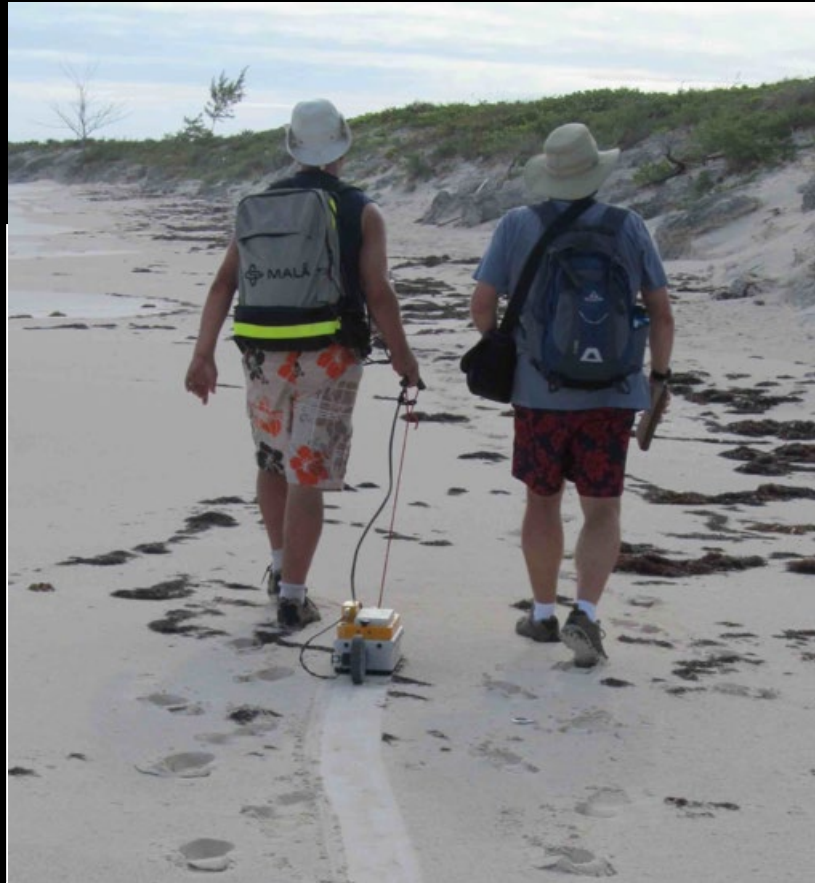
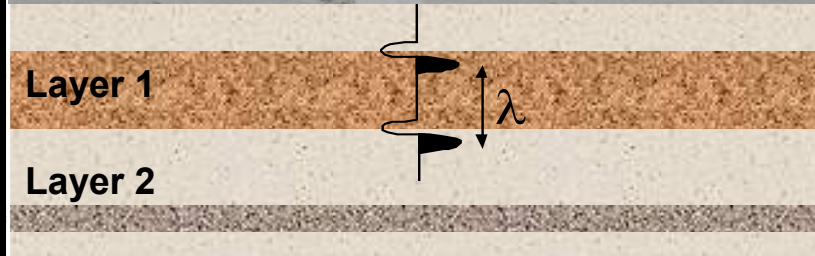
Ground-Penetrating Radar (GPR)

electromagnetic waves

1. Ground-penetrating radar (GPR) to reveal history in sediments below the surface.
2. UAV-based LiDAR: produce high-resolution DEMs.
3. Comparing pre- and post-Ian maps. Summer 2022 flights or 2018 LiDAR.
4. Quantify sediment volume gained or lost.
5. Able to assess resilience capacity of coastal segments.
6. Florida Sea Grant rapid response award starting Feb 1, 2023.

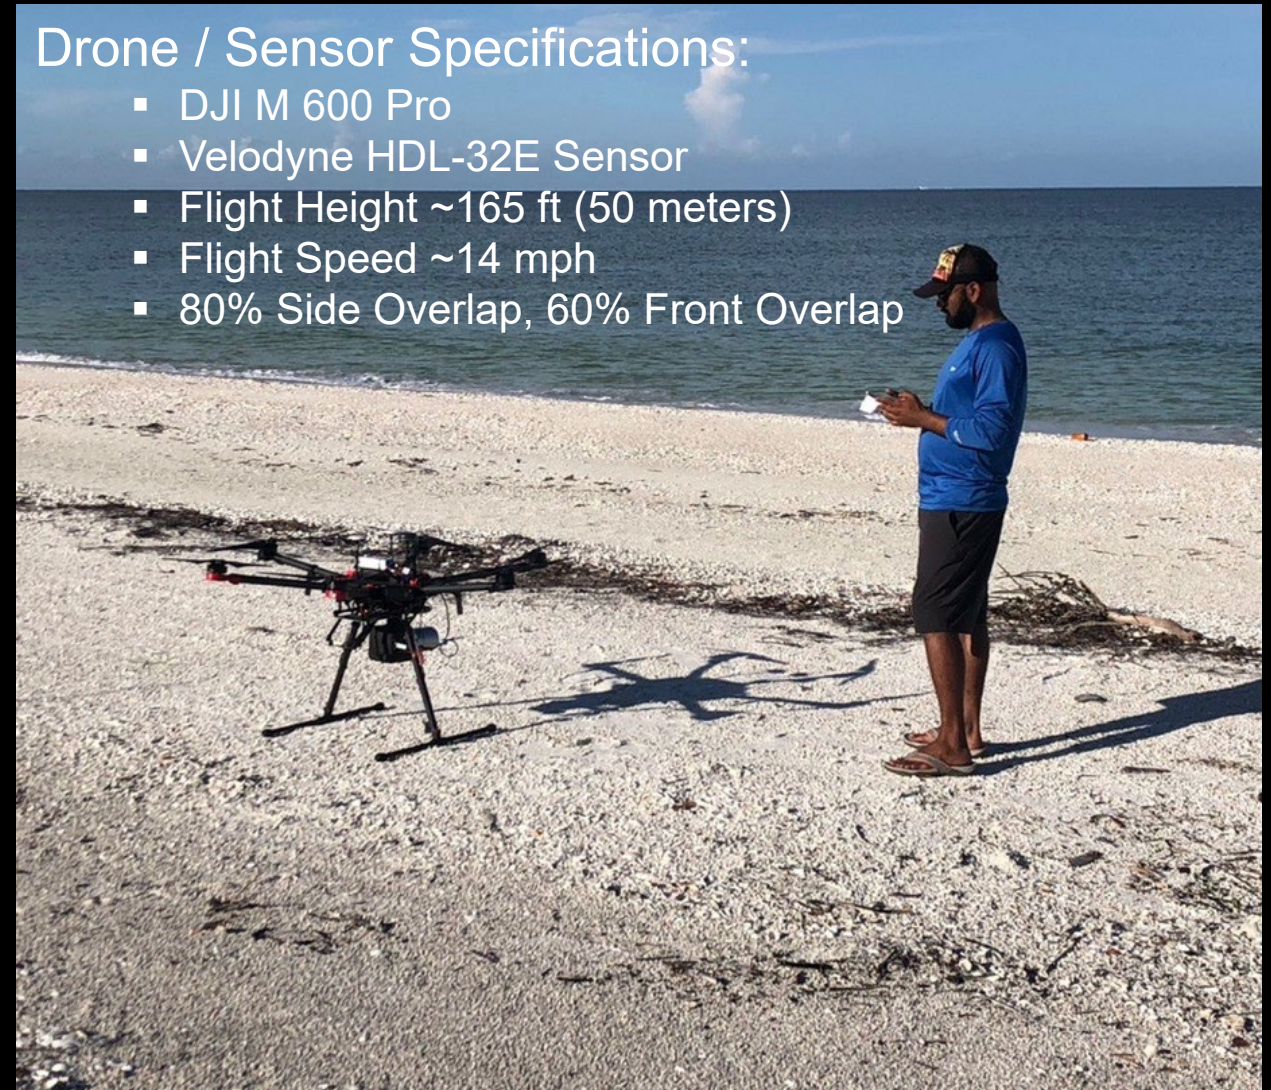
Drone & LiDAR Sensor

Drone / Sensor Specifications:

- DJI M 600 Pro
- Velodyne HDL-32E Sensor
- Flight Height ~165 ft (50 meters)
- Flight Speed ~14 mph
- 80% Side Overlap, 60% Front Overlap

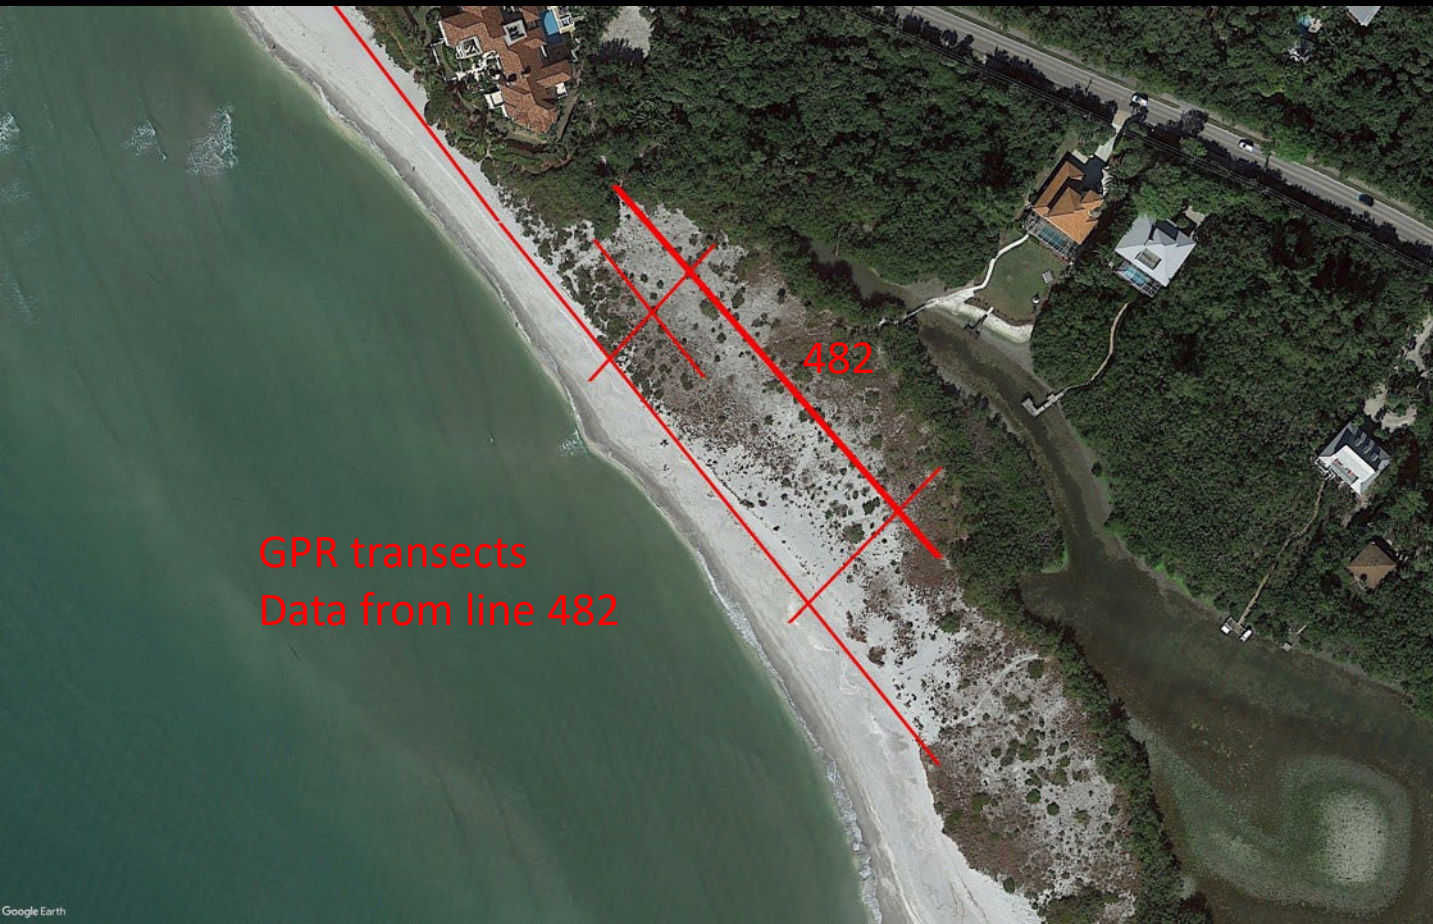
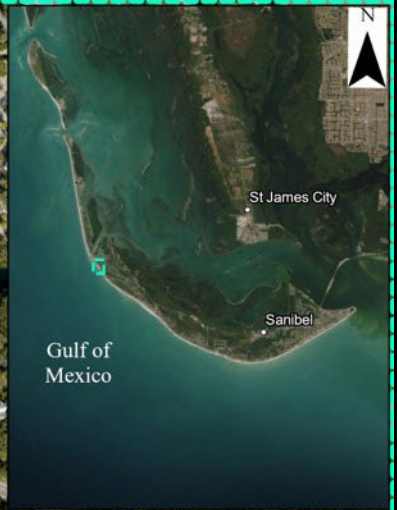
Santiva, NW Region of Sanibel Island

- Coming in: high surge with wave set-up above:
 - Sheet overtopping and overwash with wholesale sediment movement & deposition behind the foredune.
 - Foredunes destroyed or deflated.
- Going out: surge height lower:
 - Drainage cuts channels; incises incoming surge deposits.
 - Channels form preferentially along de-vegetated paths and between foundation footprints.
- Lessons learned from previous storms:
 - Ike (2008), Hugo (1989), Ivan (2004), Harvey (2017).

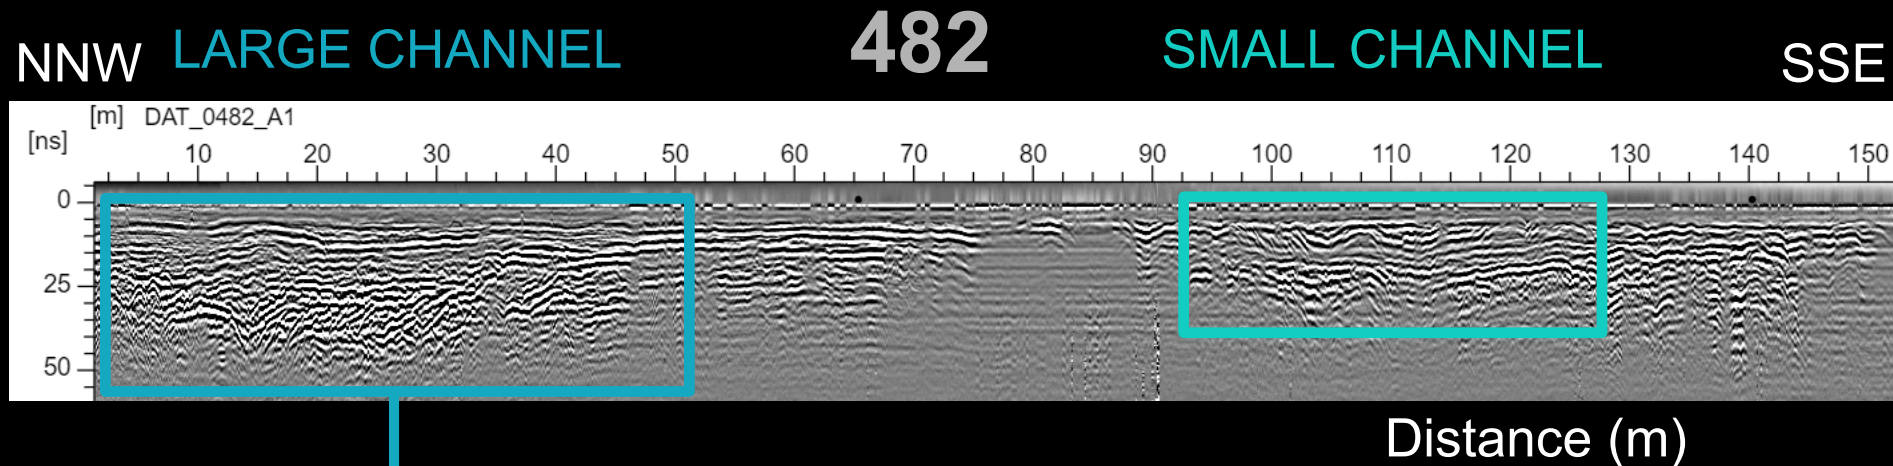
GPR Blind Pass (“Santiva”), FL

- 2 buried channels, each > 20 m wide.
- Neither channel obvious from surficial geomorphology.
- Overtop deposition since at least 1995.
- One with laterally prograded fill due to longshore transport.

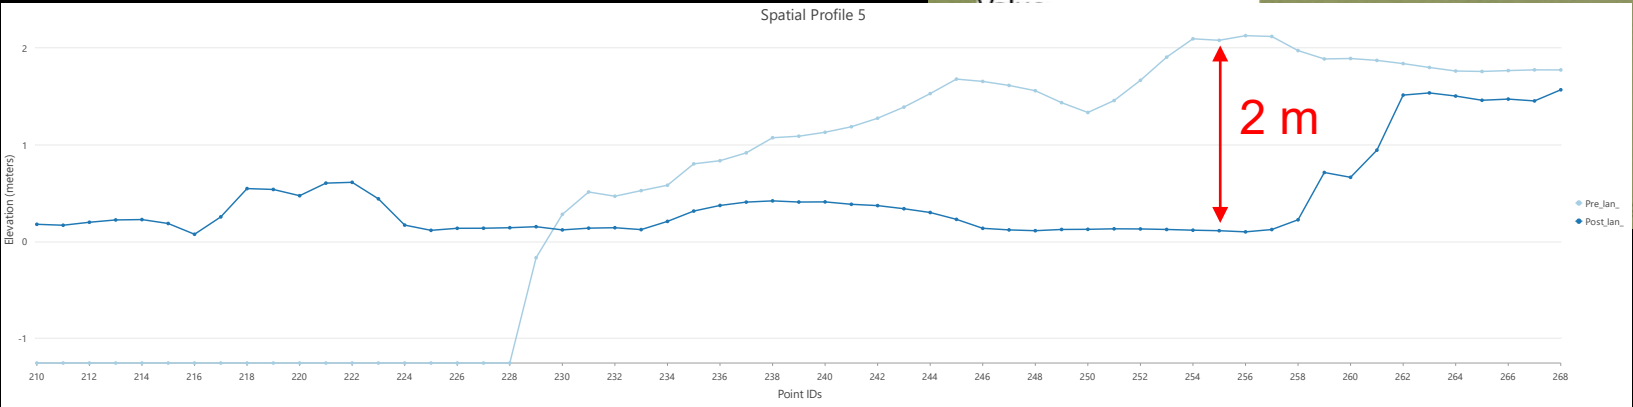
Tarpon Bay Rd Beach

Pre flown 2018
Post flown Oct 25, 2022

- Ebb surge tidal channels (profile 5)
- Overtop fan deposition (profile 3)

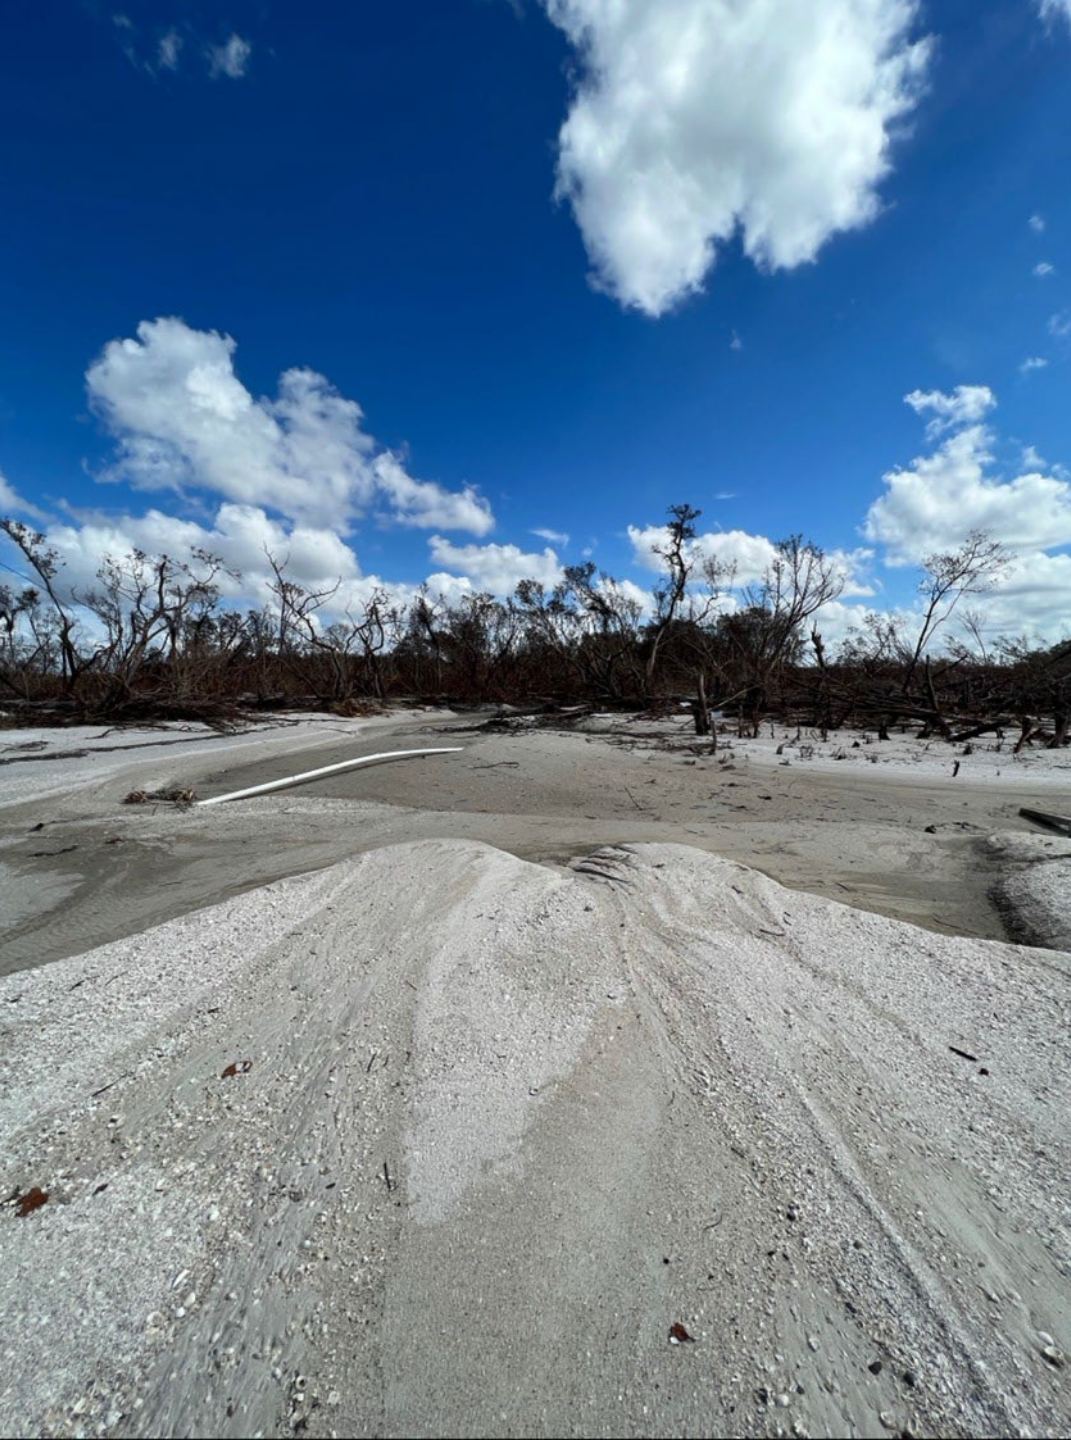
Lover's Key

- Ebb surge erosional event
- At profile, overtop fans reactivated but landward shift

Ebb Surge Channels

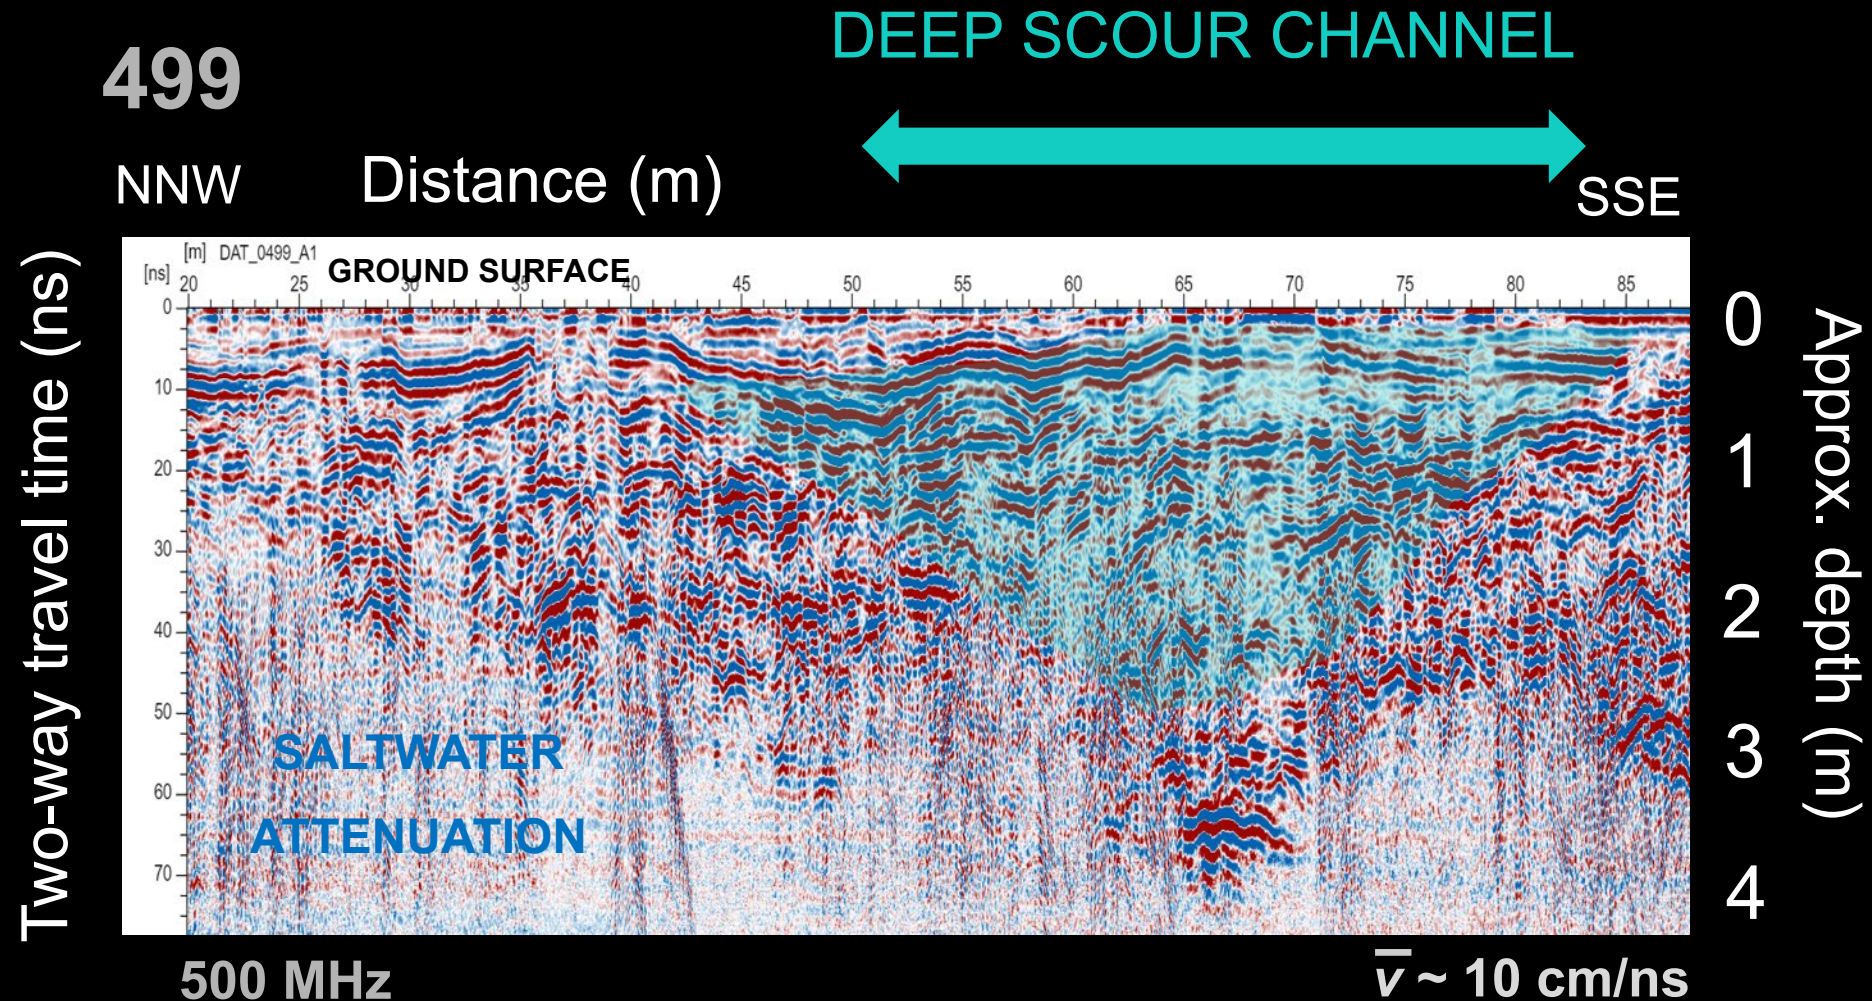
GPR → Lovers Key State Park, FL

History of surge channel erosion on Lover's Key, Santiva, Ft Myers Beach

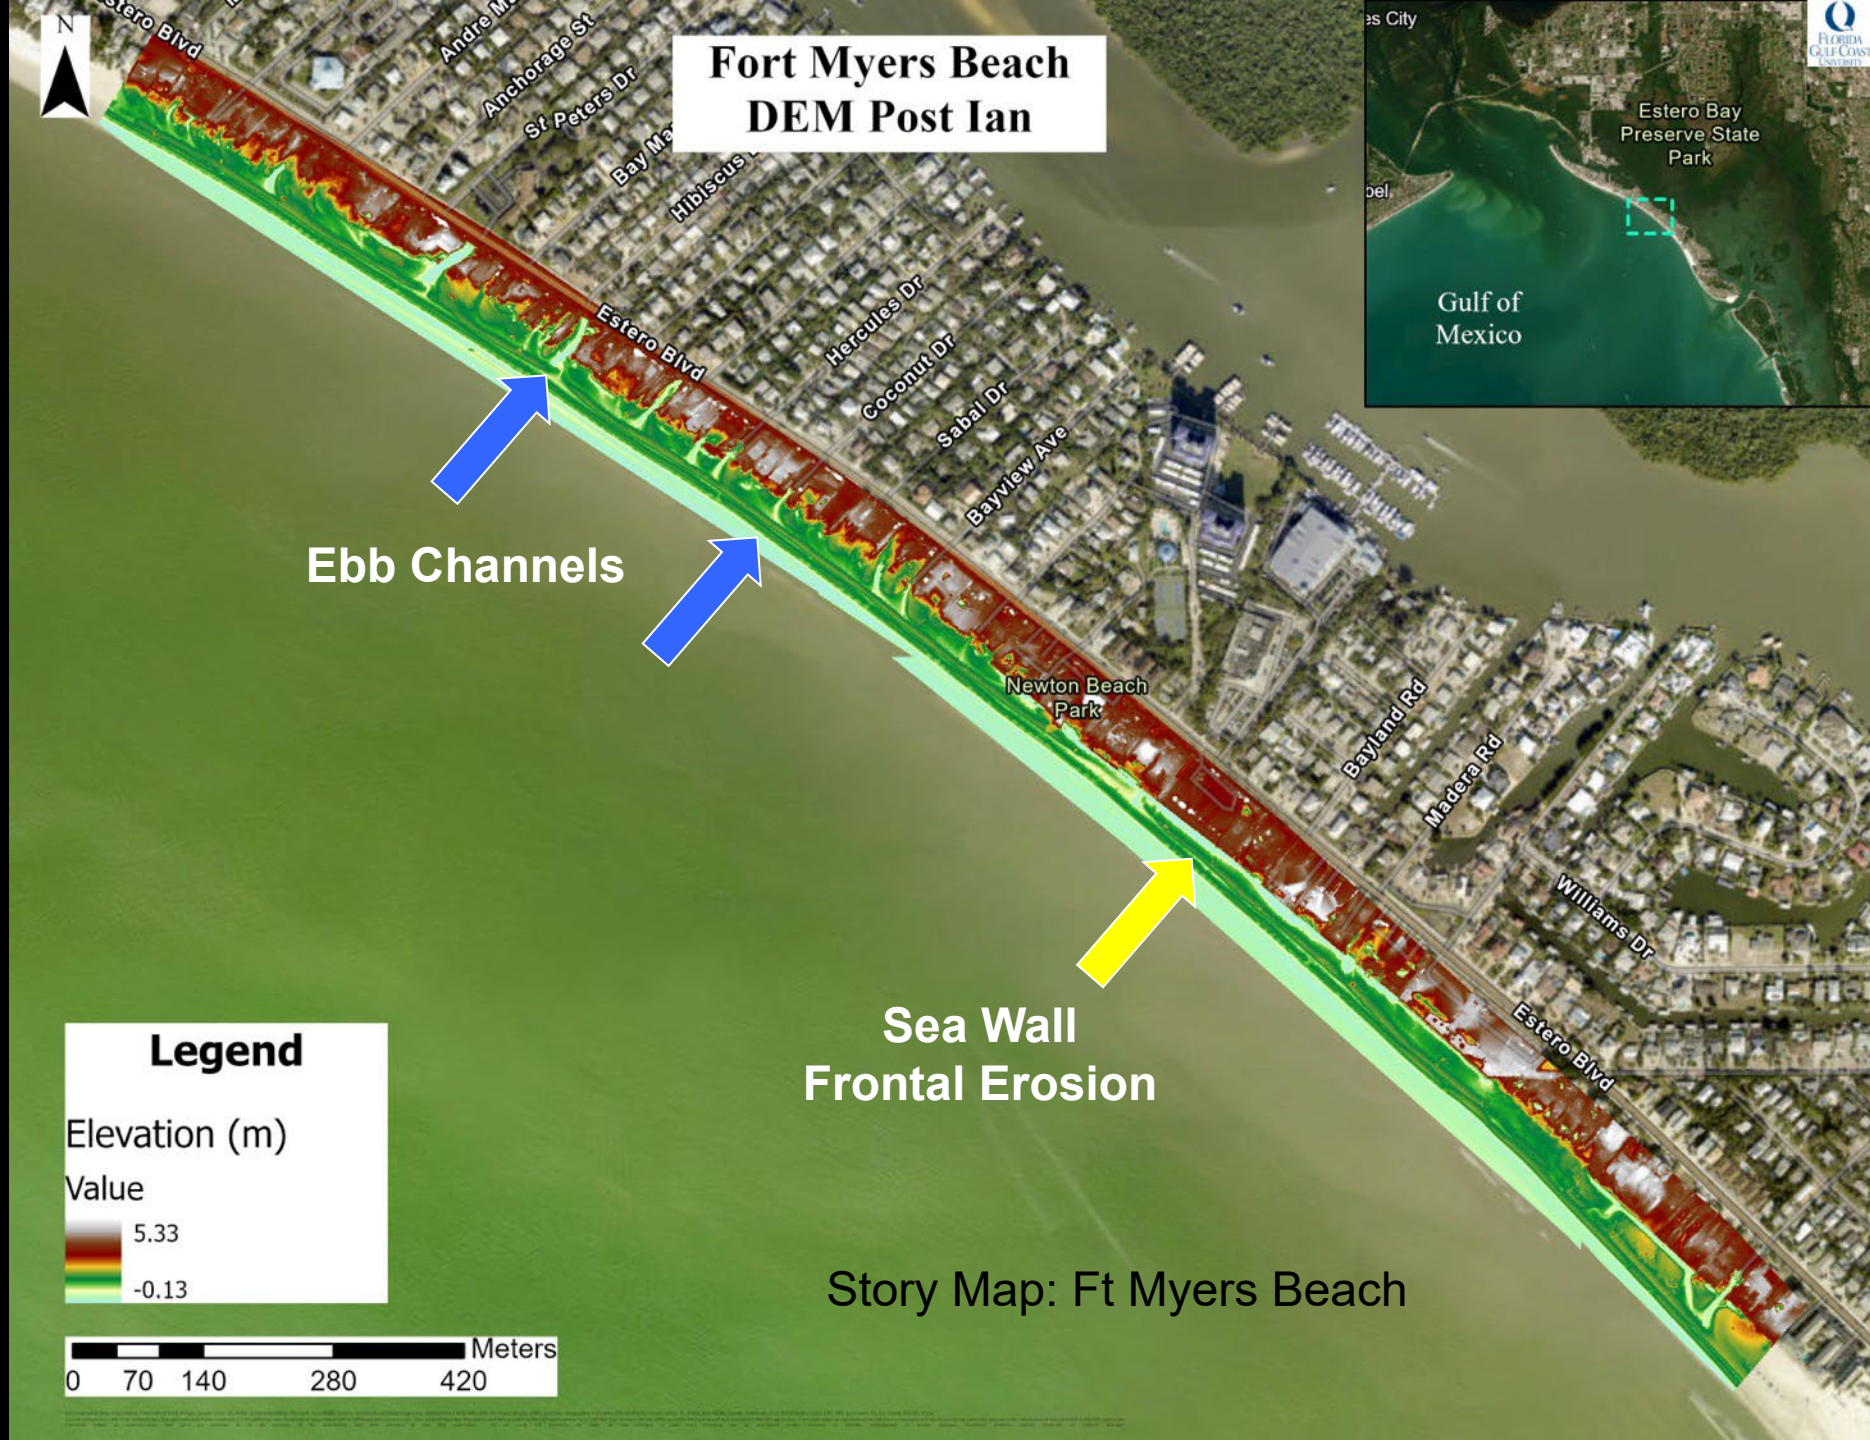
Central Fort Myers Beach

Pre flown 2018
Post flown 1st week Dec, 2022

- Prolific ebb surge tidal channel formation
- Overtop sand deposition
- Significant sediment erosion in front of sea wall

- Sea walls held ground in some and failed in other locations.
- In Naples, older, buried sea walls were exhumed.
- Extensive erosion occurred in front of sea walls.

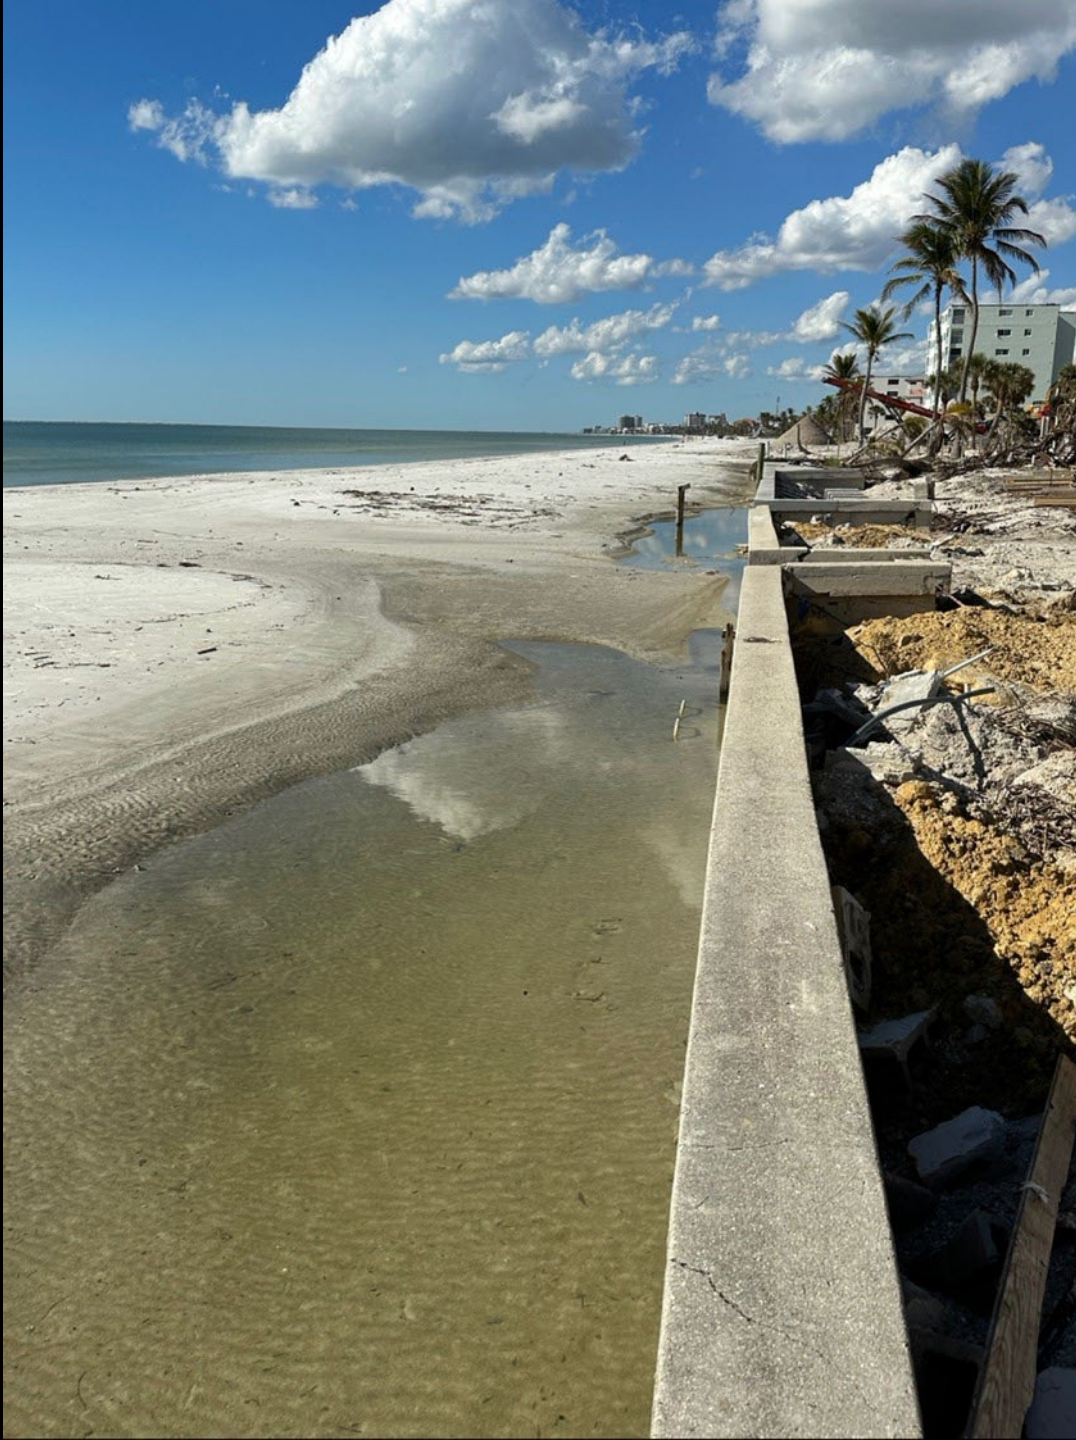
Ft Myers Beach

Sea Wall Effects

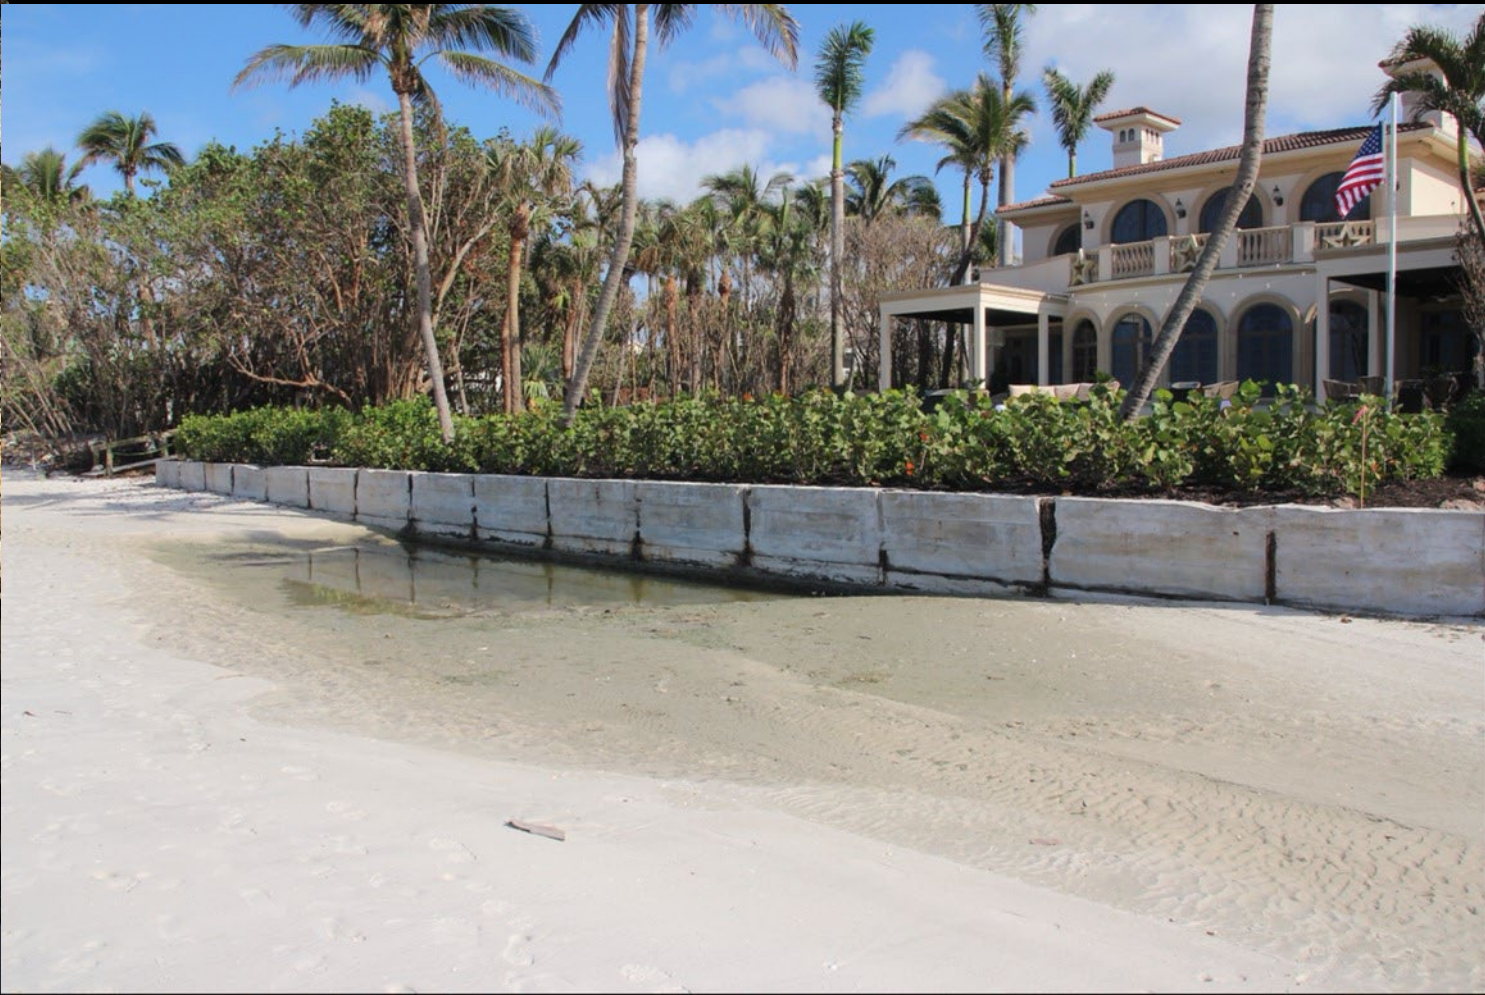
Naples Beach Near Pier

- Minor ebb surge tidal channel formation
- Overtop sand deposition
- Set back of sea wall; old sea wall revealed
- Significant sediment erosion in front of old sea wall

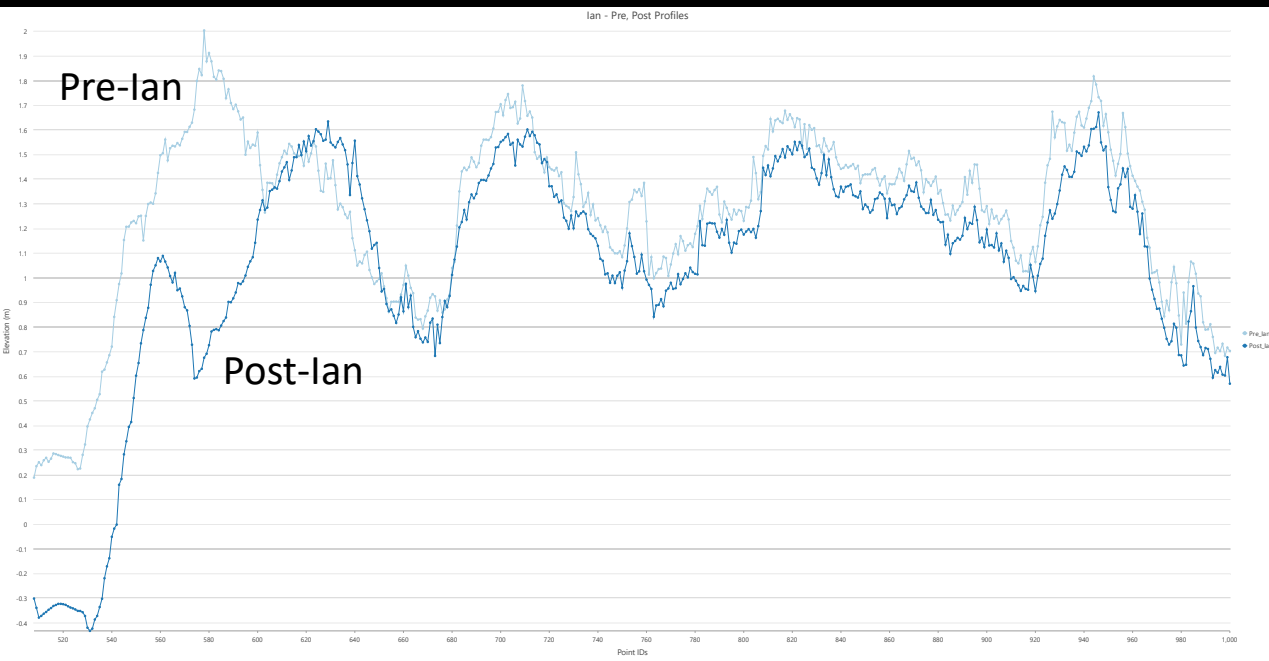
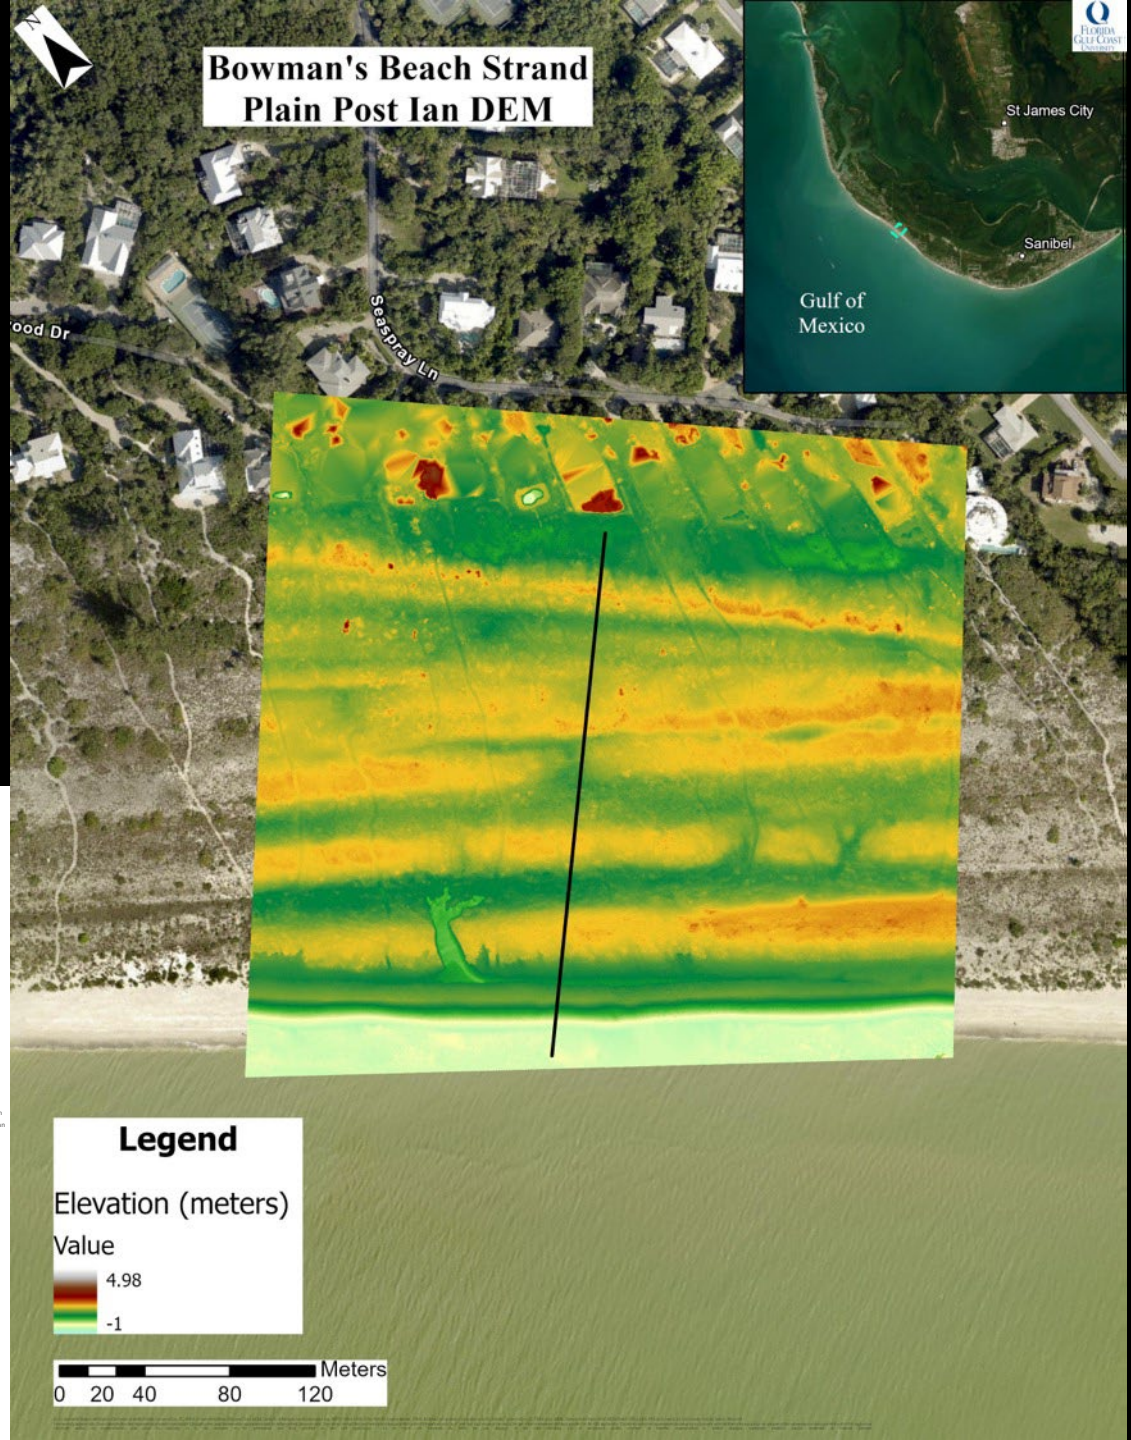
Bowman's Strandplain at Sea Spray

Pre flown Sep 7, 2022

Post flown 1st week Nov, 2022

- Foredune overtopped
- No significant erosion
- Strandplain resilience
