APPLICATION OF THE LONGSHORE TRANSPORT CURVE FOR COASTAL STRUCTURE IMPROVEMENTS AT COQUINA BEACH IN MANATEE COUNTY, FLORIDA

FSBPA Technical Conference
February 1-3, 2023
Fort Myers, FL

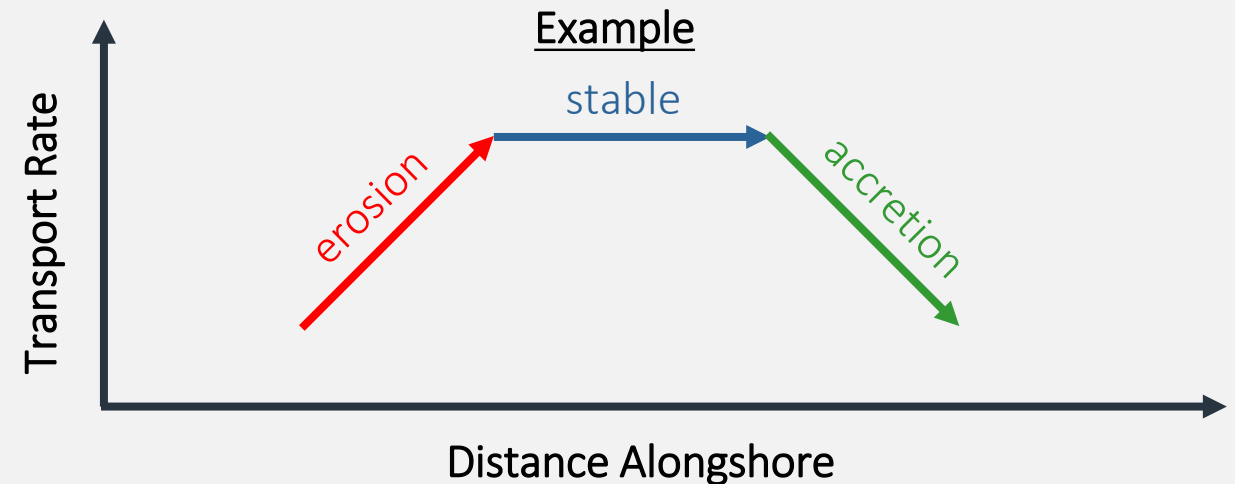
LONGSHORE TRANSPORT (LST) CURVE

- Used to track sediment migration through an area of study
- Based on measured volume changes, annualized and summed alongshore
- Adjusted for inlet bypassing and beach nourishment projects

- Shape of the curve:
 - Increasing slopes are erosion
 - Decreasing slopes are accretion
 - Flat slopes are stable (or hardened)

- Valuable tool for design of coastal structures

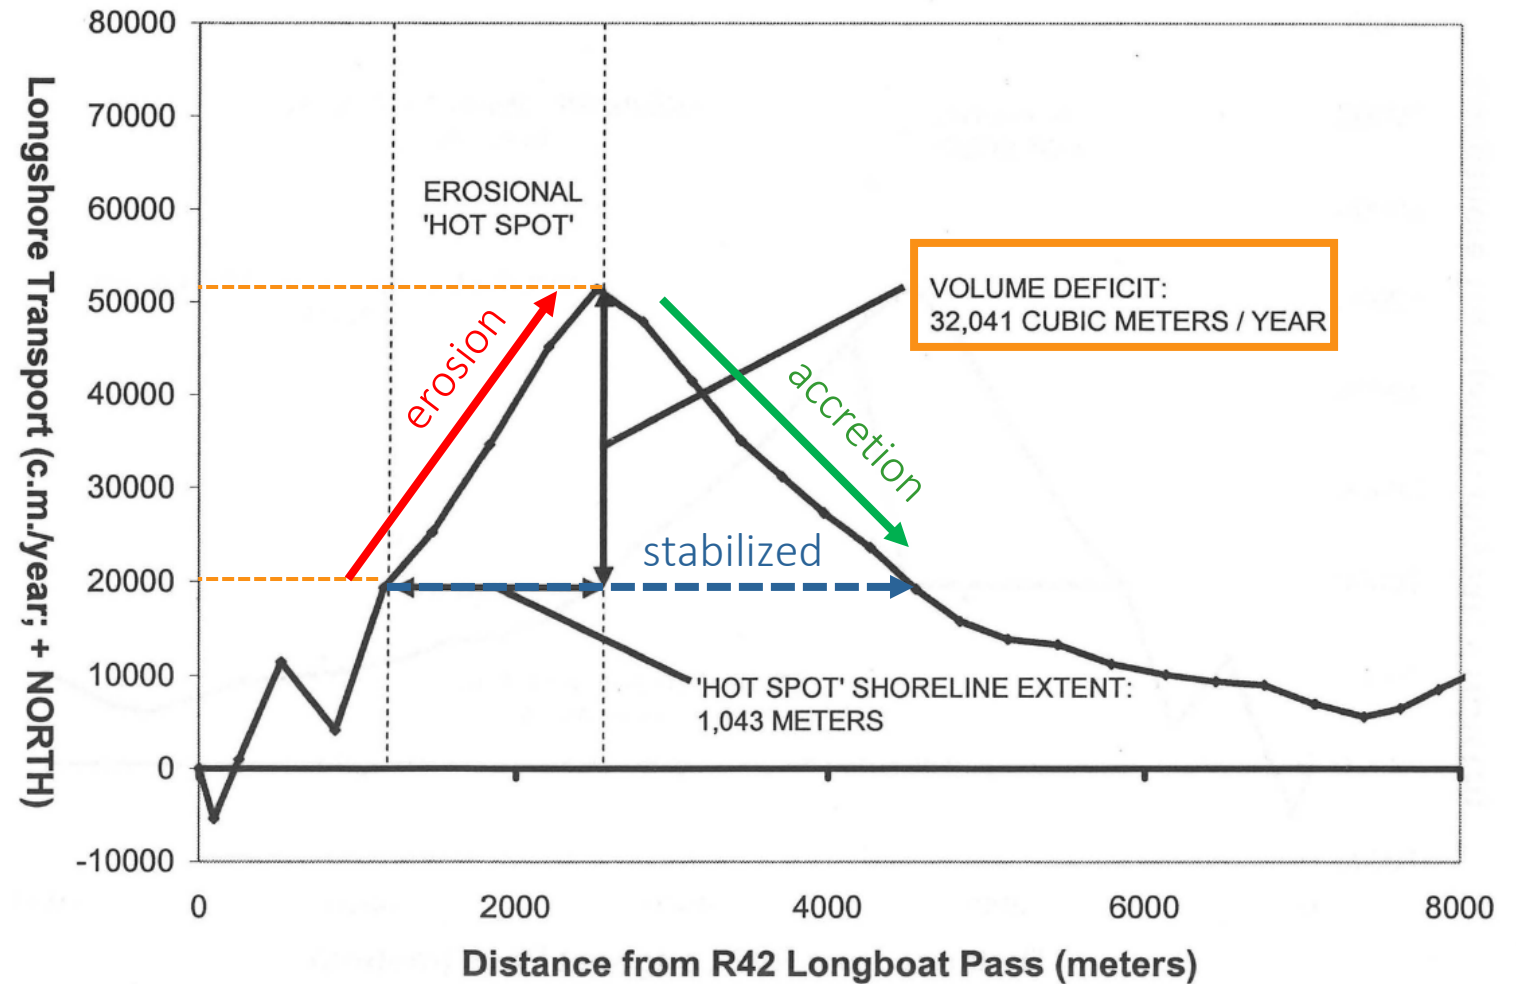
CAMPBELL & JENKINS, 2002

Campbell T.J. and Jenkins, M.G., 2002. Design considerations for hot spot erosion areas on beach nourishment projects. Proceedings of the 28th International Conference on Coastal Engineering, Vol 3, pp. 3642-3648.

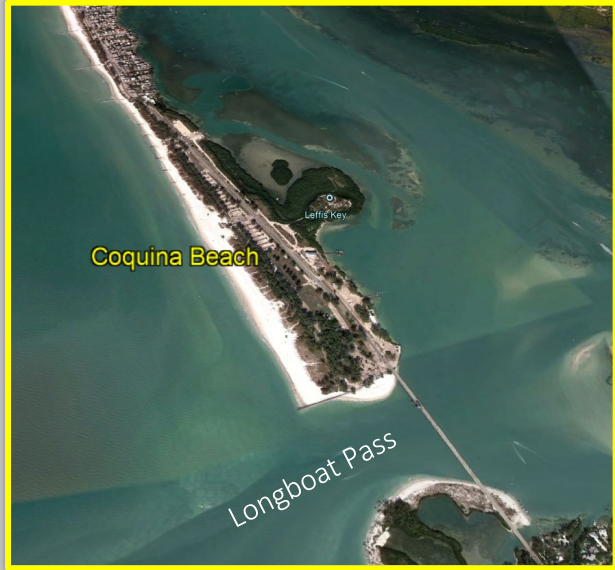
LONGBOAT PASS MANATEE COUNTY

Inlet influences coastal processes

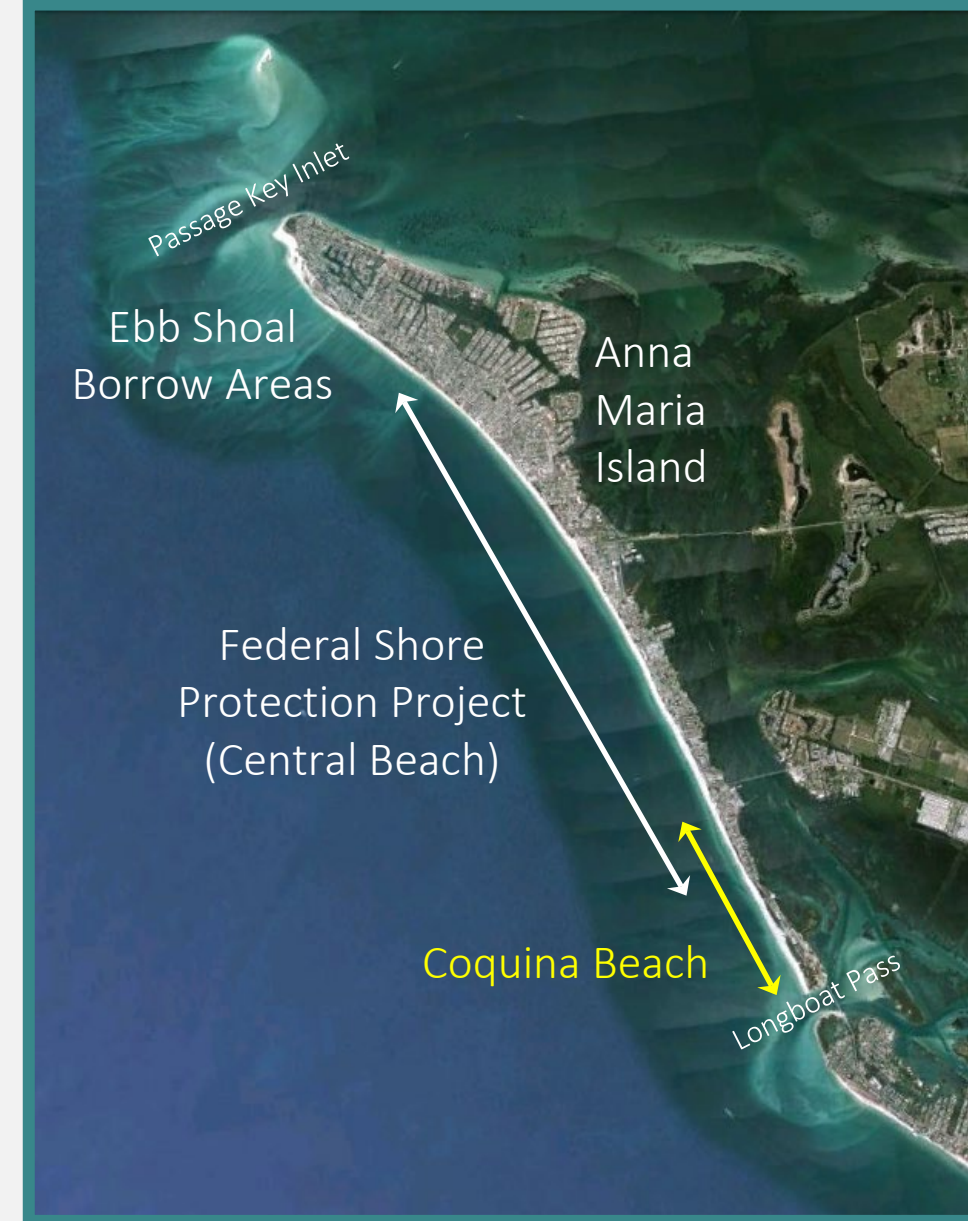
COQUINA BEACH PROJECT

- Locally managed by Manatee County
- 1.5 miles from 4th St. S to Longboat Pass
- Initial restoration in 2011
- Renourished in 2013-2014 and 2020
- FEMA repair project completed 2021
- Stabilized by groins and terminal groin (Longboat Pass Jetty)

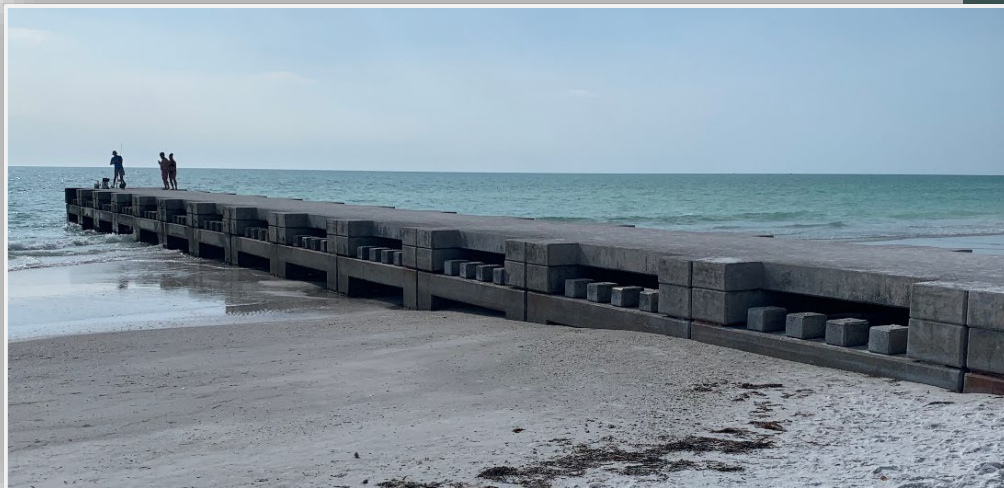
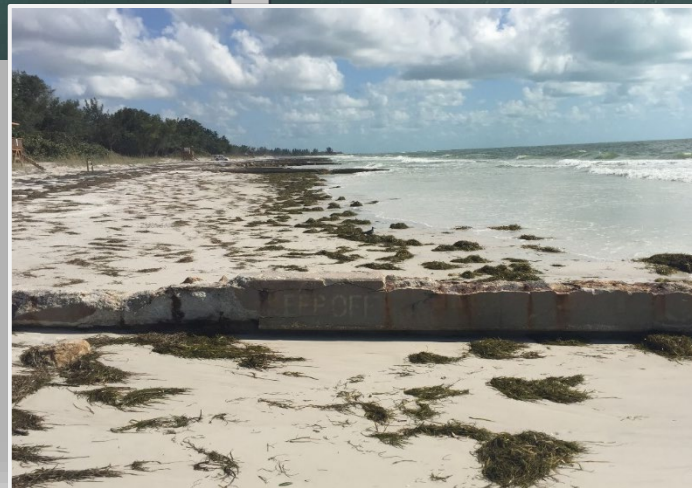
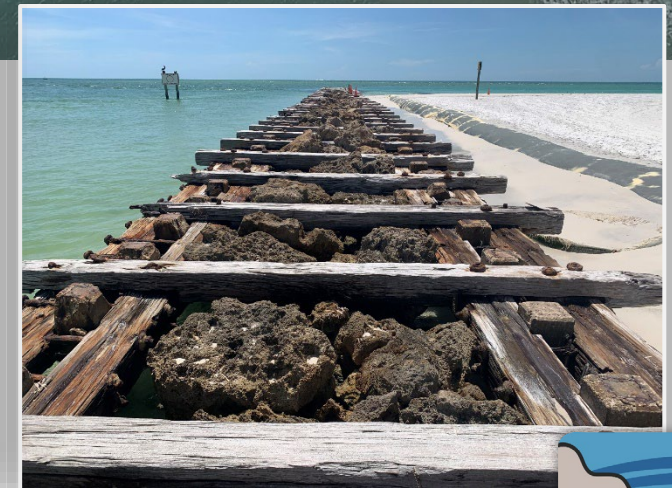
EXISTING COASTAL STRUCTURES

- Cortez (PAG) Groins
- Coquina Beach Groins
- Longboat Pass Jetty
- Geotextile Tubes

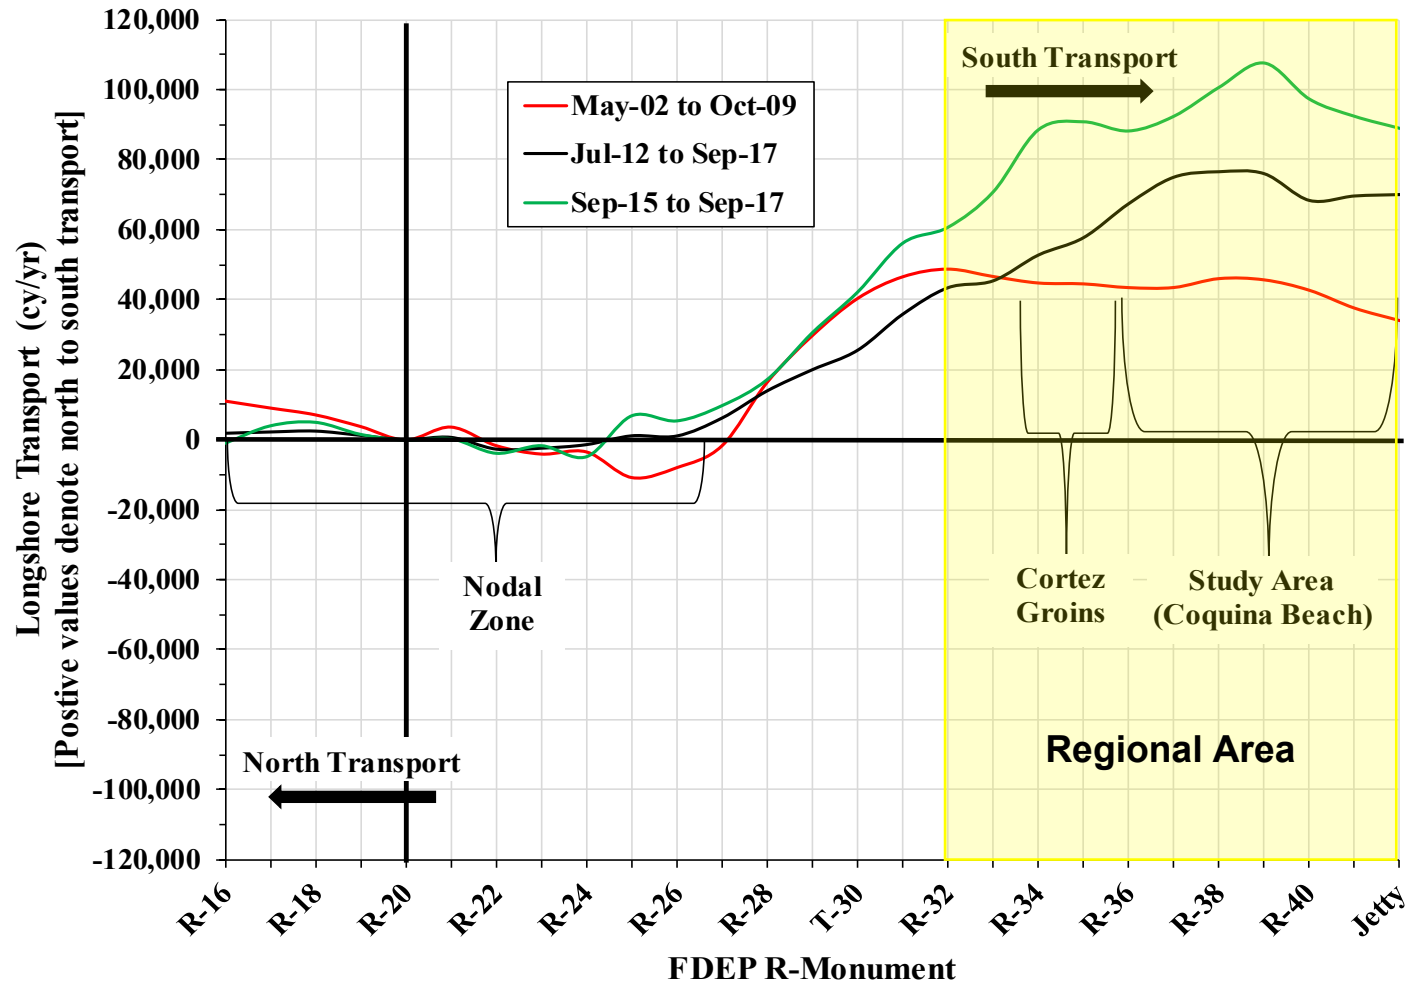
COASTAL PROCESS ASSESSMENTS

- Shoreline changes
- Volume changes
- Even odd analysis
- Sediment budget
- Longshore transport:
 - 2012 – 2017
 - 2015 – 2017
- Regional area:
 - +30,000 cy/yr
 - Net erosion

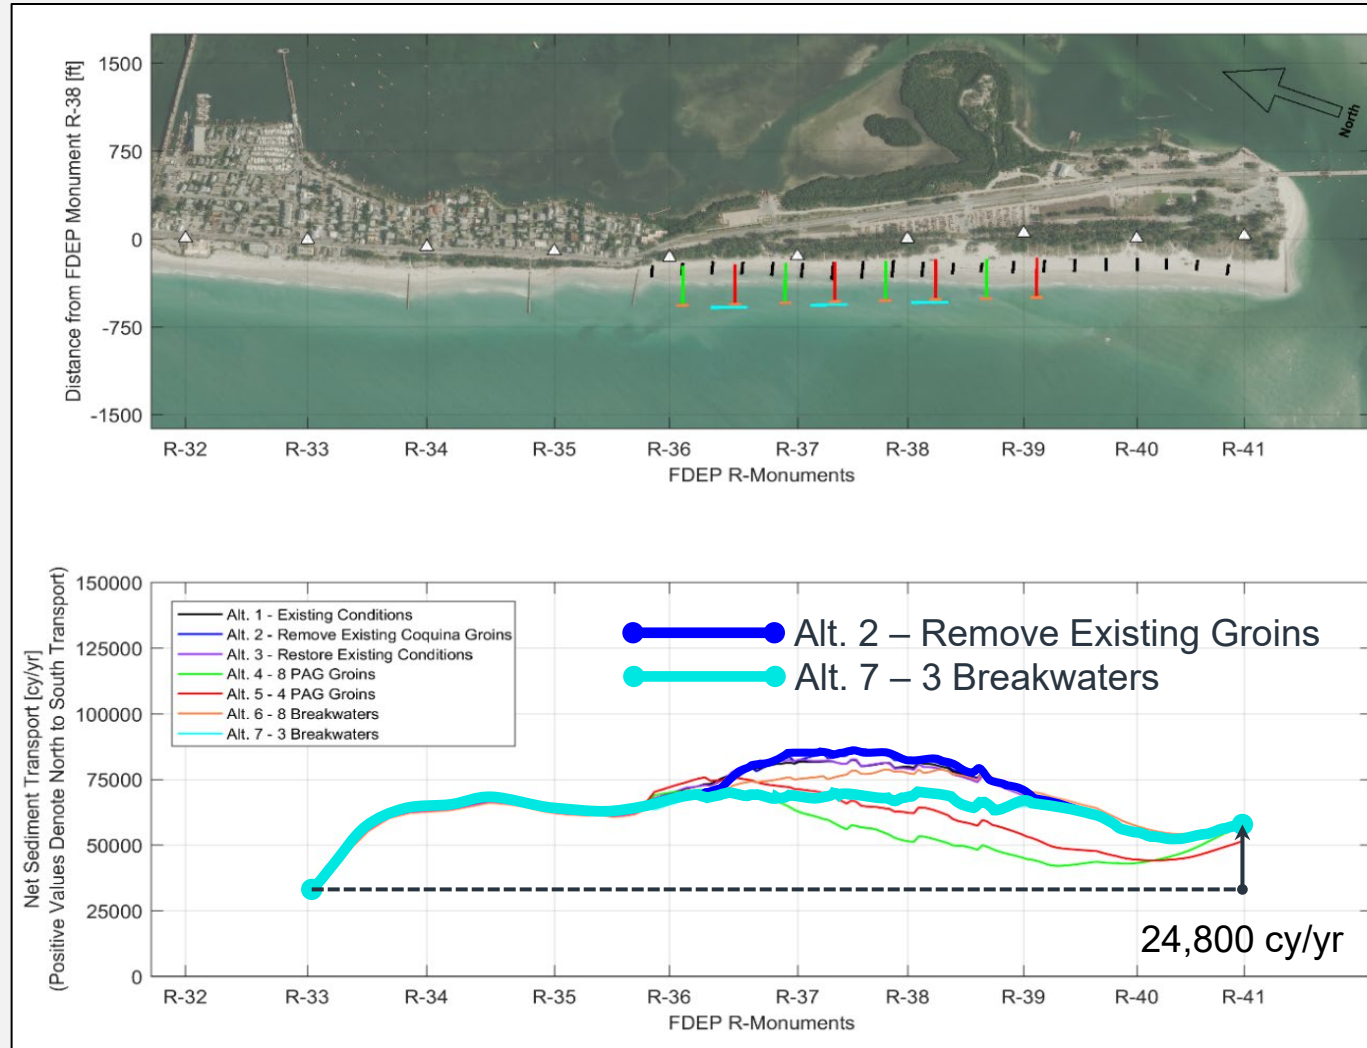
APPLICATION OF LST CURVE (1-YEAR SIMULATION)

- Southerly directed transport
- 24,800 cy/yr (existing)

- Objectives:
 - Preserve regional transport
 - Balance erosion trend
 - Extend life of beach fill

- Stabilize beach in north
- Extend into accretion area
- Overlap inlet fillet

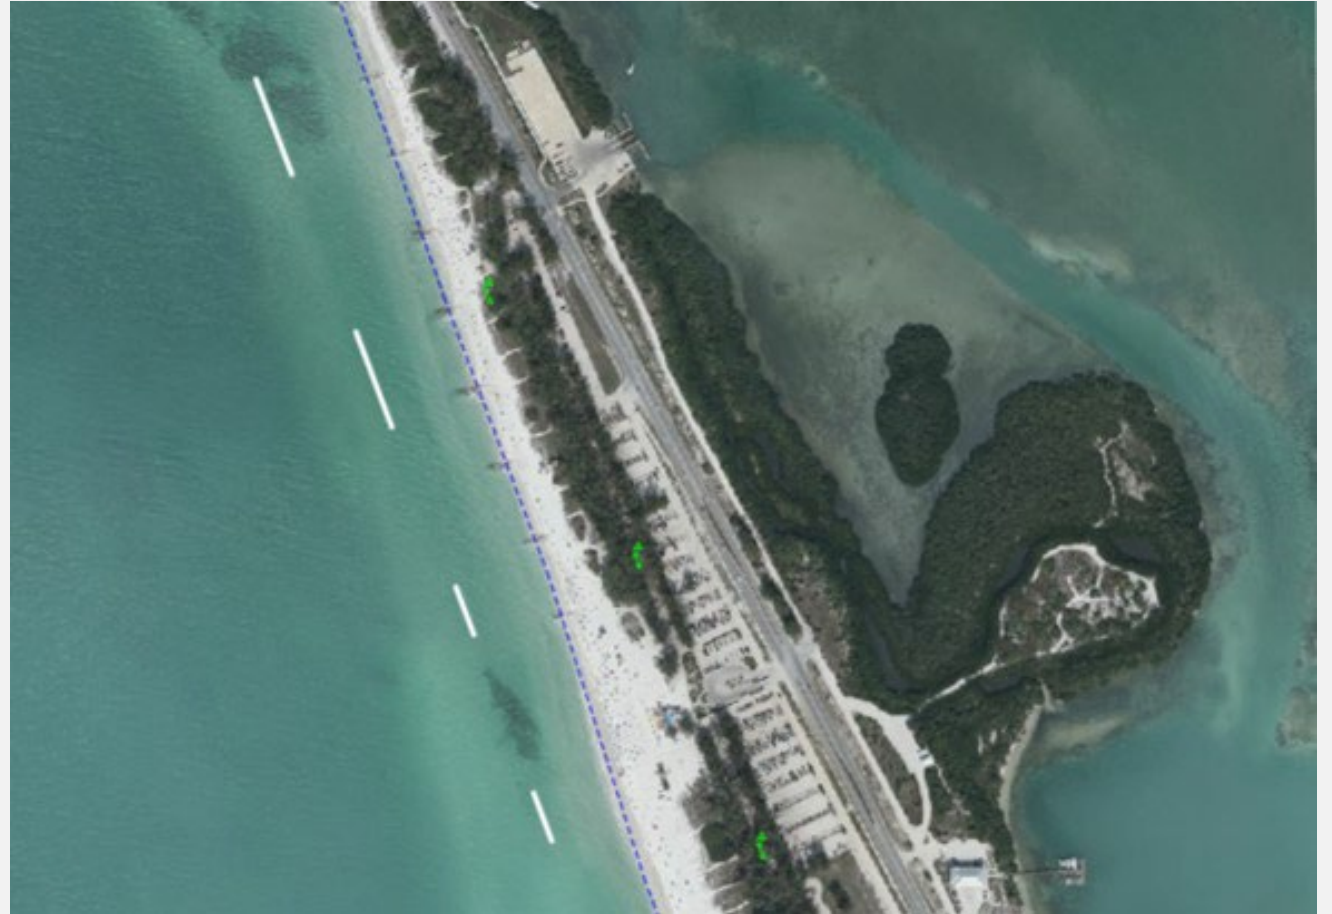
BREAKWATER DESIGN REFINEMENTS

Split Southern Breakwater

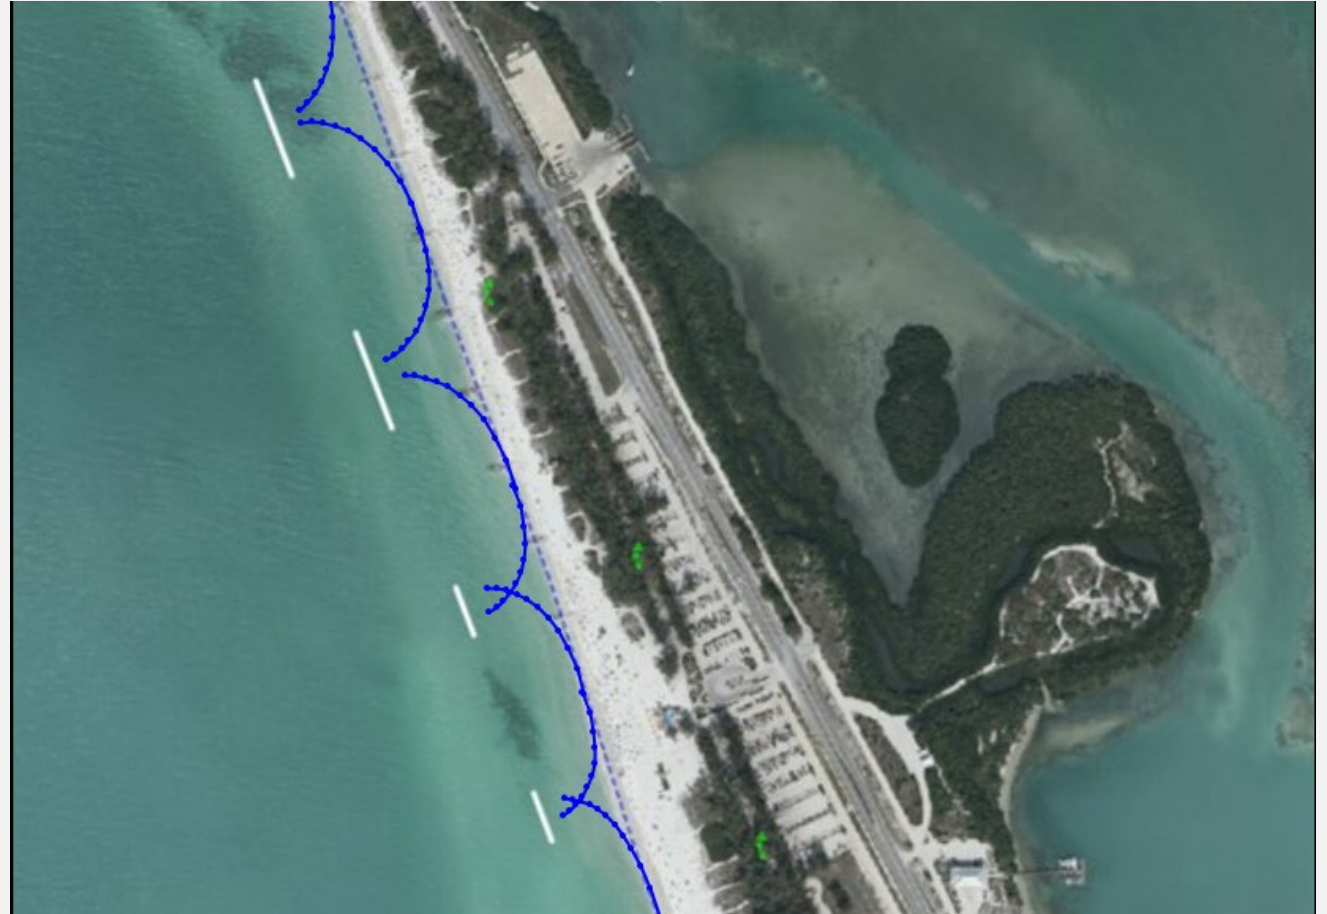
BREAKWATER DESIGN REFINEMENTS

Parabolic Shoreline Model
(Silvester & Hsu, 1993)

MepBay Application: Hsu, J.R.C.; Benedet, L.; Klein, A.H.F.; Raabe, A.L.A.; Tsai, C.P., and T.W. Hsu, 2008. Appreciation of static bay beach concept for coastal management and protection. *Journal of Coastal Research*, 24(1), 198–215. West Palm Beach (Florida), ISSN 0749-0208.
