USACE Emergency Operations Mission to Assess Failing Coastal Infrastructure Caused by Hurricane Ian (and Nicole) in Volusia County, FL

Will Reilly, P.E.
Chief of Waterways Section
U.S. Army Corps of Engineers, Jacksonville District

Florida Shore & Beach Preservation Association
36th Annual National Conference on
Beach Preservation Technology

February 1, 2023

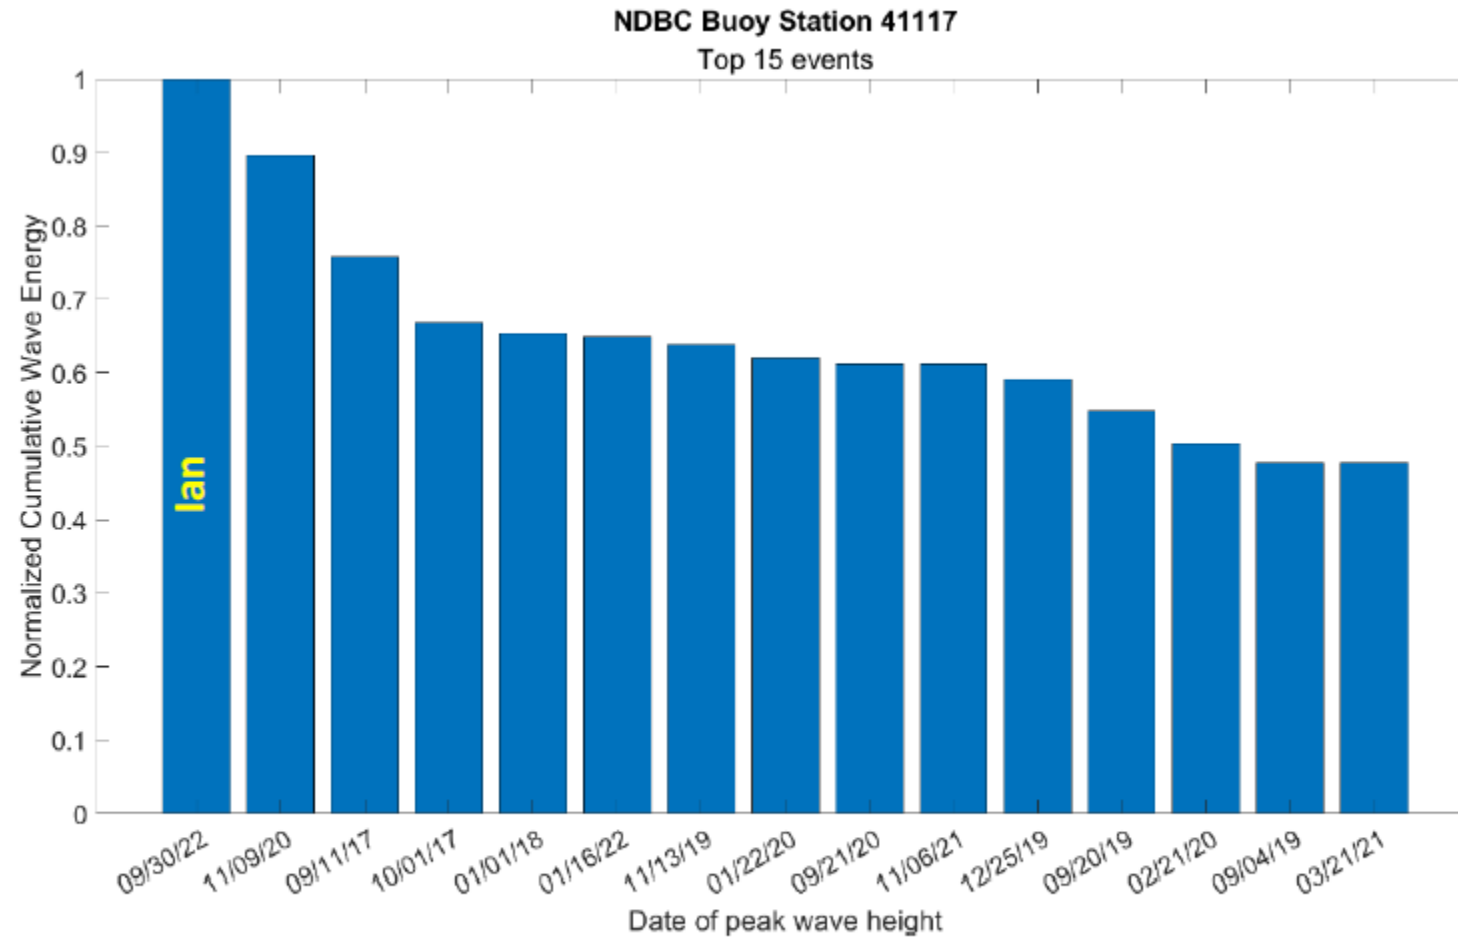
Figure 153: Top 15 storm events in terms of normalized cumulative wave energy at NDBC Buoy 41117

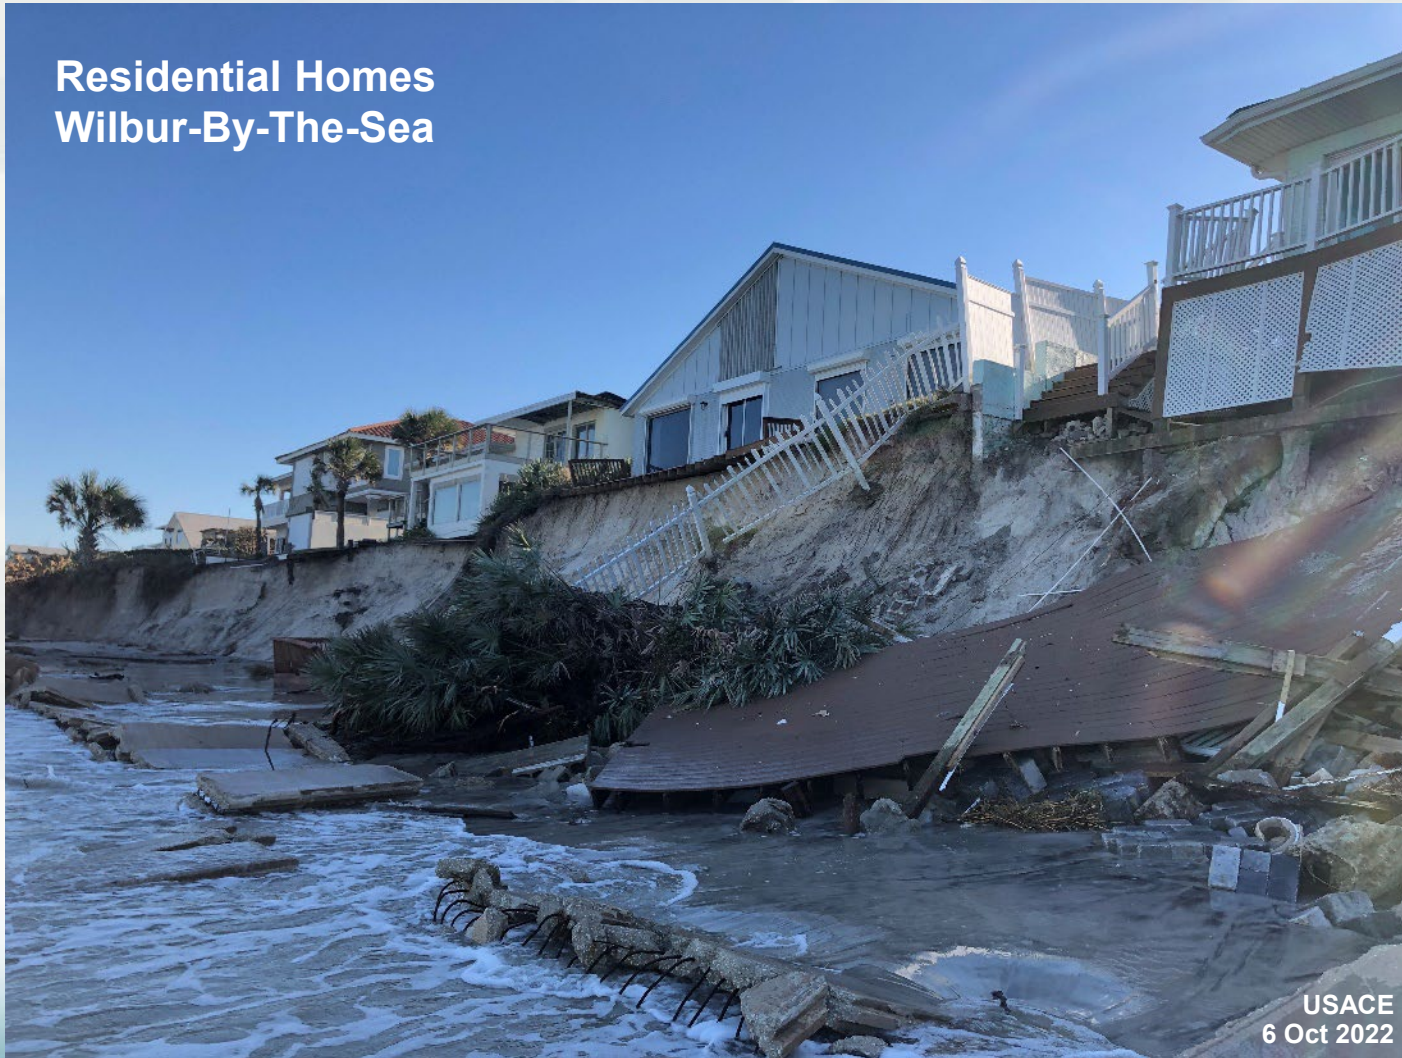
Residential Homes Wilbur-By-The-Sea

- Widespread seawall/retaining wall damage or collapse
- Significant erosion of dune bluff progressed close to several structures partially undermining the foundations

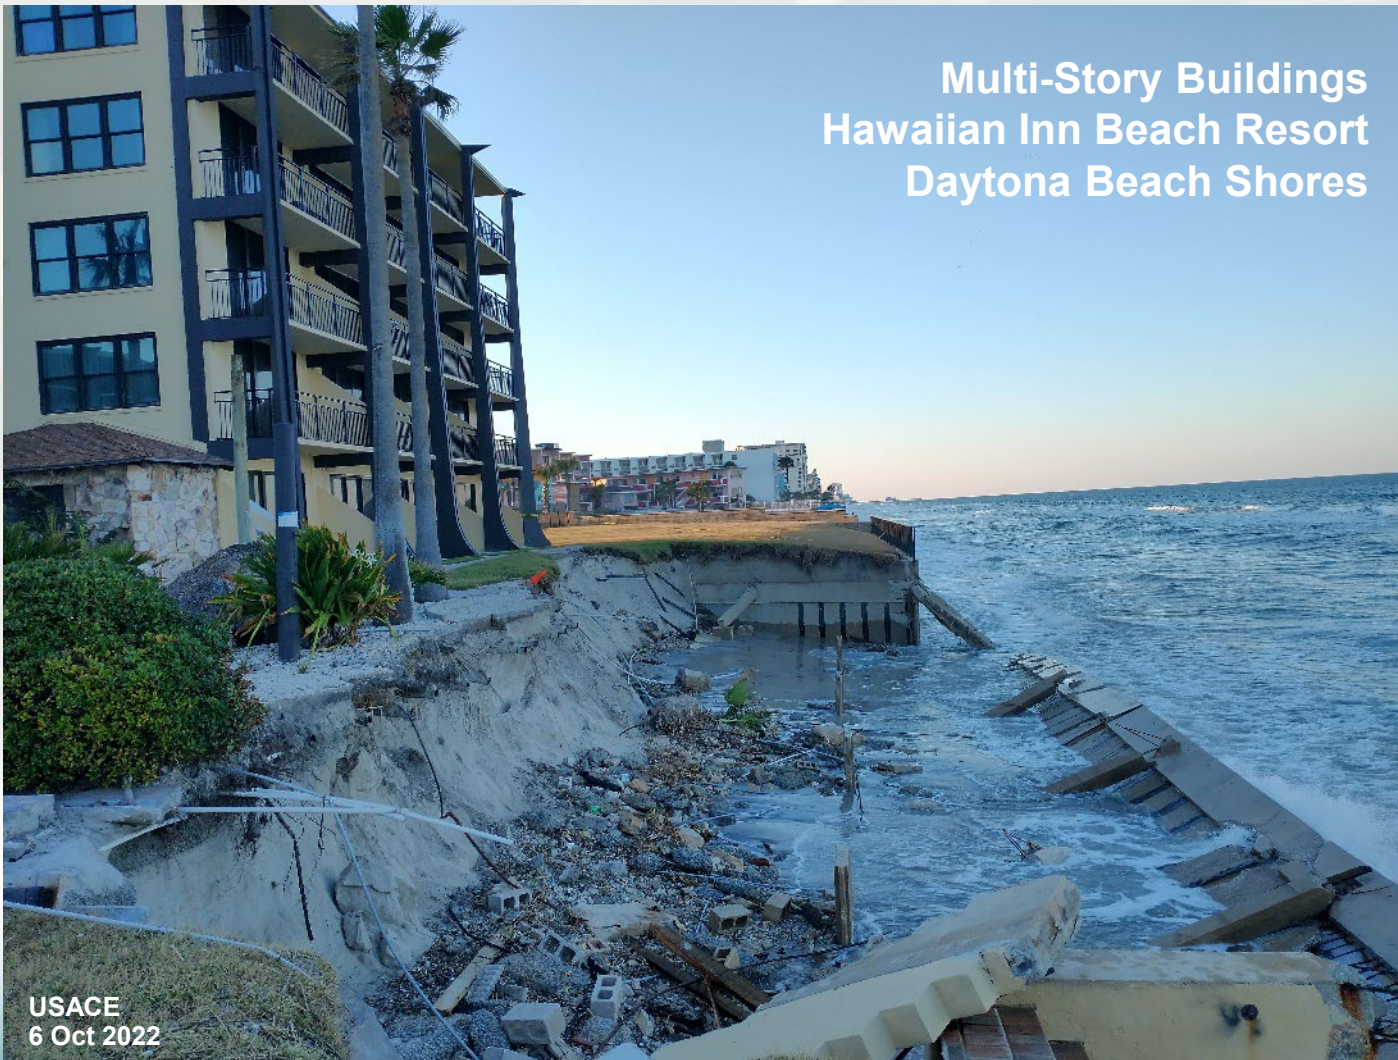
Multi-Story Buildings
Hawaiian Inn Beach Resort
Daytona Beach Shores

- Widespread seawall/retaining wall damage or collapse
- Significant erosion of dune bluff progressed close to several structures partially undermining the foundations

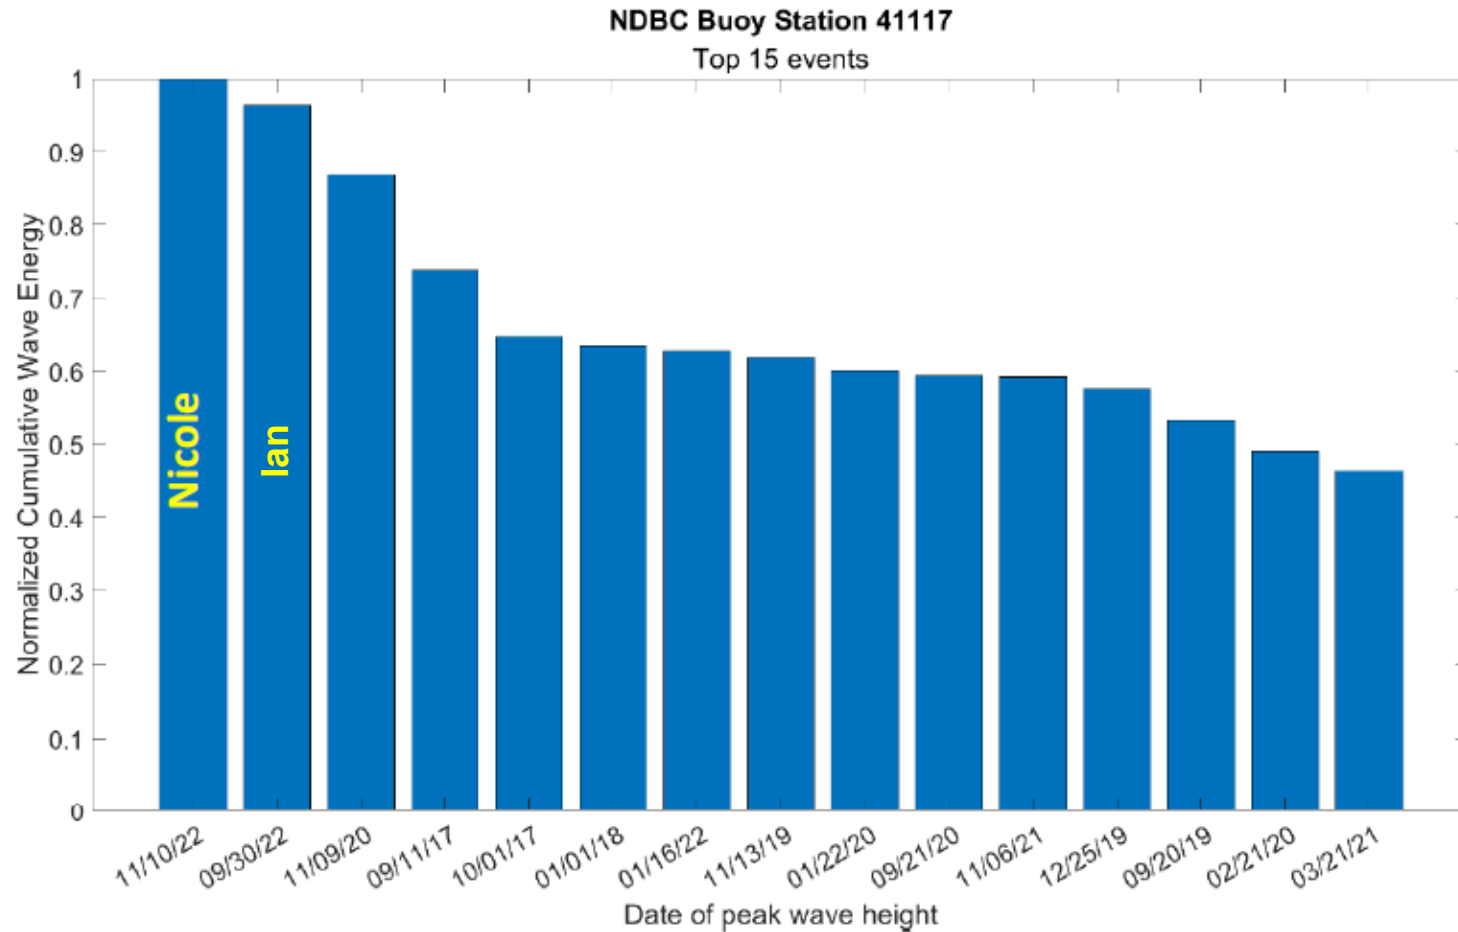
Figure 75: Top 15 storm events in terms of normalized cumulative wave energy at NDBC Buoy 41117

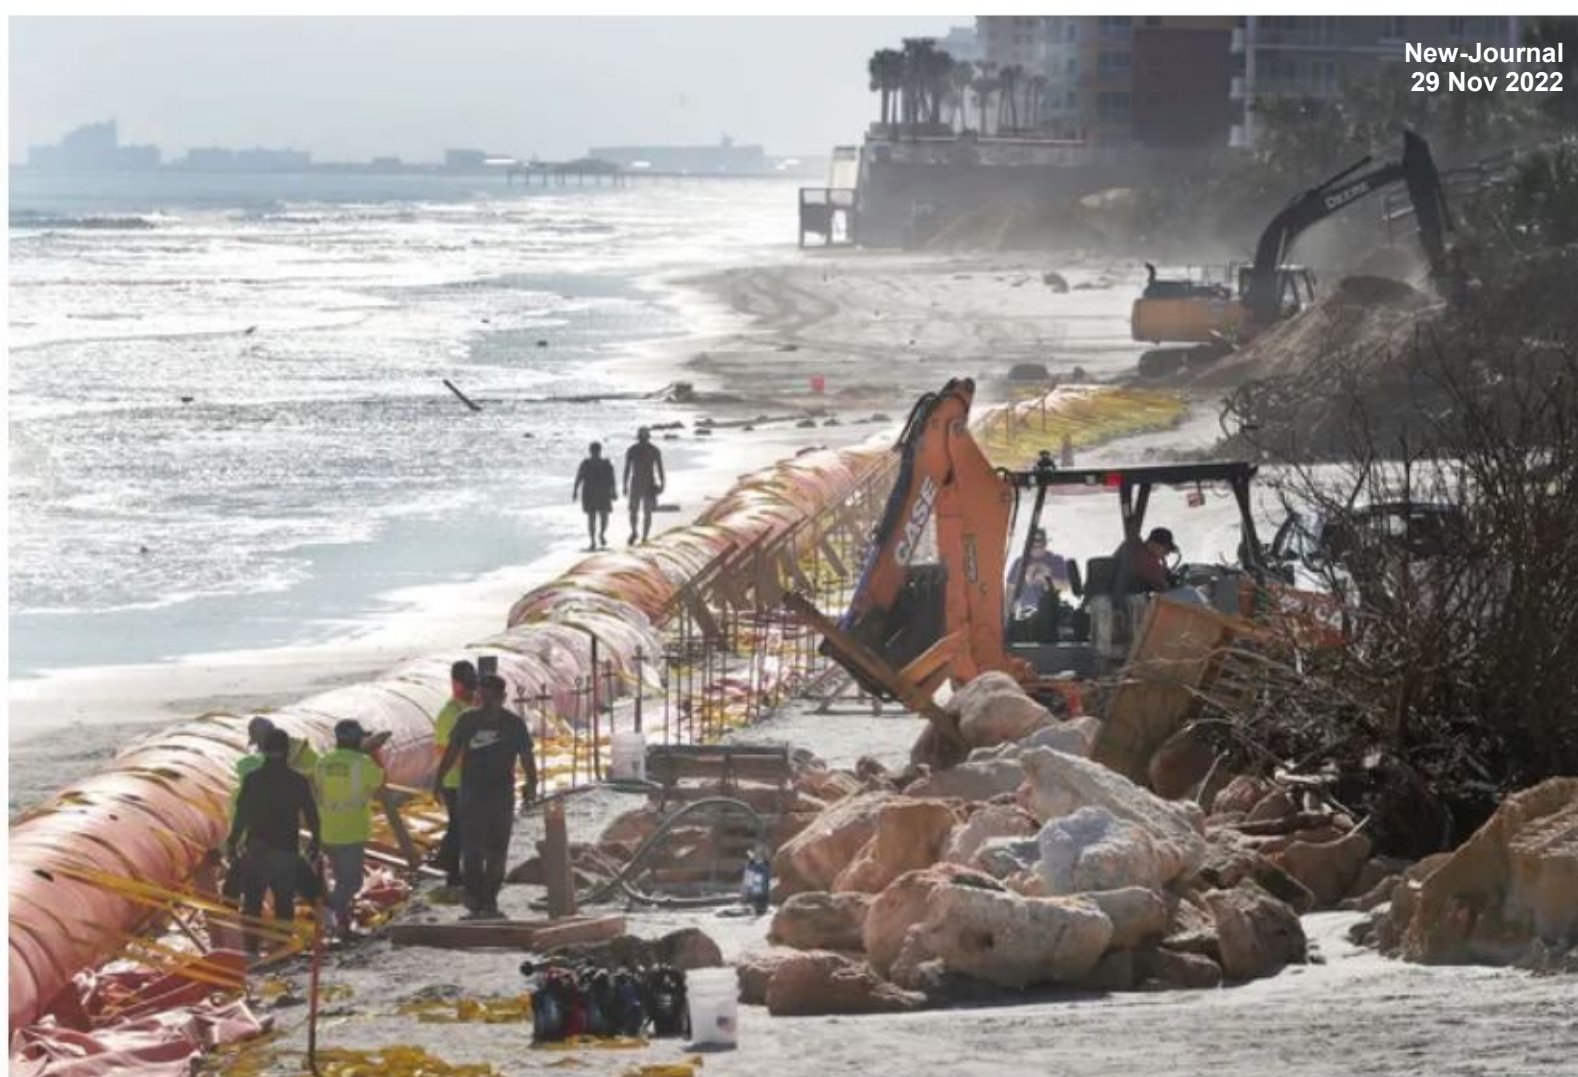
Construction crews install a Tiger Dam system Tuesday, Nov. 29, 2022, south of Frank Rendon Park in Daytona Beach Shores. The system is intended to offer a temporary protection against future erosion caused by storms. *David Tucker/News-Journal*
