Using a Towed ROV System to Map Submerged Aquatic Vegetation in the Sunken Island Beneficial Placement Area Hillsborough Bay, Tampa Harbor

FSBPA 37th Annual National Conference
on Beach Preservation Technology
February 8, 2024
Session A3, Presentation #34

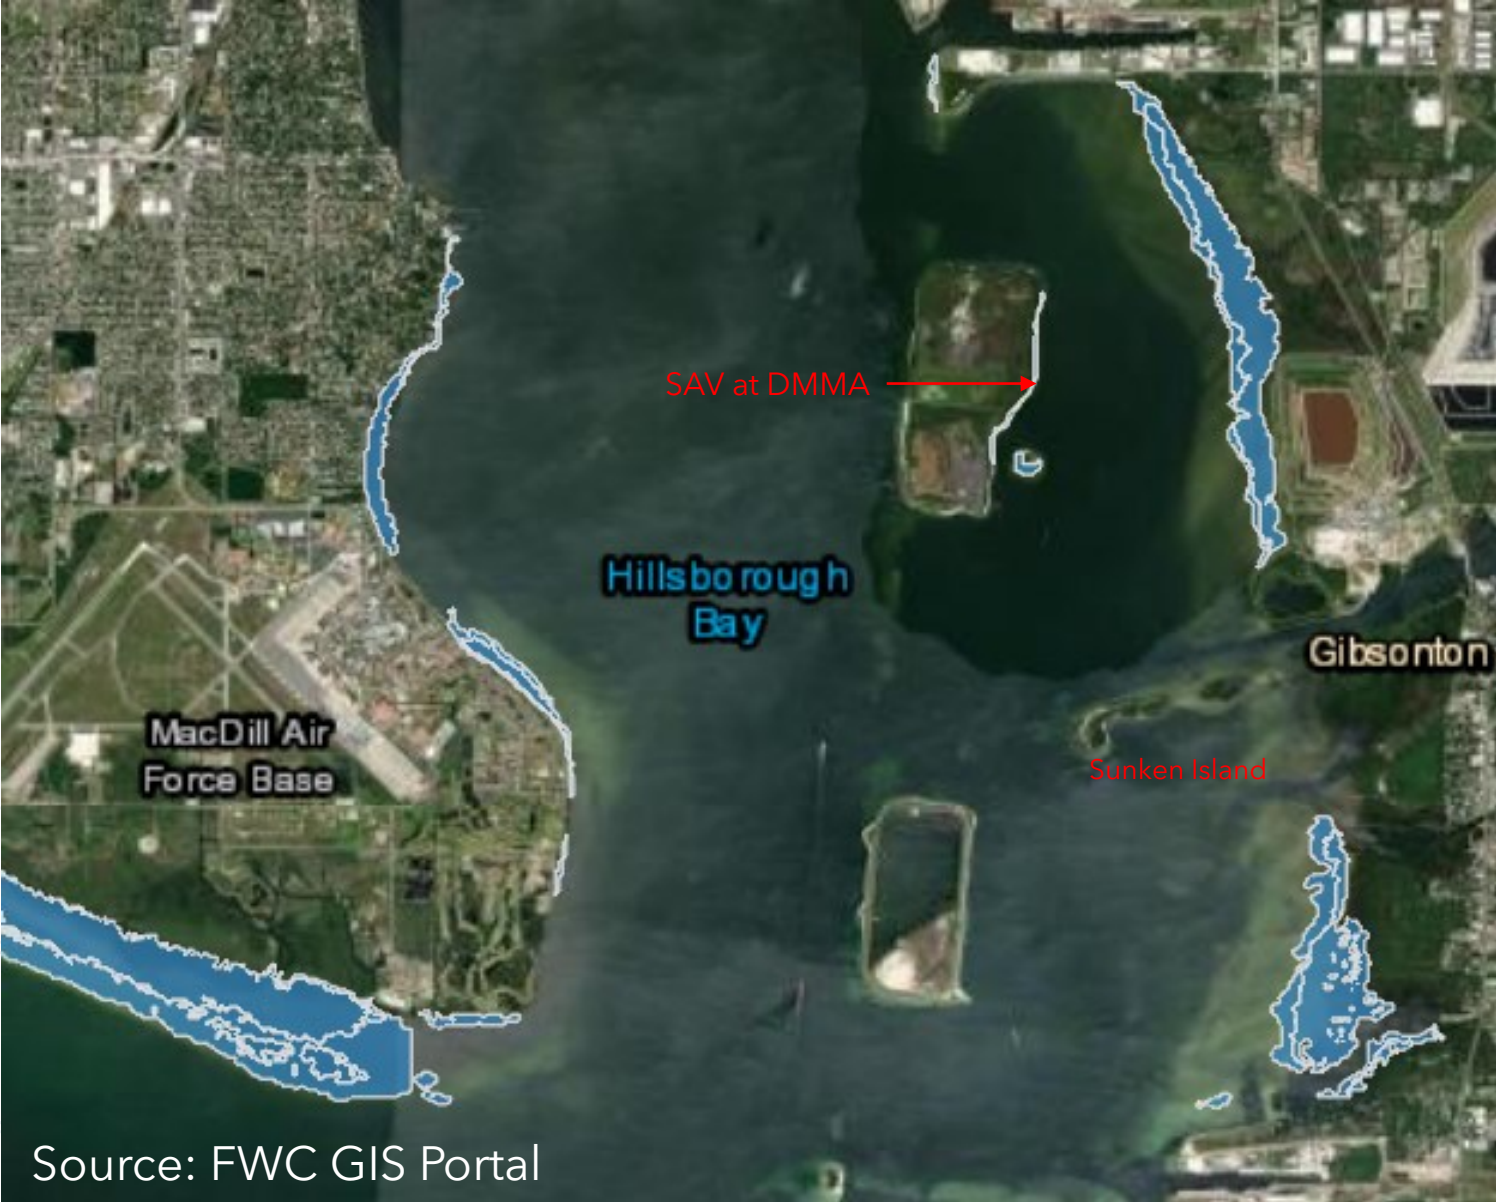
Desktop Assessment

Source: FWC GIS Portal

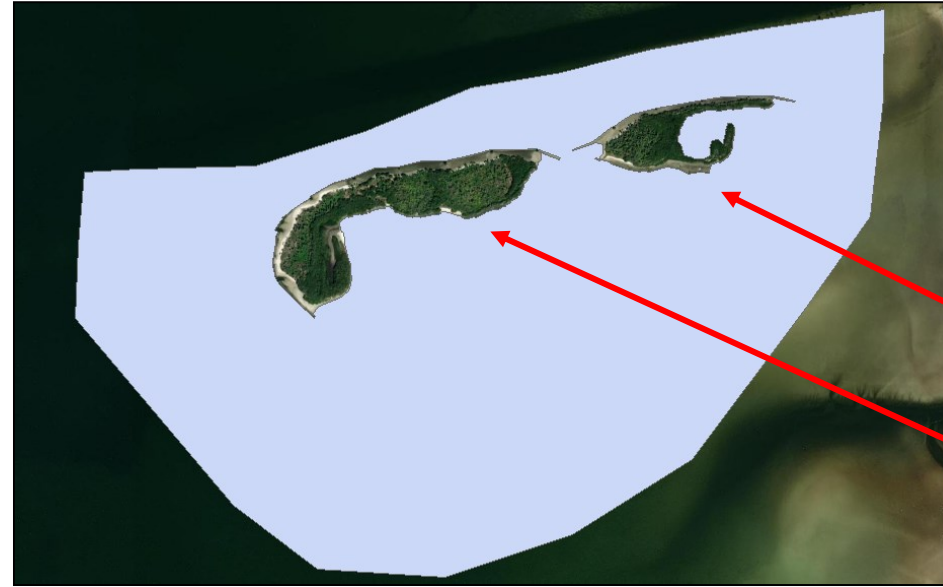
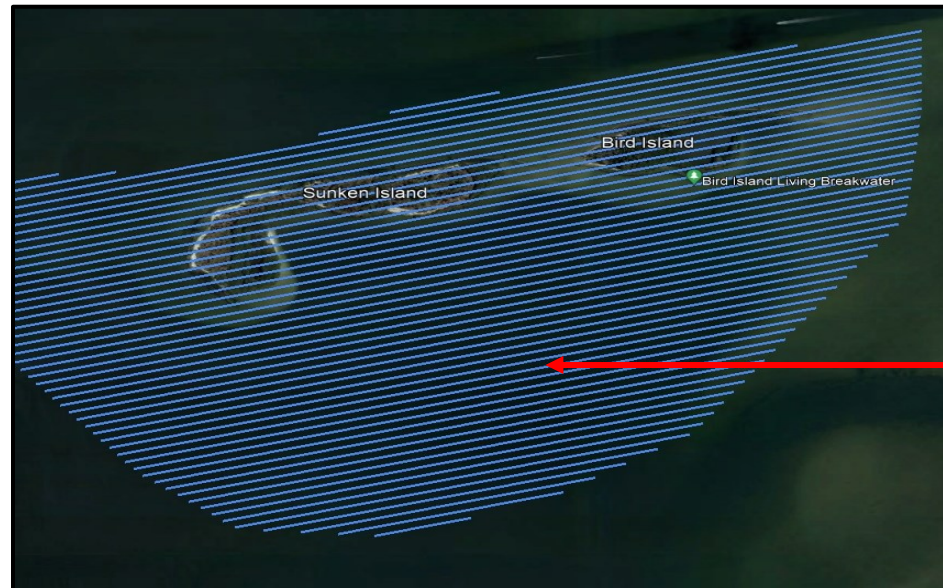
51 Transects

- Side-scan sonar is a common method for SAV surveys, some taxa cannot be detected (FDEP, 2020)
- A visual reconnaissance survey required
- For such large area (722 acres), a Remotely Operated Vehicle (ROV) with a live video feed proposed
- 51 pre-planned east-west transects

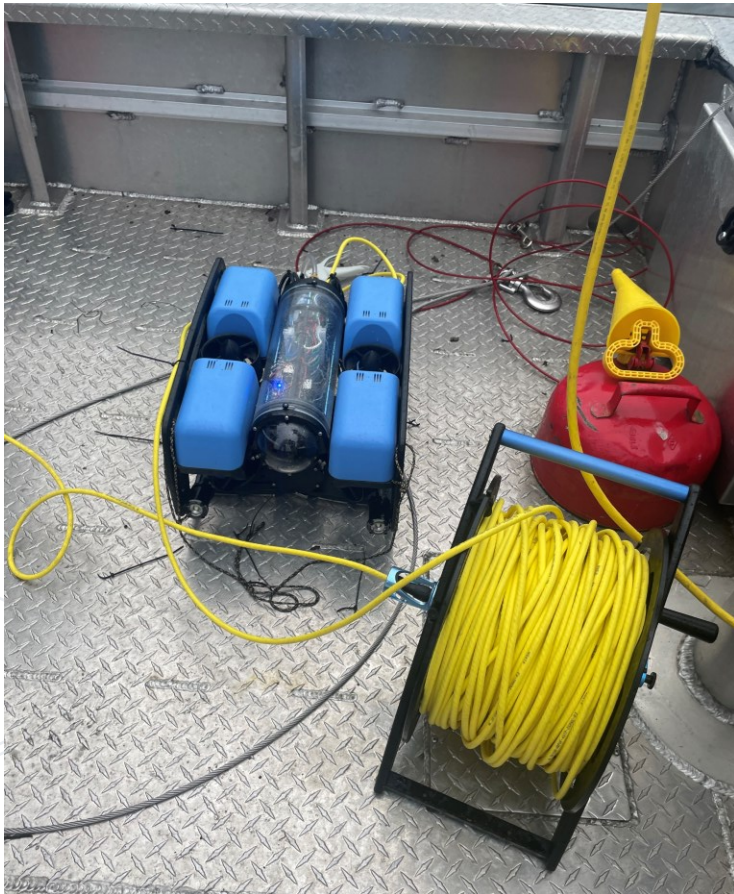
BlueROV2 System

Blue Robotics *BlueROV2* system

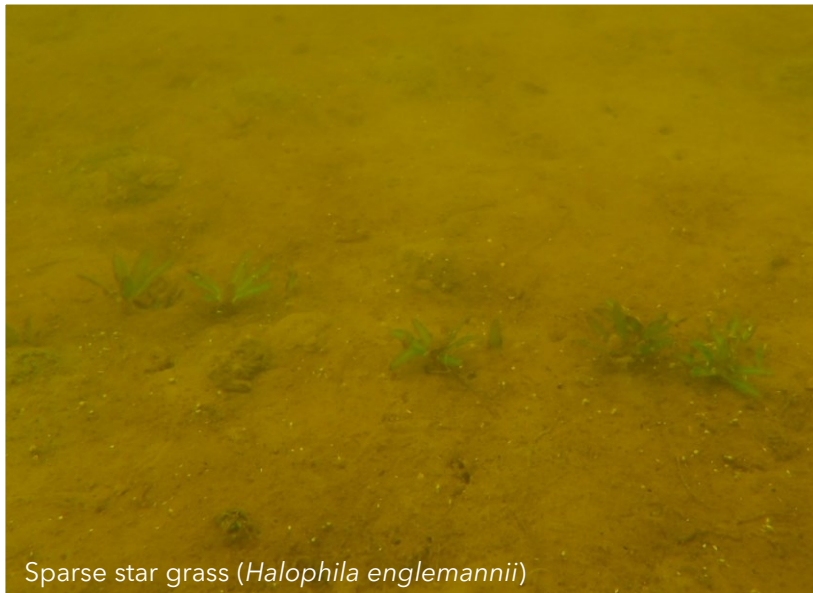
Sparse star grass (*Halophila englemannii*)

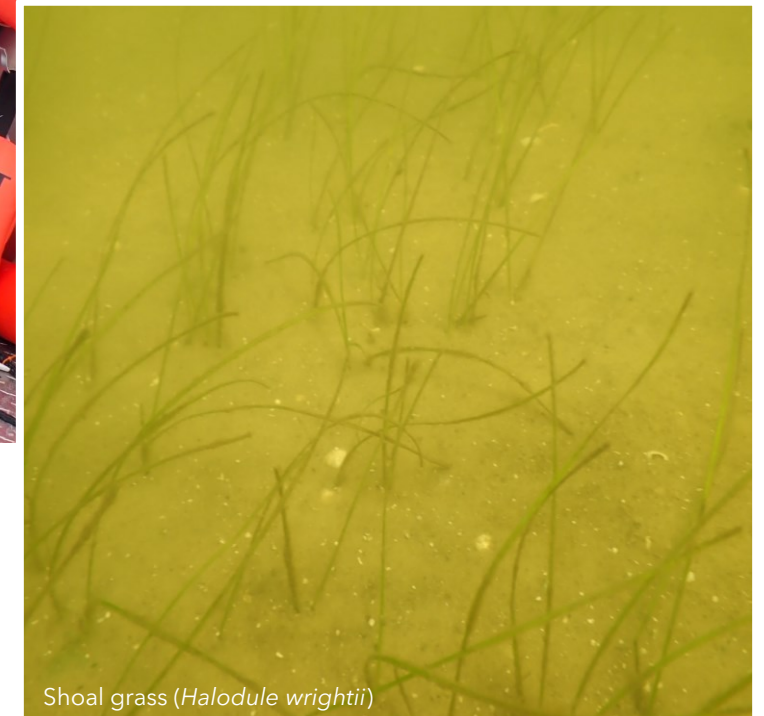
Shoal grass (*Halodule wrightii*)

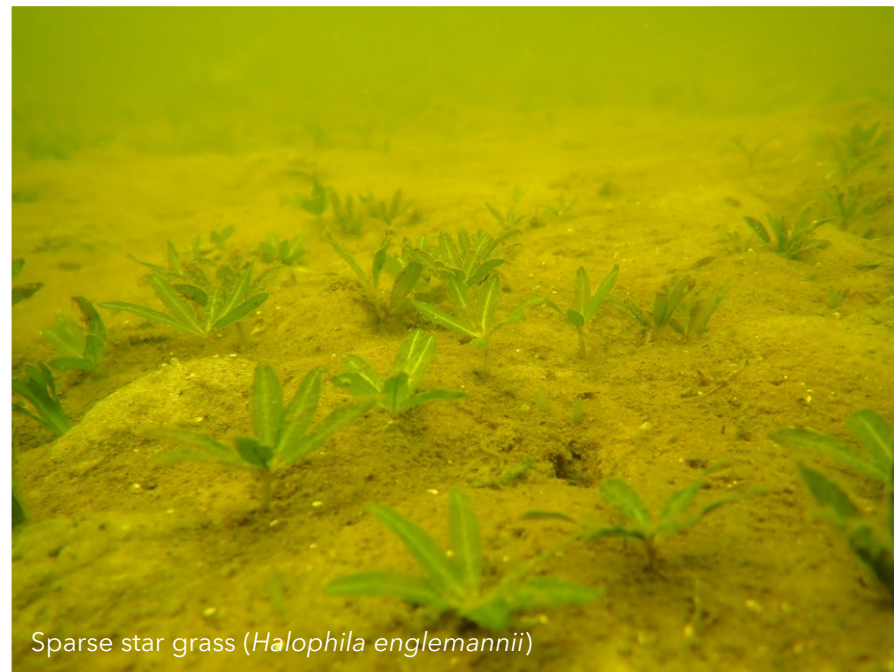
Sparse star grass (*Halophila englemannii*)

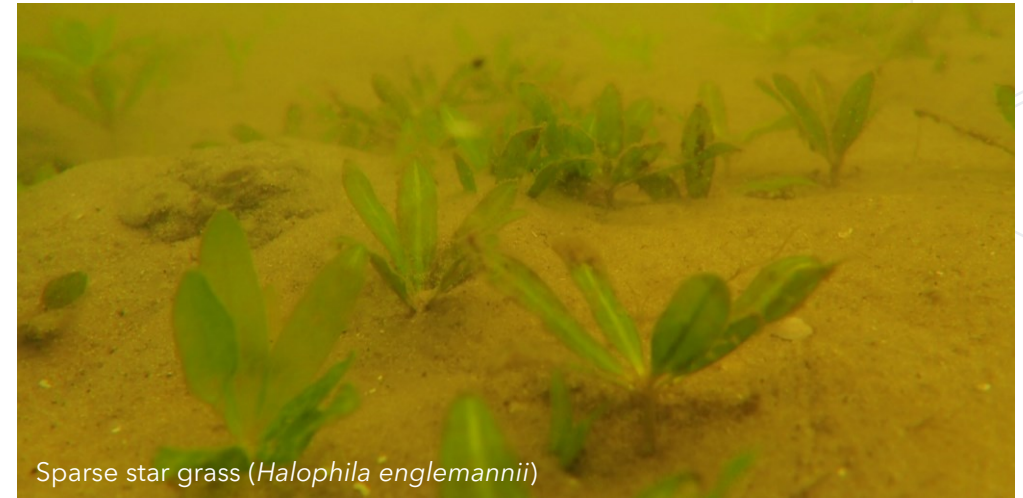
Sparse star grass (*Halophila englemannii*)

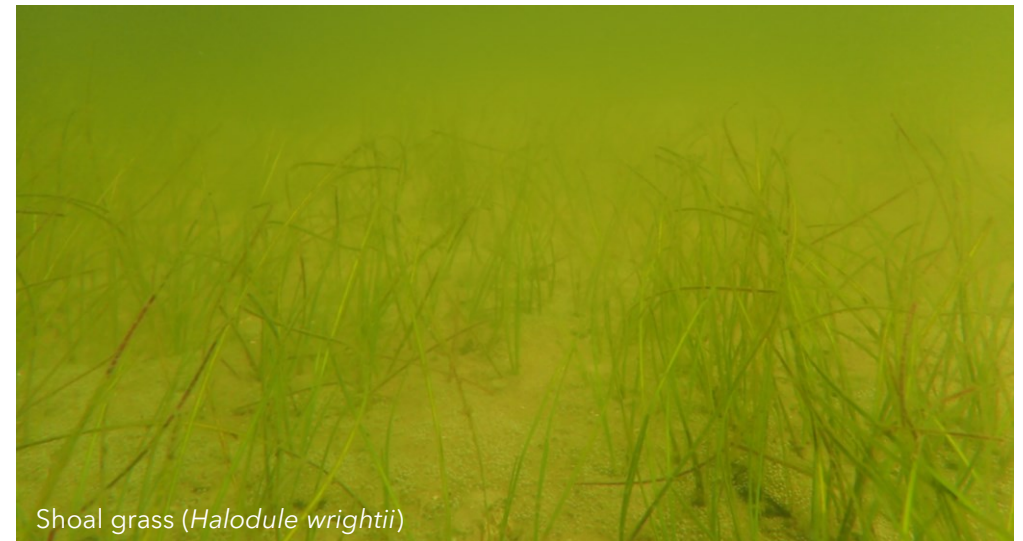
Shoal grass (*Halodule wrightii*)
