Lovers Key – Bonita Beach Hurricane Recovery

FSBPA
FEBRUARY 7, 2024

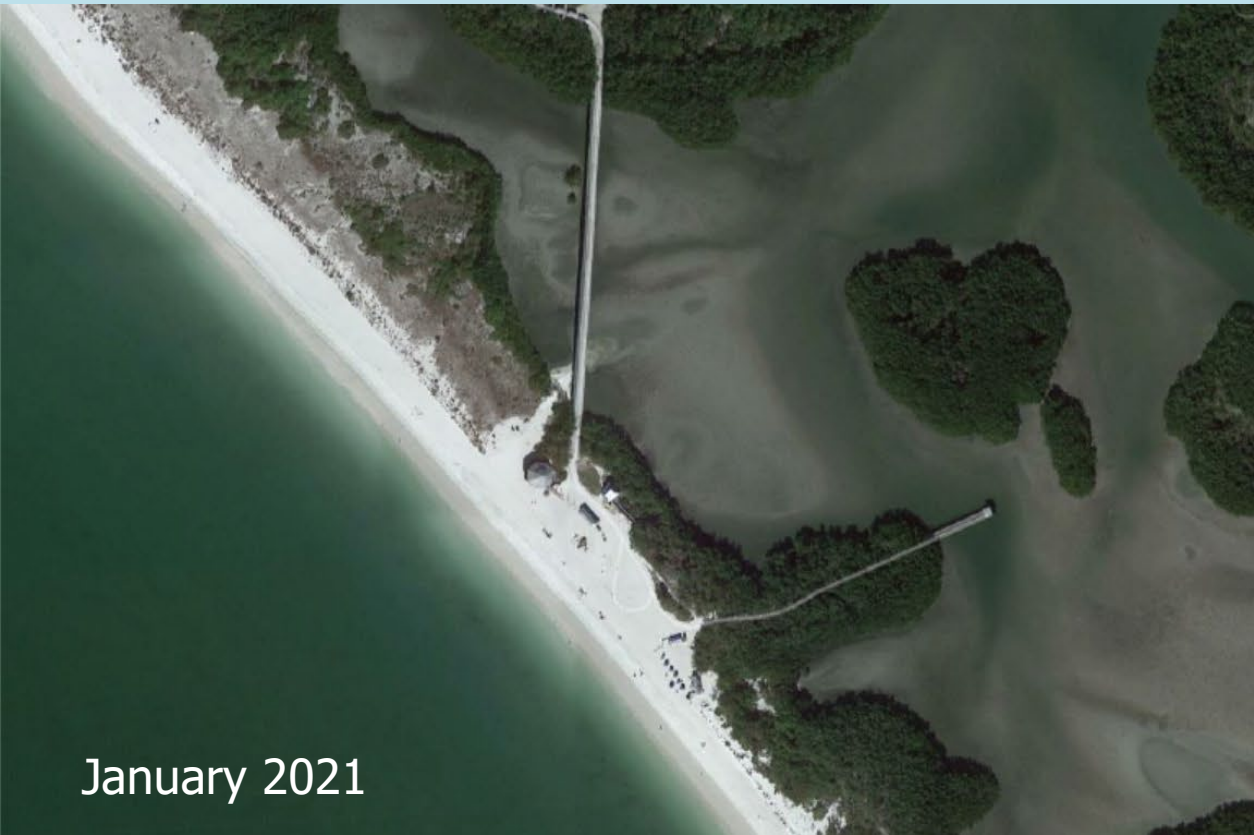
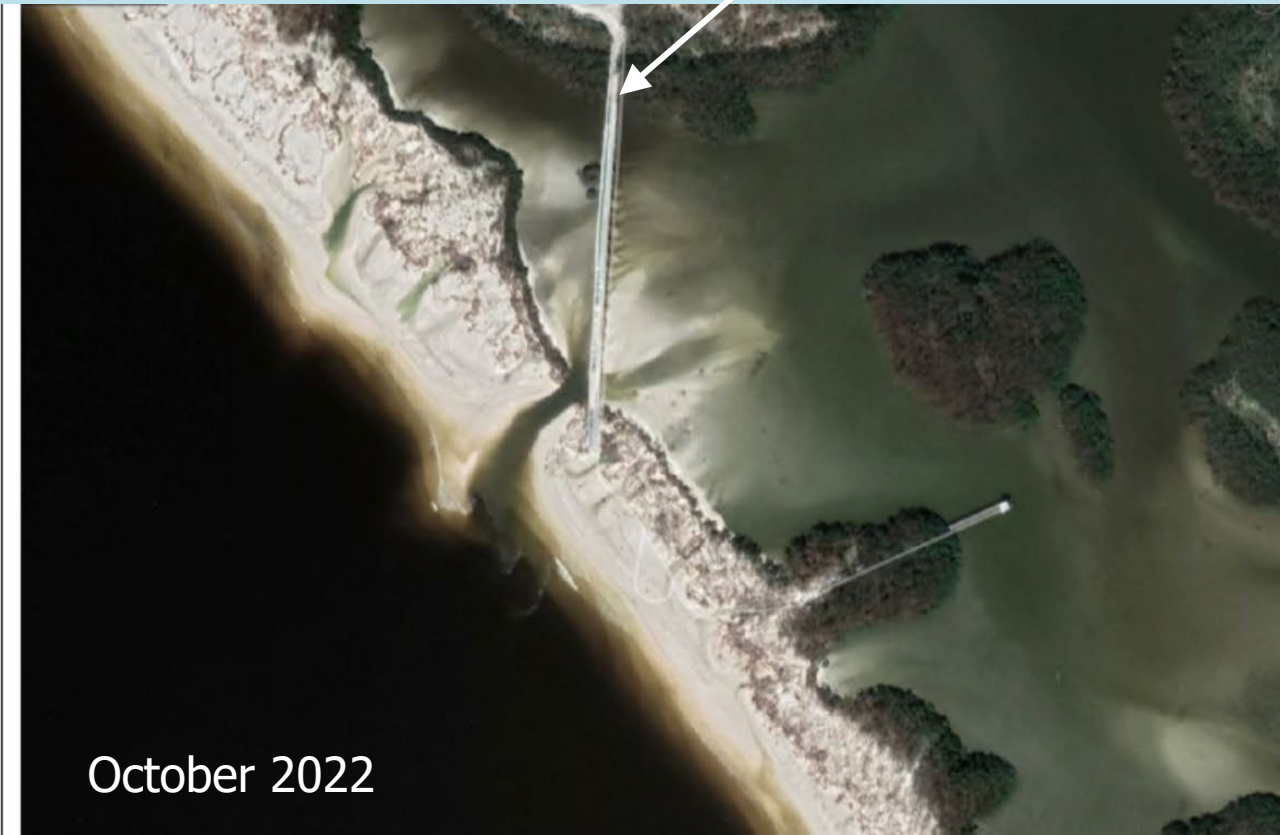
Lovers Key Aerial View Before (left) and After (right) Hurricane Ian
Note Breach in Island

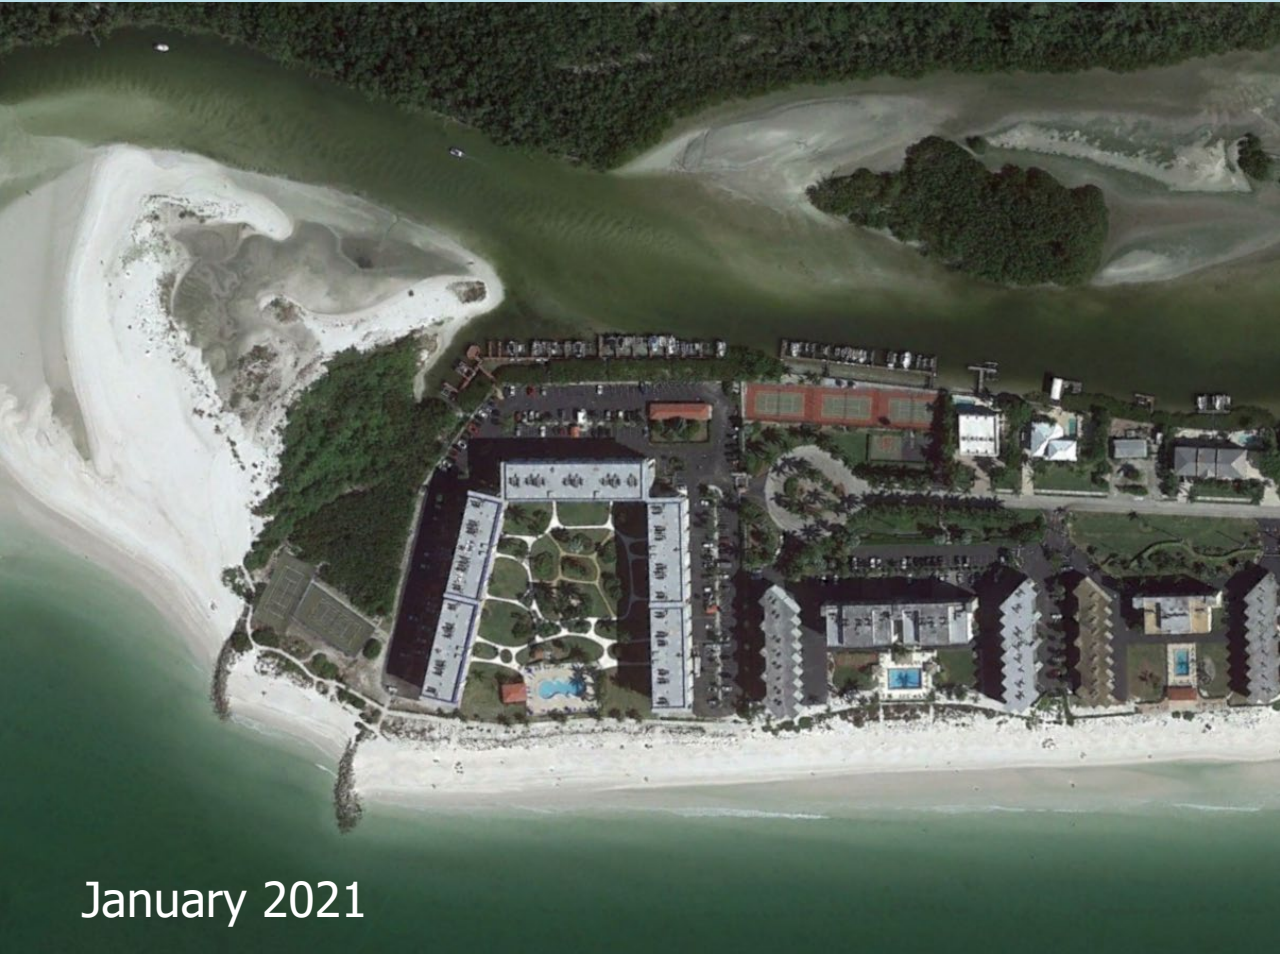
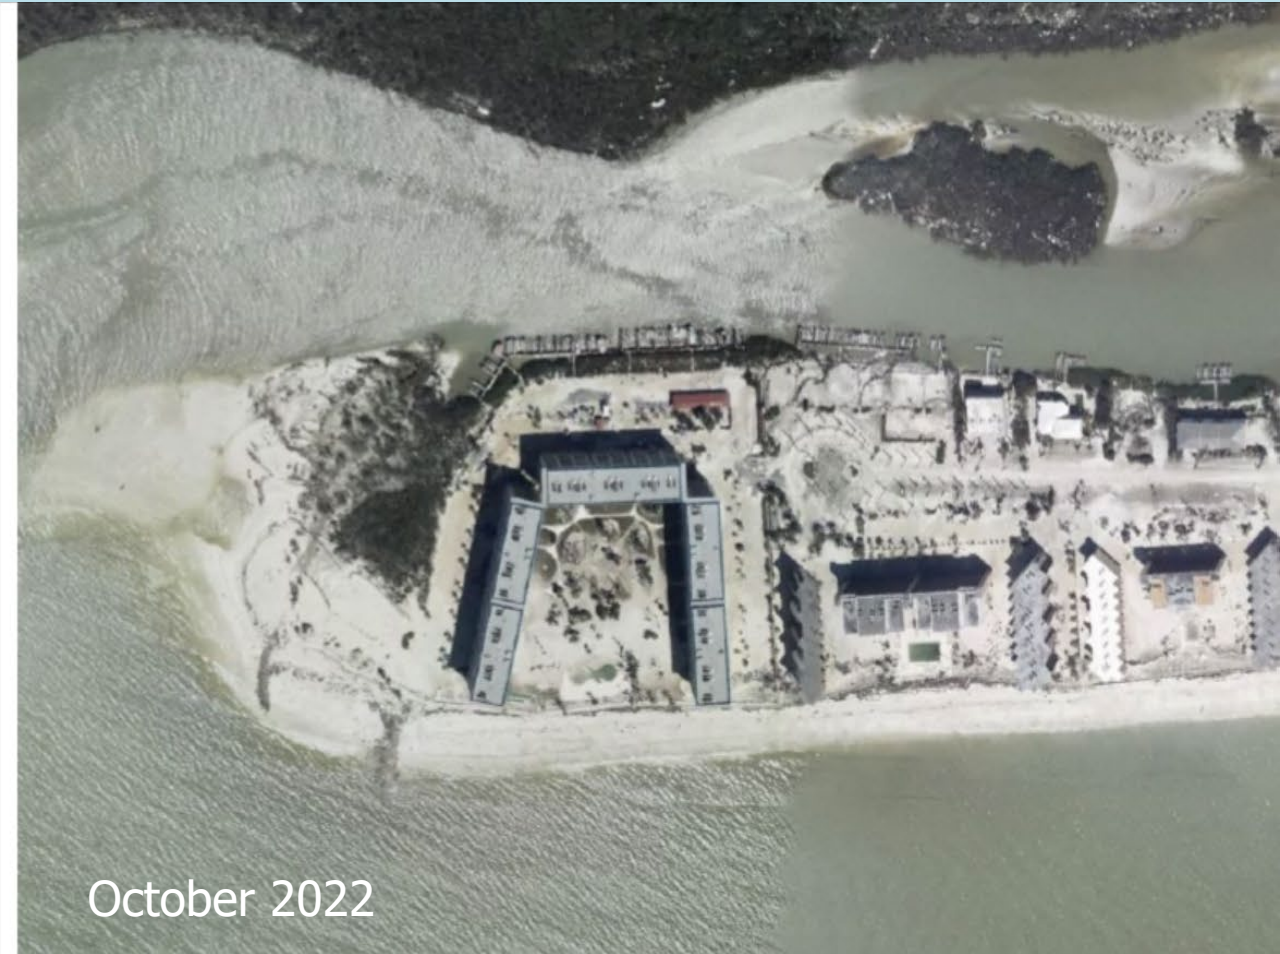
January 2021

October 2022

Bonita Beach Aerial View Before (left) and After (right) Hurricane Ian

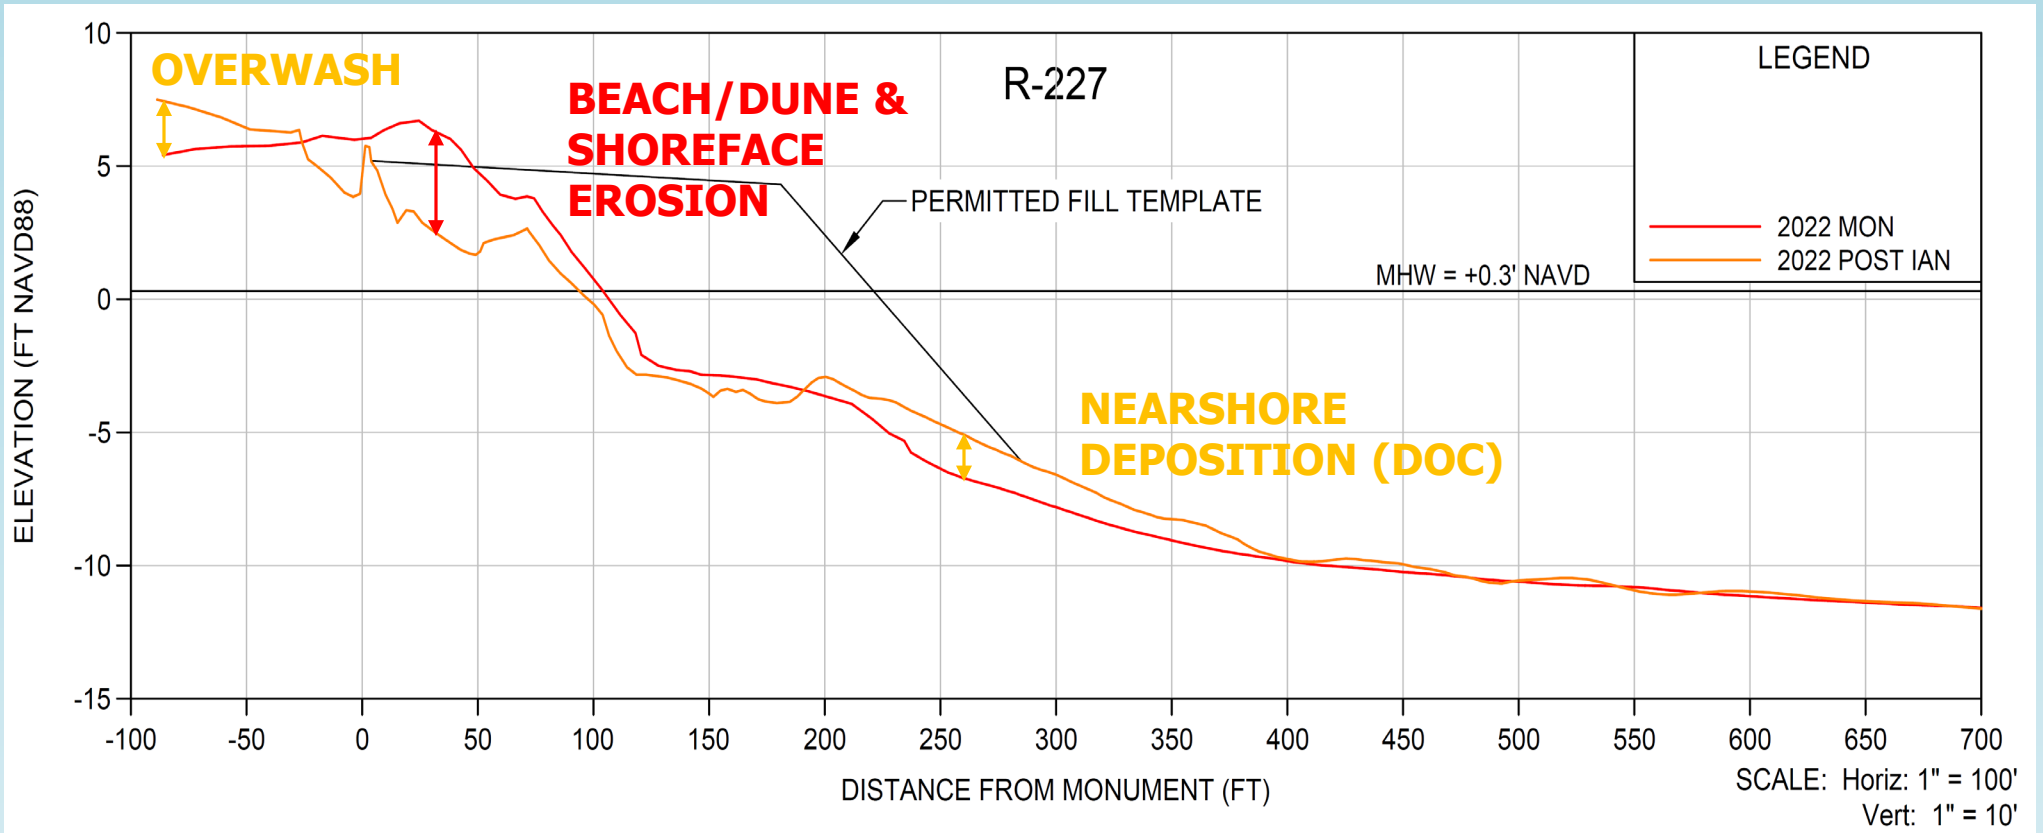
Bonita Beach

SEGMENT	DESCRIPTION *	EROSION (CY)	DENSITY (CY/LF)
North	Managed-Cat G	9,810	-2.5
North	Managed-Template	37,720	-9.6
South	Natural	70,900	-7.4

* Category G calculation to depth of closure (with background erosion)
 Template calculation within permitted template (with pro-rata background erosion)
 Natural beach calculation to MHW (with background erosion [net accretion])

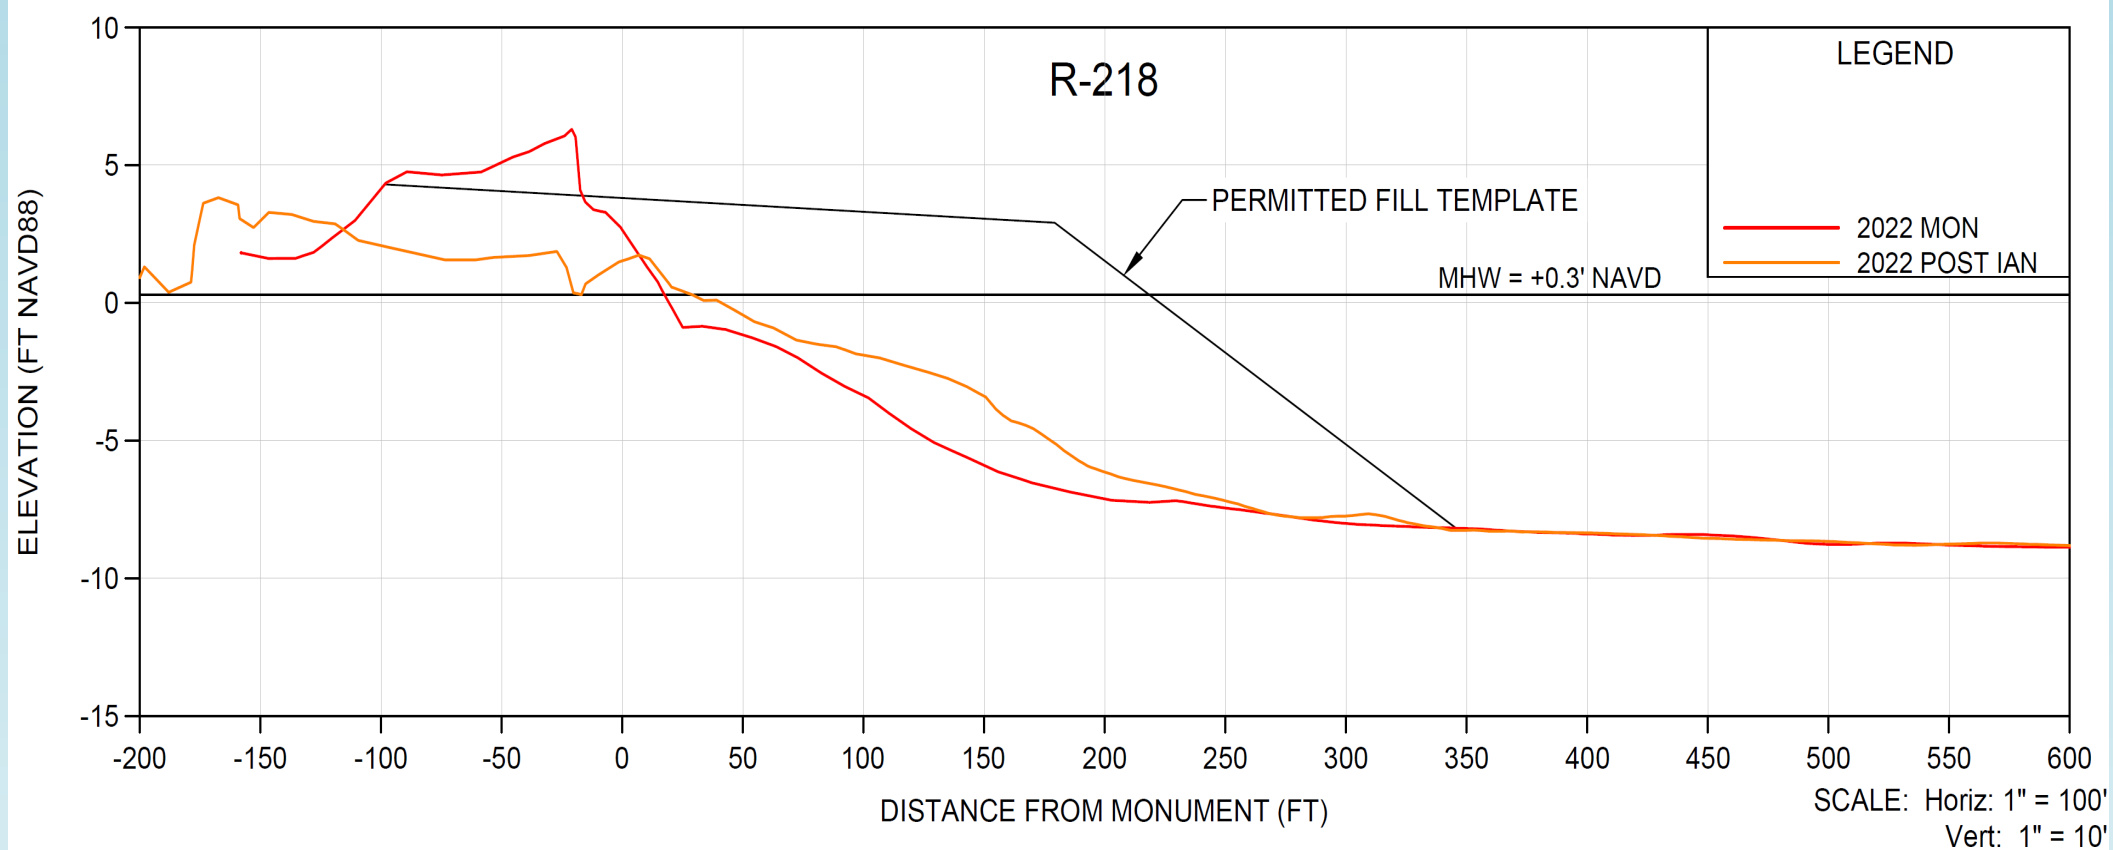
Lovers Key

SEGMENT	DESCRIPTION *	EROSION (CY)	DENSITY (CY/LF)
Fill Limits	Managed-Cat G	27,540	-4.2
Breach		15,240	
Total		42,780	-6.6

* Category G calculation to depth of closure (with background erosion)

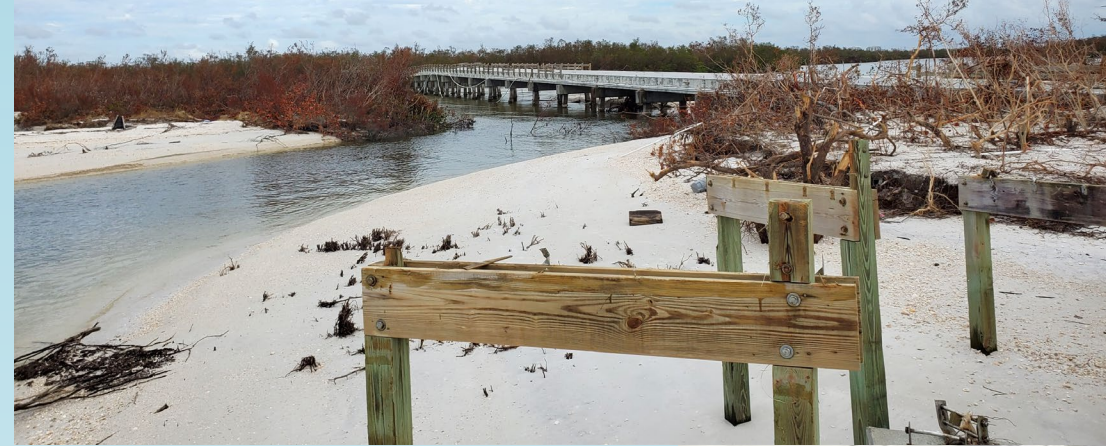
FROM NOAA, DATED OCTOBER 2022

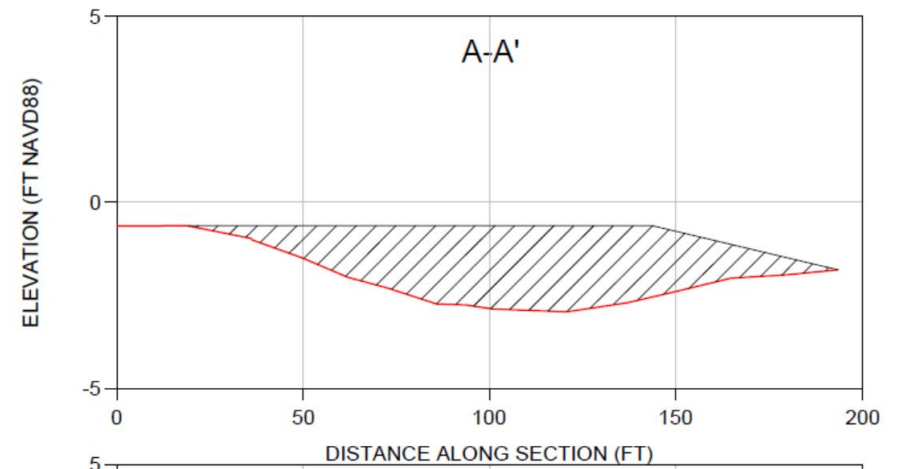
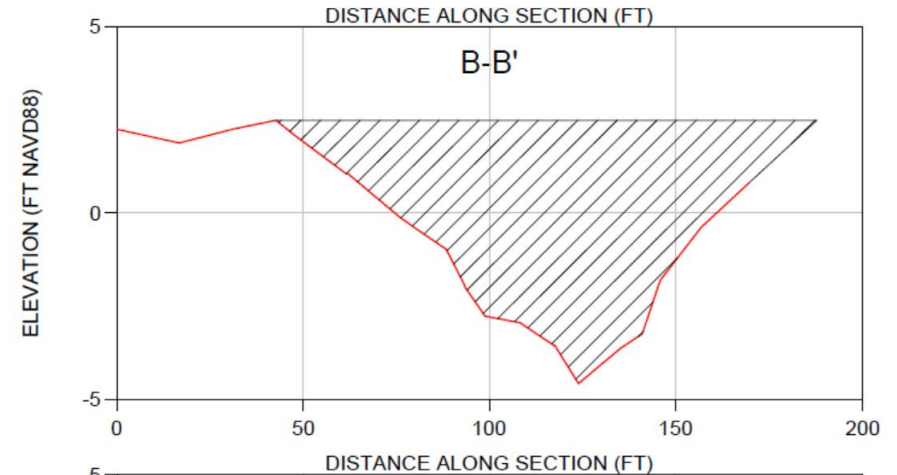
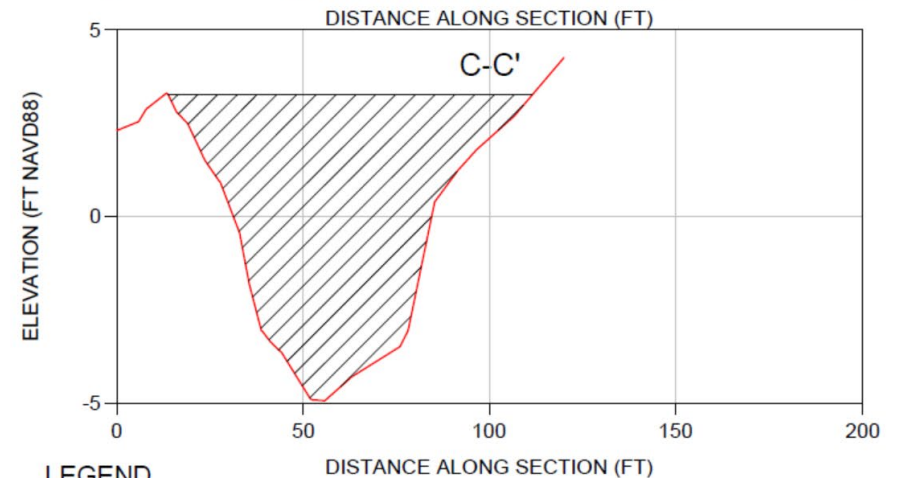
Category G Assessment

- OCT. 12, 2022 SURVEY
- PROPOSED FILL

SCALE: Horiz: 1" = 50'
Vert: 1" = 5'

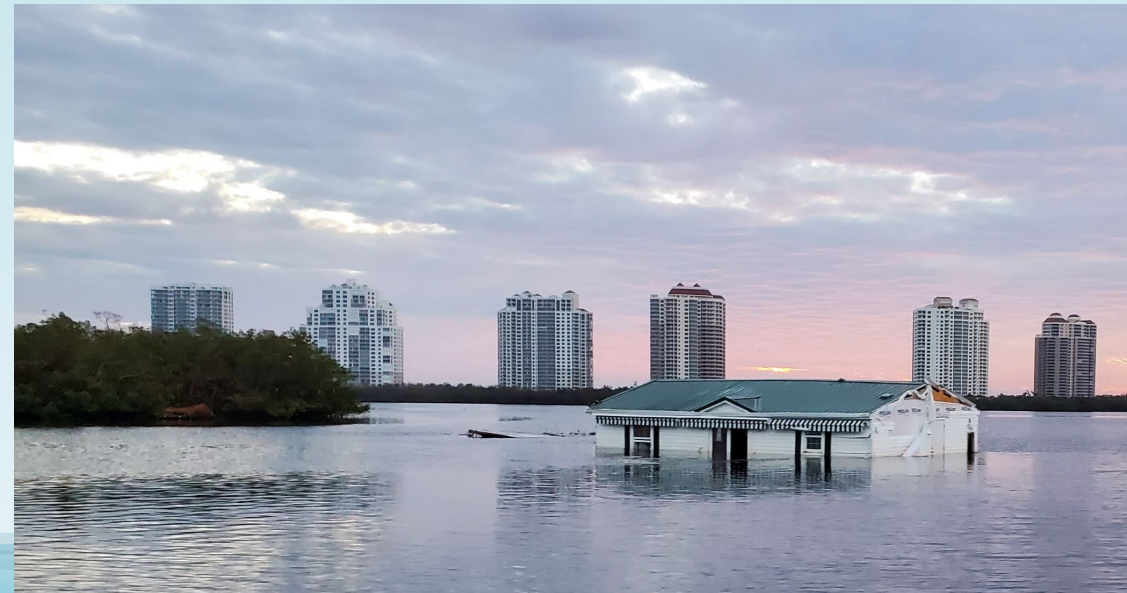
Hurricanes Ian, Nicole & Idalia Combined Impacts

- Erosion Losses
 - 52,600 CY – Category G Claim
 - 40,000 CY – State of Florida Hurricanes Ian & Nicole Recovery Plan (Losses within Dune and Dry Beach in addition to Cat G claim)
 - Nicole & Idalia Volumes Losses Unquantified
- Damages to Park Infrastructure
 - Pavilions, Restroom, Boardwalks
 - Tram/Pedestrian Bridge (condemned)
 - Lost Direct Construction Access

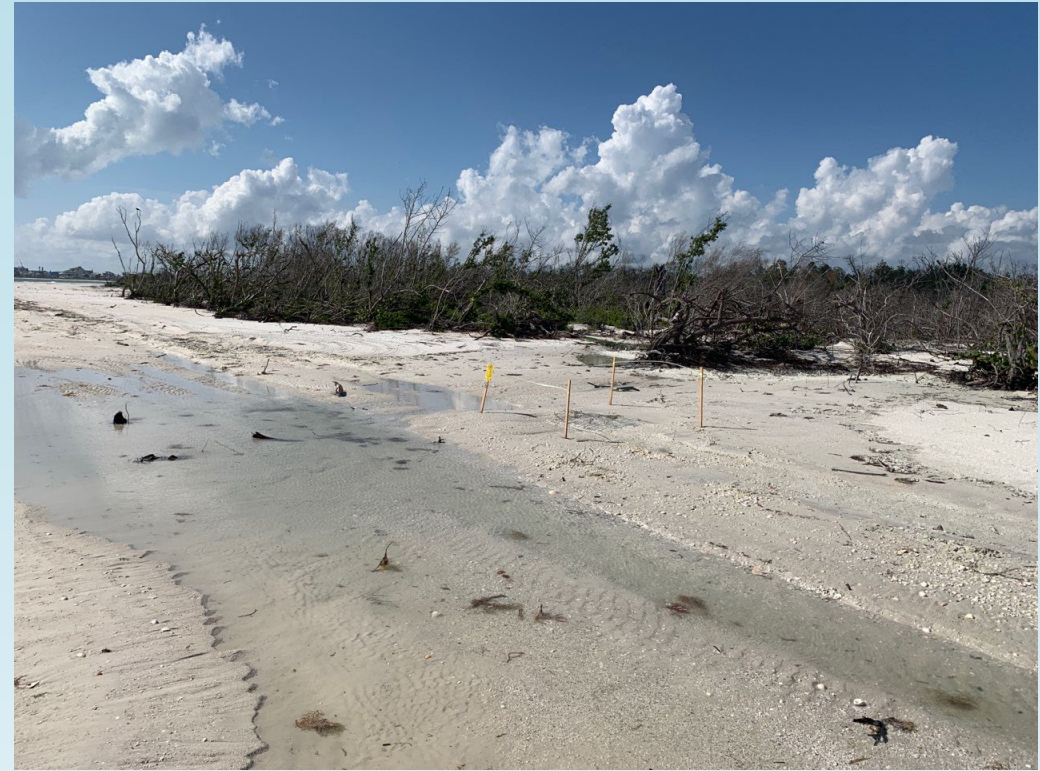
Hurricanes Ian, Nicole & Idalia Combined Impacts

- Lovers Key Natural Resource Habitats
 - 37 Sea Turtle Nests (2023)
 - 105 False Crawls
 - 16 Nests Complete Washout
 - 12 Nests Washed Over
 - Lowering of Profile – Inundations
 - 0% Hatch Success ~ Project Limits
 - 25% Hatch Success ~ Adjacent Beaches
- South Bonita Beach
 - 70,000 CY of Erosion Loss
 - Wiped out Dunes
 - Major Scouring / Property Damage

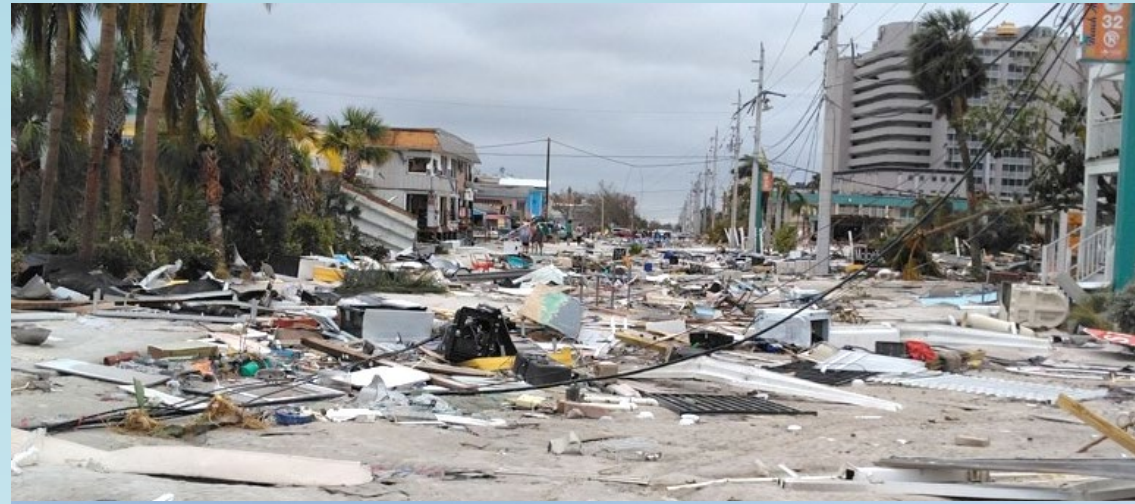
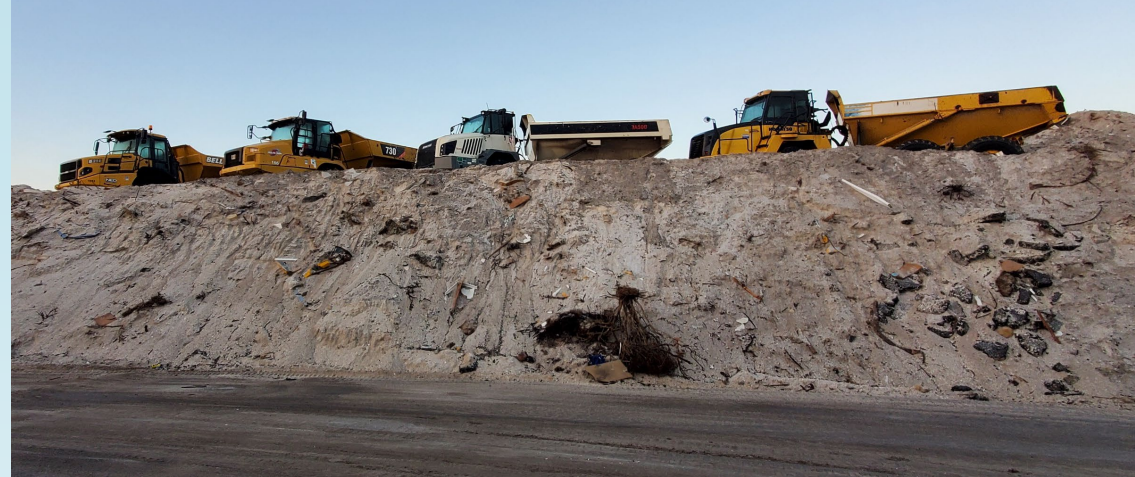
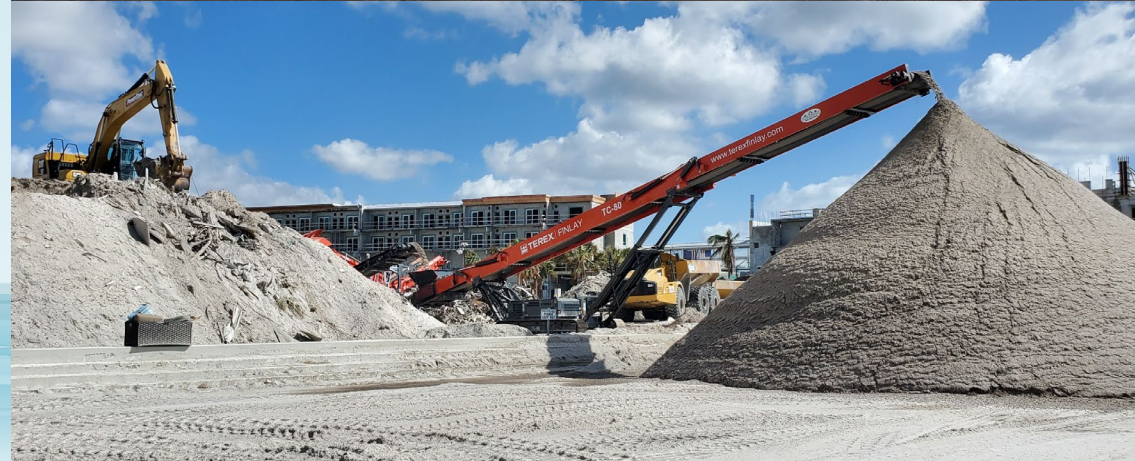
BONITA BEACH – NORTH

- Erosion Losses to Dry Beach ~ 38K CY
- County Aggressively Pursued Recovering, Screening, and Returning Sand to Bonita-North
 - Easements
 - ECL

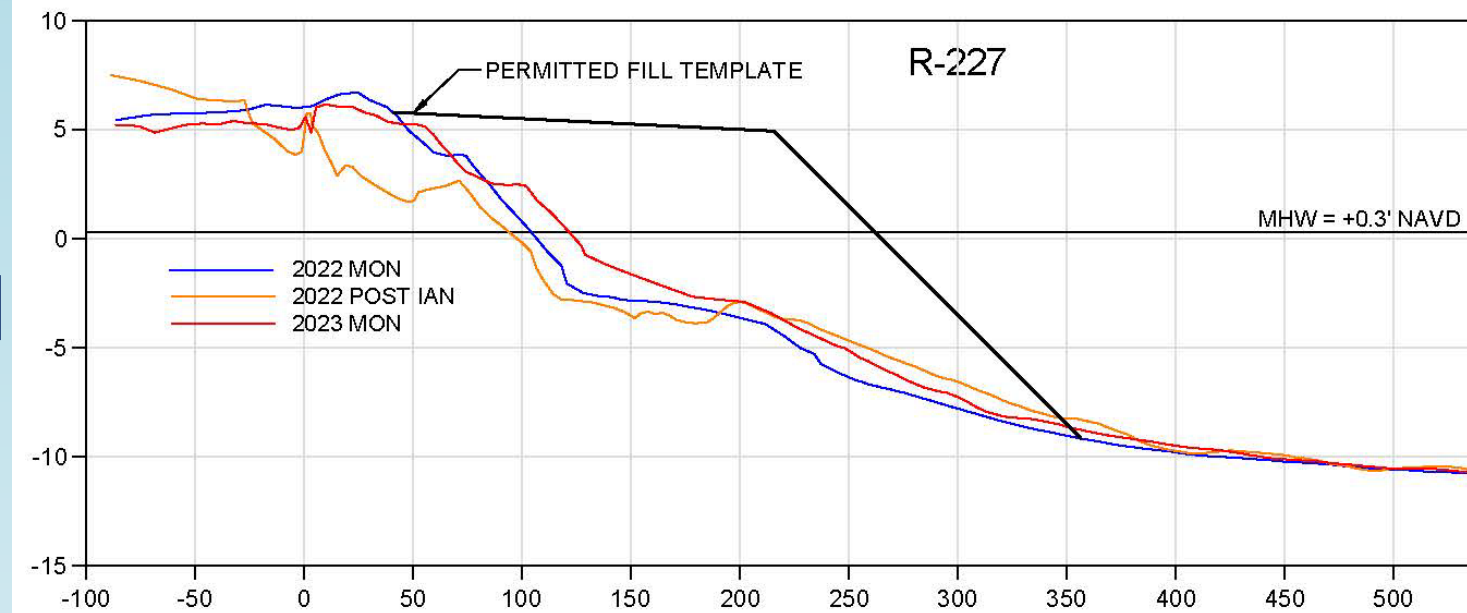
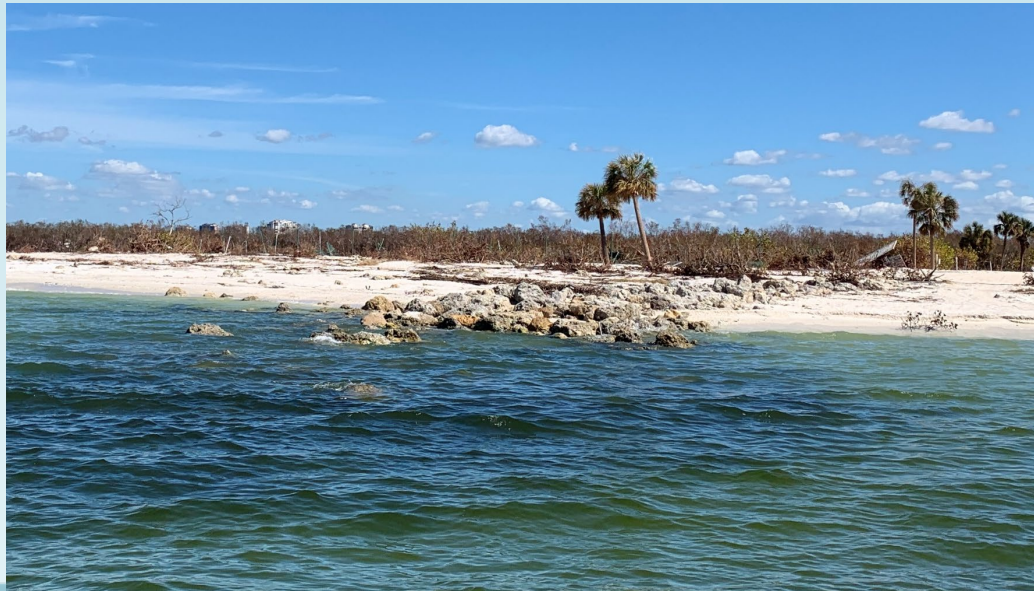
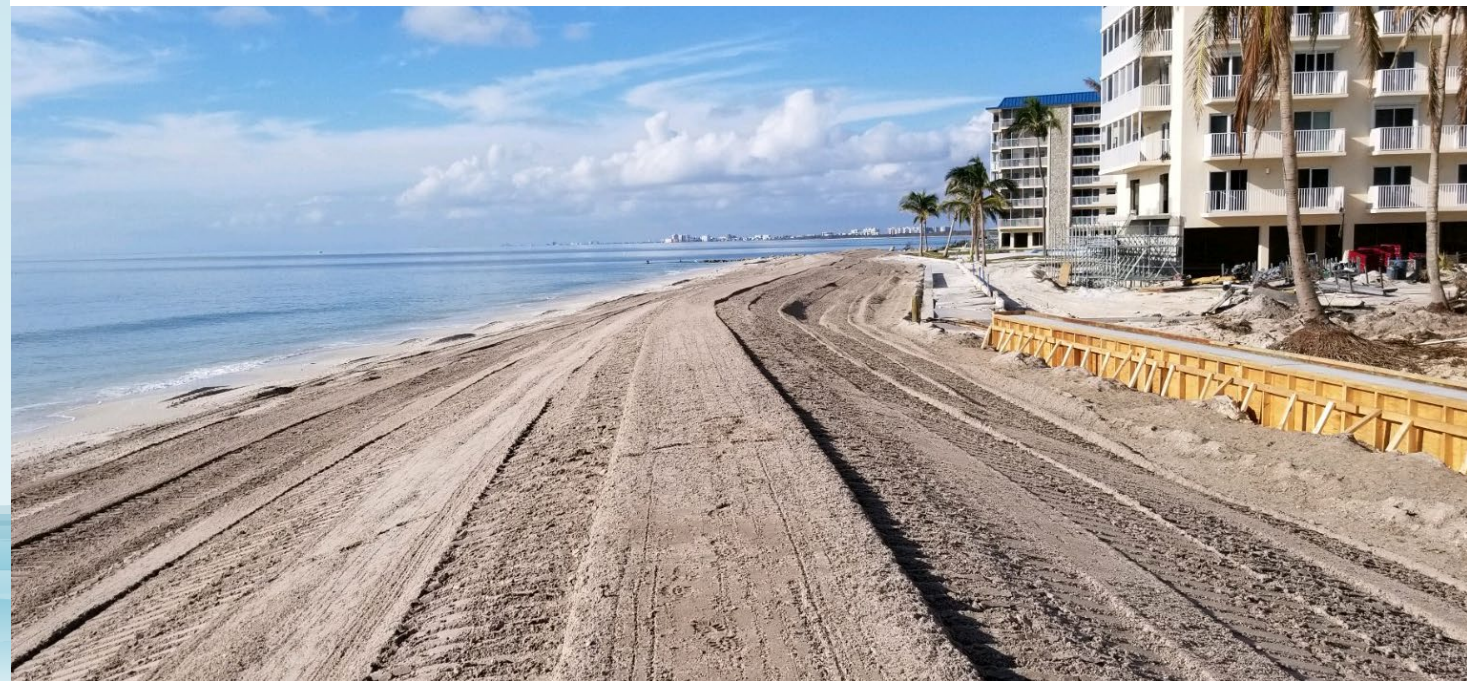
BONITA BEACH – NORTH

- Sand Recovery Efforts Offset Majority of Impact
- Terminal Groins Damaged

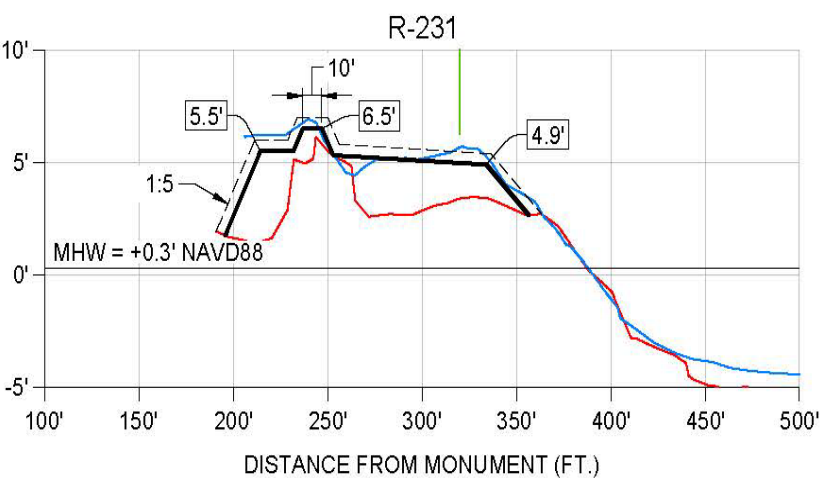
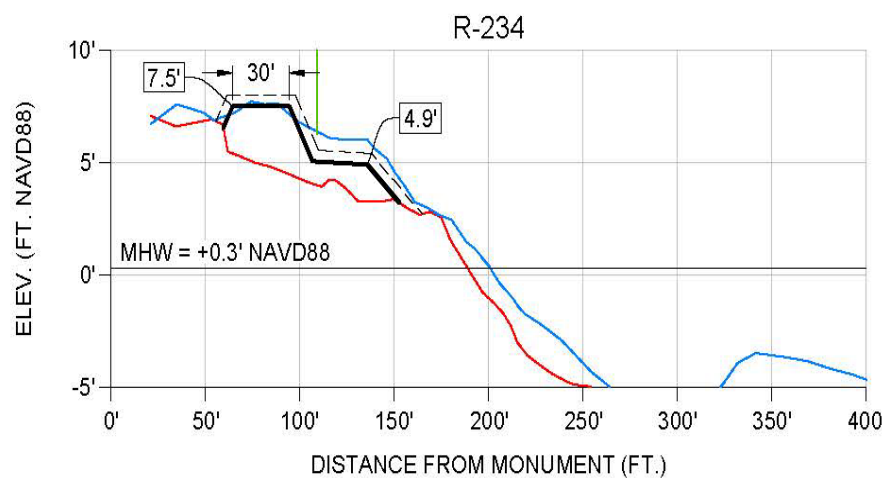
BONITA BEACH – SOUTH

- Historically Stable Beach
- ~ 71K CY of Dry Beach / Dune Loss (State Recovery Plan)
- Partner with County to Address Impacts Concurrent with BB-N

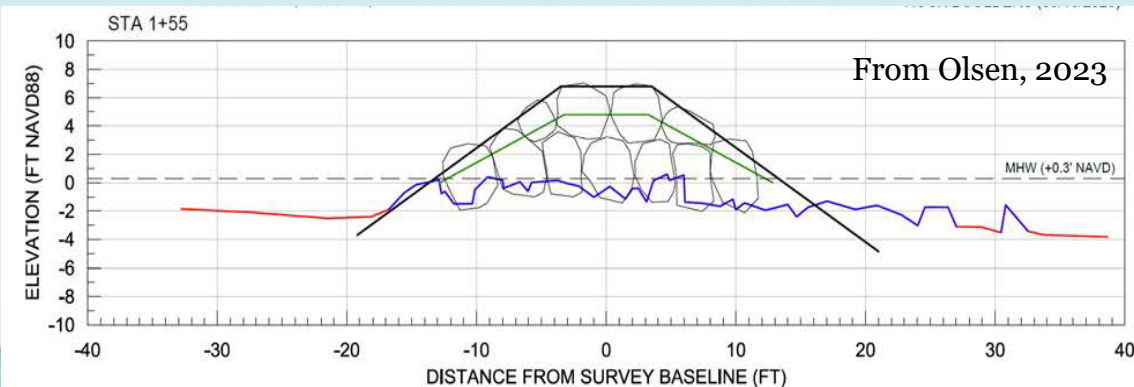
Figure 19: Representative cross-sections of the **South Groin** with May 2023 existing grade and rock boulders (red and blue line, respectively), recommended modification (black line) and 1994 groin plan (green line).

- Assessment & Recommendations for Bonita Beach Groin Repair (Kevin Bodge, Olsen Associates, 2023)
 - Repair groins and increase resiliency and their functionality
 - Improve structures' stability (storm durability) and keep up with SLR
 - 2-ft increase in elevation (50-yr horizon)
 - Extend seaward length ~ 18-20 ft
 - Increase armor stone size to 3-4 ft
