Restoring Littoral Drift Along a Jettied Shoreline

Jenna Kooker, EIT

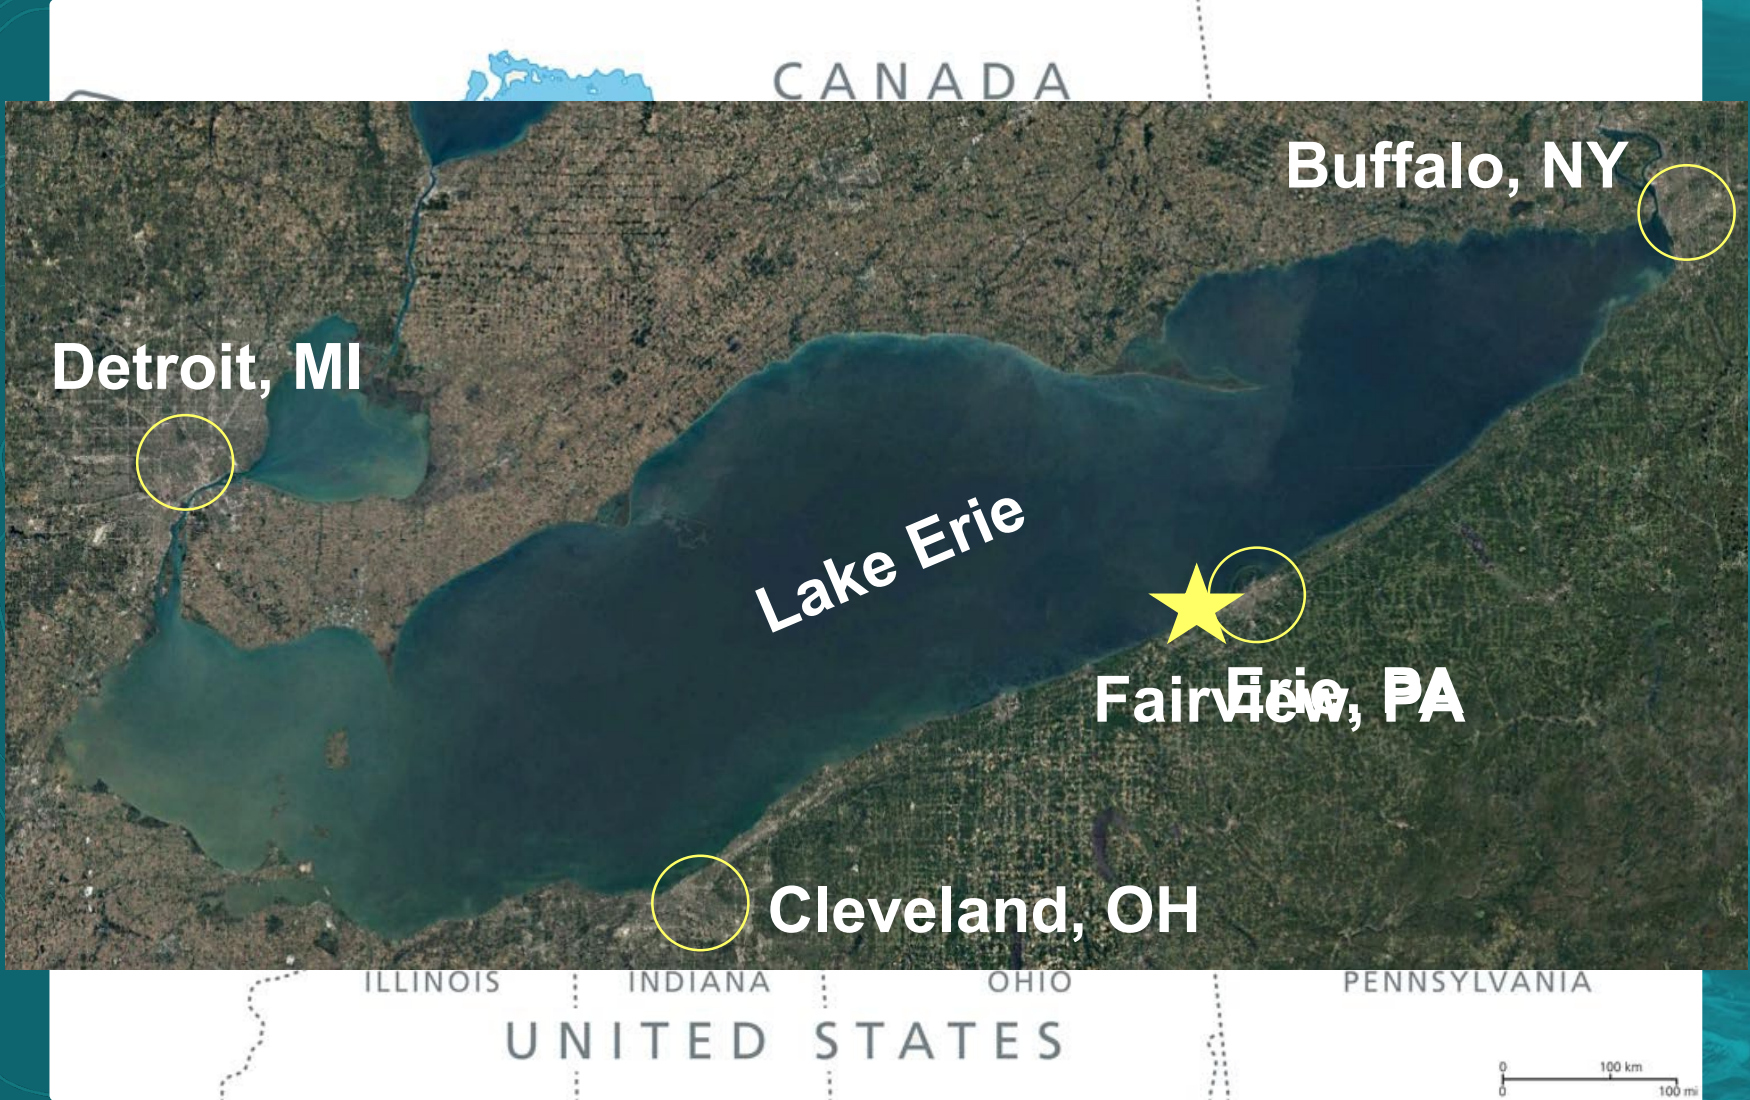
Existing Conditions – Where Are We?

Walnut Creek Access Area

- Public Boat Launch
- 72-Slip Marina
- Public Beach
- Popular Fishing Spot
- Jetties at Creek Mouth
- Groins Along Beach

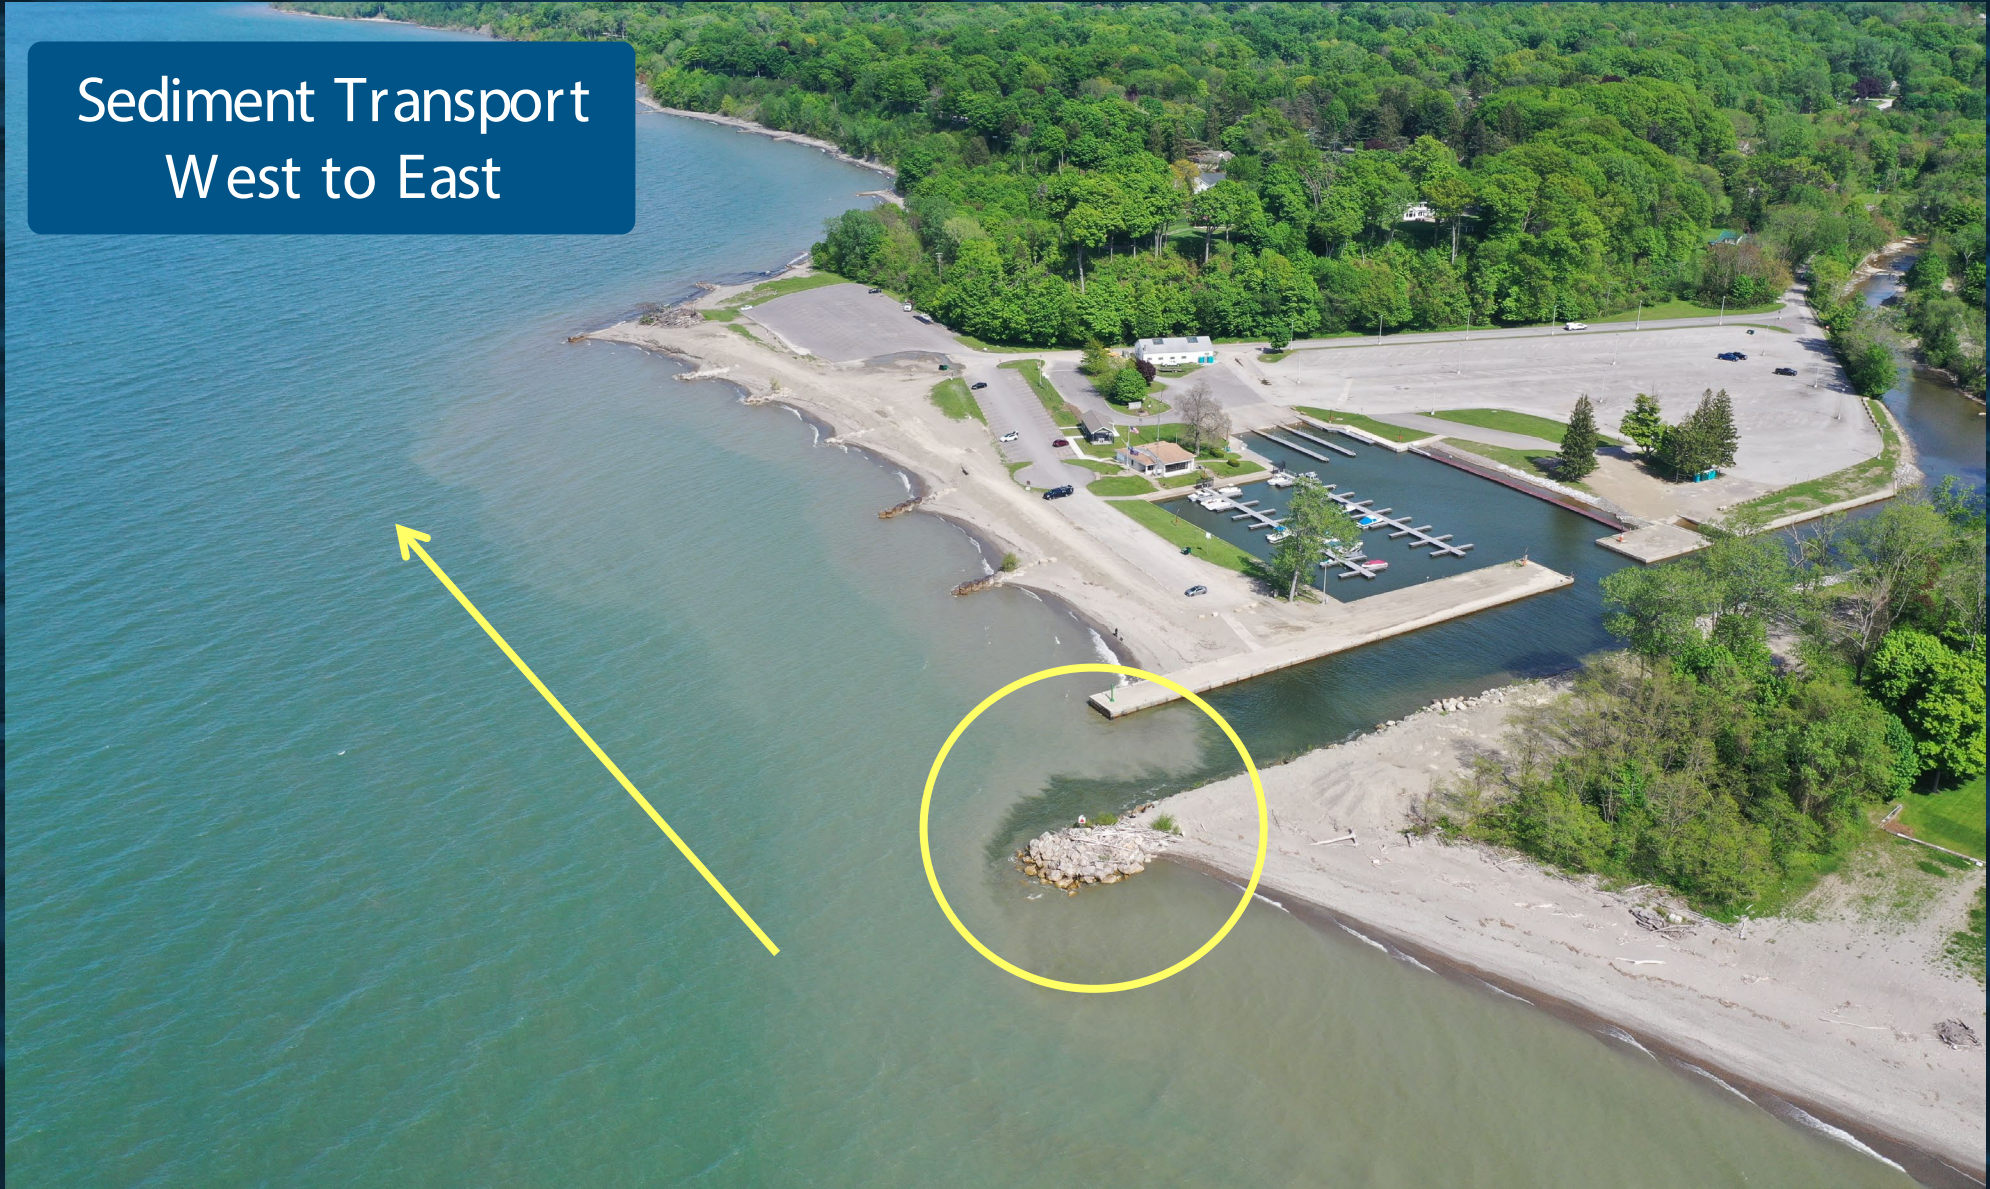
Sediment Transport
West to East

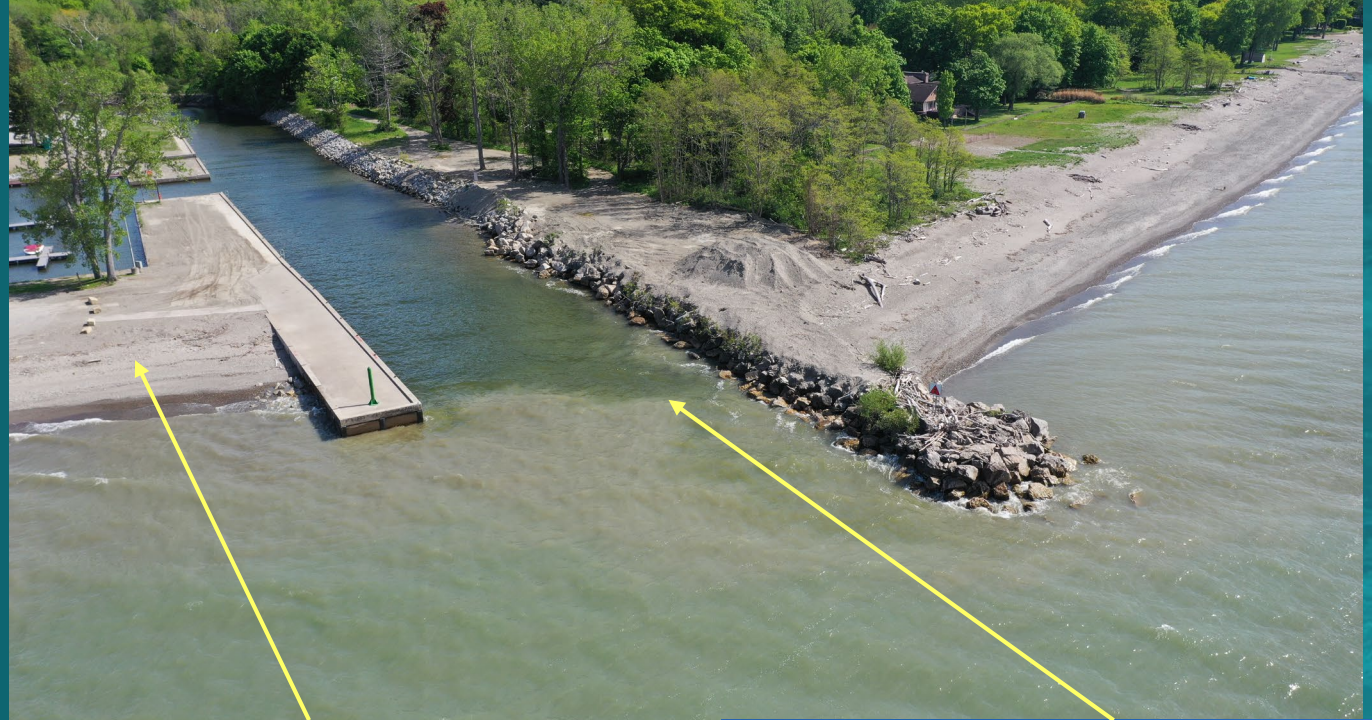
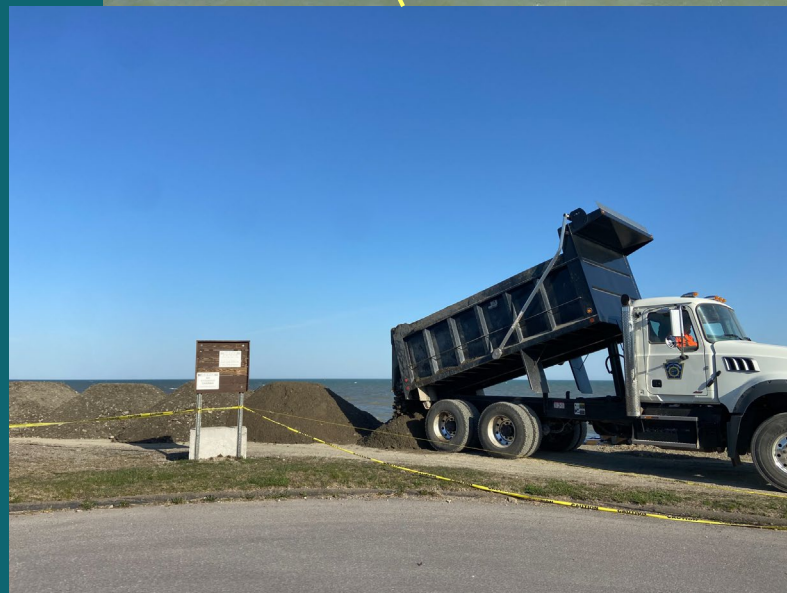
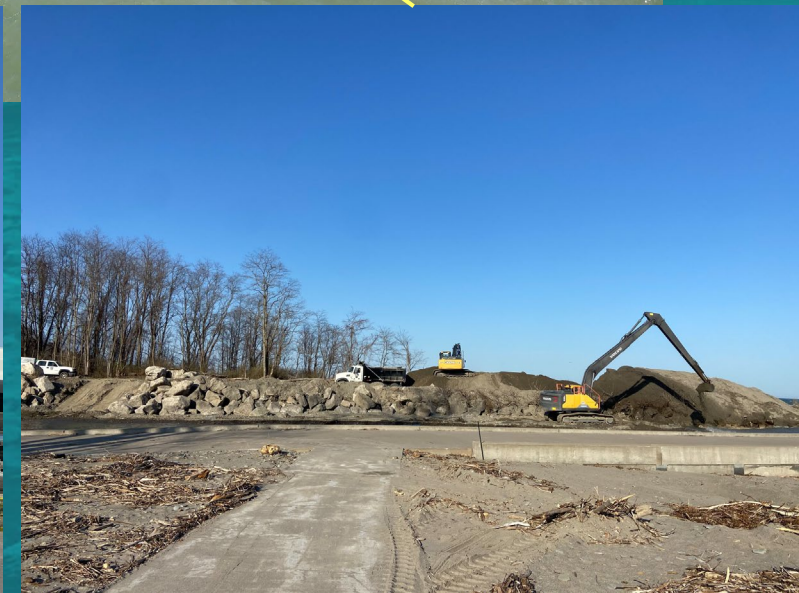
- Severe sedimentation in creek mouth and marina basin
- Frequent dredging required to manually bypass sediment

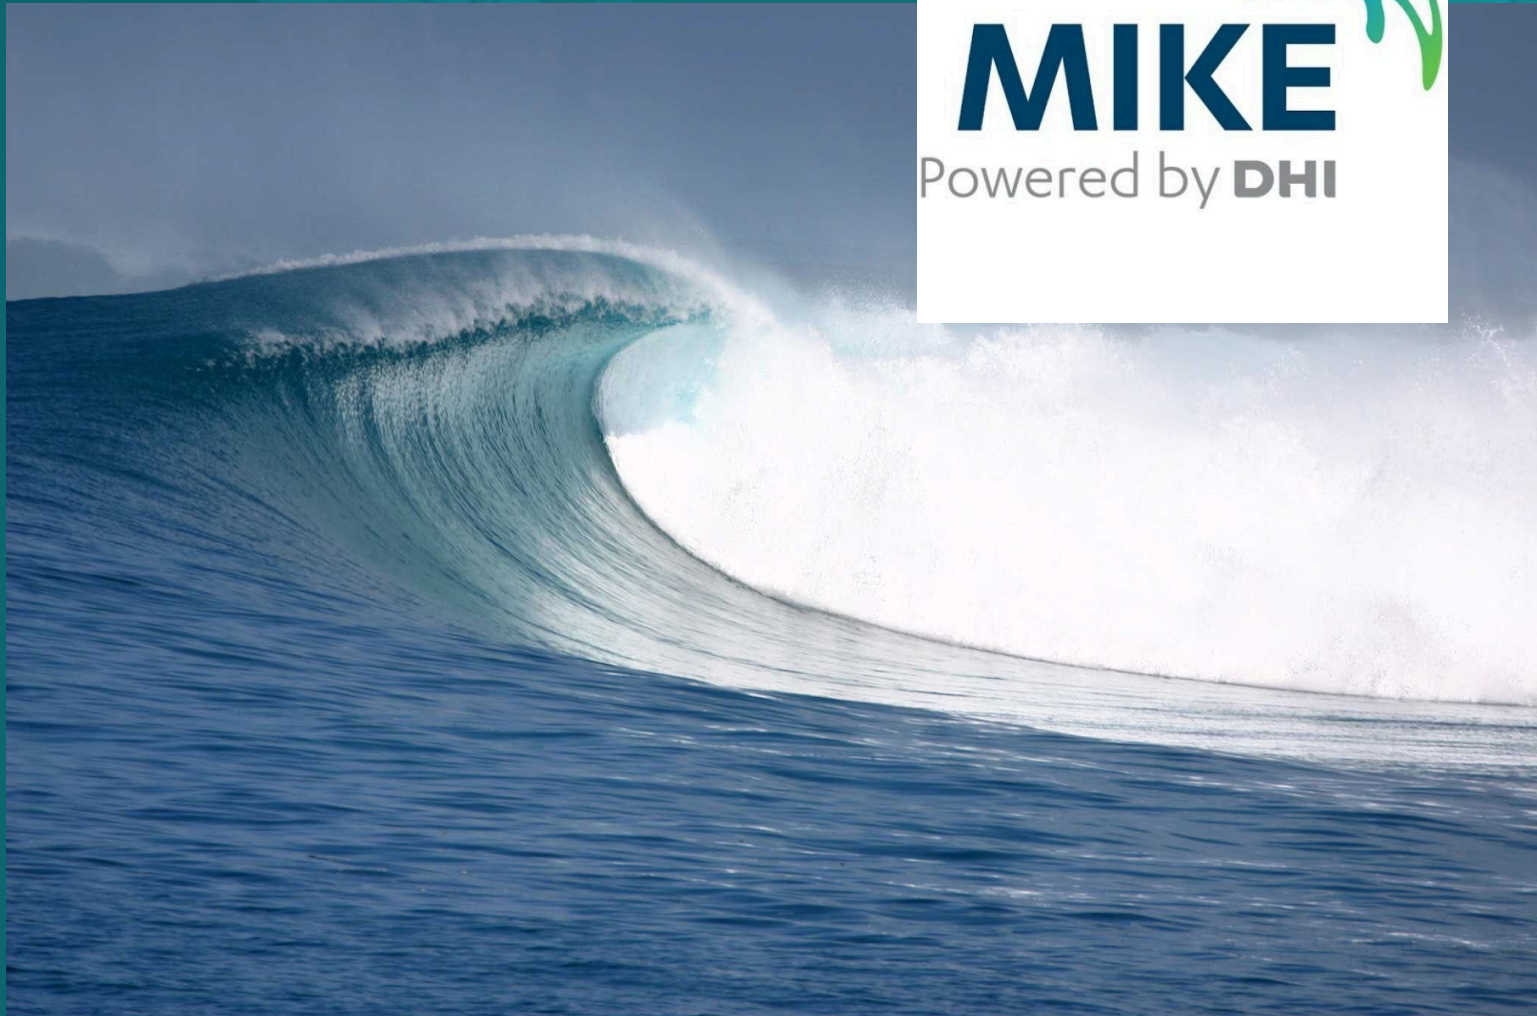
MIKE 21 Domain

- MIKE 21 Modeling Software
 - Spectral Wave Module
 - Hydrodynamic Module
 - Sediment Transport Module

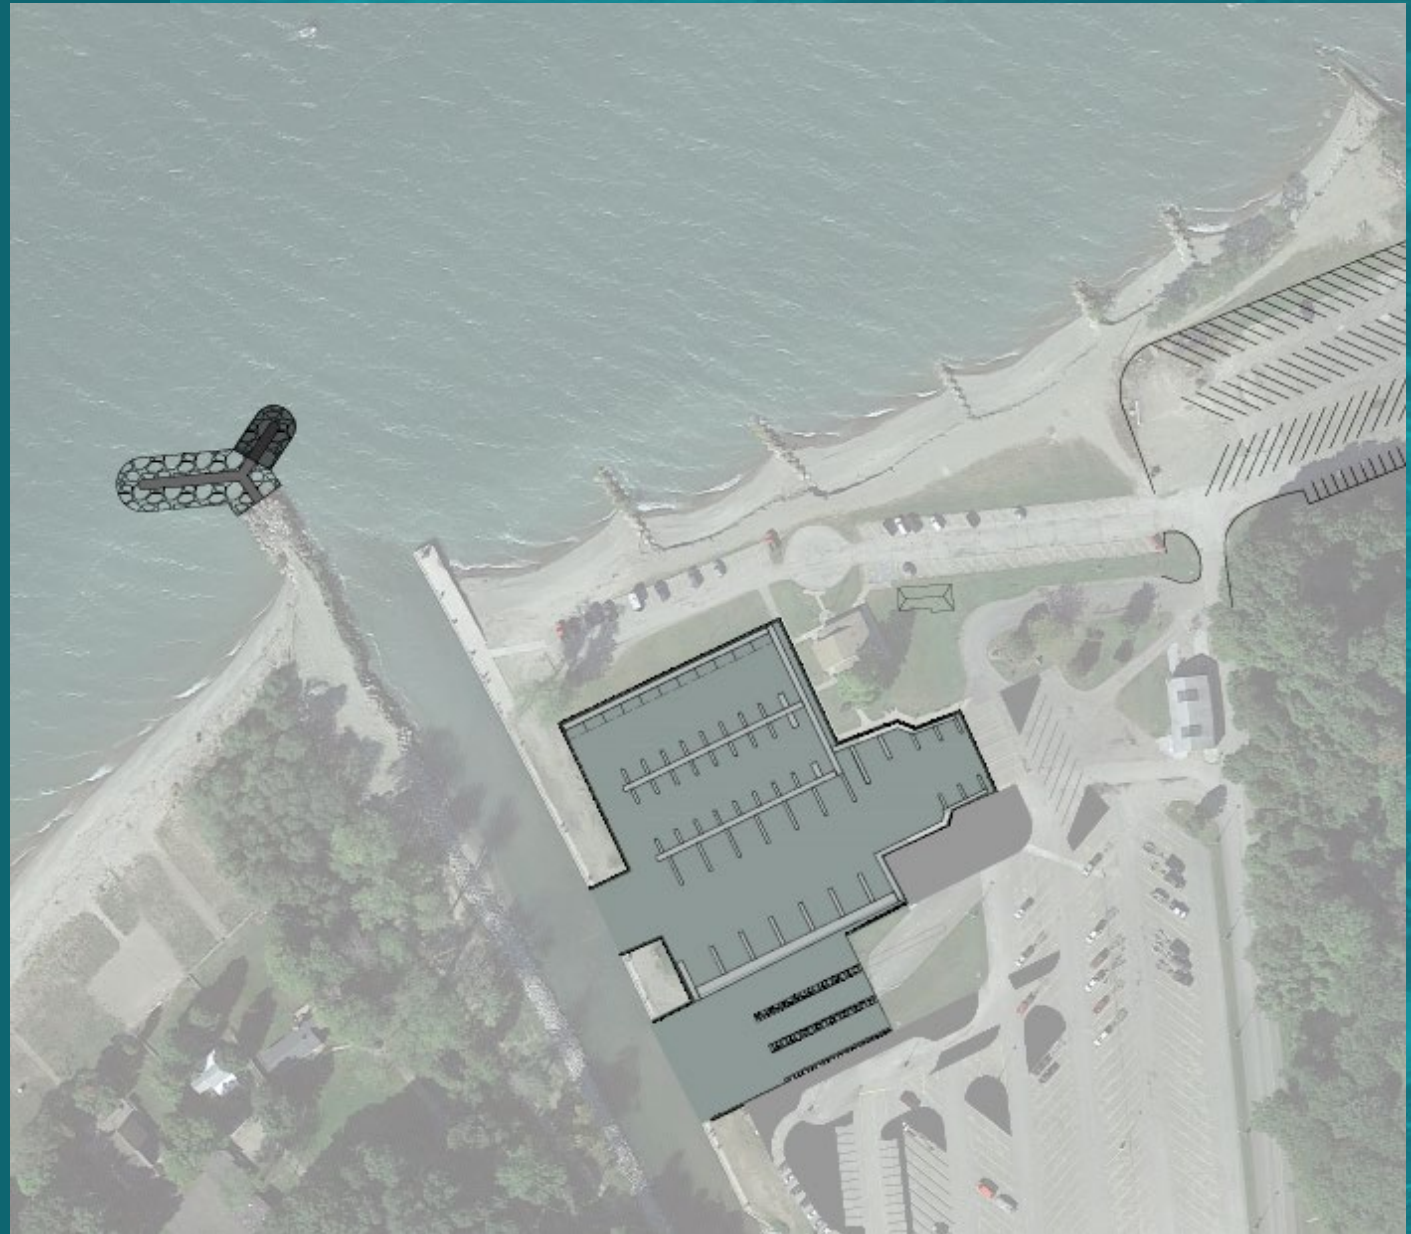
- Sediment diversion from channel minimizes frequency of dredging
- Optional dogleg spur
- Further analysis would include additional wind directions and water levels
