POST-STORM ASSESSMENT METRICS FROM ANNA MARIA ISLAND

Thomas P. Pierro, P.E., D.CE, Principal Engineer, Coastal Protection Engineering (CPE)

37th Annual National Conference on Beach Preservation Technology February 2024, St. Augustine Beach, Florida

HURRICANE IDALIA POST-STORM ASSESSMENT

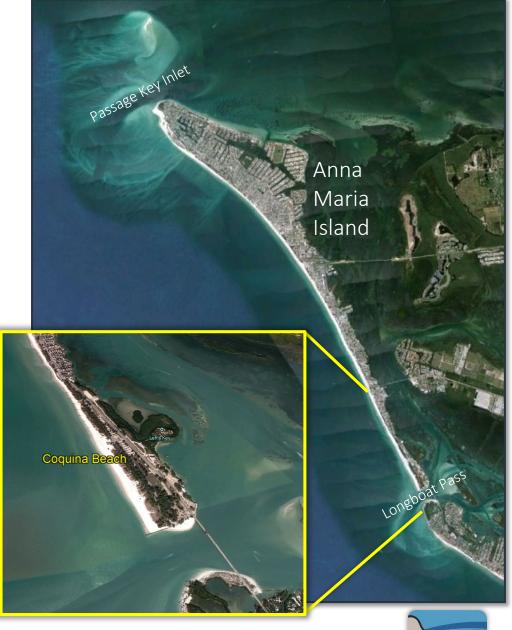
- Manatee County, Florida
- 7-mile-long barrier island
- Passage Key Inlet to north
- Longboat Pass to the south
- 6.8 million cubic yards placed since 1992
- Coquina Beach:
 - Southern mile of island (erosional hotspot)
 - Public beach and recreation facility
 - Roadway and critical evacuation route
 - County managed coastal program

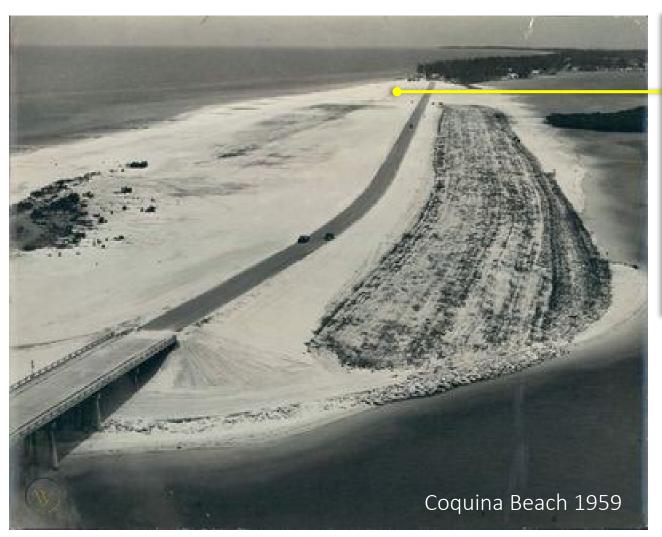
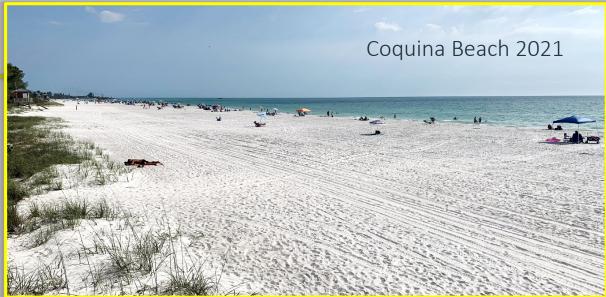
COQUINA BEACH HISTORY

- Island only accessible by boat until 1921
- Man-made extension of Anna Maria Island
- Stabilized by groins to protect road in 1959
- Recreational area and wildlife habitat

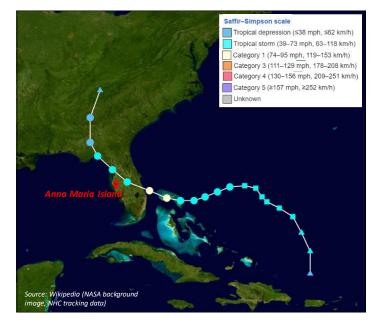
Hurricane Ian

- September/November 2022
- Federal disaster, DR-4673-FL
- Landfall in the Cayo Costa as Cat 4
- Major reverse surge (drawdown)
- Minor impacts from surge and waves
- FEMA approved Categories A-G

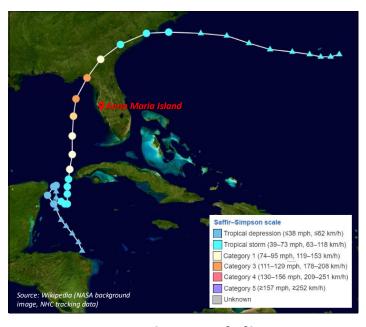
Hurricane Nicole

- November 2022
- Federal disaster, DR-4680-FL
- Two landfalls as Cat 1 and T.S.
- Minor surge event
- Indirect impacts from surge and waves
- FEMA approved Category B only

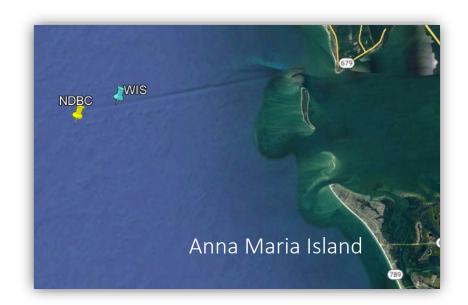
RETURN INTERVAL

- Water levels and return period from NOAA station at St. Petersburg, FL
- Wave return period analysis based on WIS hindcast (1980-2022)
- Wave data measured during the storms from NDBC buoy

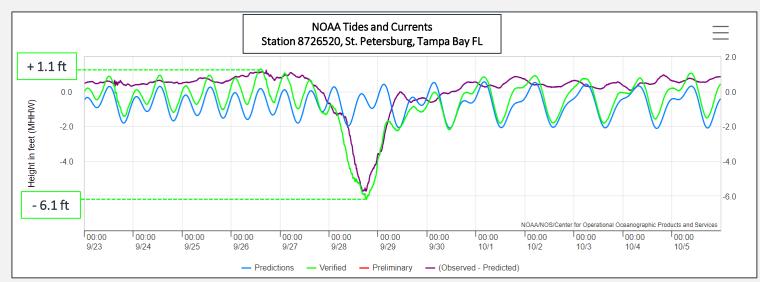
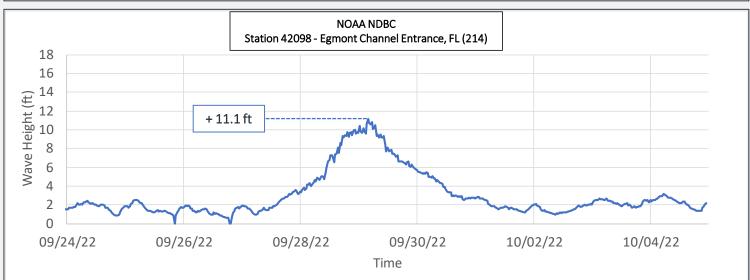
HURRICANE IAN (2022)

Water Levels:

- -5.8 ft surge (drawdown)
- +1.1 ft MHHW (+0.3 m)
- 1-year return interval

Waves:

- 11.1 ft peak (3.4 m)
- 5-year return interval

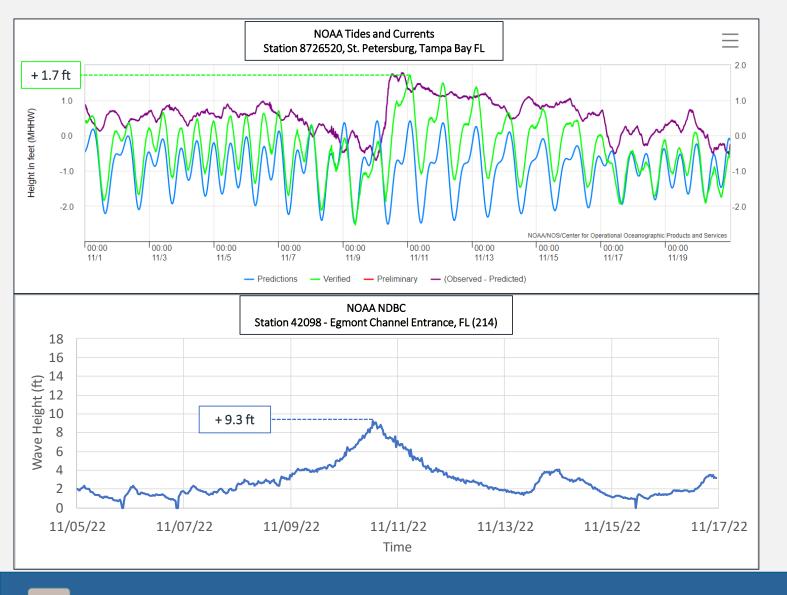
HURRICANE NICOLE (2022)

- Water Levels:
 - +1.8 ft surge (peak)
 - +1.7 ft MHHW (+0.5 m)
 - 2-year return interval

- Waves:
 - 9.3 ft peak (2.8 m)
 - < 1-year return interval</p>

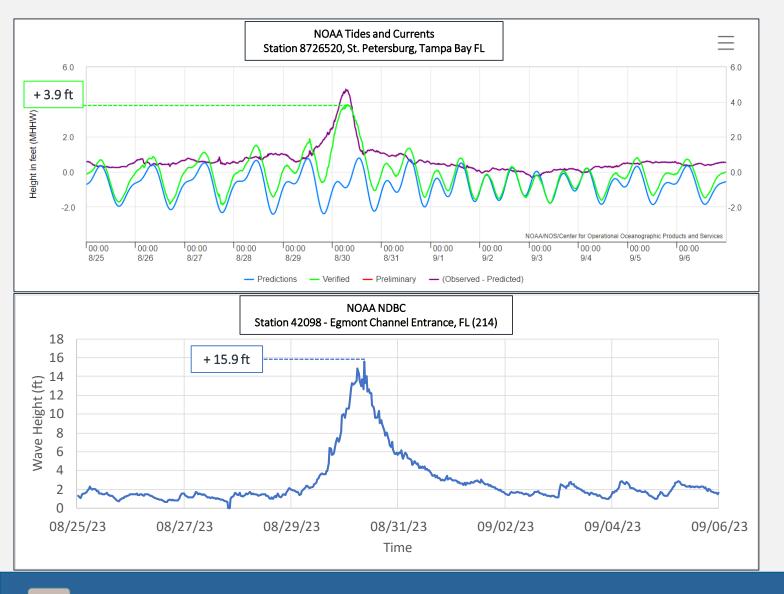
HURRICANE IDALIA (2023)

- Water Levels:
 - +4.7 ft surge (peak)
 - +3.9 ft MHHW (+1.2 m)
 - 40-year return interval

- Waves:
 - 15.9 ft peak (4.8 m)
 - >100-year return interval

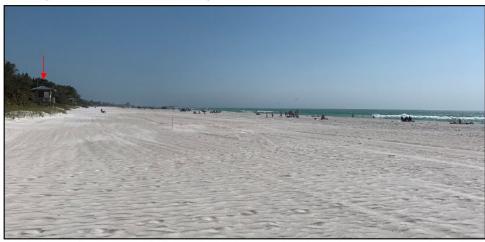
R-35.6 (Southernmost Cortez Groin)

March 25, 2021 (Post-Construction)

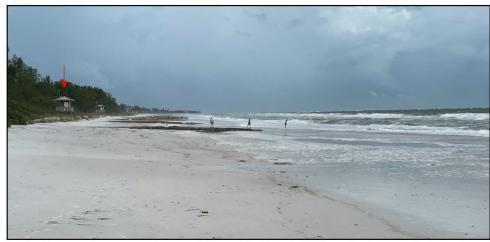
August 31, 2023 (Post-Idalia)

- -91,200 cy Pre (Dec 2022) to Post (Oct 2023)
- +16,400 cy background erosion
- -74,800 cy storm-induced change (to DOC)
- Cost Estimate \$4.5M (pending FEMA review)
