# Side-by-Side-by-Side Comparison of Beach Restoration, Dune Restoration, and Natural Beach Response

Summer Haven St Johns County, Florida

Michael Trudnak, P.E., Taylor Engineering Andrew Ames, P.E., St. Johns County

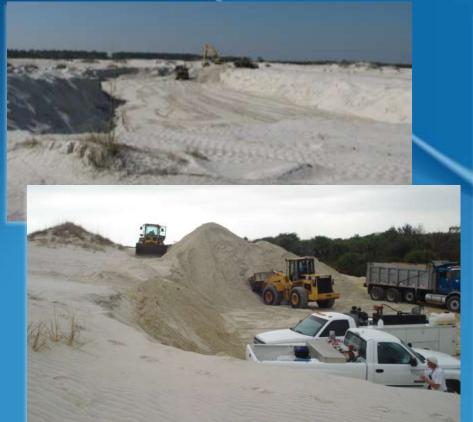
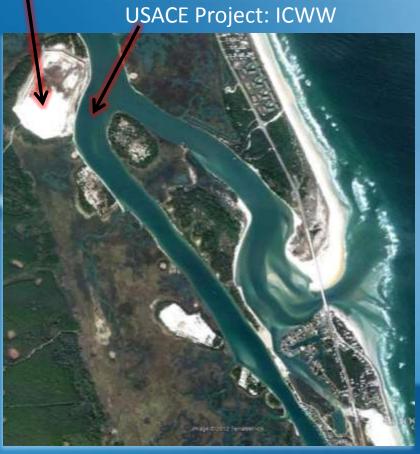
#### **Borrow Sites**

FEMA Project: FIND DMMA SJ-1

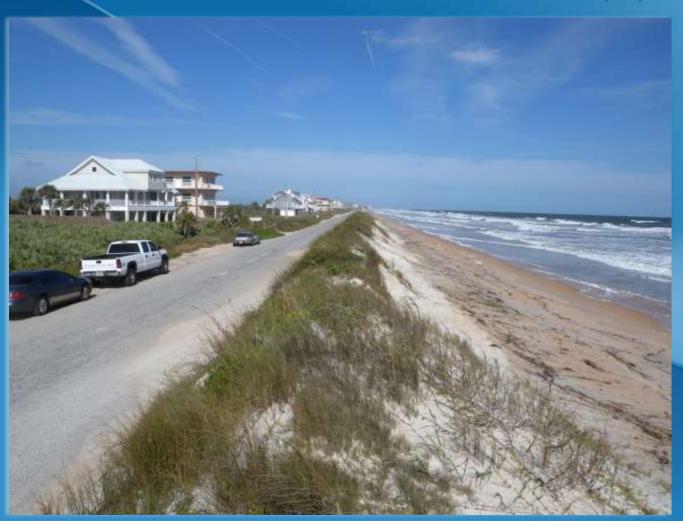
## Pre-construction Conditions Near R-208 – 11/5/09

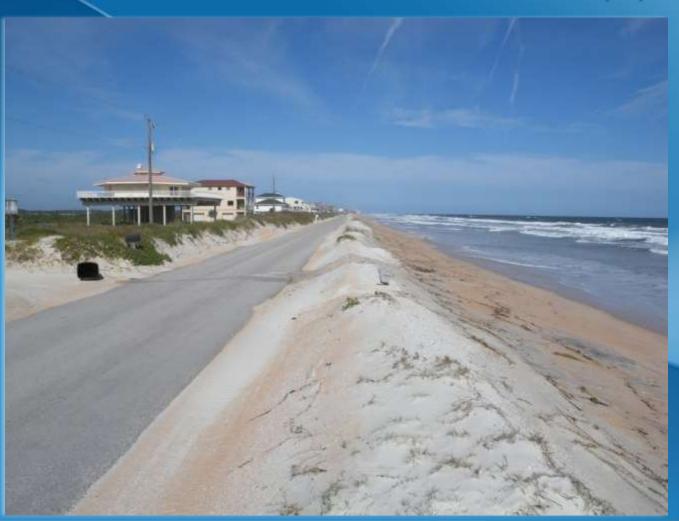
## Pre-construction Conditions Near R-207 – 11/5/09

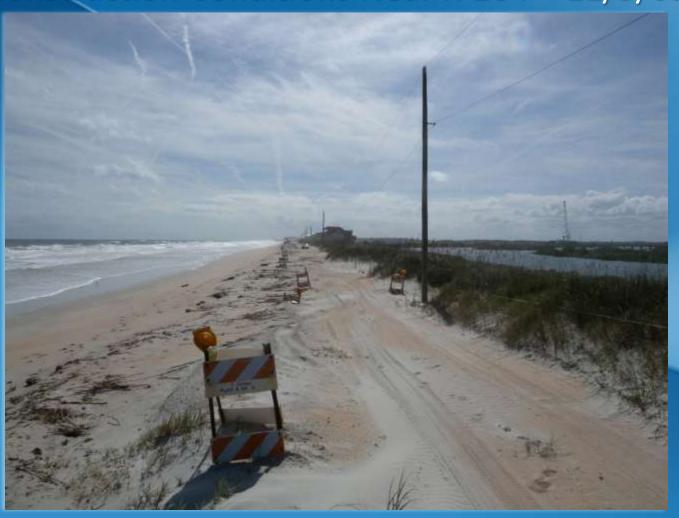
## Pre-construction Conditions Near R-204 – 11/5/09

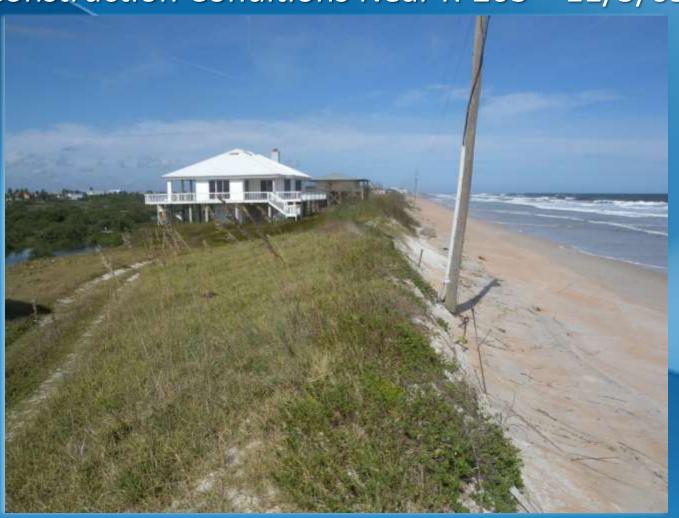
## Pre-construction Conditions Near R-203 – 11/5/09

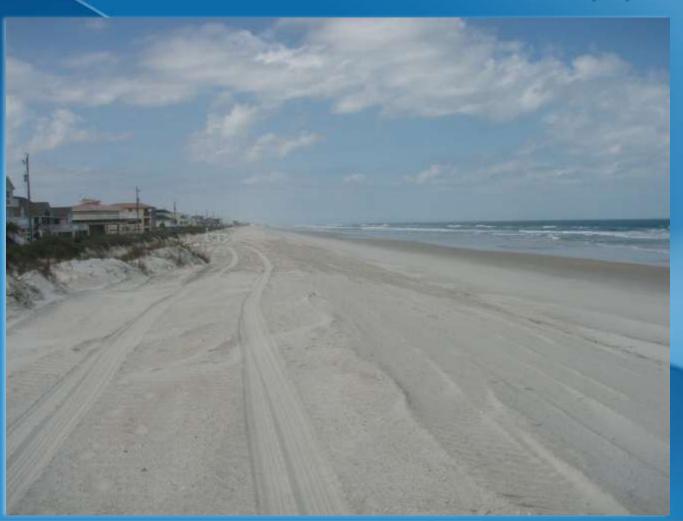
## Post-construction Conditions Near R-207 – 3/8/11

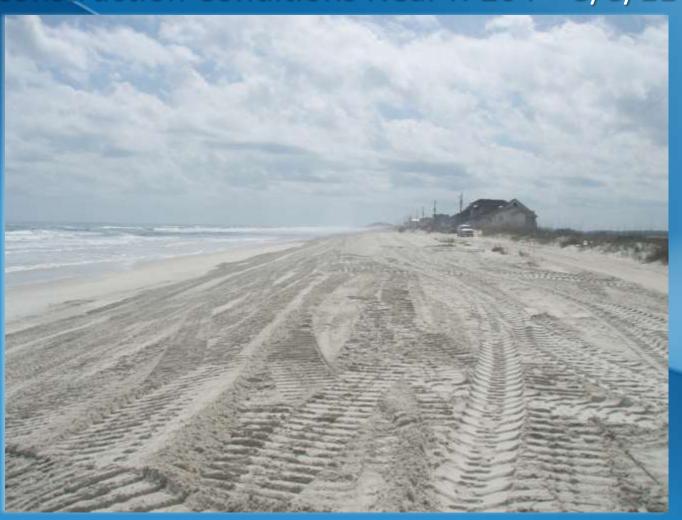
### Post-construction Conditions Near R-204 – 3/8/11

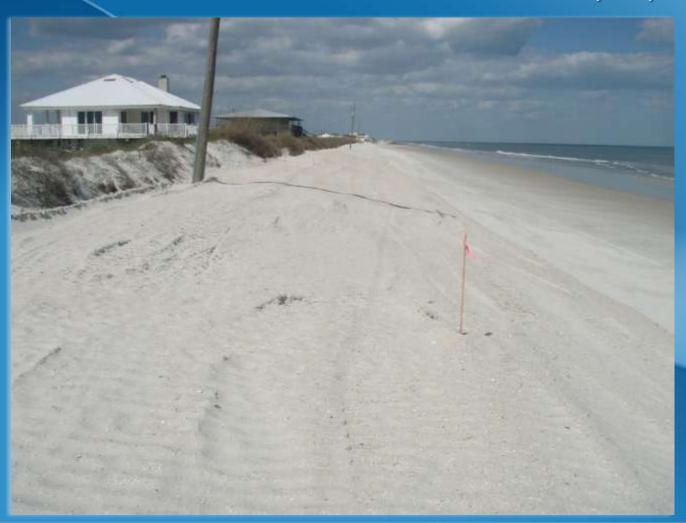
## Post-construction Conditions Near R-203 – 2/22/11

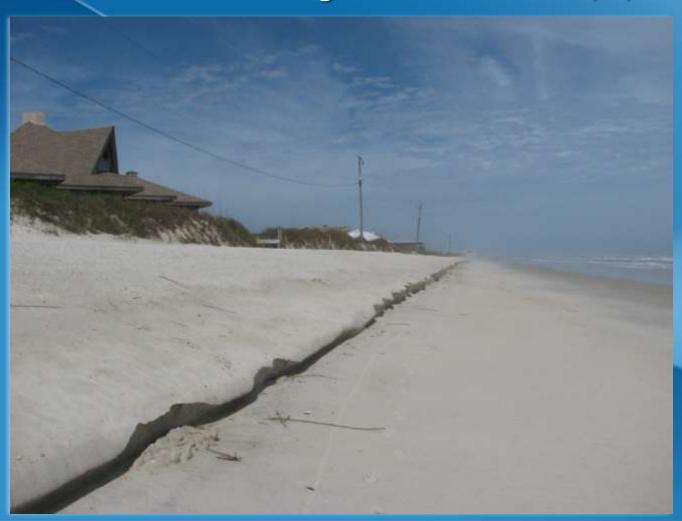
## Post Mini Nor'easter During Construction – 3/5/11

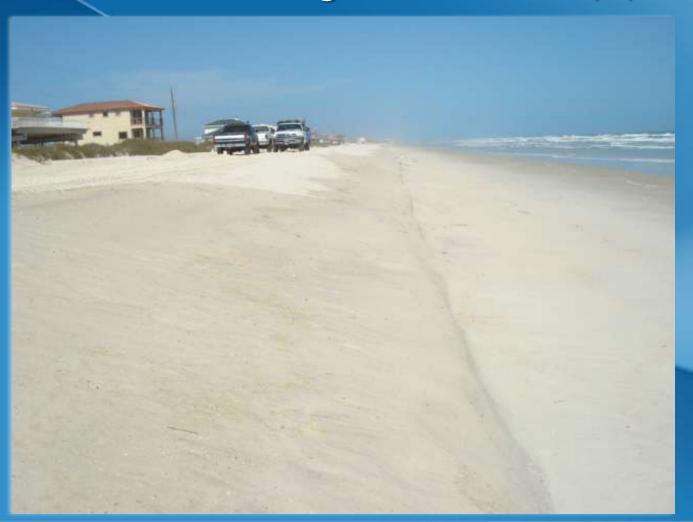
## Post Mini Nor'easter During Construction – 3/4/11

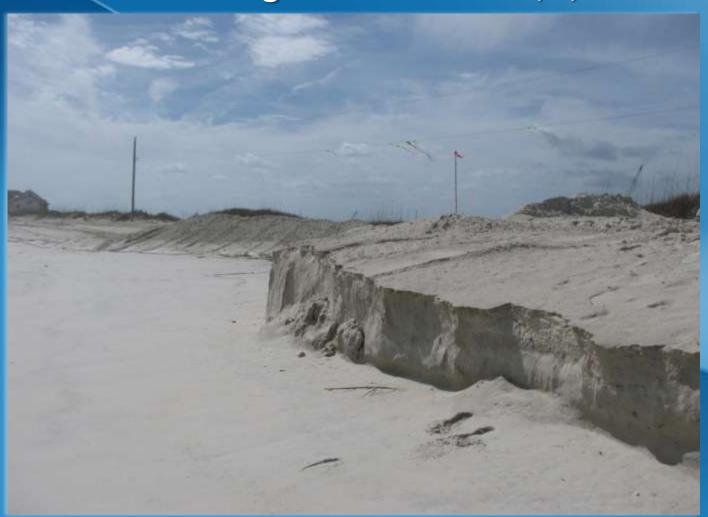
## Mini Nor'easter During Construction – 3/5/11

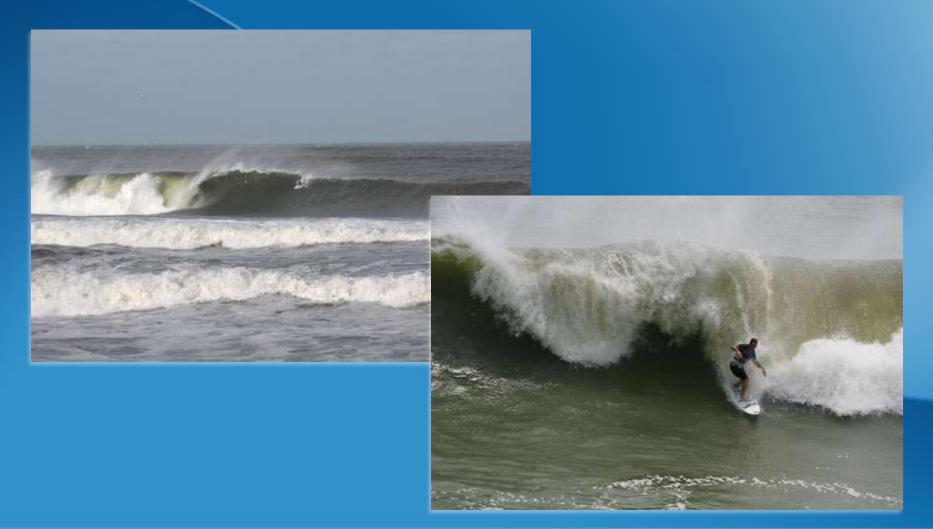
#### Hurricane Irene Conditions — 8-26-11

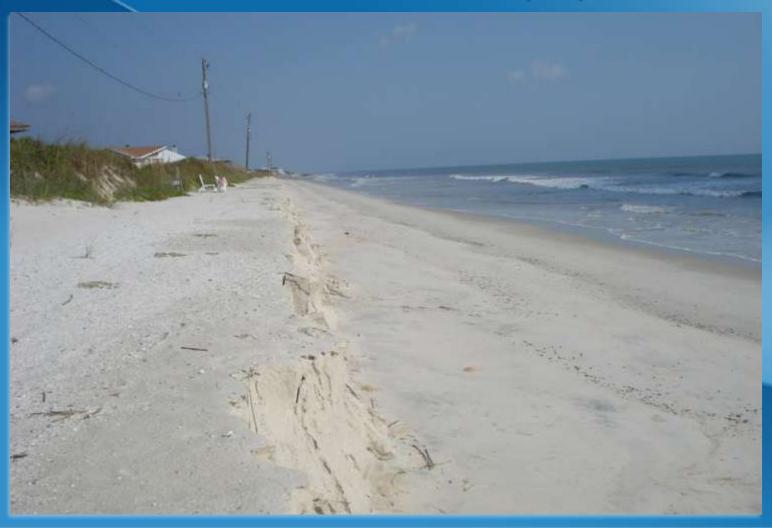
## Post-Irene Conditions Near R-203 — 8/28/11

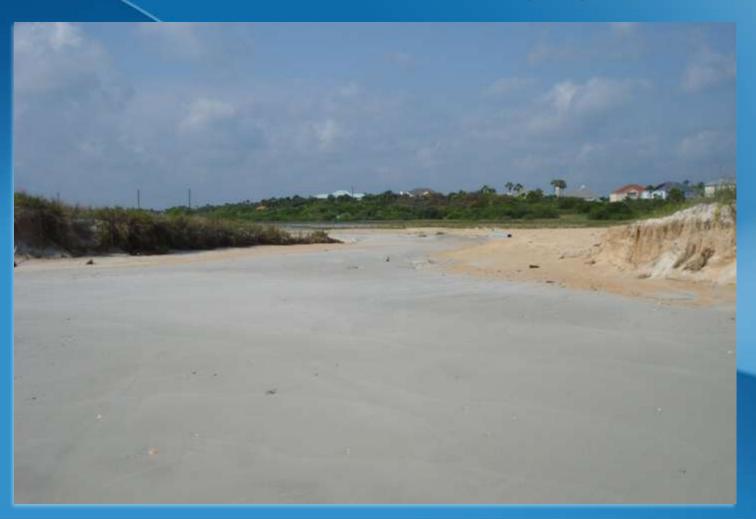
## Natural Area Post-Hurricane Irene – 8/28/11

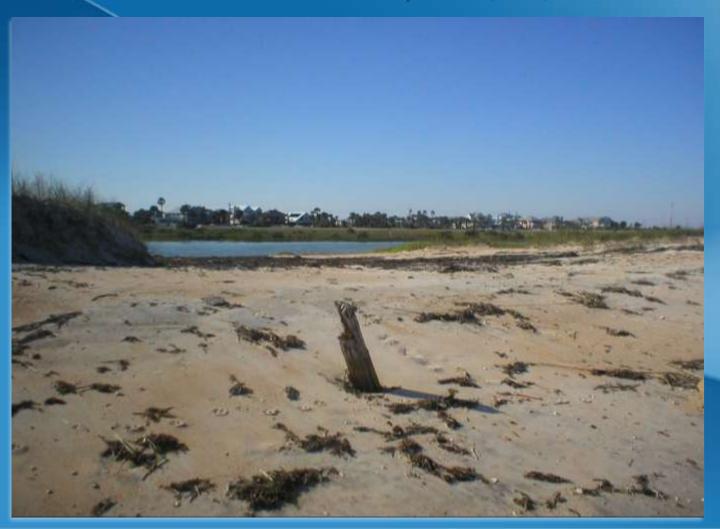
## Southern Washover Post-TS Fay – 11/28/08

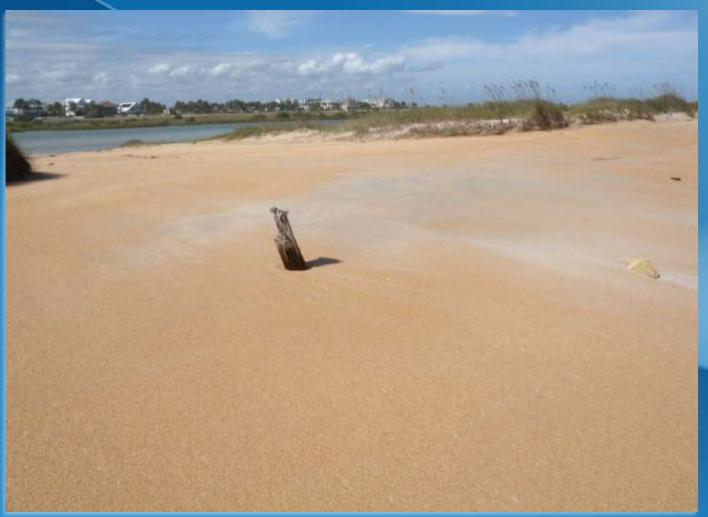
# Southern Washover – 11/5/09

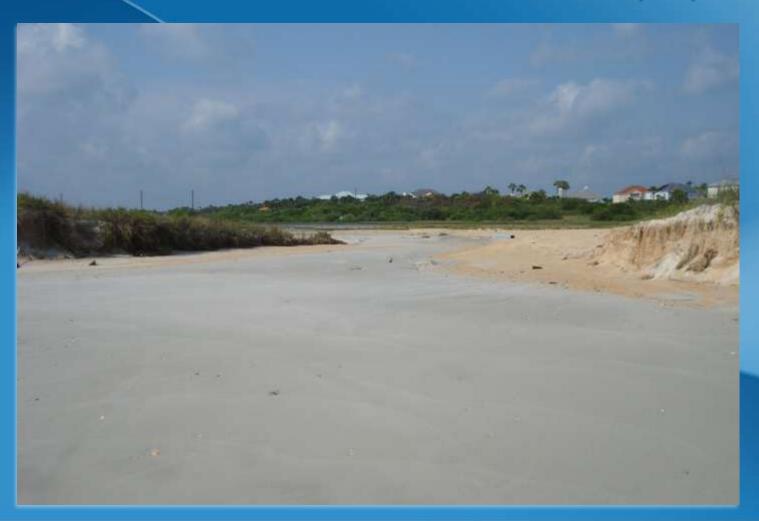
## Southern Washover Post-Hurricane Irene – 8/28/11

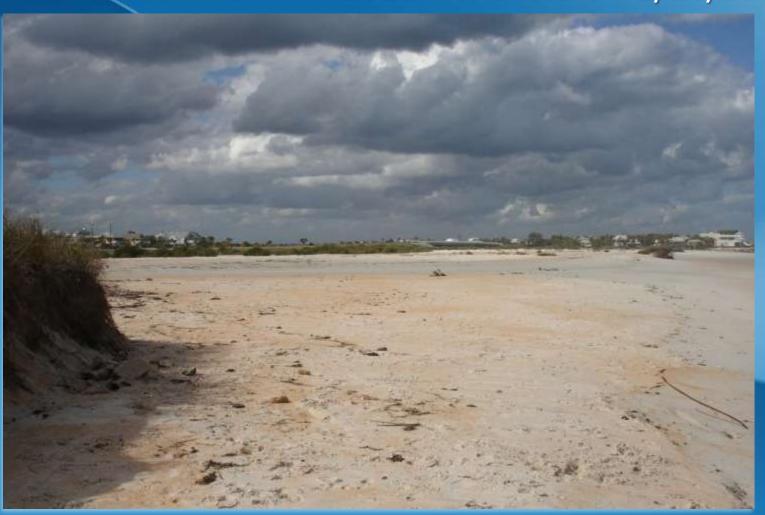
## Southern Washover Post-2011 Nor'easters – 1/26/2012

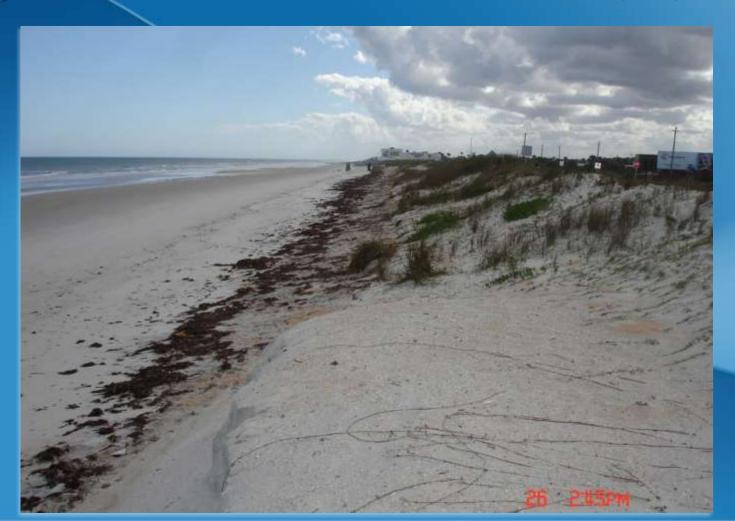
#### Project Area Present Conditions at R-208 – 1/26/12

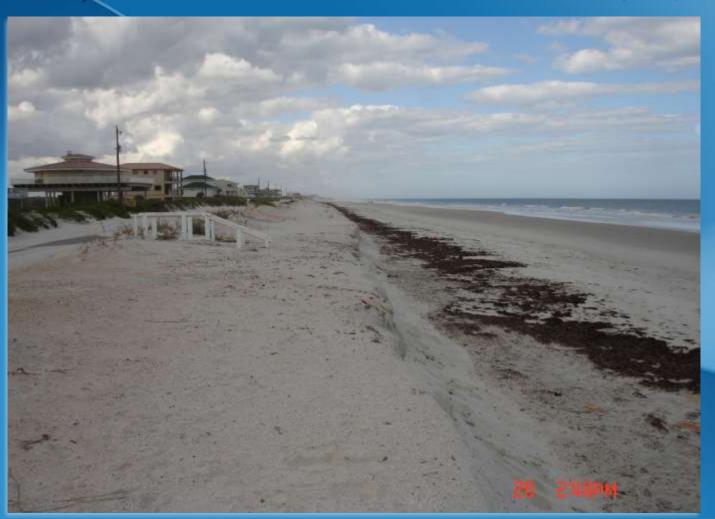
#### FEMA Project Present Conditions at R-207 – 1/26/12

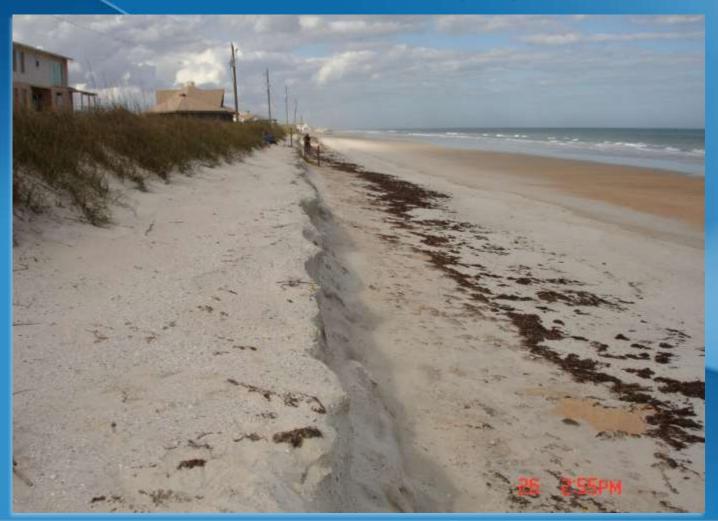
#### Present Conditions Near R-203 – 1/26/12
