SHOAL GRASS TOLERANCE TO HURRICANE IRMA IN ARAGONITE SILTS, TURKS & CAICOS ISLANDS

2024 FSBPA Conference

Leaf Erickson, PHD
Erickson Consulting Engineers, a GRAEF Company
William Precht, PHD
Dial Cordy Associates

BLUE CAY ESTATES: COASTAL INFRASTRUCTURE PROJECT

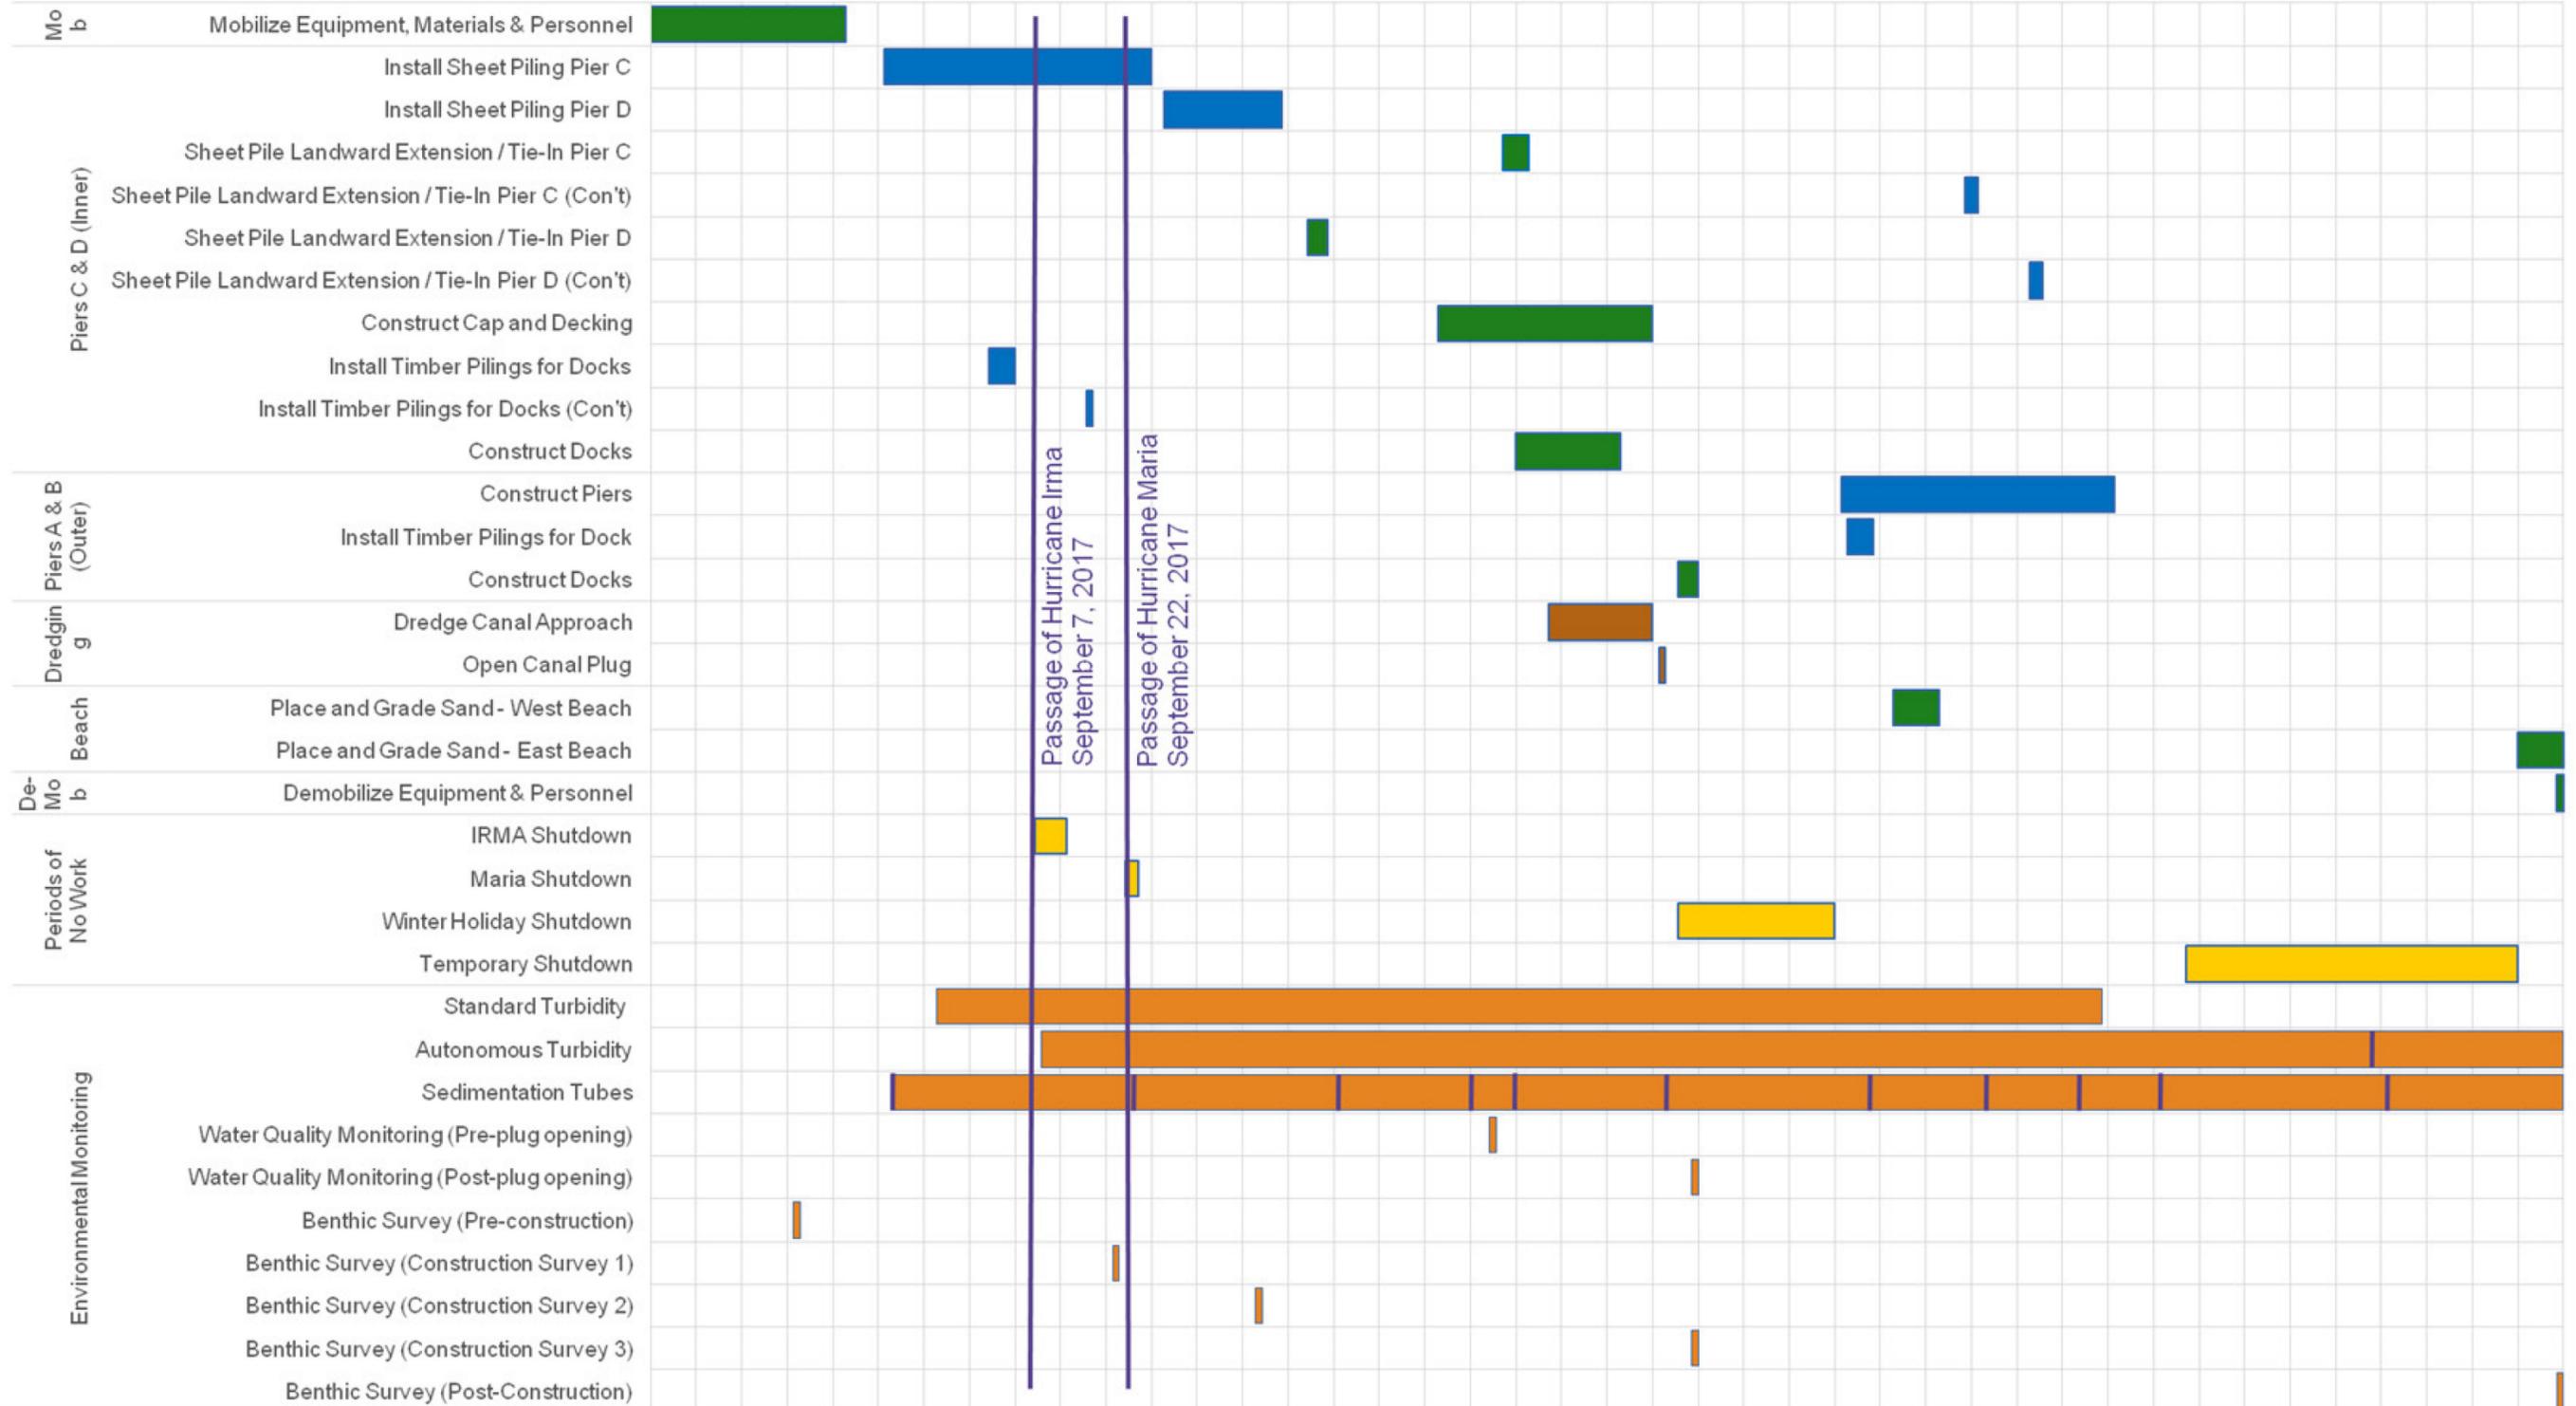
Passage of Hurricane Irma
September 7, 2017

Passage of Hurricane Maria
September 22, 2017

TURKS & CAICOS ISLANDS

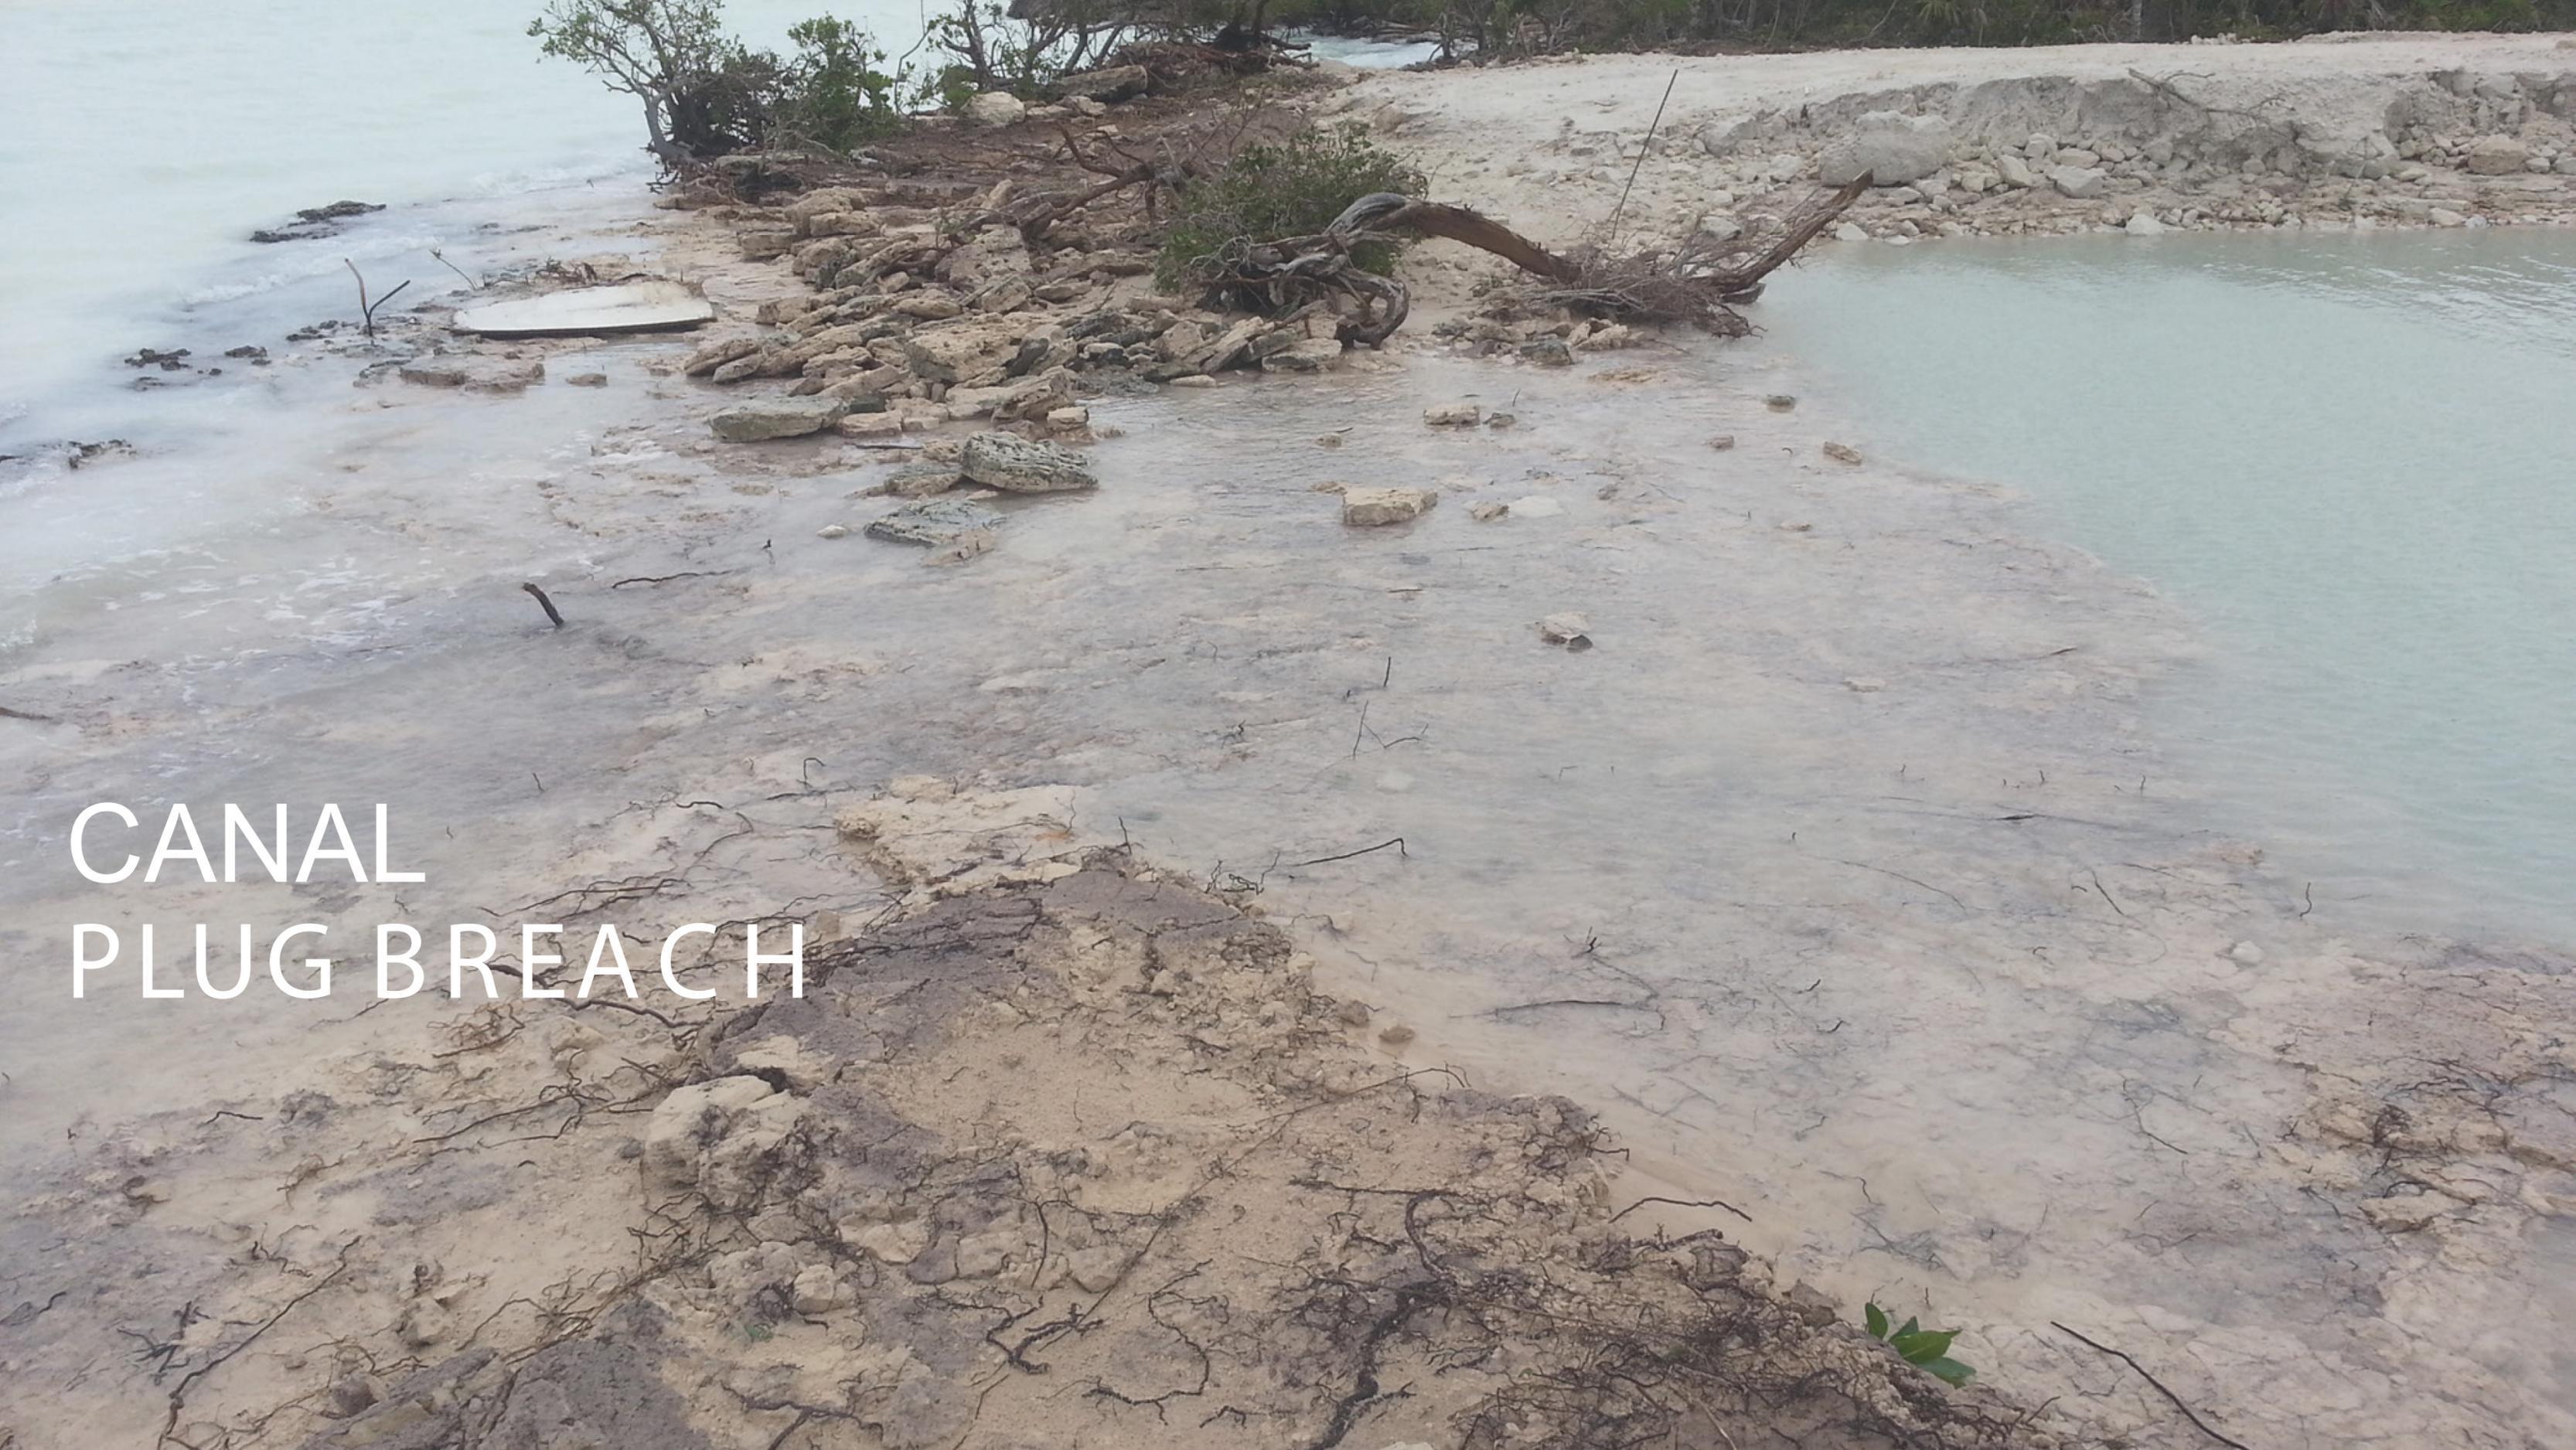
CANAL
PLUG BREACH

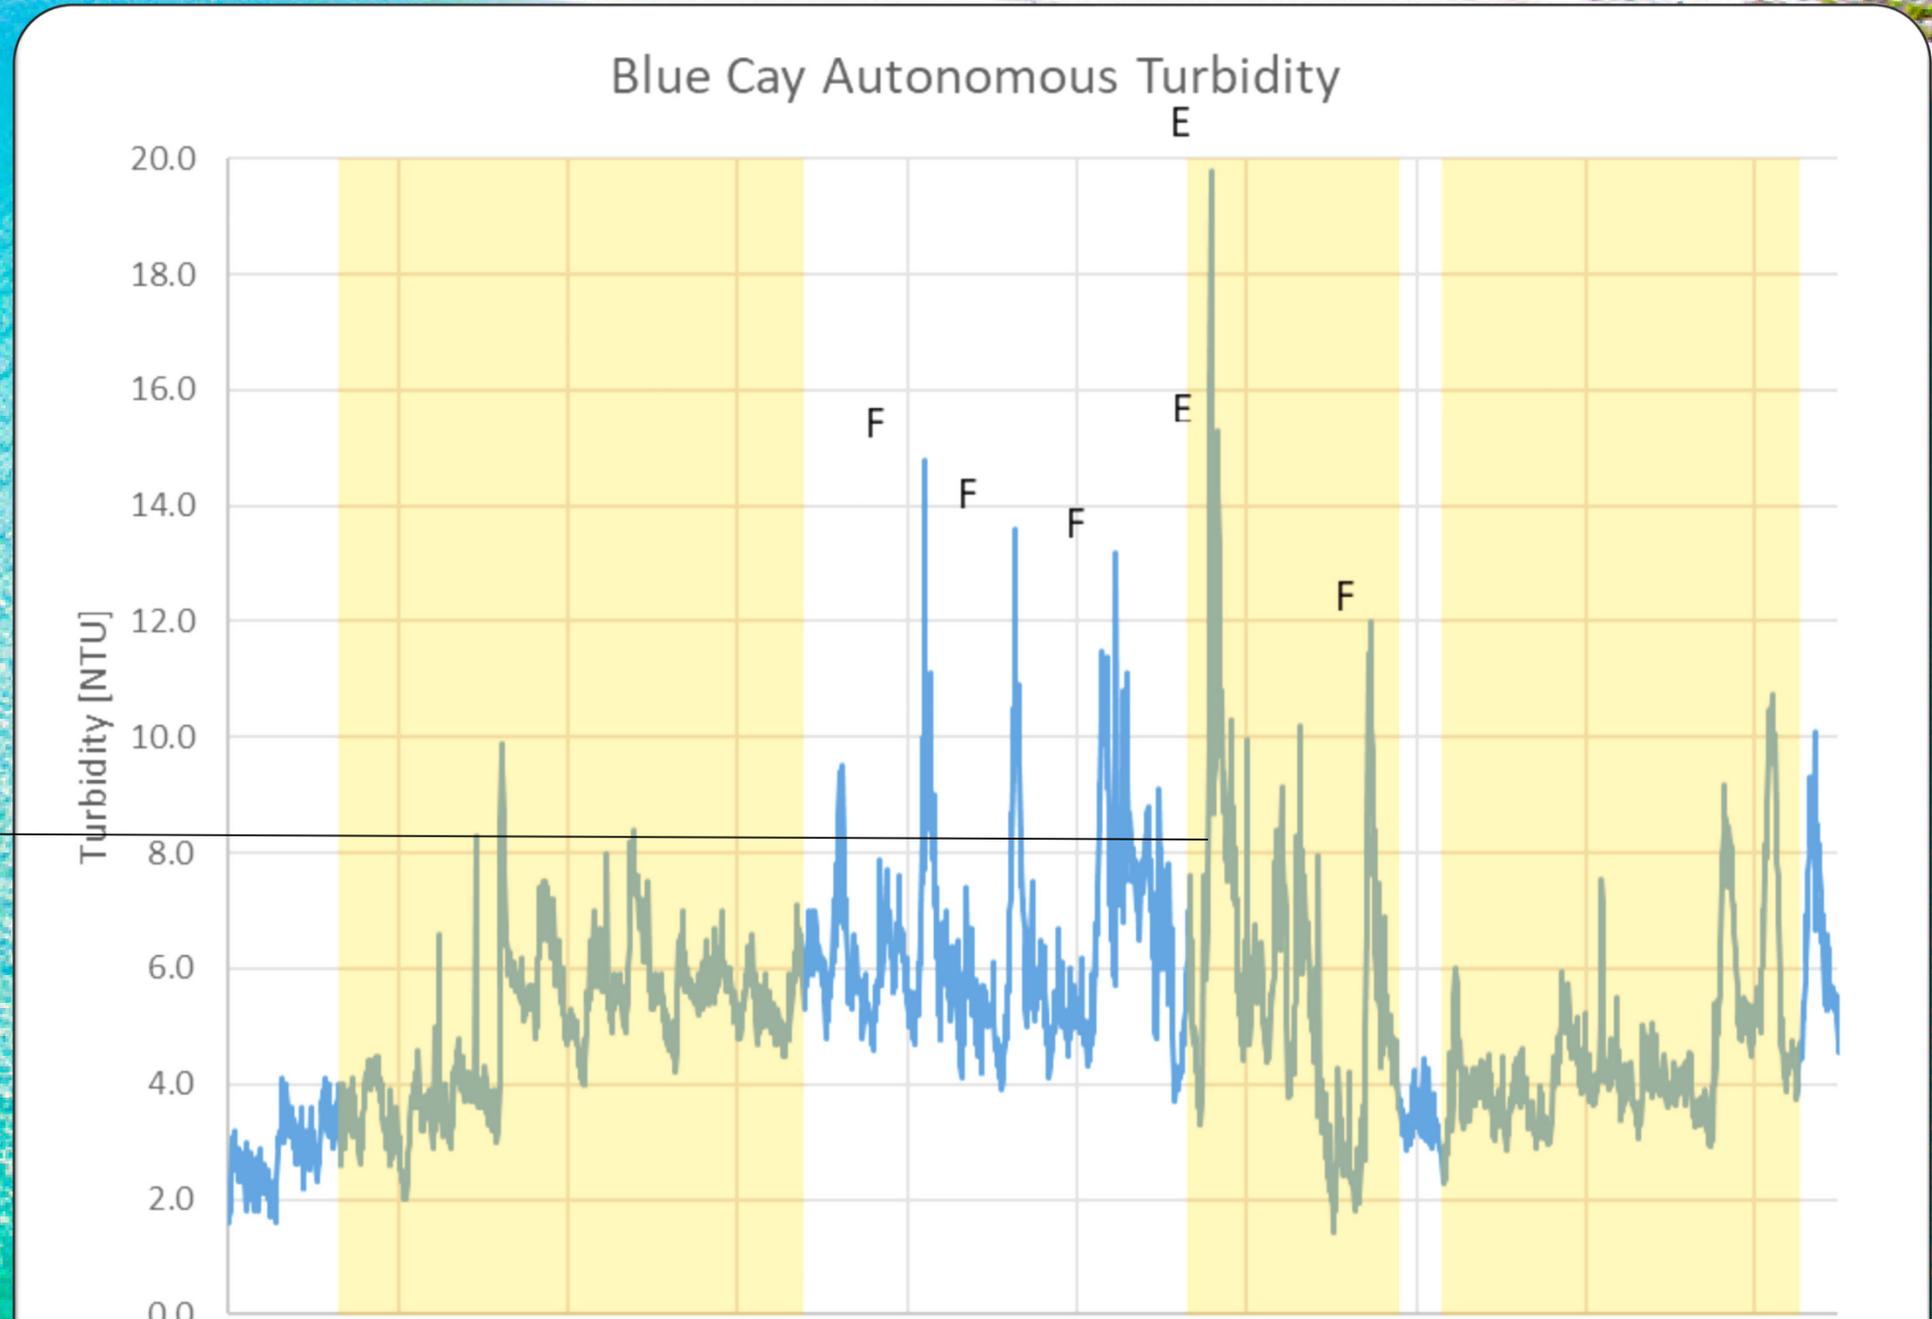
IN-SITU DATA

YSI 600 OMS
Turbidity
Conductivity
Temp

Flood tide turbidity from
project, Ebb tide from west

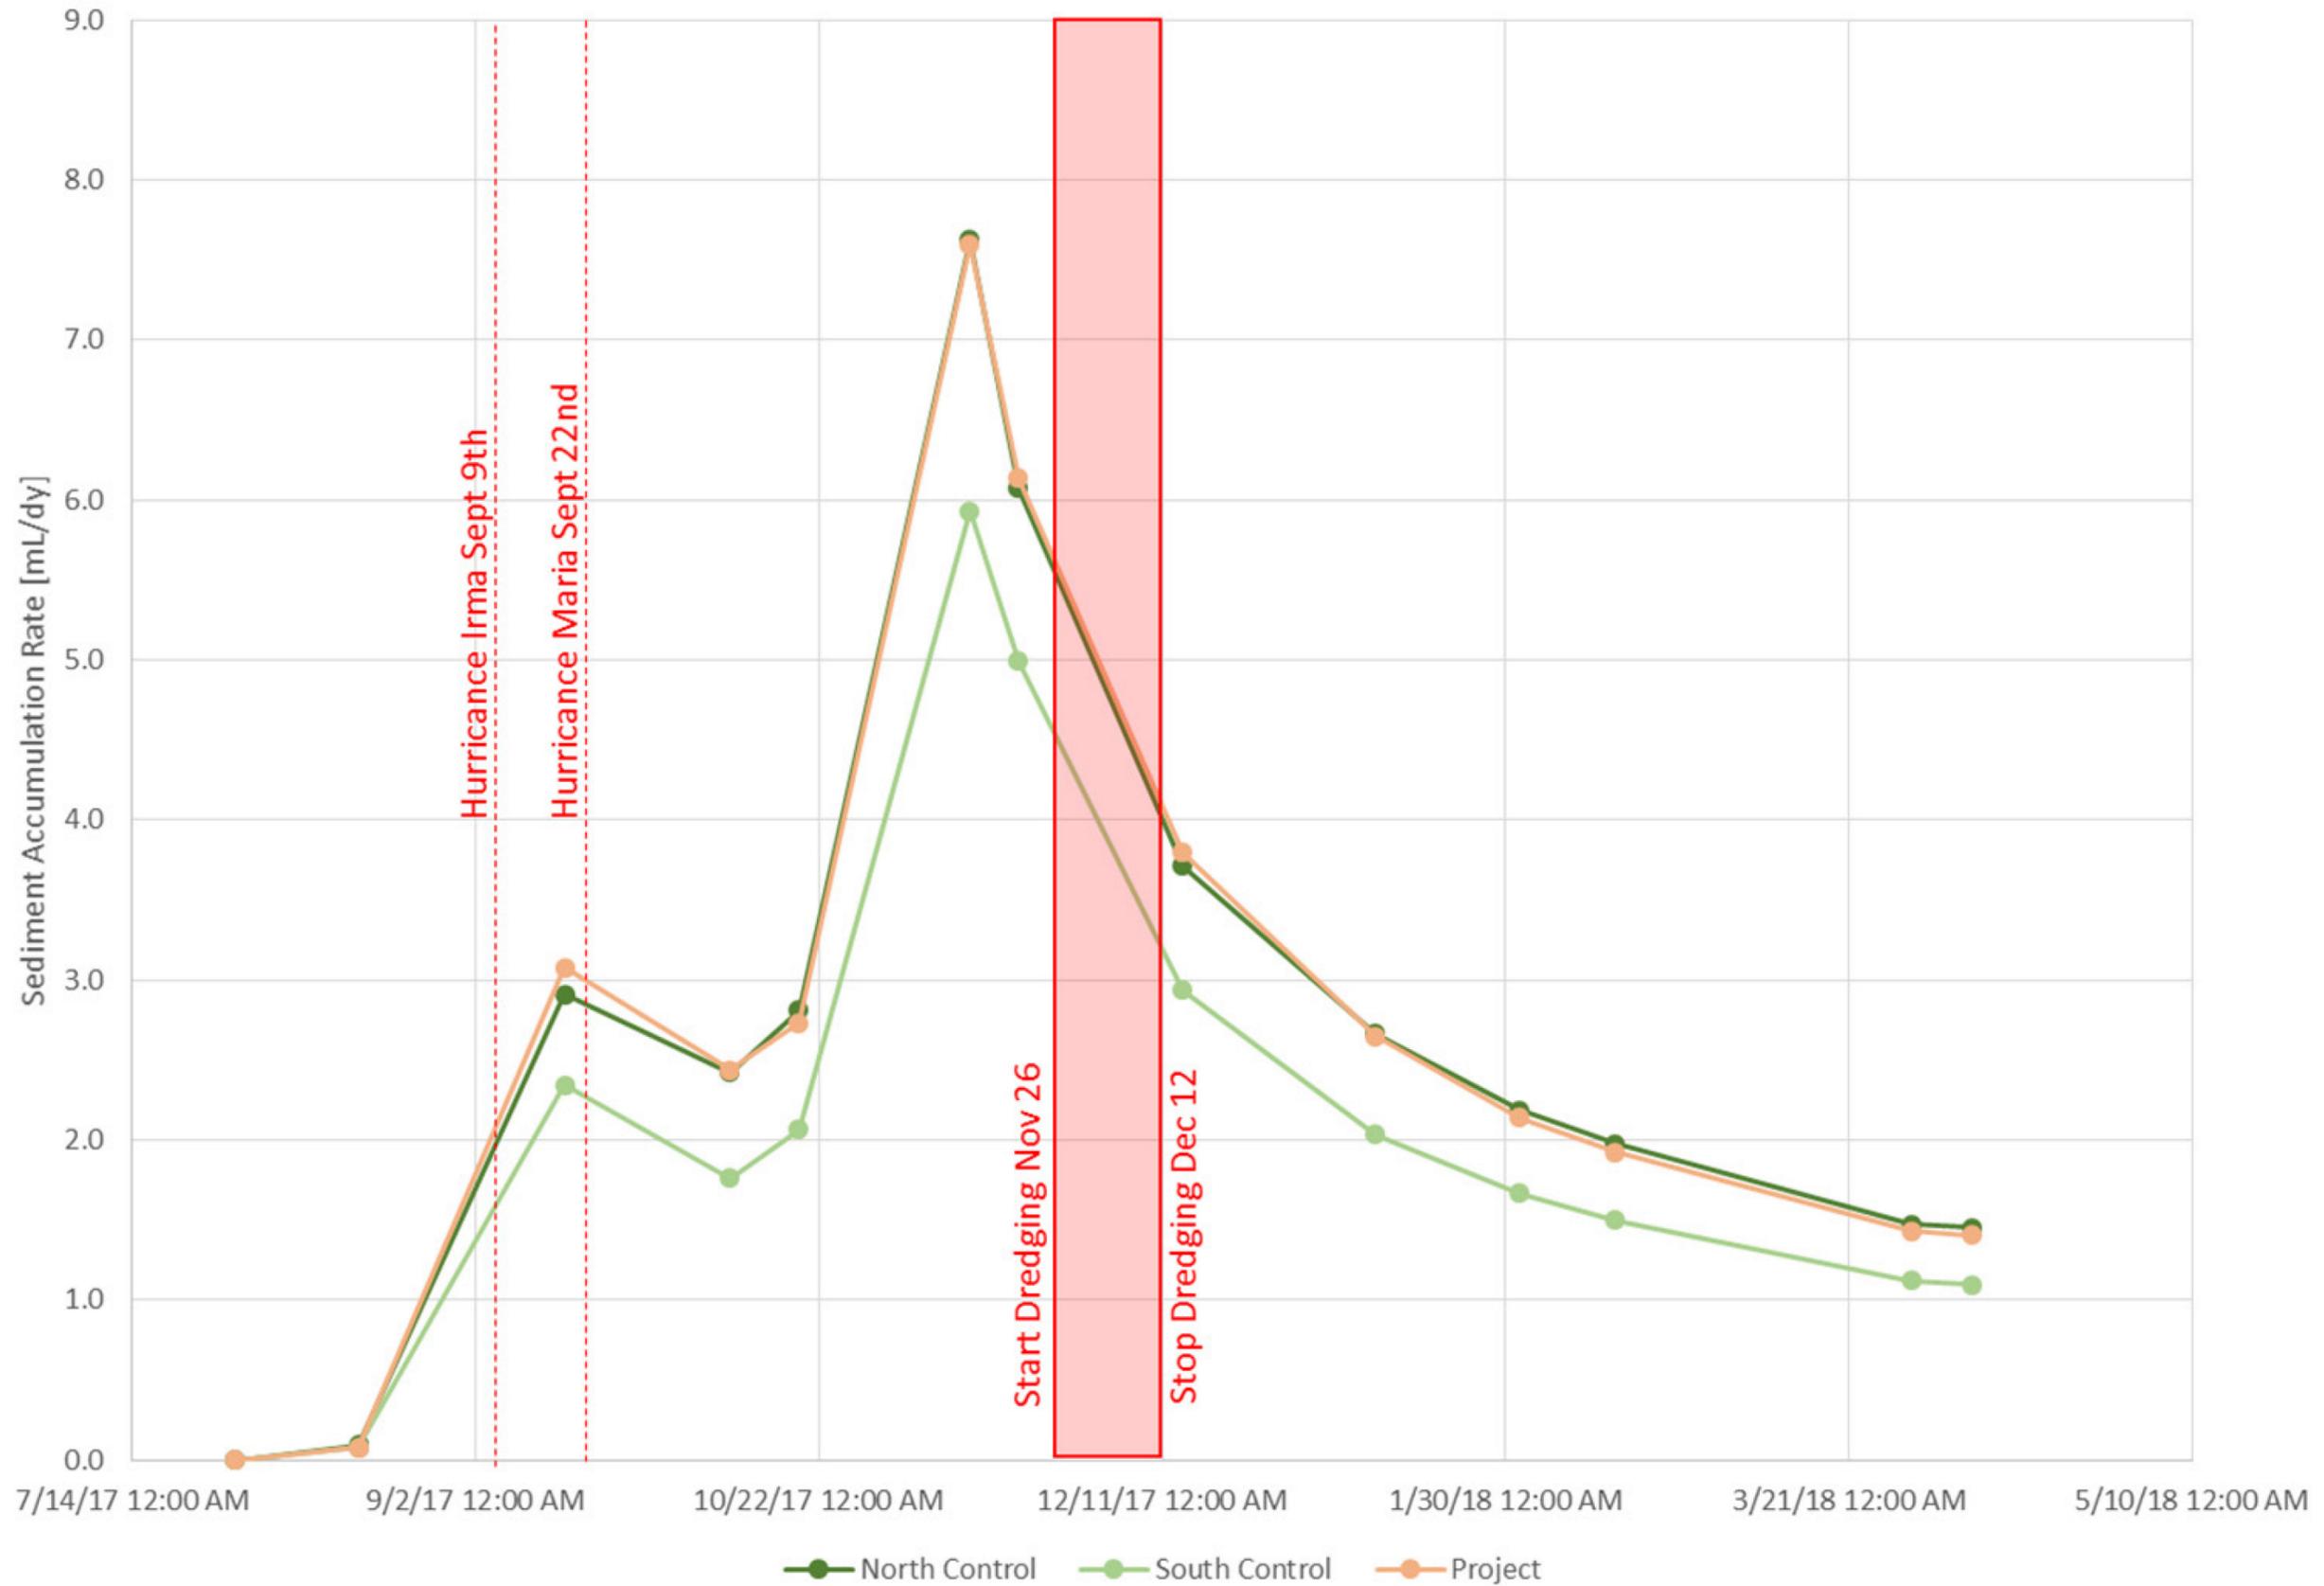
Blue Cay Sediment Accumulation Rates

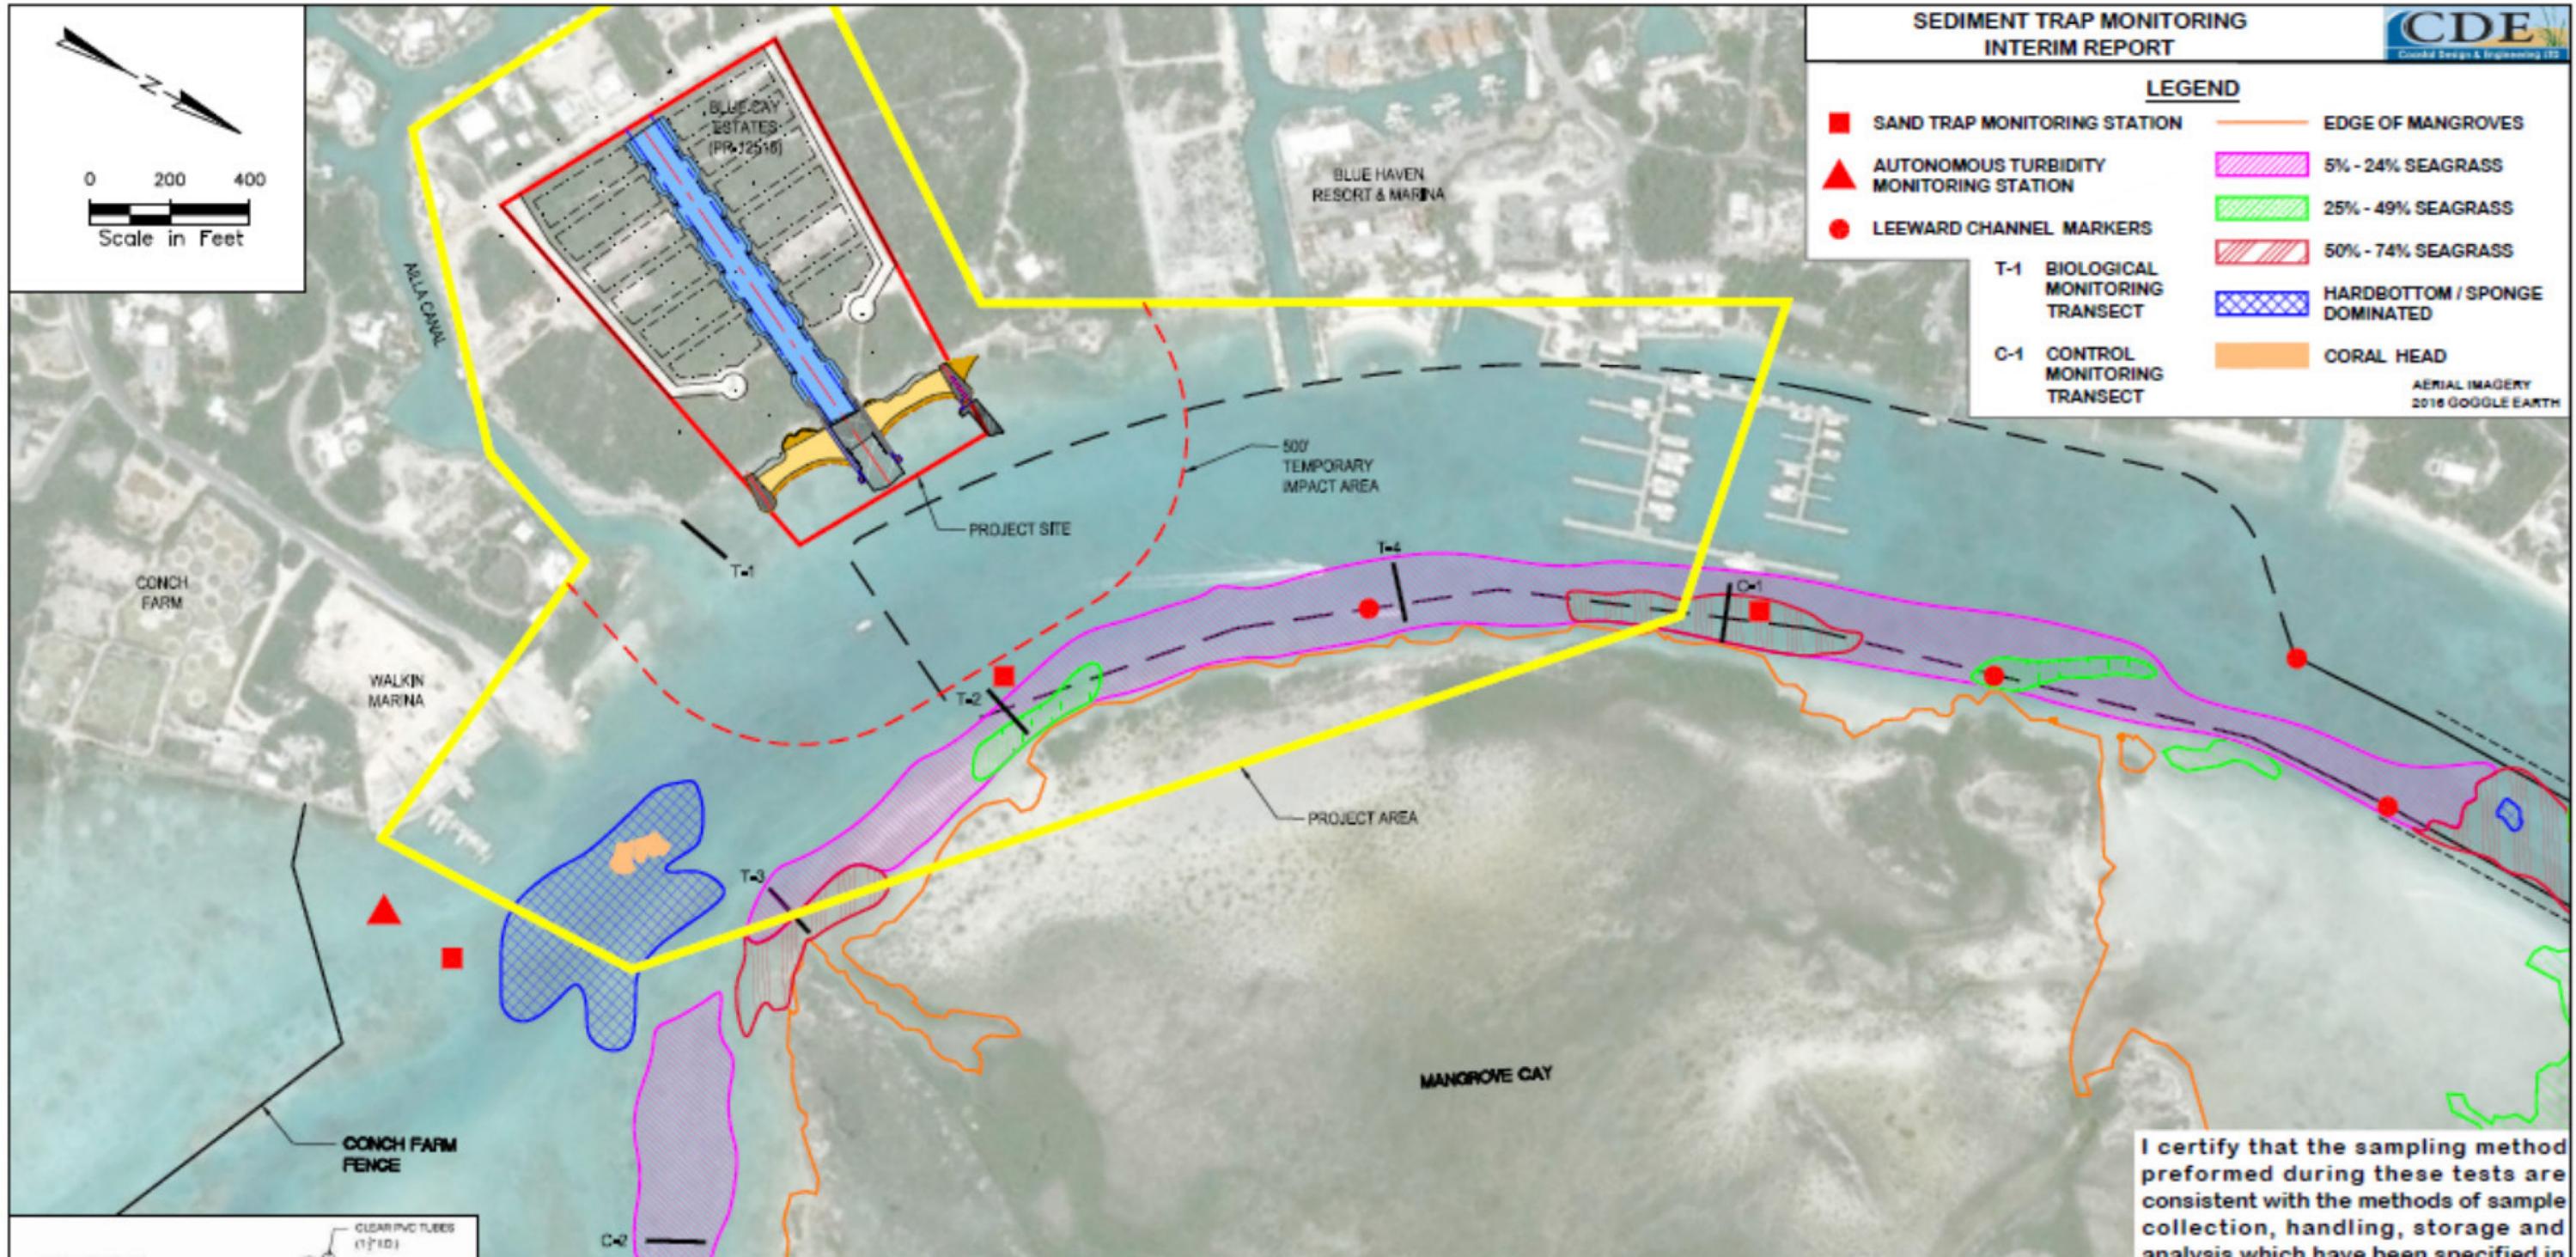
- SAND TRAP MONITORING STATION
- ▲ AUTONOMOUS TURBIDITY MONITORING STATION
- LEEWARD CHANNEL MARKERS
- EDGE OF MANGROVES
- 5% - 24% SEAGRASS
- 25% - 49% SEAGRASS
- 50% - 74% SEAGRASS
- HARDBOTTOM / SPONGE DOMINATED
- CORAL HEAD
- T-1 BIOLOGICAL MONITORING TRANSECT
- C-1 CONTROL MONITORING TRANSECT

AERIAL IMAGERY
2016 GOOGLE EARTH

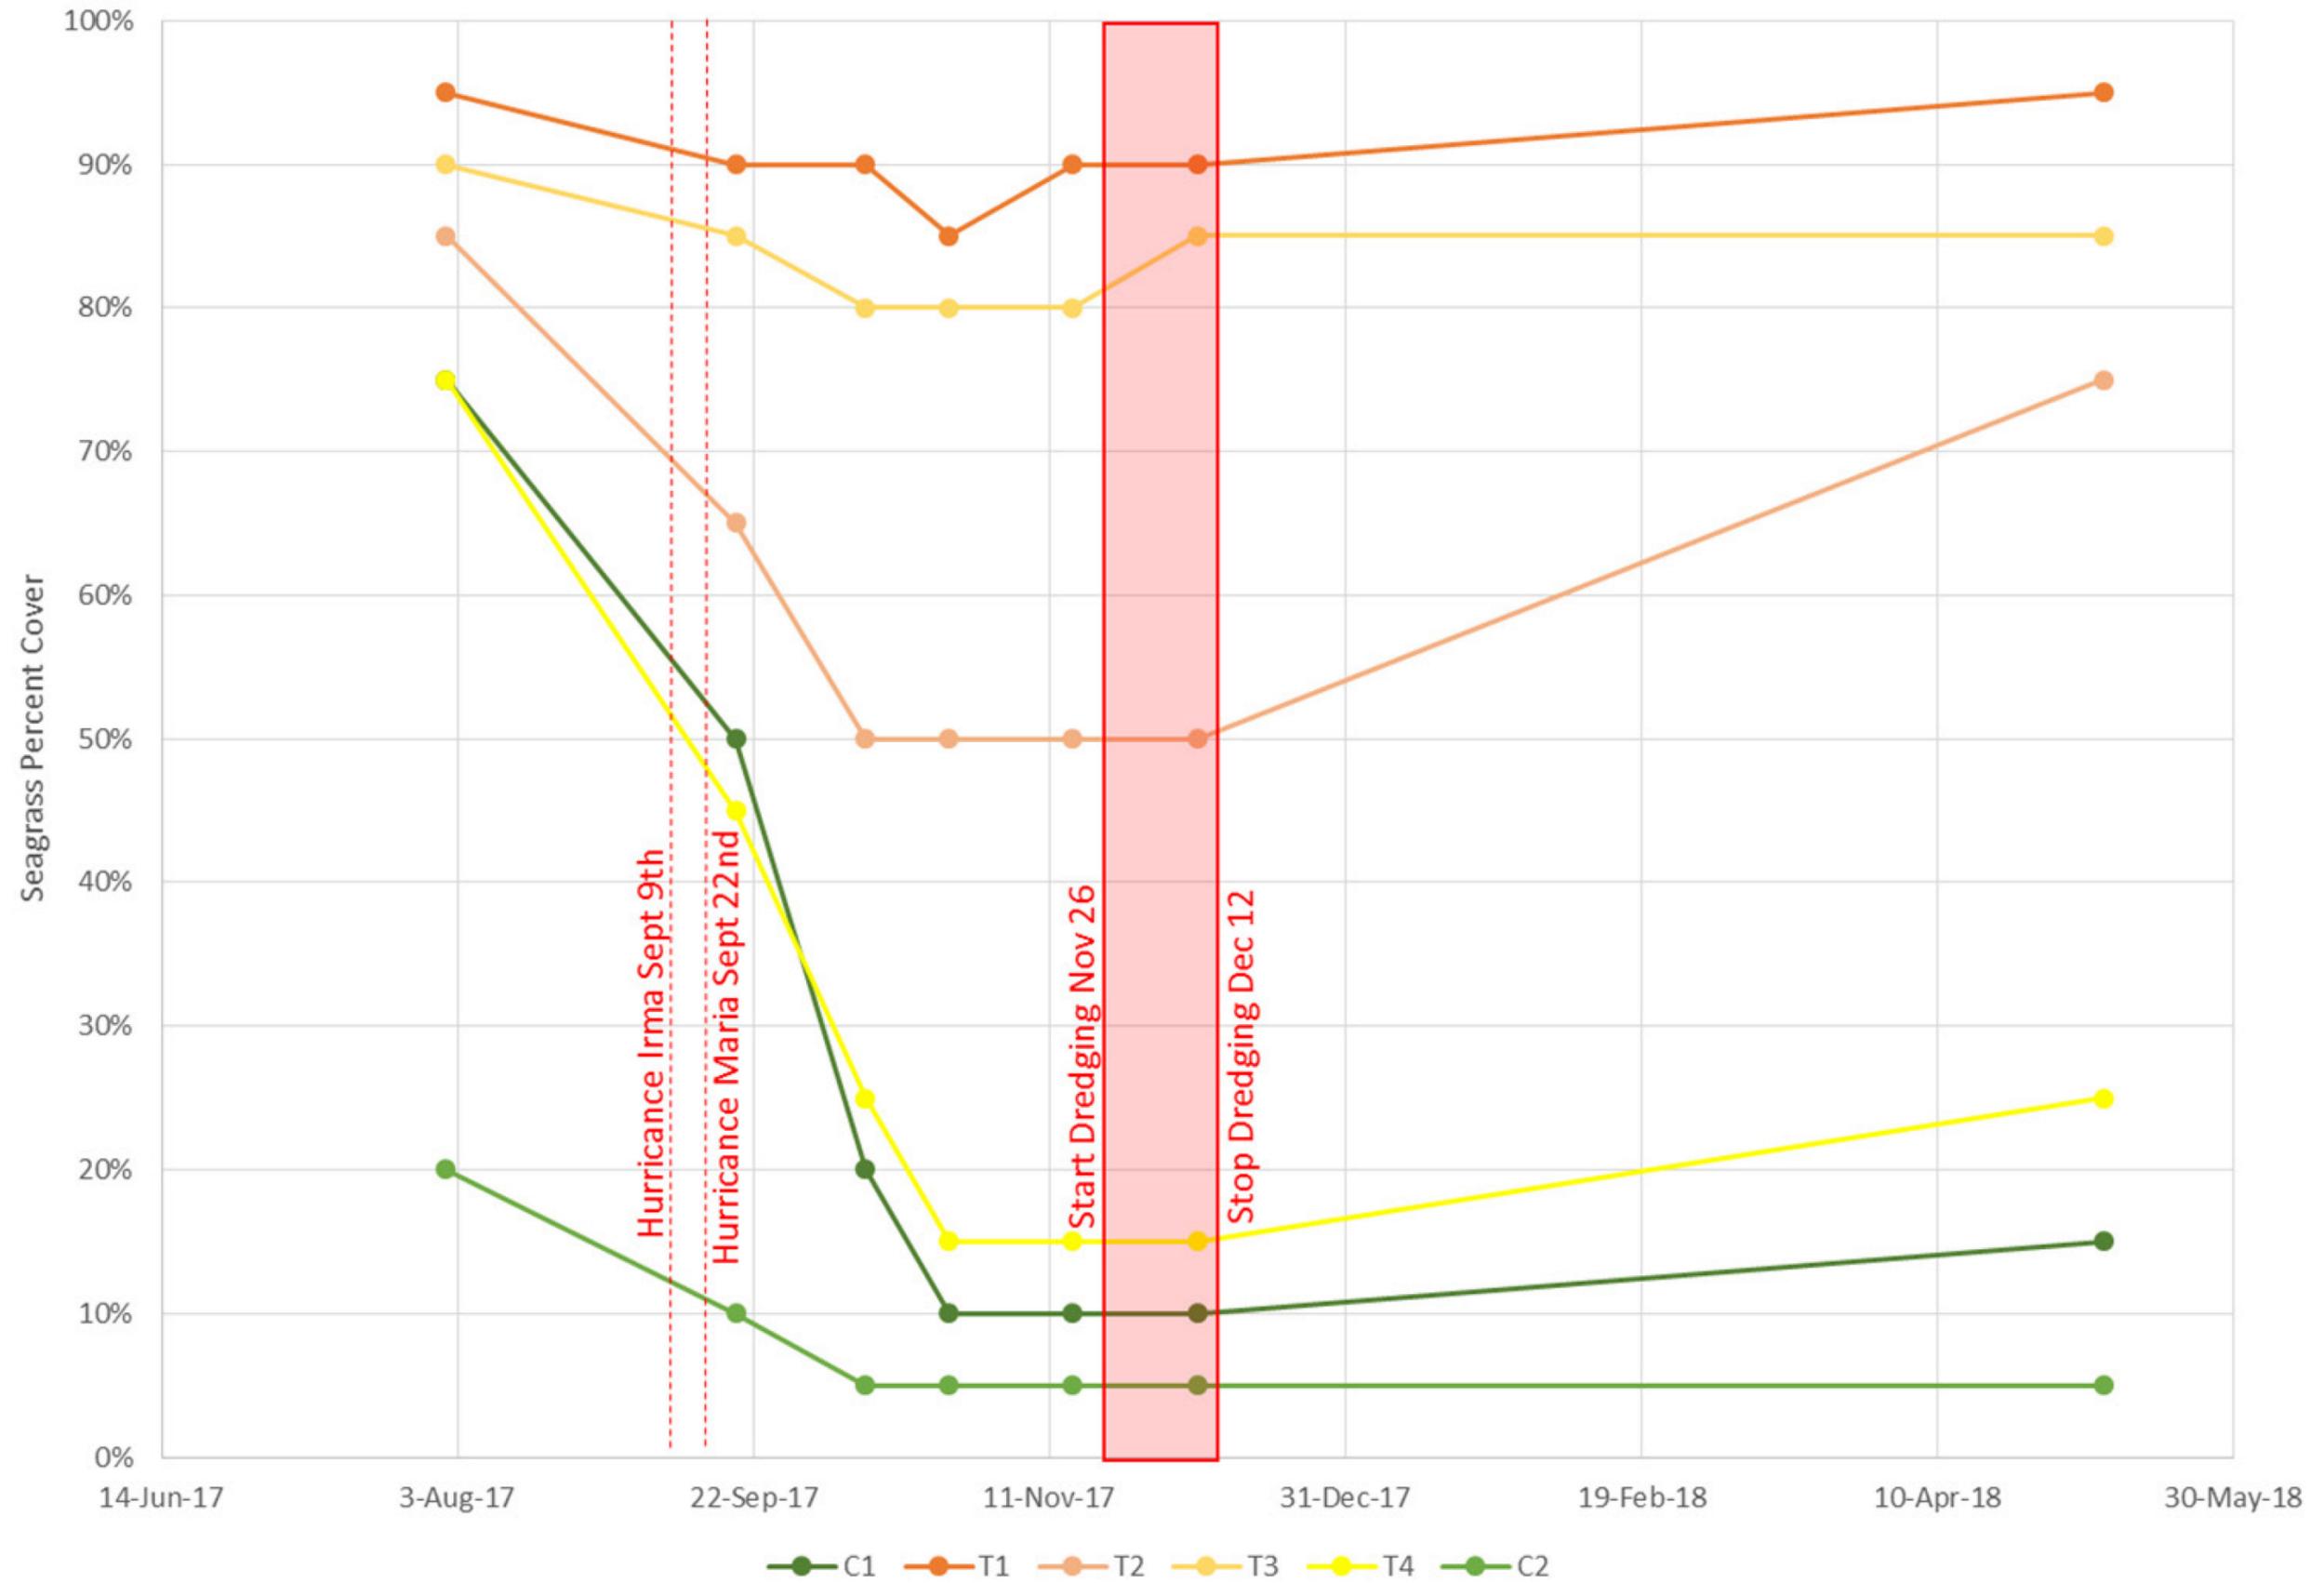
Blue Cay Seagrass Abundance

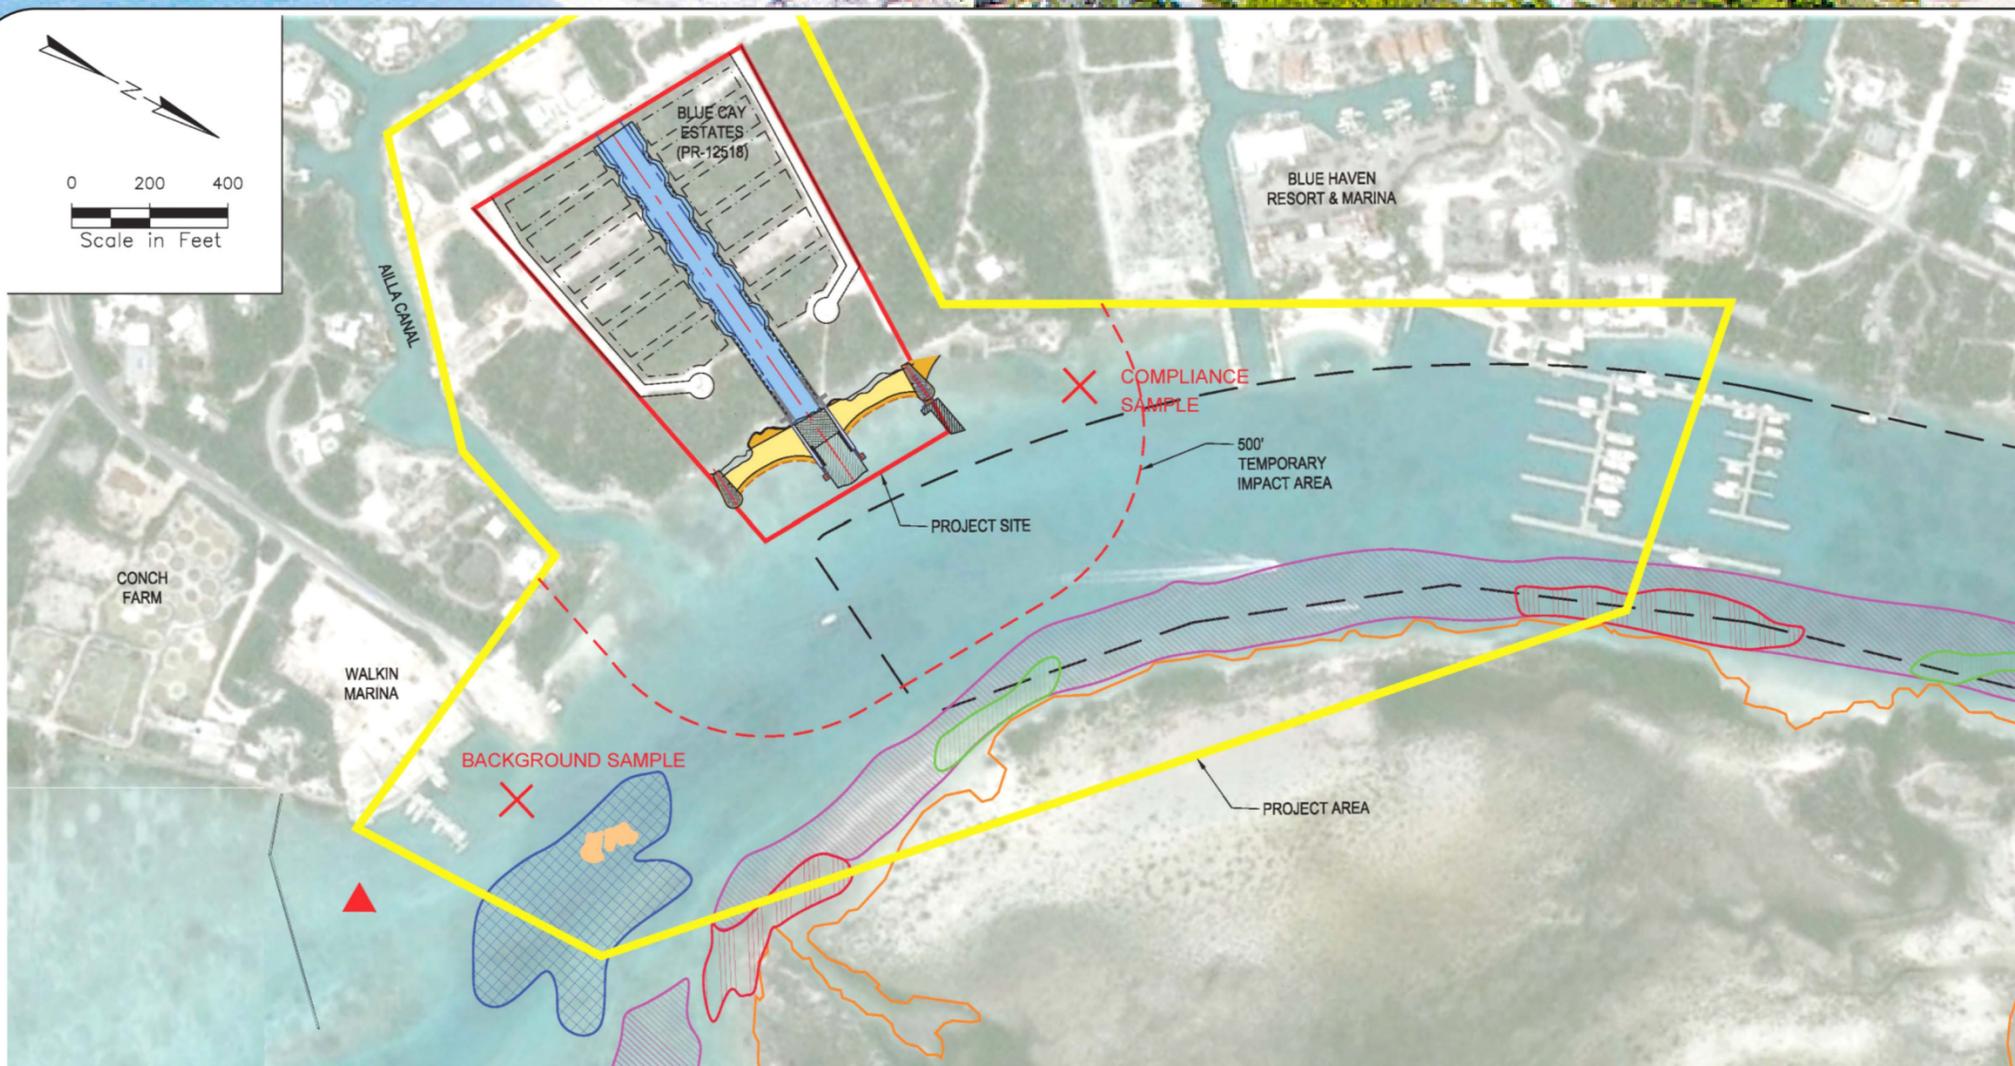
- Pre- and Post- Construction In-Situ Turbidity Monitoring Sample
- x Background Sample (During Active Construction)
- x Compliance Sample (During Active Construction)
- ↓ Current Direction

Method: Collected more than 2 hours after sunrise and more than 2 hours prior to sunset following at least 1 hour of continuous construction activity or dredging at: (a) 1,200 feet up-current from the construction activity or dredge (Background), (b) 500 feet down-current of the dredge within the densest visible plume (Compliance). A surface sample (S) and mid-depth sample (M) shall be collected at each location.
