WHEN DUNES MISBEHAVE

ROBERT H. BARRON
COASTAL MANAGEMENT CONSULTING
<beachmaker@aol.com>

The Coastal Engineering Community has become quite proficient working with the fluids of Wave, Wind and Weather, but with recent focus on construction of dunes, faces for the first time a fluid with an agenda. That is LIVING BEHAVIOR. The living dune ecosystem, can sometimes perform in unexpected ways, at times beneficial and occasionally harmful.

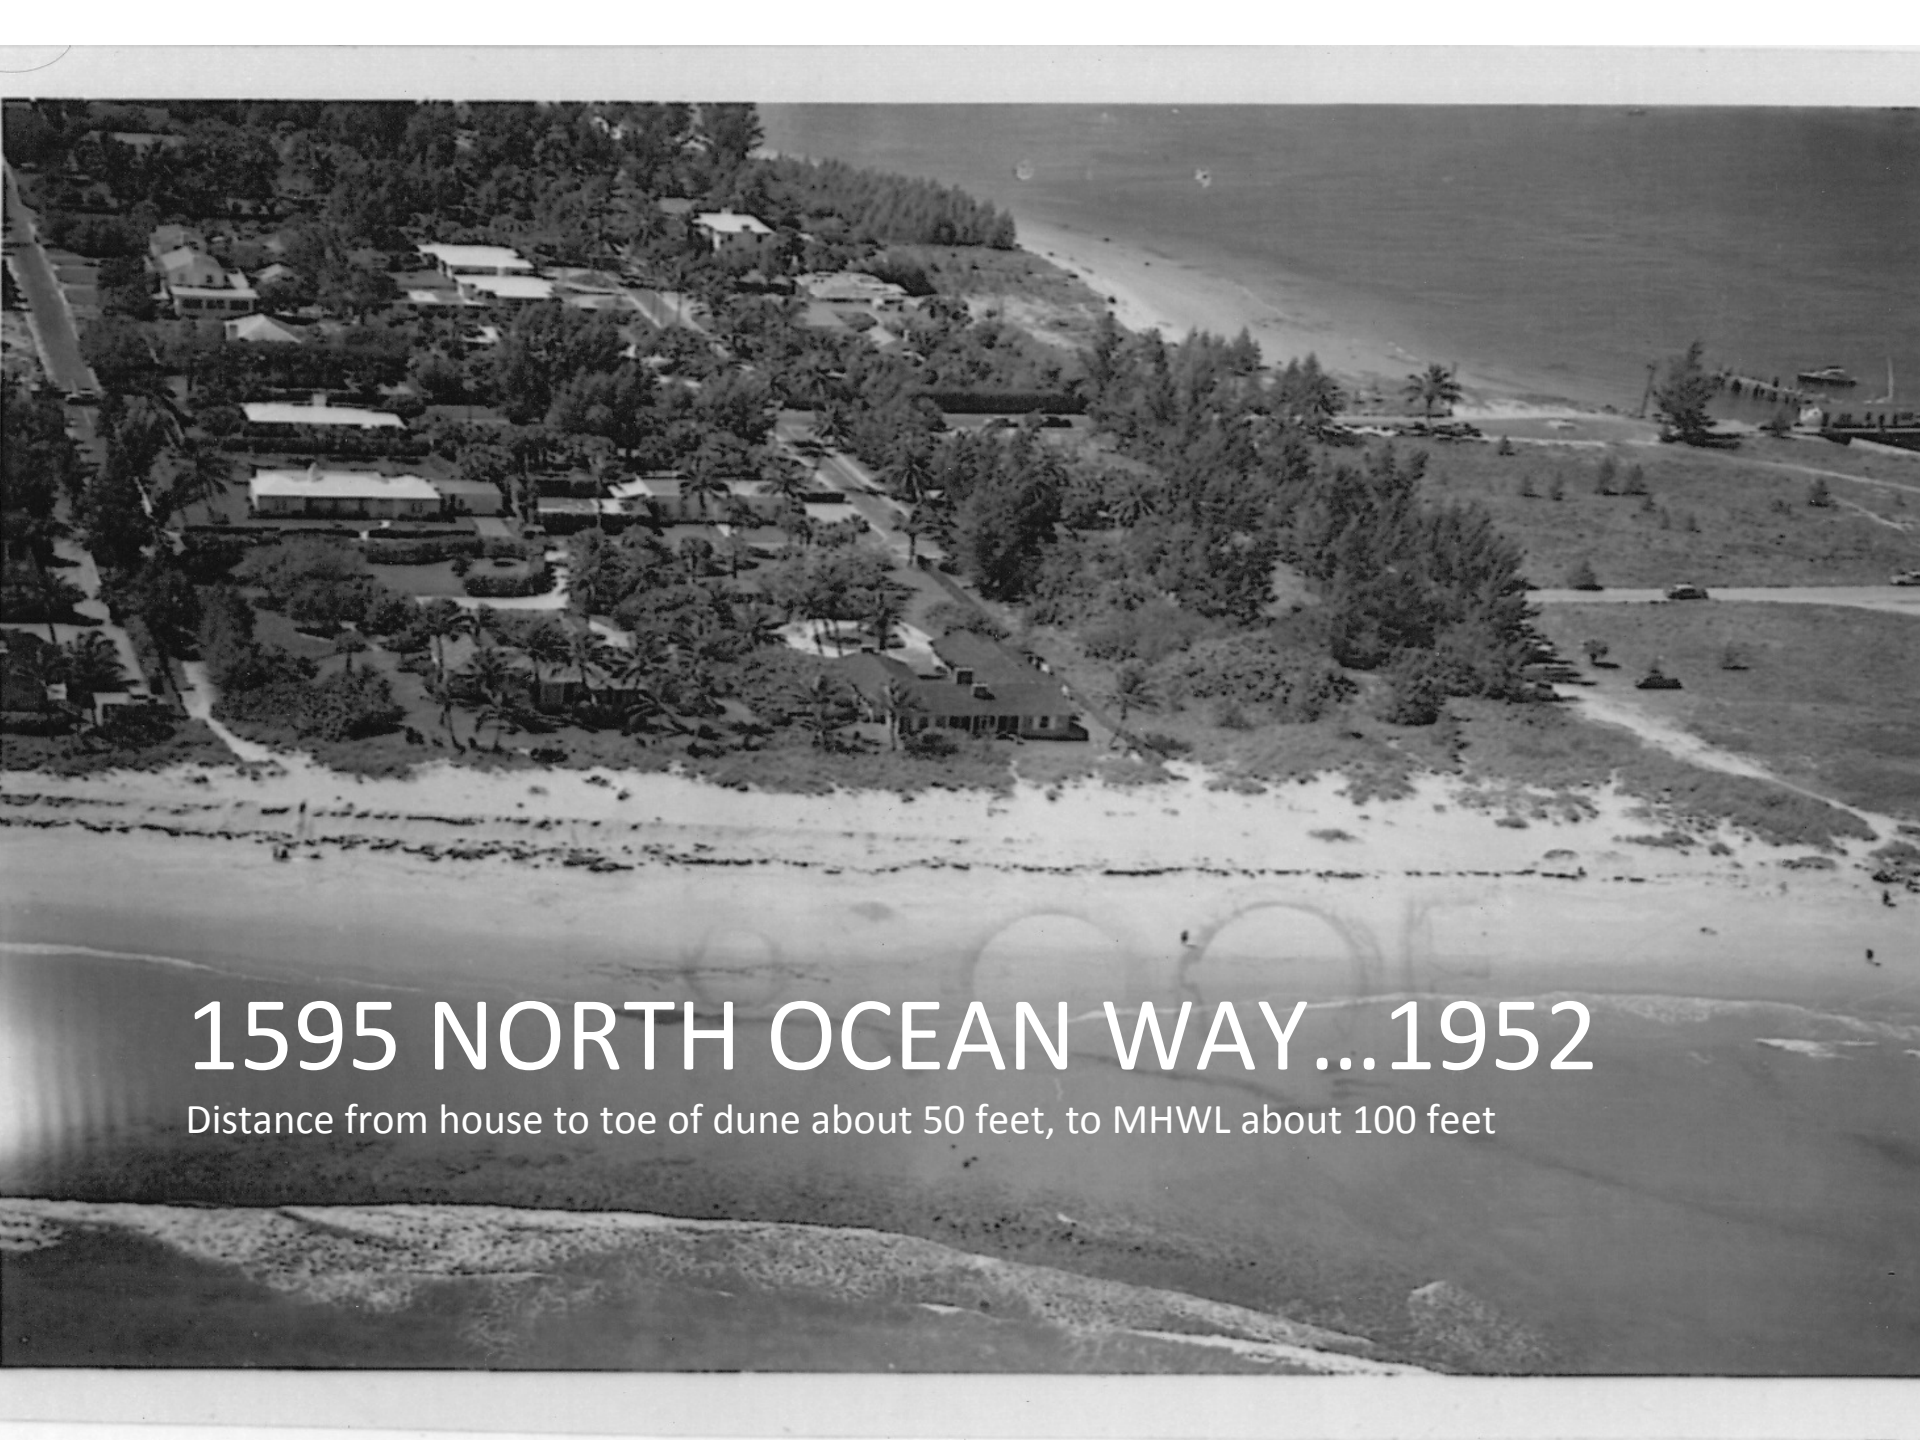
1595 NORTH OCEAN WAY...1952

Distance from house to toe of dune about 50 feet, to MHWL about 100 feet

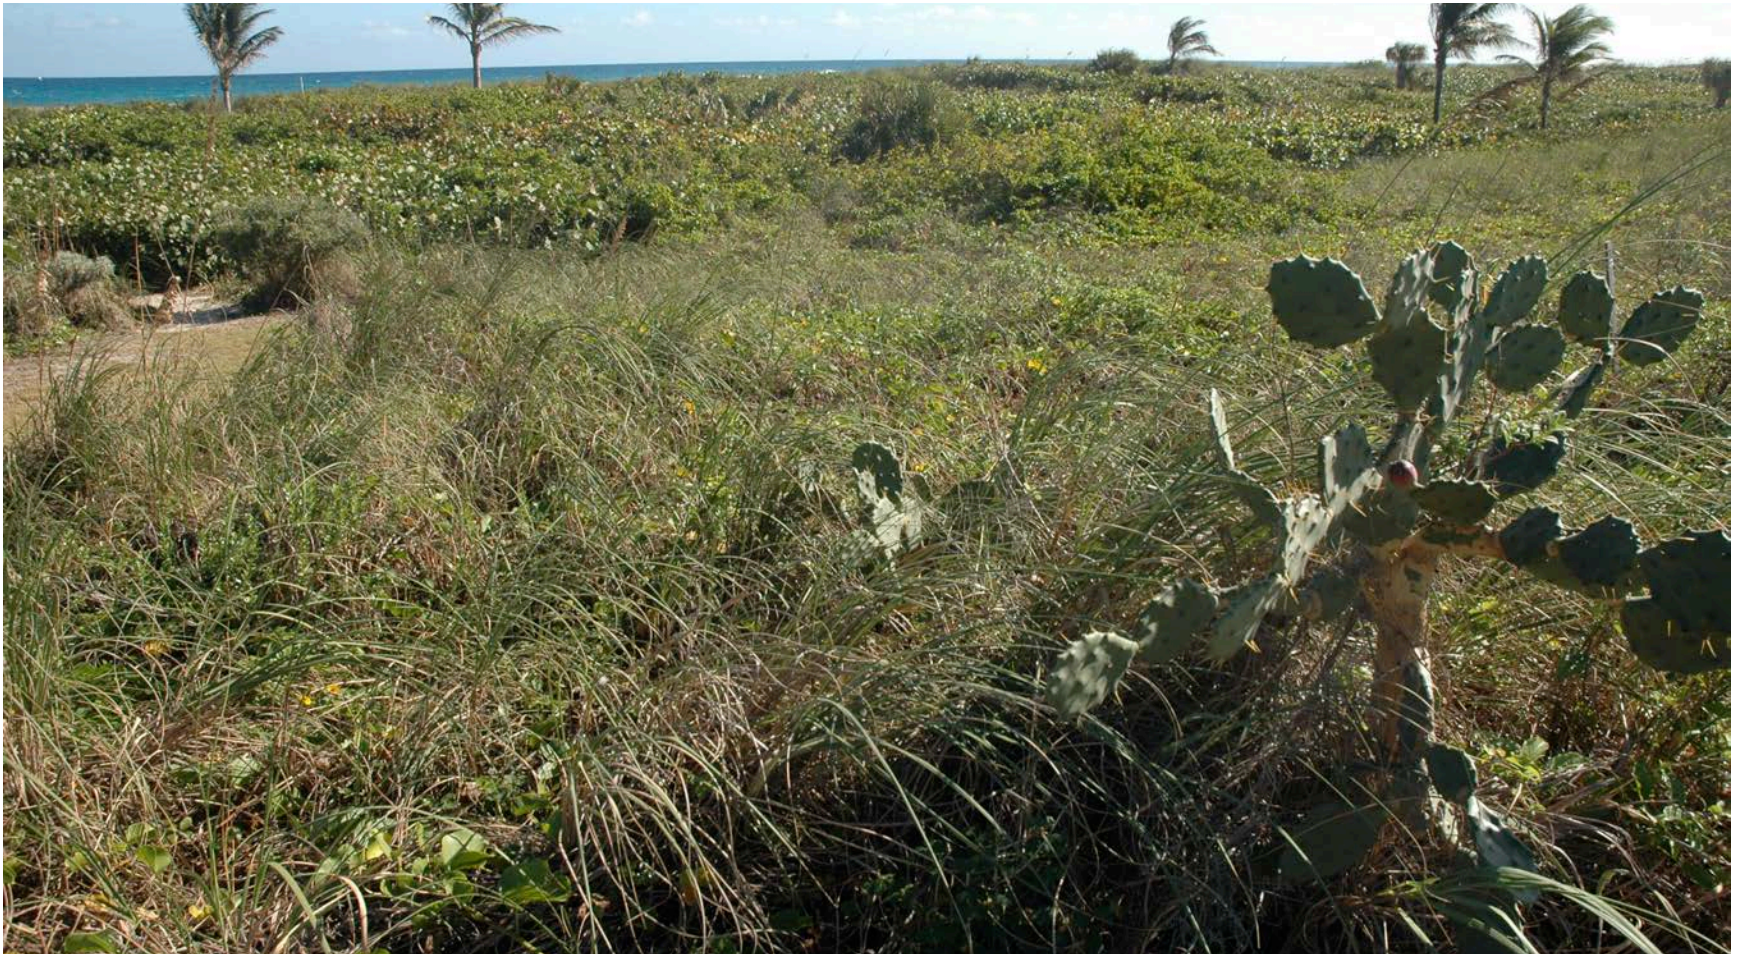
Photo from same approximate position, with now 650 feet to water line. How bout' them inlets?

2017..400 foot advance to veg line

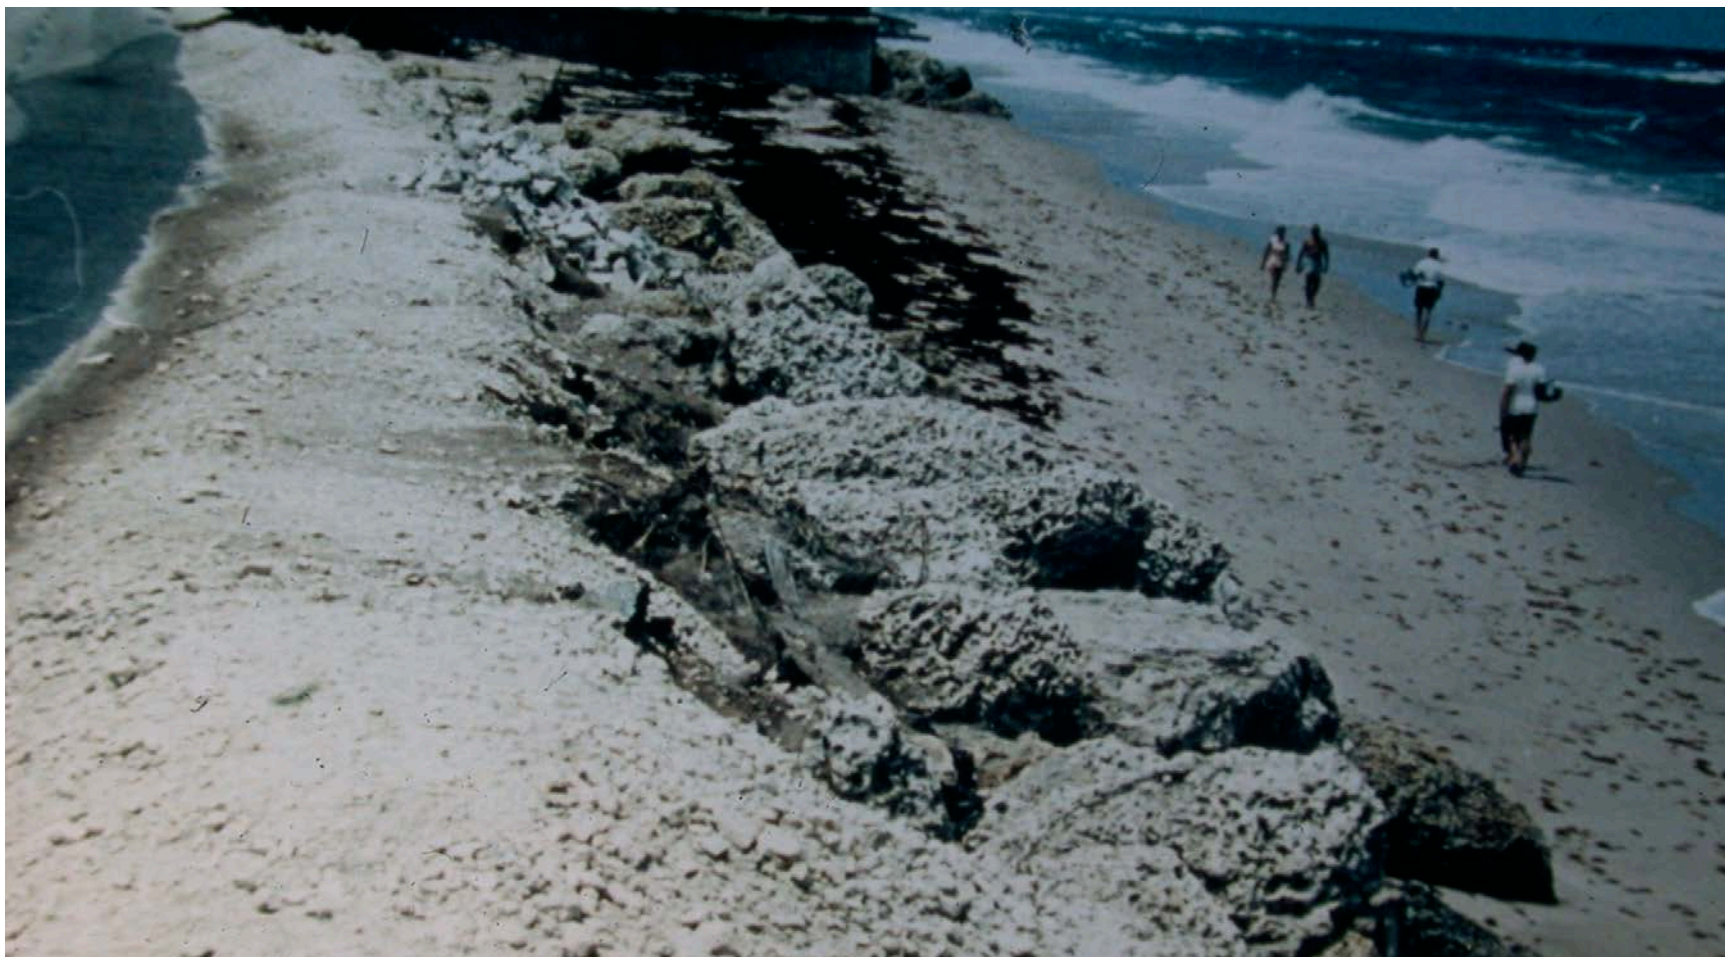
DELRAY BEACH 1970 BEFORE FIRST NOURISHMENT..AIA threatened and protected only by rock revetment. No vegetation surviving seaward of the roadway.

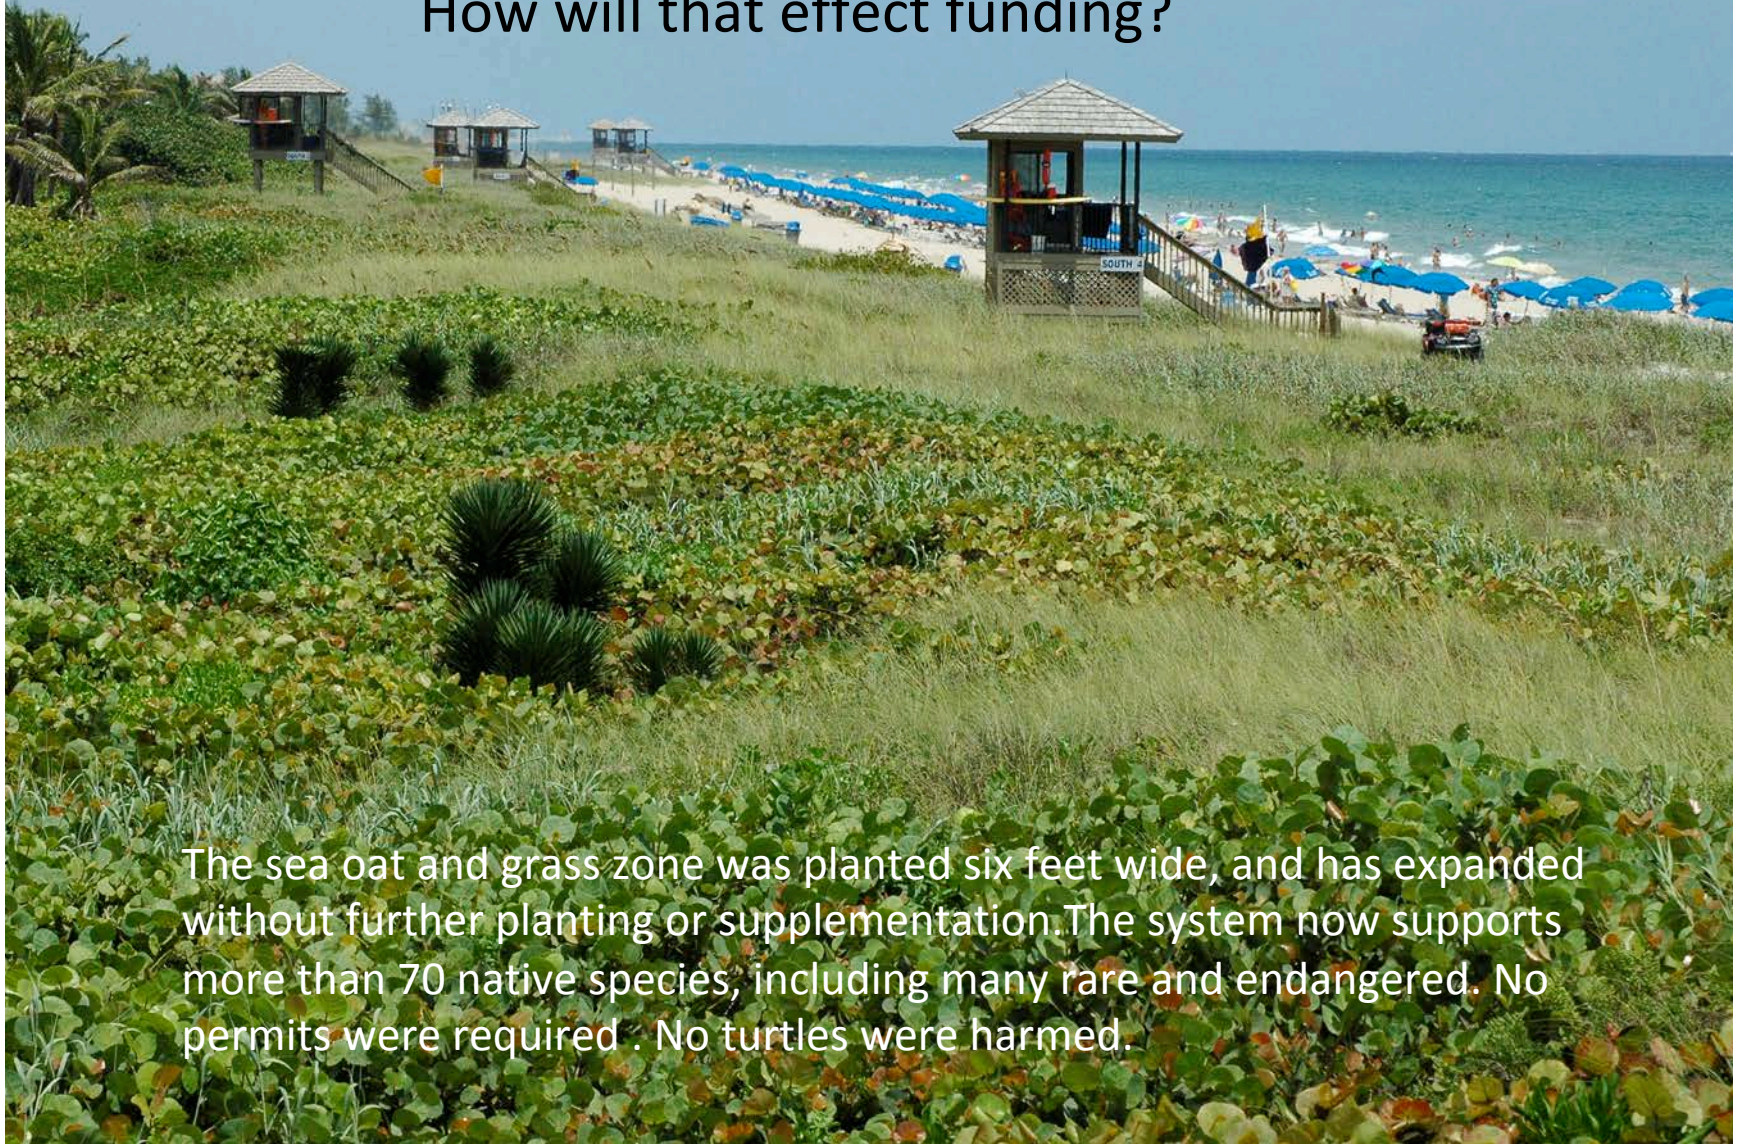
The sea oat and grass zone was planted six feet wide, and has expanded without further planting or supplementation. The system now supports more than 70 native species, including many rare and endangered. No permits were required . No turtles were harmed.

Ten year project permit allows control and occasional grading to installed footprint and limiting elevations so owner is assured the view and recreation area will not be lost.

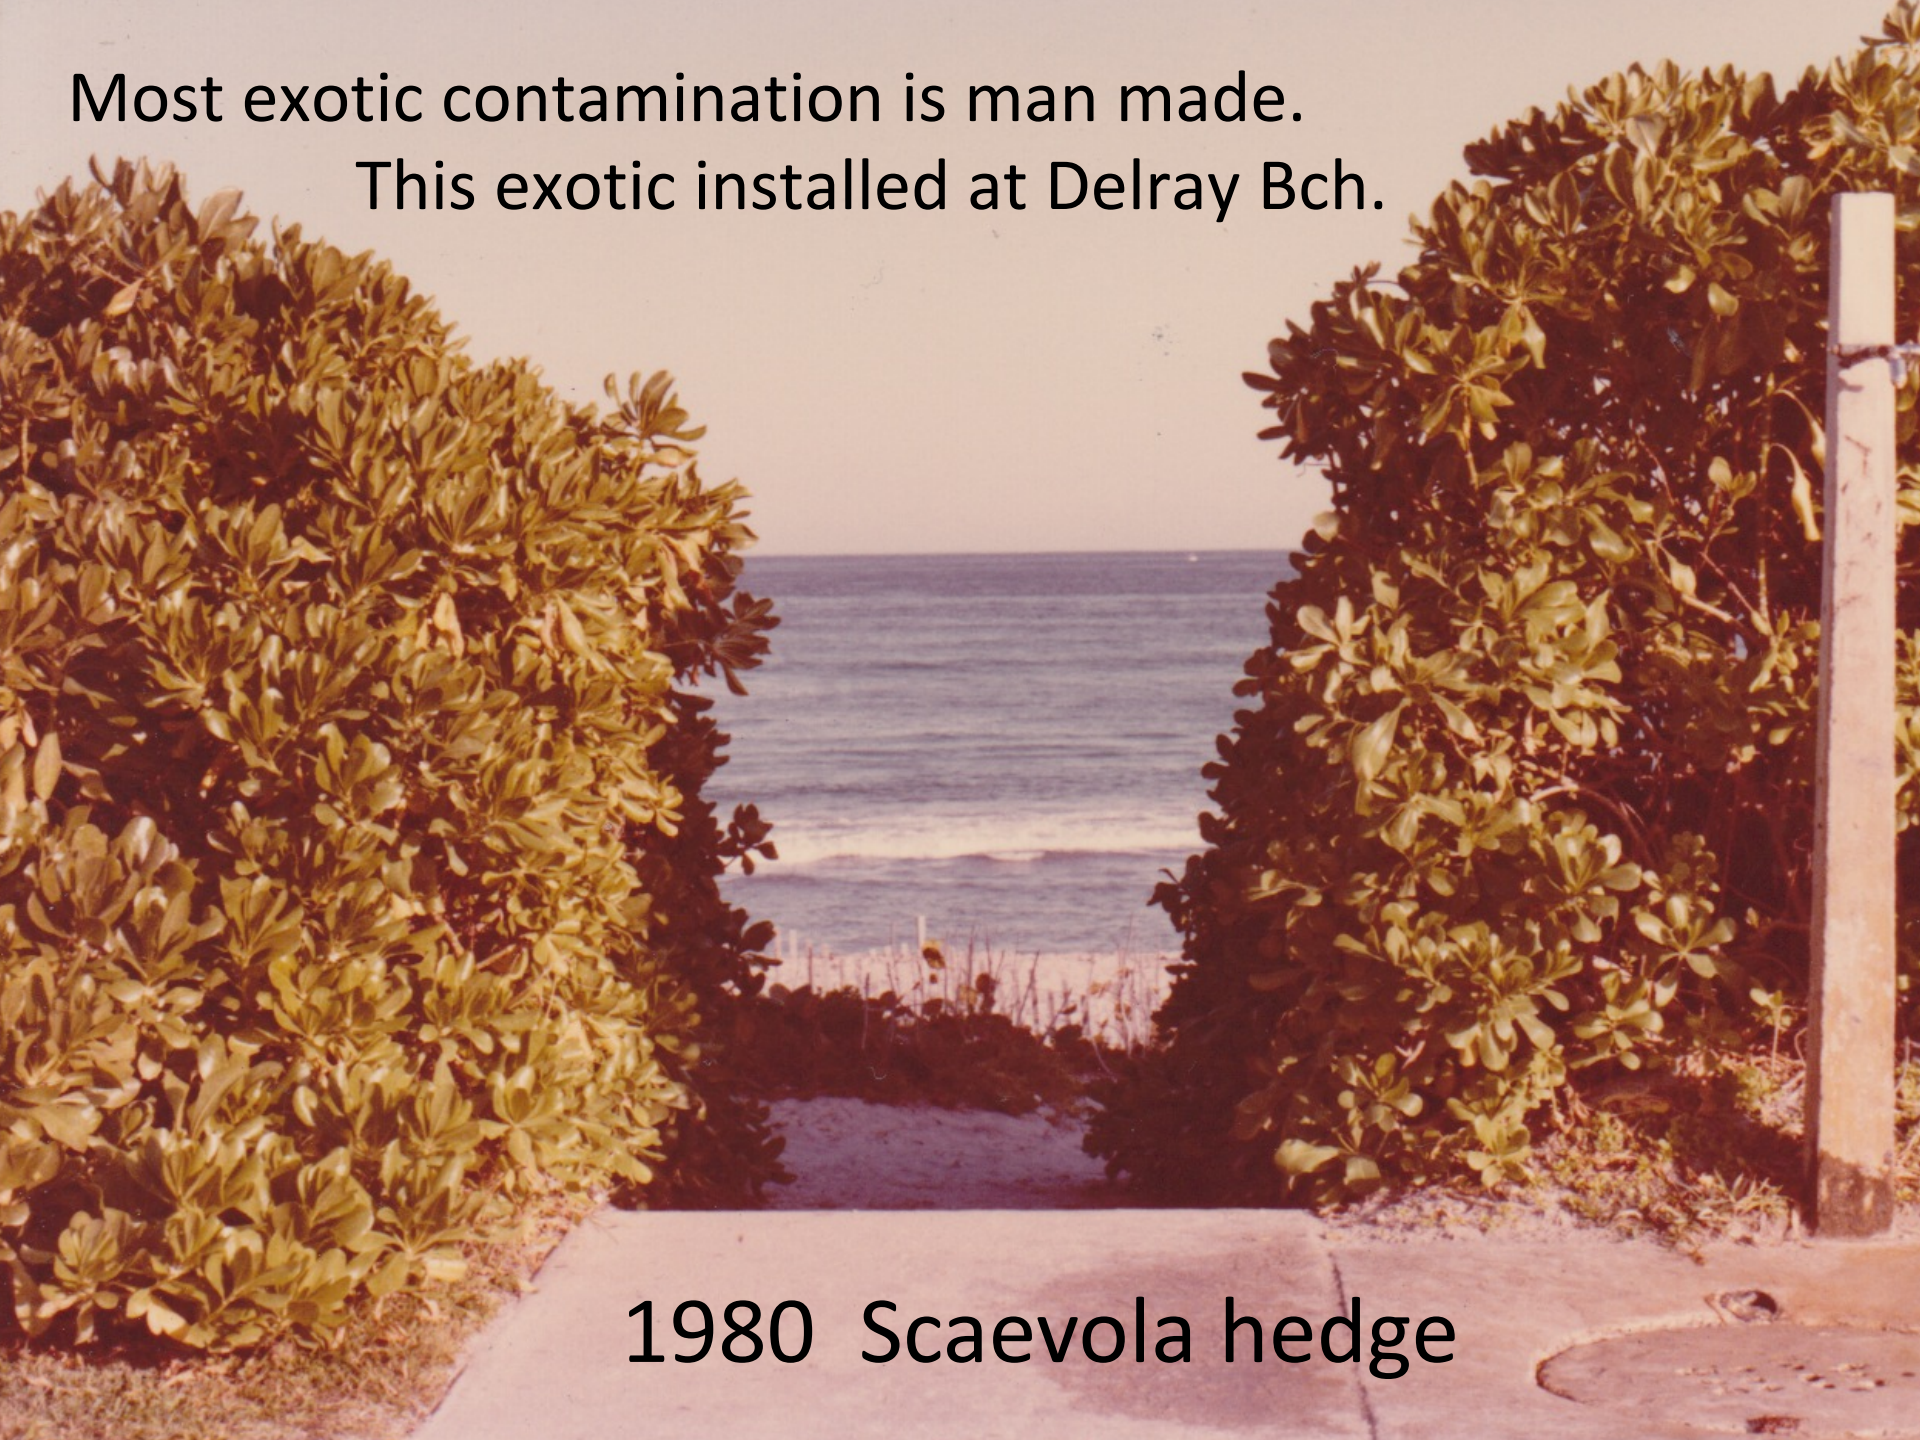
Most exotic contamination is man made.
This exotic installed at Delray Bch.

1980 Scaevola hedge

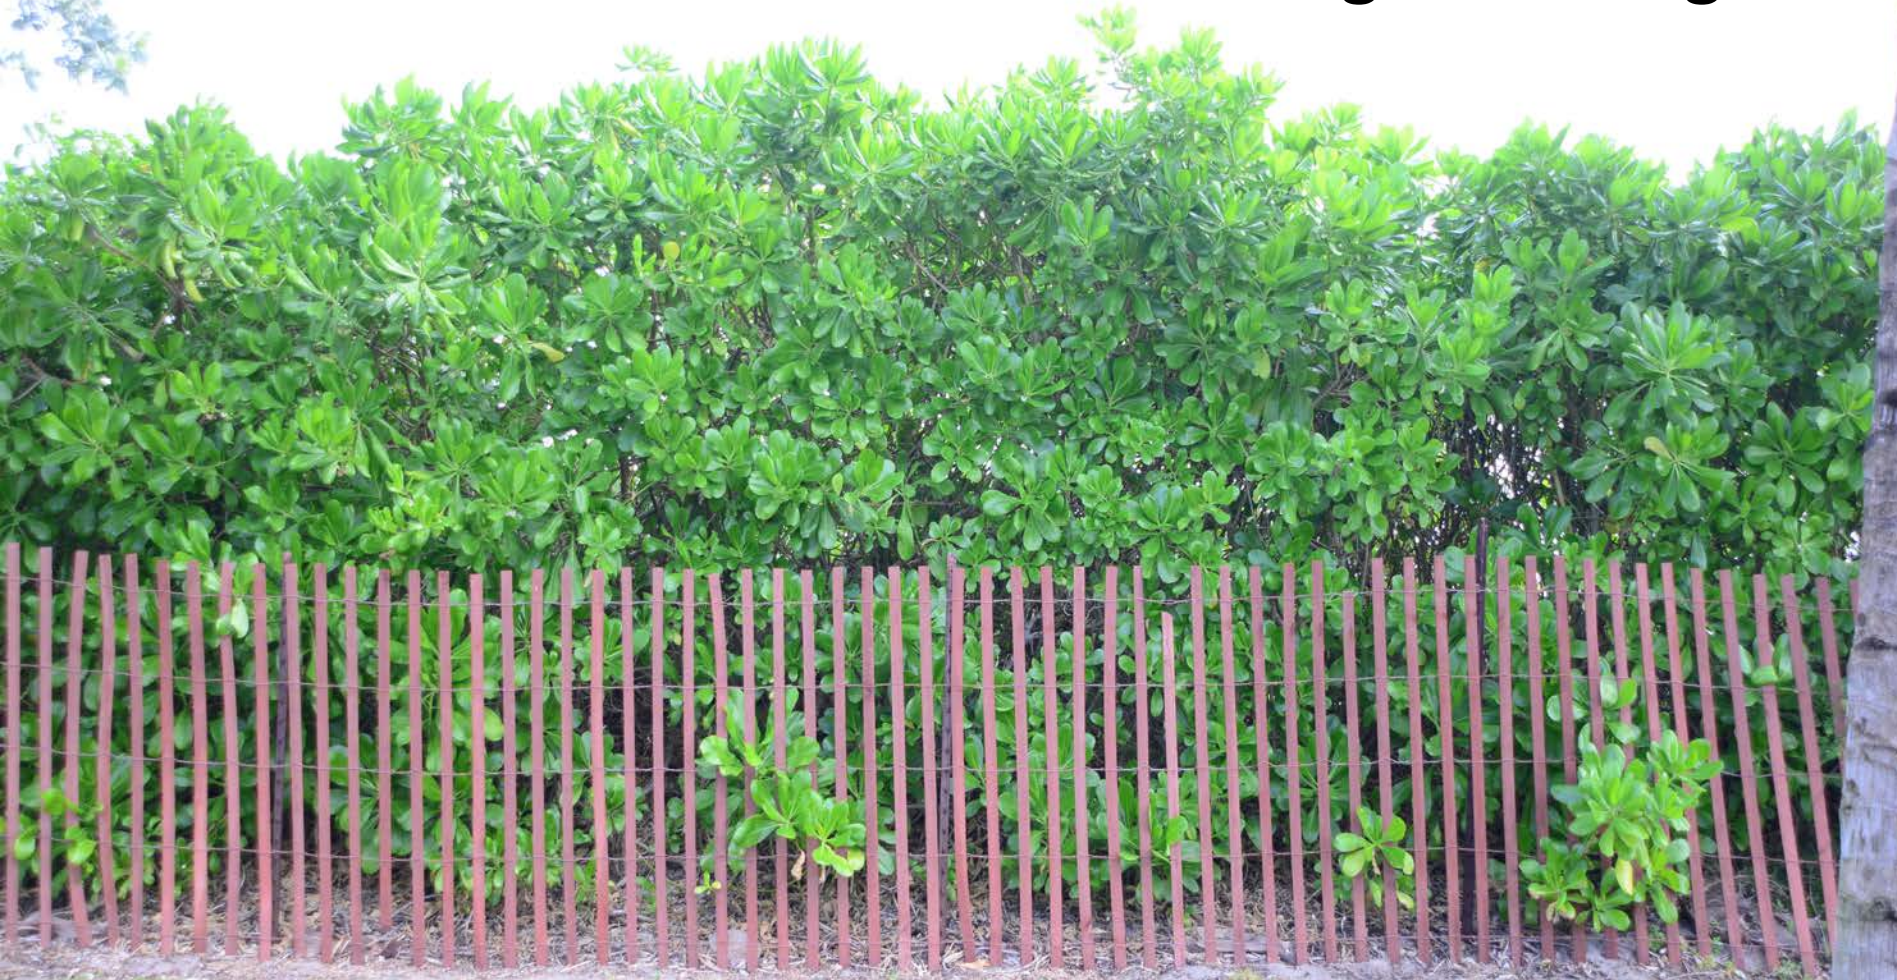
Between 1985 and 1997 the unmanaged dune grew.

View from the street was **this ..**

And the stuff had escaped to the open dune.

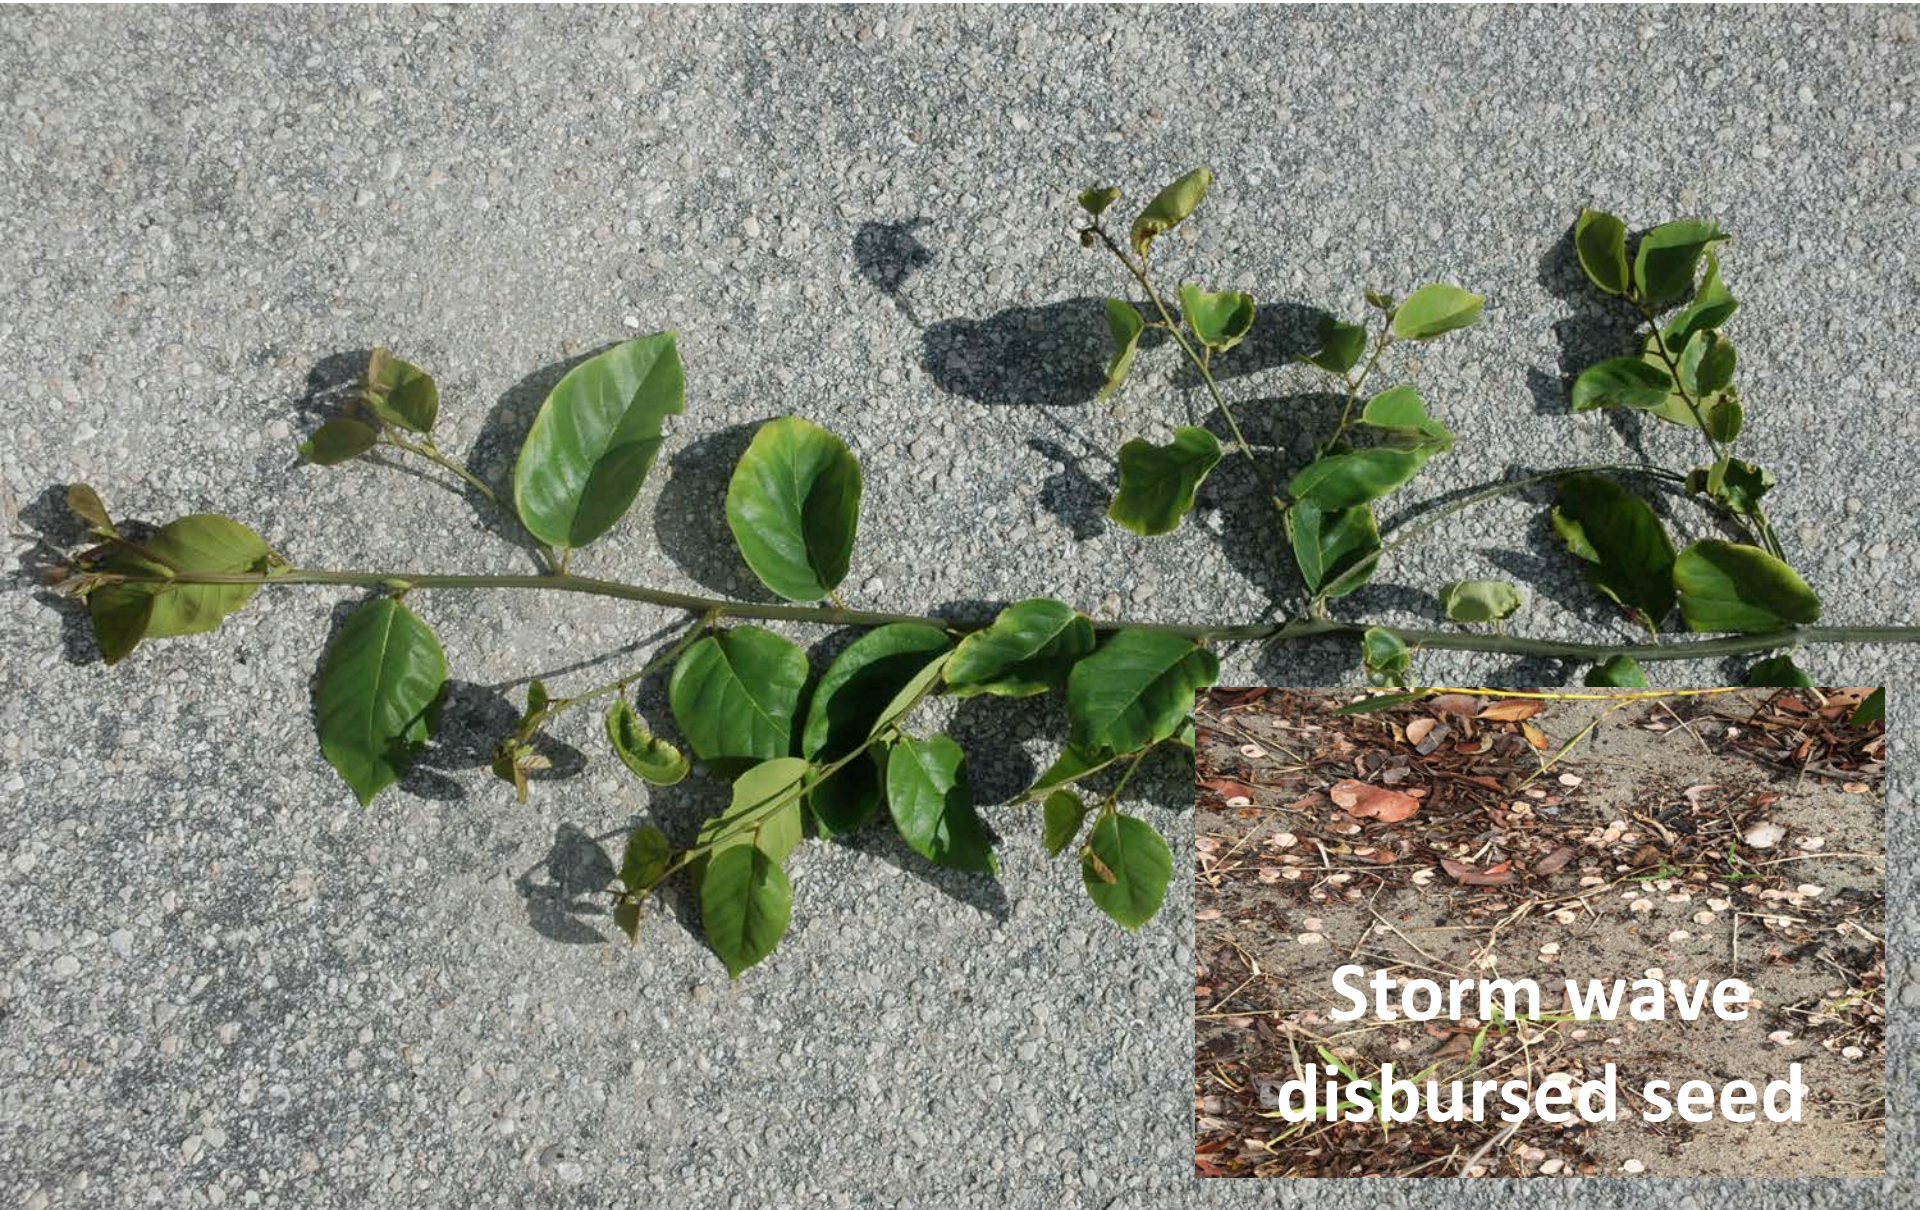
Dahlbergia e. at Ocean Village

Storm wave
disbursed seed

Dalbergia ecastophylum (coin vine) infestation.

Contaminating over 500 square yards this two year old infestation is only three individual plants, largest of which had 26 leads radiating out as much as 36 feet with laterals out to fifteen feet. These completely overshadow the native dune grasses and strand species below. First noticed in August of 2009.

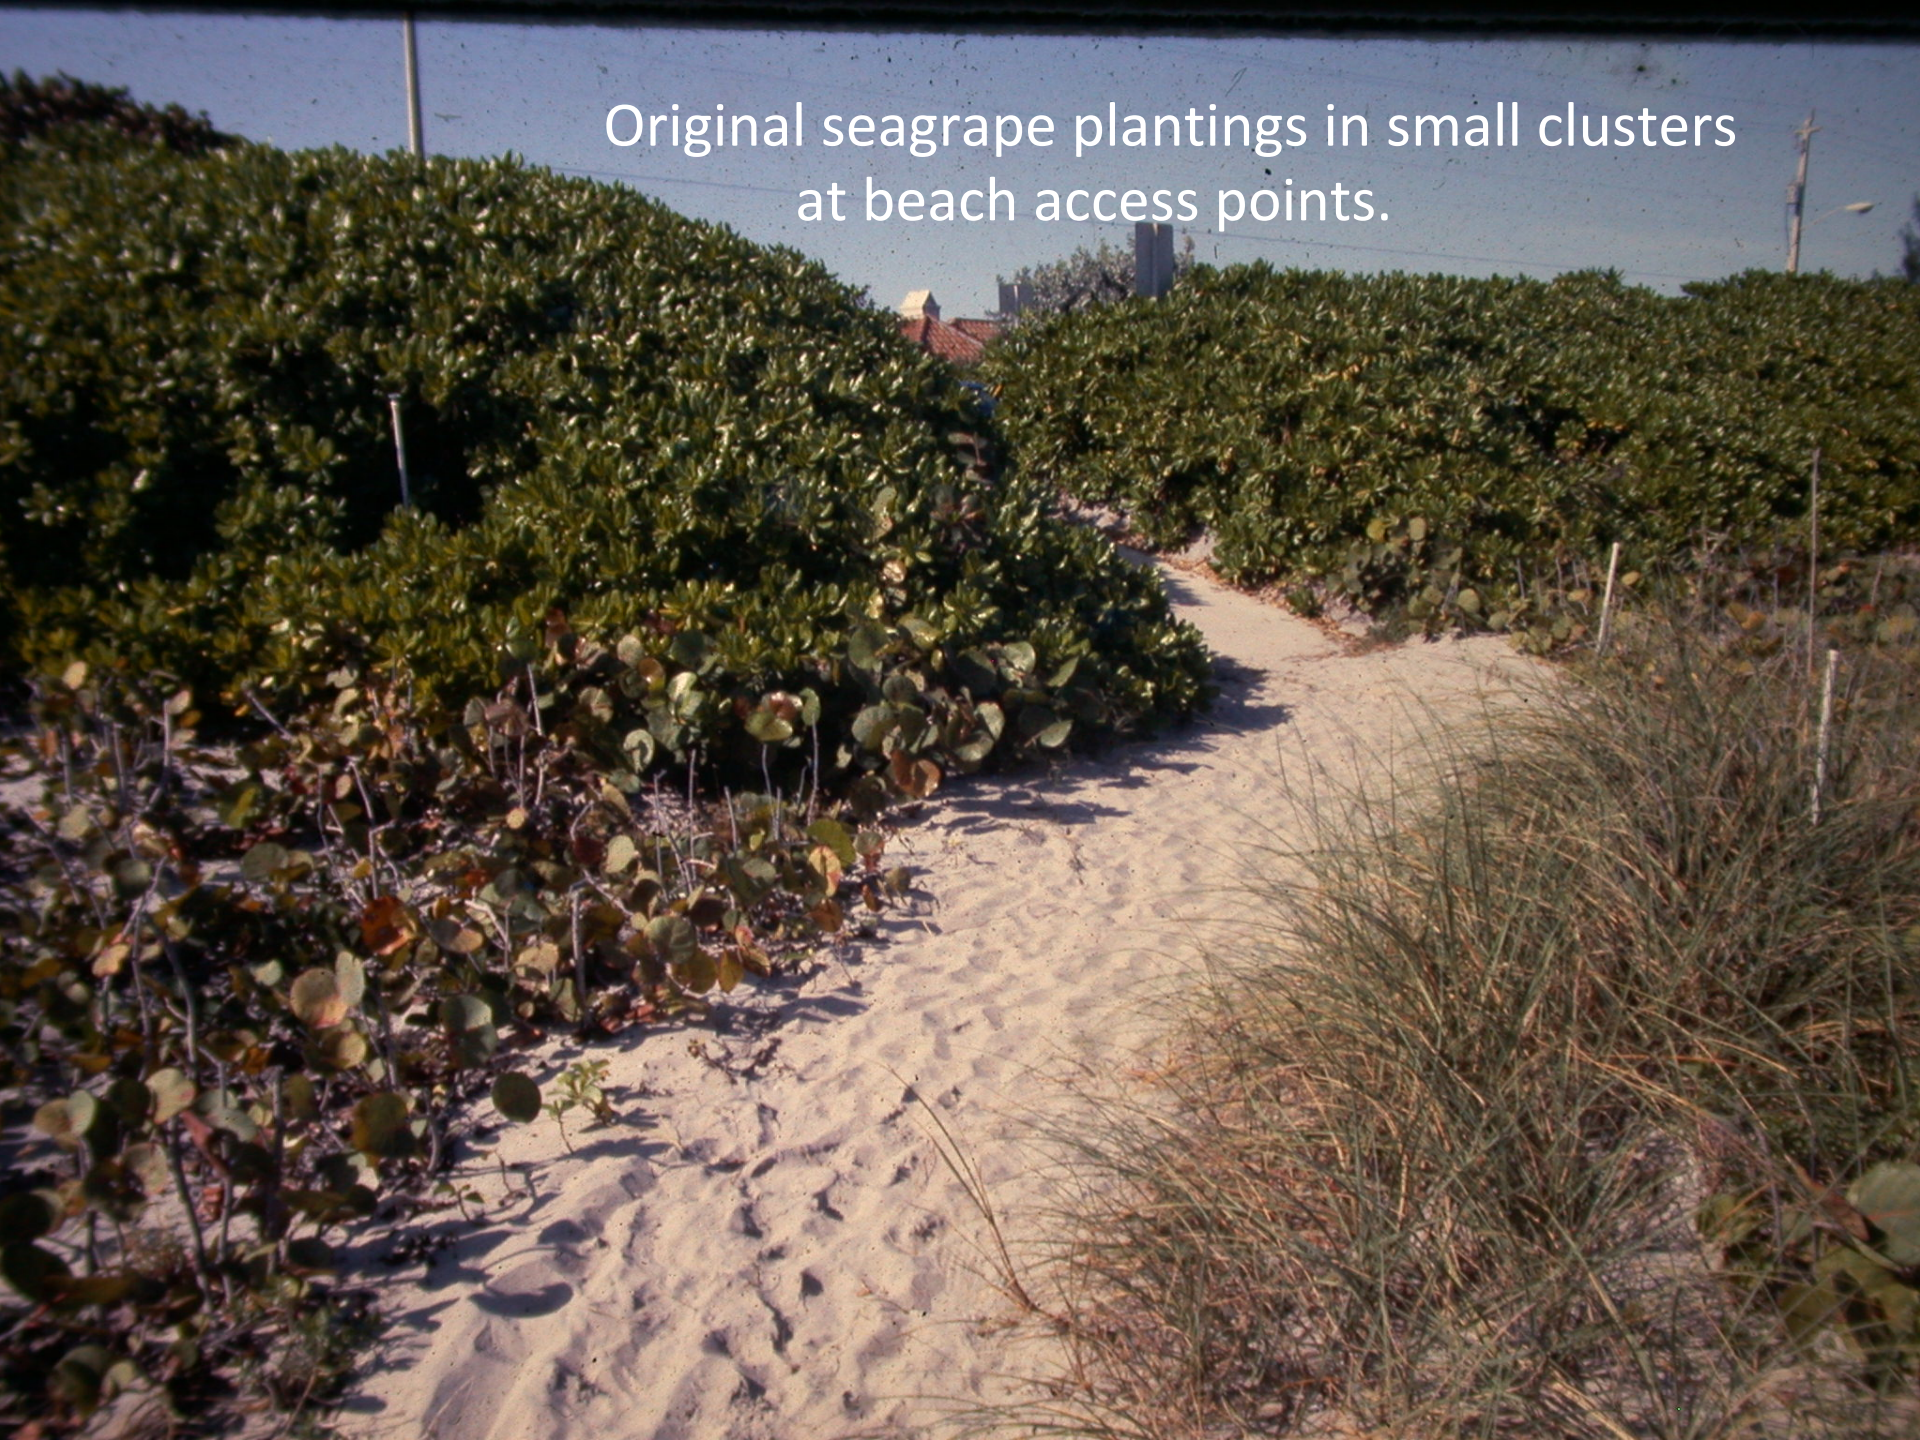
Section 17 Seagrape expansion since 1985

Red line is approximate footprint of seagrape clusters as installed to trap sand at access points 1982; about 300 sq ft.

Yellow is footprint at time of 2001 FDEP pruning permit; about 4,500 sq.ft.

White line is seagrape footprint at 2015 FDEP exotic removal permit; about 10,500 sq. ft.

35X increase since planting, 2.3X increase since pruning began. 7% /year, expansion since pruning began.

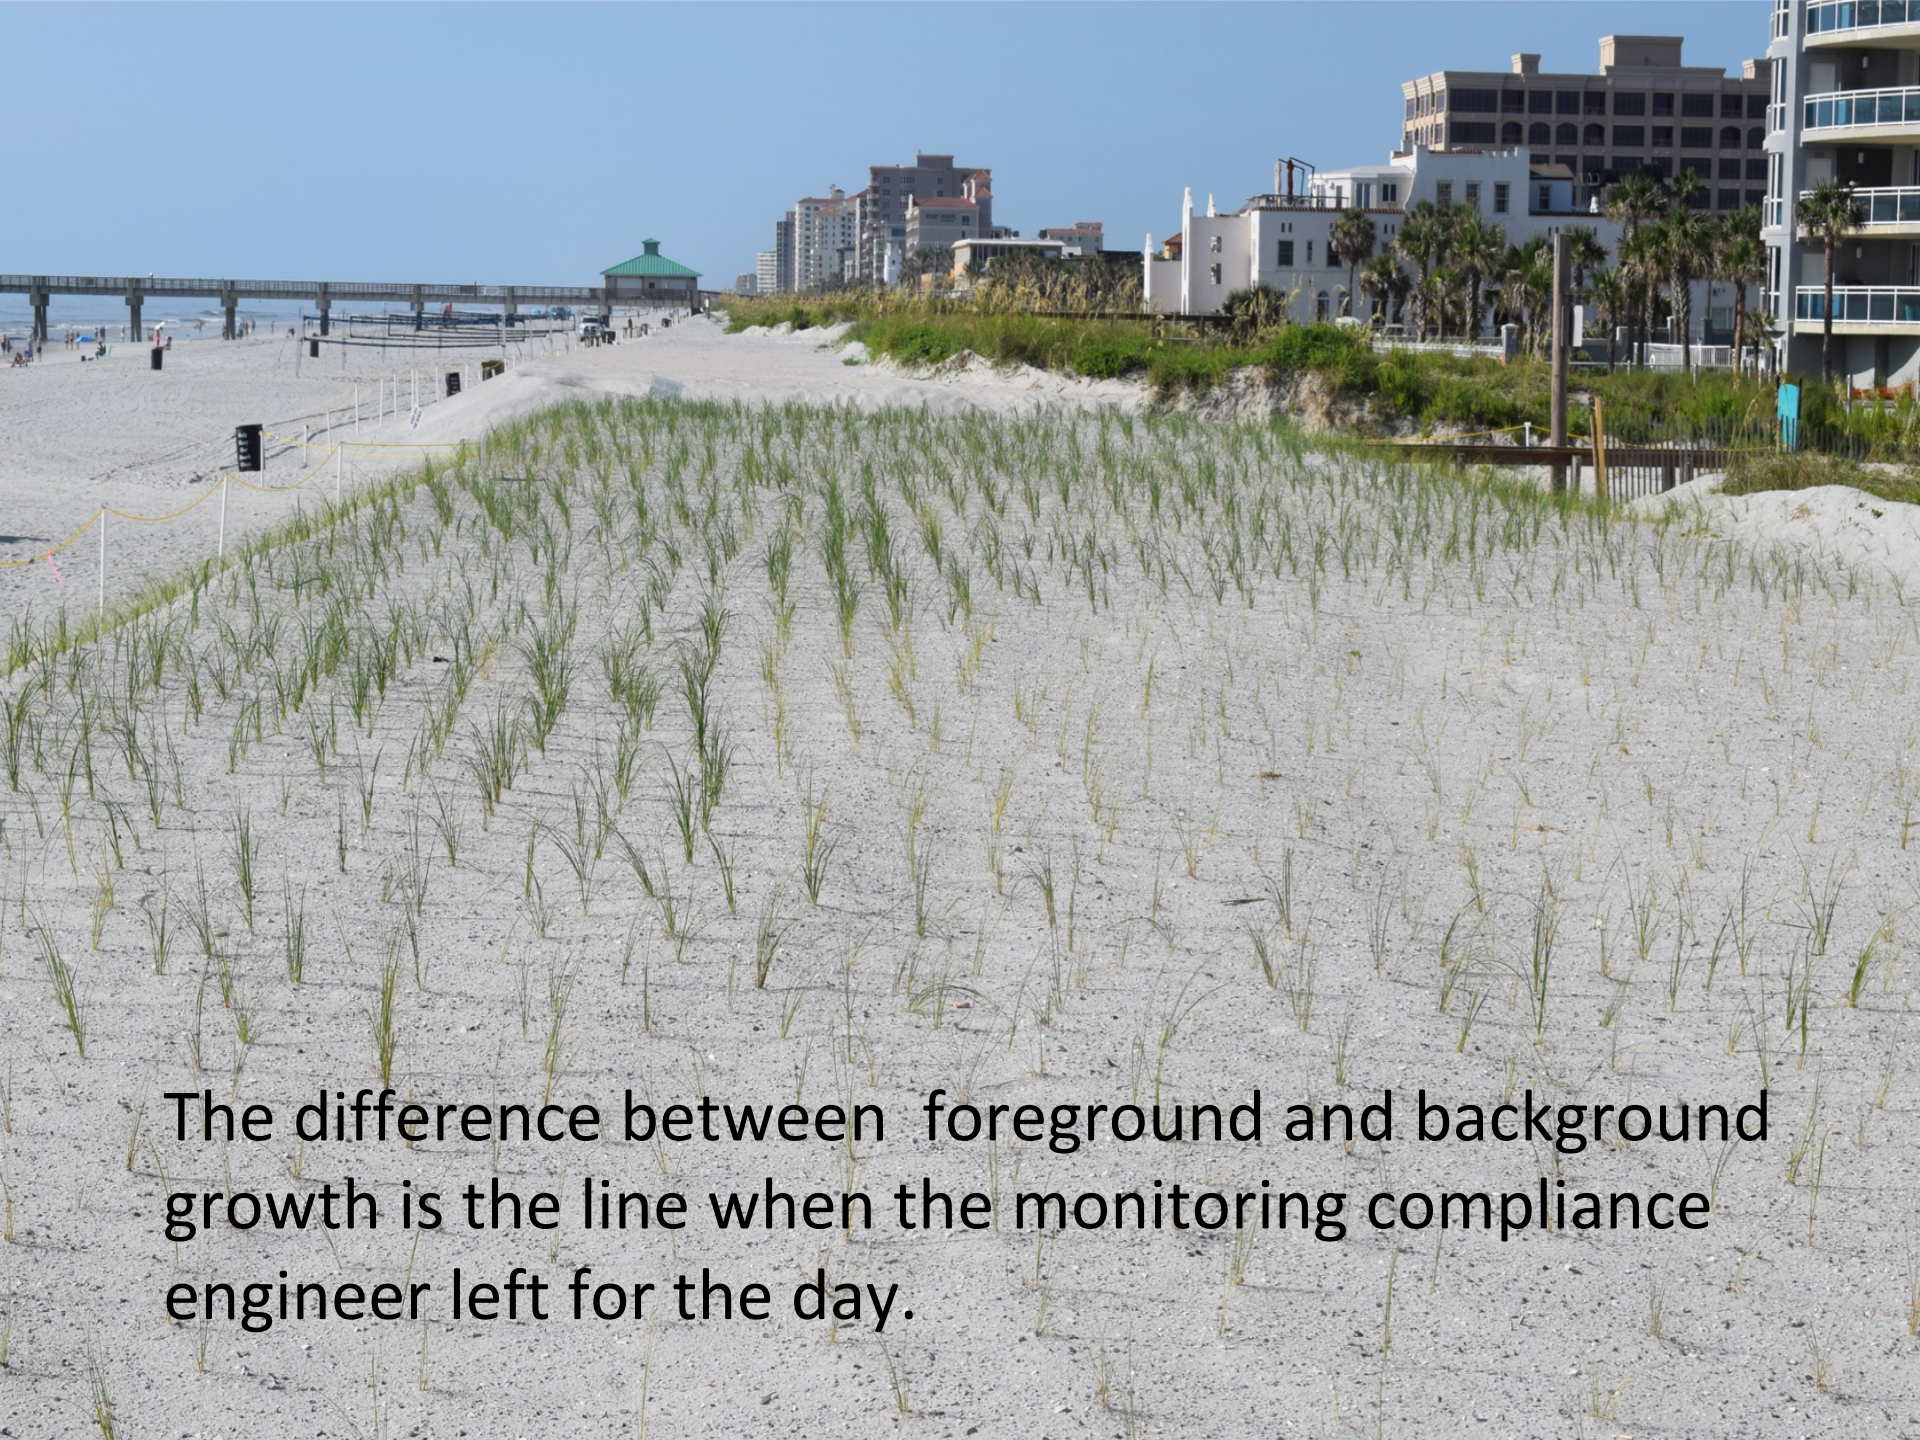
Dune planting specifications typically call for planting depths of 6 inches to get plants into zone of constant moisture. Most projects fail to achieve this, yet still get paid.
THE RESULT IS POOR PLANT SURVIVAL AND FAILURE TO THRIVE.

The difference between foreground and background growth is the line when the monitoring compliance engineer left for the day.
