Town of Palm Beach, FL Lake Worth Inlet Sand Transfer Plant Integrity Assessment

FSBPA 36th National Conference on Beach Preservation Technology
February 1-3, 2023

Integrity Assessment

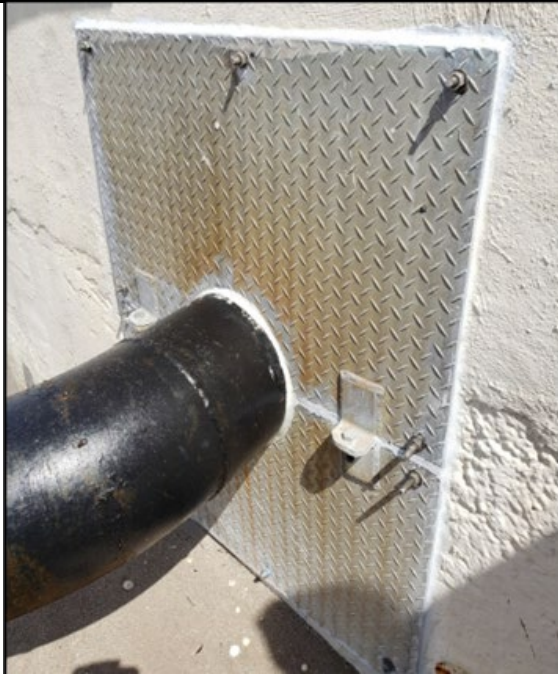
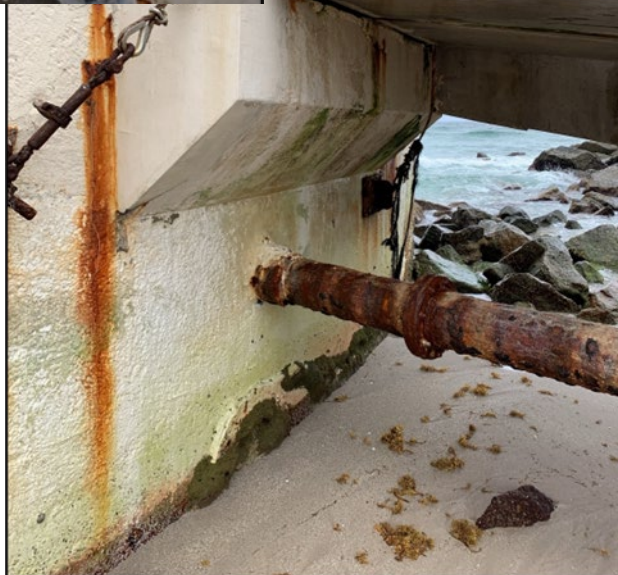
4.4 Pipes and Fittings – Outside STP

3.	Environment / Soils	Corrosion	Hardware as new. Soils non-corrosive.	Evidence of coating aging. Environment / Soils non-corrosive.	Coating visibly delaminating / exposing pipe steel at one or two points in section. Environment / Soils mildly corrosive.	Coating visibly delaminating / exposing pipe steel at several places in section. Pipe steel corroding. Environment / Soils promoting corrosion.	Coating visibly delaminating / exposing pipe steel over majority of section. Pipe steel heavily corroded. Environment / Soils highly corrosive.	A rating of 3 was given because of the age of the pipe/fittings (~90 days) already shows corrosion. Further, intake pipe is displaying more advanced corrosion. Reference b, c, d, e, f, g

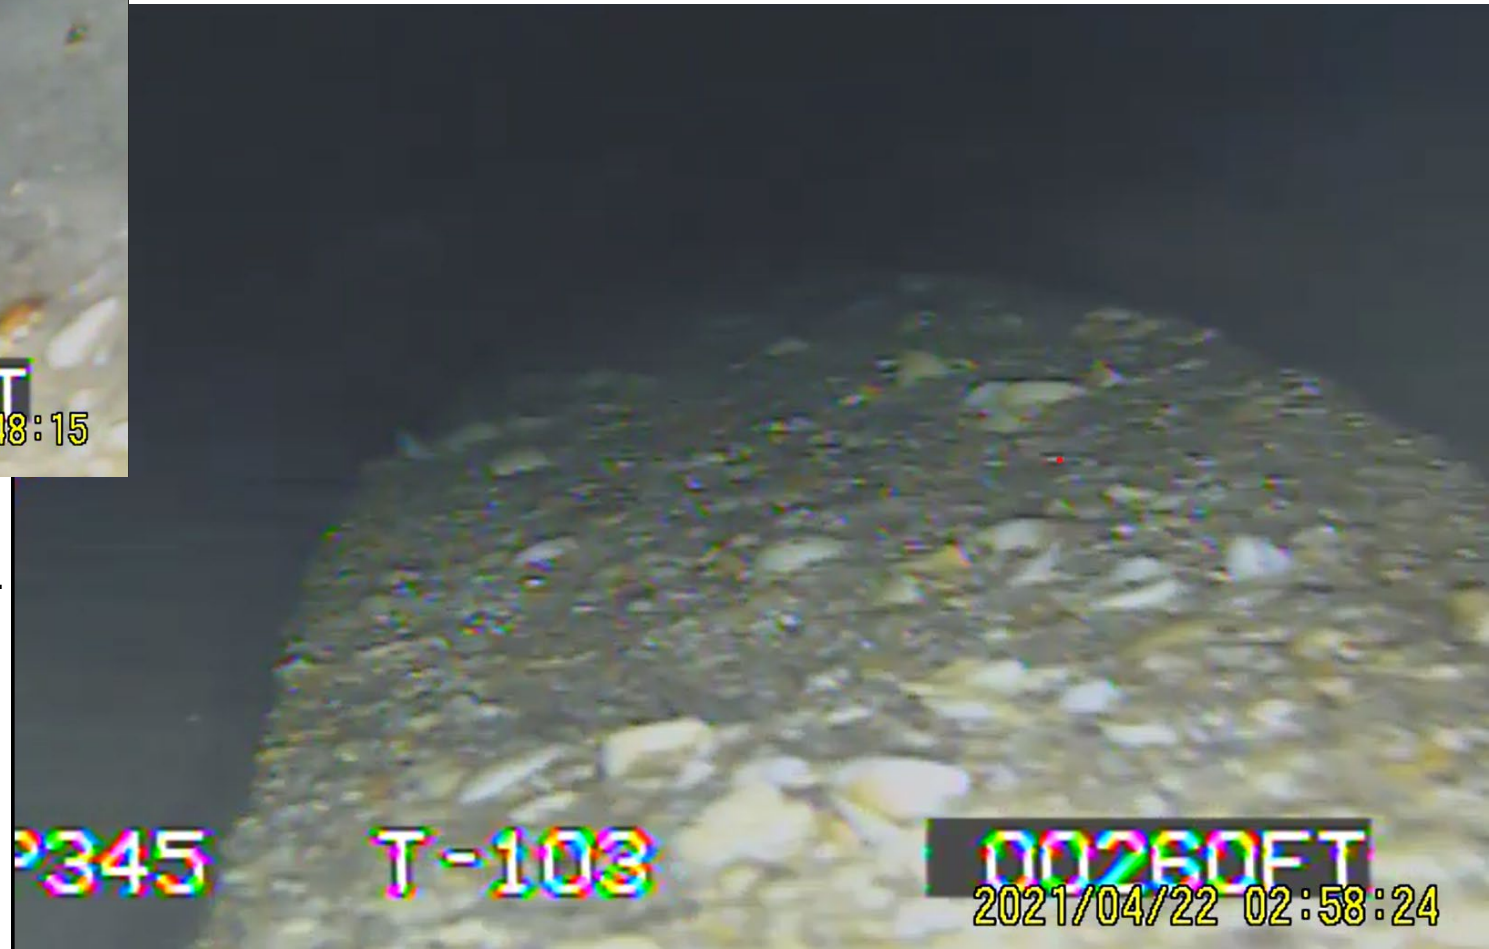
Non-Functional Line
Distance Documented = ~370 linear feet
(Straight line as measured by crawler)

- ~35 LF a steep downward angle and banking left turn was difficult to transit without crawler rollover.
- ~ 260 LF, deposits of sand and shell occur with a wave pattern.
- Forward progression stopped at ~370 LF. Pipe cross-sectional area of sediment coverage is approximately 40-50%.

- The excess slope (>40-degree decline) in the non-functional discharge line as it transitions back up to the beach south of the Inlet may be the functionality issue with this asset. Remedial measures may be available to bring this line back into service without complete replacement, but additional investigations are necessary to further define the challenges.
