# TAYLOR ENGINEERING, INC.

## Embassy Suites St. Augustine Beach, Florida Shoreline Protection and Seawall Replacement

J.B. Brumfield, P.E. February 7, 2024

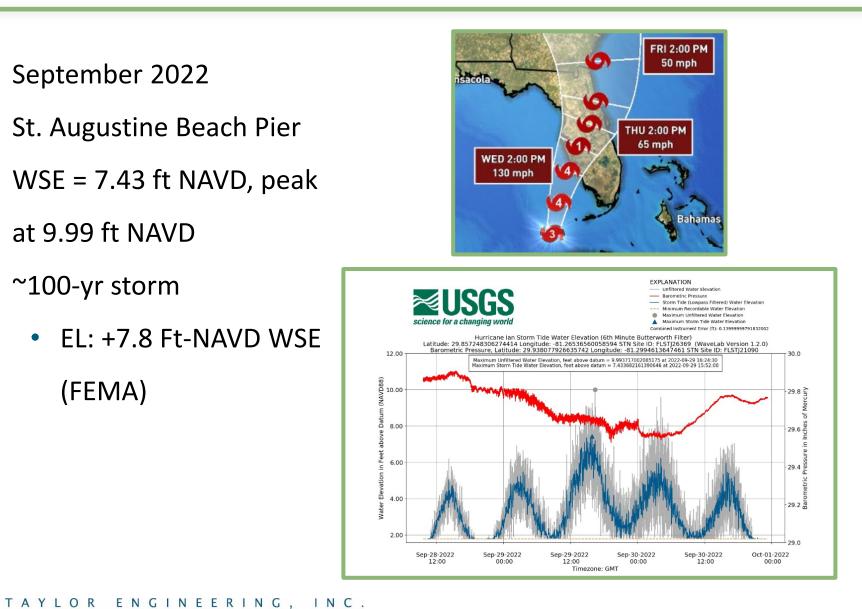
## Hurricane Ian

- September 2022
- St. Augustine Beach Pier
- WSE = 7.43 ft NAVD, peak at 9.99 ft NAVD
- ~100-yr storm
  - EL: +7.8 Ft-NAVD WSE (FEMA)

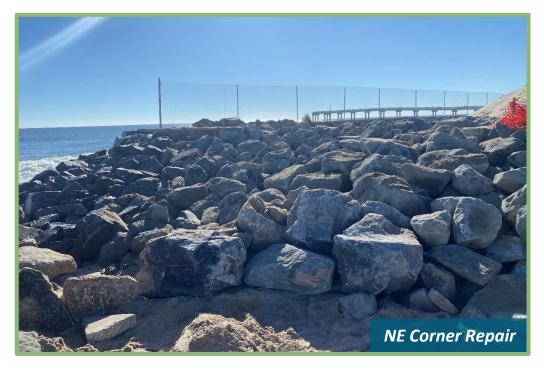
## **Phase II: Northeast Corner Armor Stone**

• (FAC 62B-33.0051) states,

"Armoring shall not to exceed a 50-year design storm."

- Coastal conditions analysis:
  - 50-yr H<sub>design</sub> = 5.5 ft
  - T = 13 s
- Rock sizing:
  - D<sub>n50</sub> = 2.11 ft
  - W<sub>50</sub> = 1,553 lb

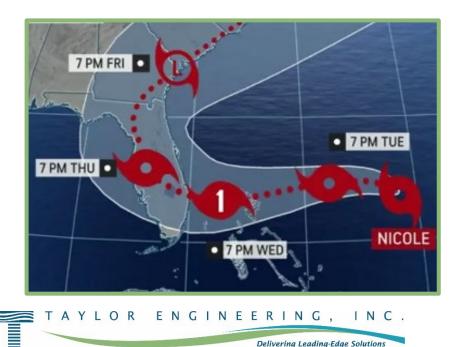
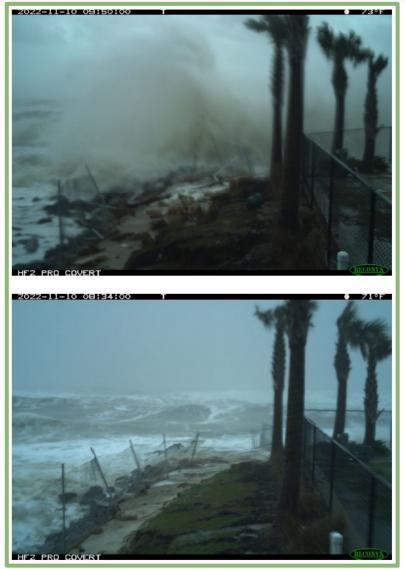
# Hurricane Nicole (St. Augustine Beach Area)

- November 2022
- NOAA Station 41117
- Peak offshore wave (H) = 5.7 m (18.7 ft)
  @ average T = 8.65 s
- Volume Change: -1.5M CY (FDEP<sub>1</sub>)

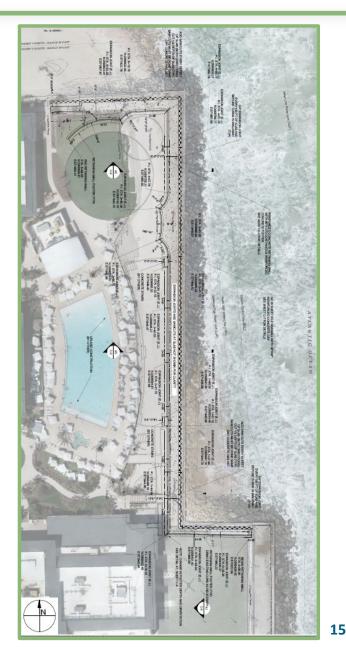
# **Phase IV: Seawall Construction**

#### **Design considerations:**

- Wave overtopping/flooding
- Sea level rise
- Aesthetics and functionality

- Seawall (raised 4 ft and 600 LF long)
- Pedestrian walkway and upland retaining wall
- Sundeck and wedding venues

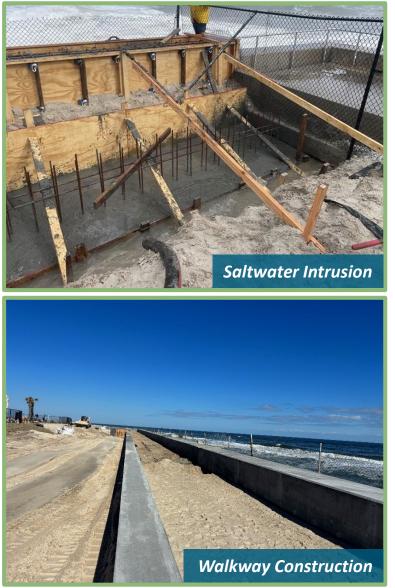
# Phase IV: Seawall Cont.

- High wave loads & chloride intrusion
  - Silica fume concrete (5500 psi)
- Walkway aesthetics/features
  - Pigmented concrete with tabby finish
  - S.S. #2 mesh rebar & fiber mesh

- 650 LF pump distance
- Workability of concrete mix
- Wind and wave climate
