Longboat Key, FL (Additional) North End Stabilization

DEC 2018
Photos from the Air

Krista J. Egan, P.E.
Albert E. Browder, Ph.D., P.E.

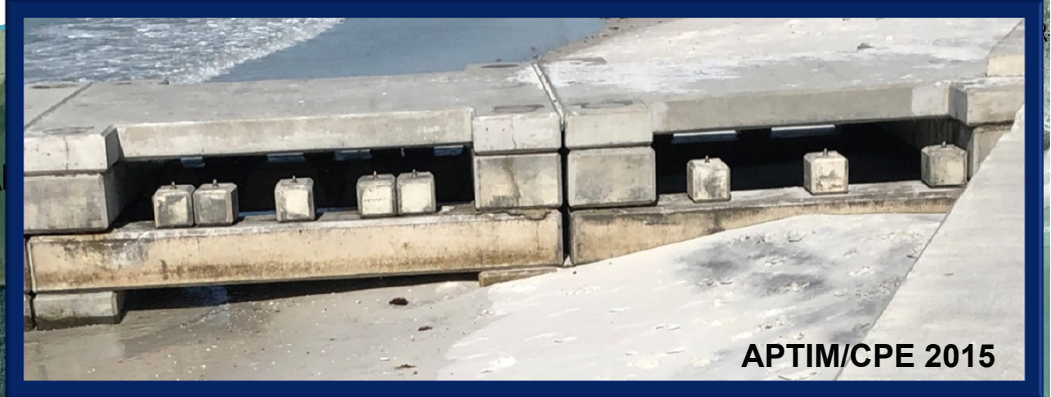
Proposed Stabilization 2012

Terminal Groin

Permeable
Adjustable Groins
(PAGs)

APTIM/CPE 2015

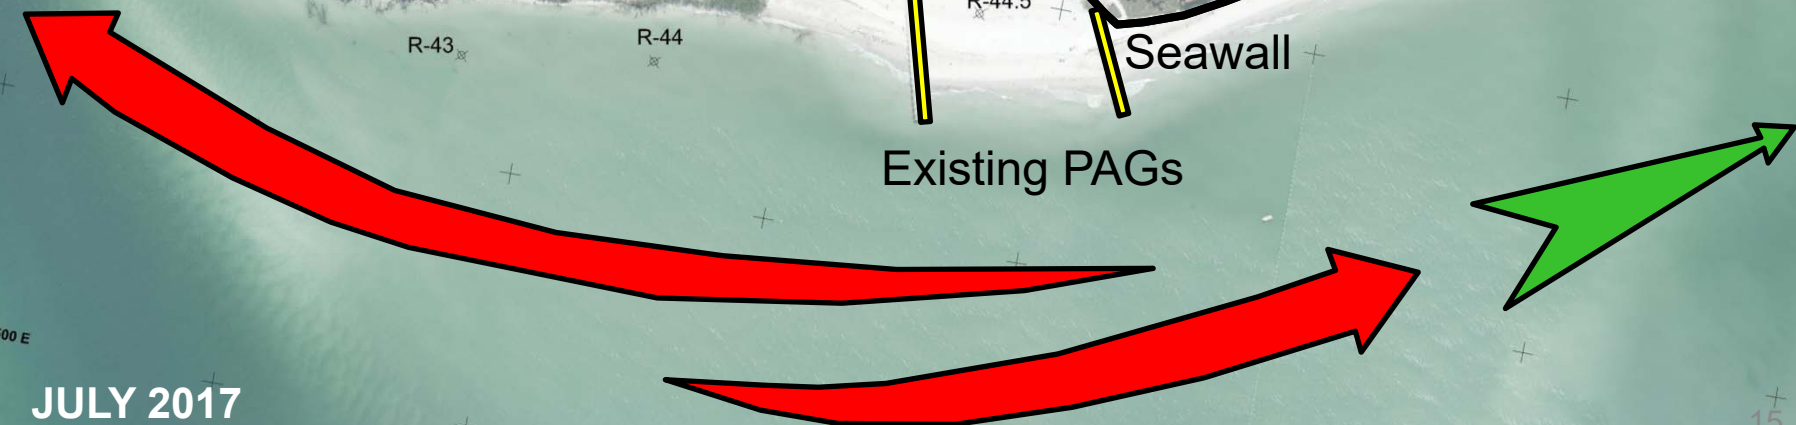
Sediment Transport

Seawall

Existing PAGs

FLOOD
EBB

JULY 2017

Modeling Takeaways

1. No significant sand supply for the area of concern
2. Zone of transport reversal
 - Farther north than shown in prior studies
 - Consistent with field observations
3. Existing groins do not span the erosional zone
