Twin Rivers Shoreline Restoration: Getting the Most out of Florida's Publicly Accessible Shorelines

John Duchock, P.E.,¹ Kevin L. Landry, ASLA²

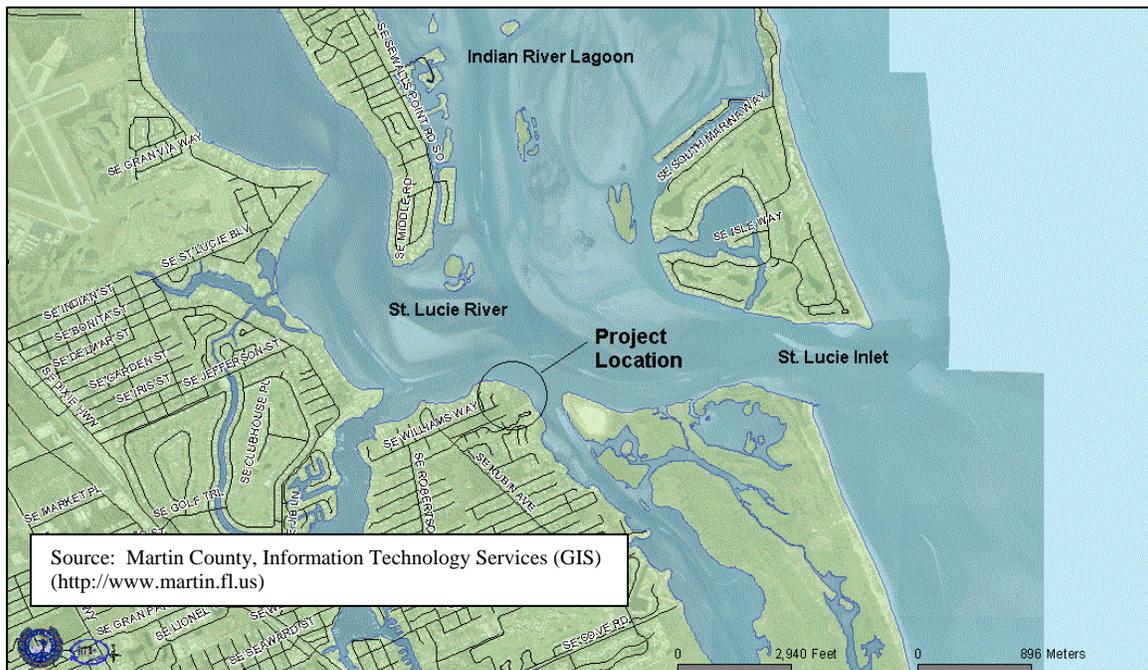
Figure 2 – Project Location Map

The Twin Rivers park is located at the junction of the Indian River Lagoon, St. Lucie River, and St. Lucie Inlet. As reflected in Figure 2, the property is exposed to wind and wave activity from the east and north to northwest. A series of existing shoals within the Indian River Lagoon and east of the property towards the inlet provide natural buffers to wind-generated waves. More problematic is the property's location relative to local navigation corridors. The location of the property at the headwaters of the St. Lucie River and Indian River Lagoon, within close proximity to an ocean inlet, exposes the property to a high volume of boat traffic.

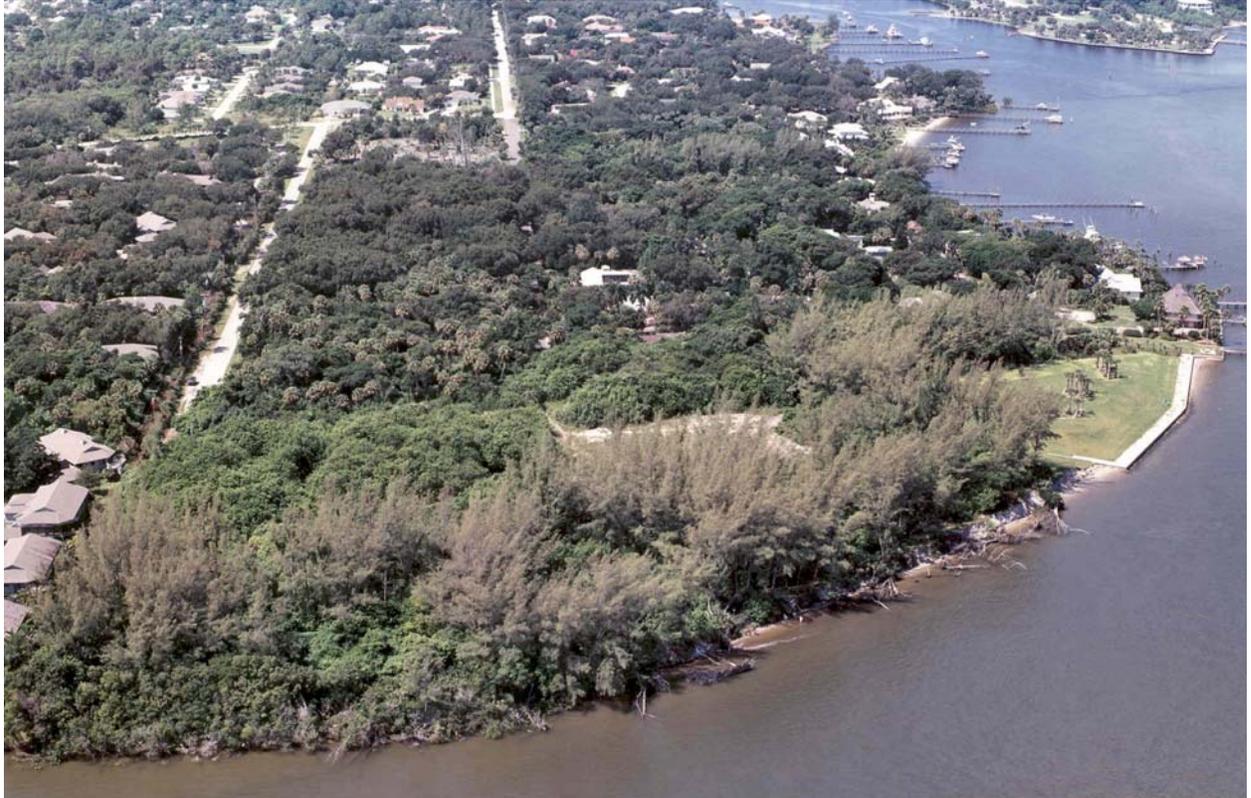
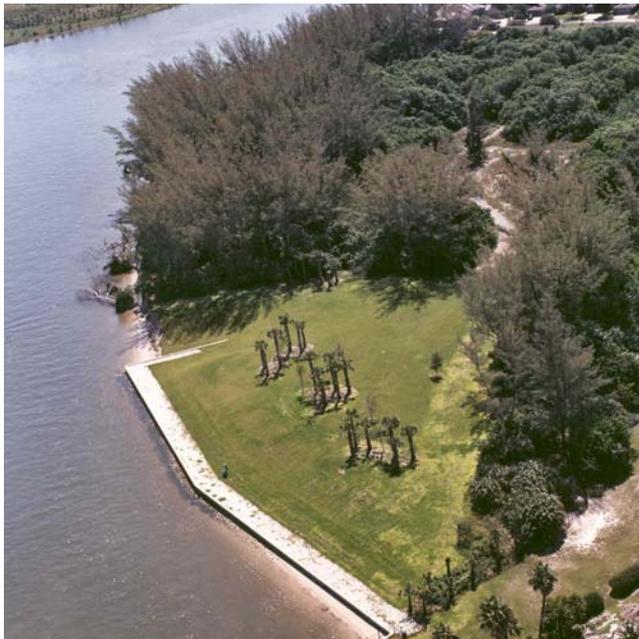
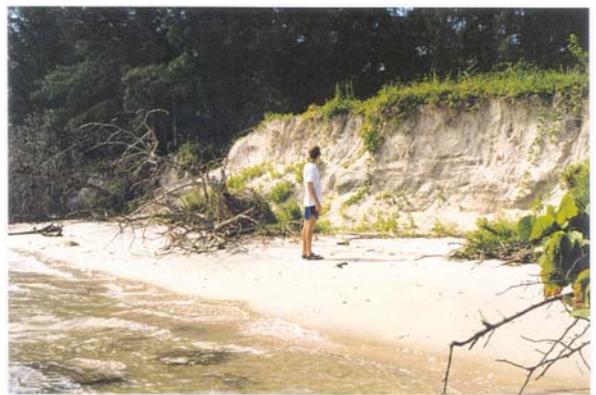
Figure 3 -Pre-Construction Conditions: Oblique Aerial of Twin Rivers Park Looking West from St. Lucie Inlet (Top). Oblique Aerial of Park Looking Southeast from "Crossroads" (Left). Eroded Shoreline Bluff (Above).

Due to chronic erosion problems, the County installed over 480 linear feet of bulkhead to protect the northernmost shoreline in 2001/2002. Following completion of the original bulkhead, continued erosion problems persisted along most of the remaining property shoreline. As evidenced in Figure 3, undermining had led to a substantial loss of property.

on the property. There is approximately 1,400 feet of shoreline along the property, 465 feet of which had been bulkheaded prior to more recent construction efforts. The shoreline has retreated under erosive wind/wave and boat wake attack. As such, there were numerous trees and other remnants scattered along the shoreline. Figure 3, below, provides several perspectives of the pre-construction site condition, including the near vertical bluff feature standing eight to ten feet high in some areas.

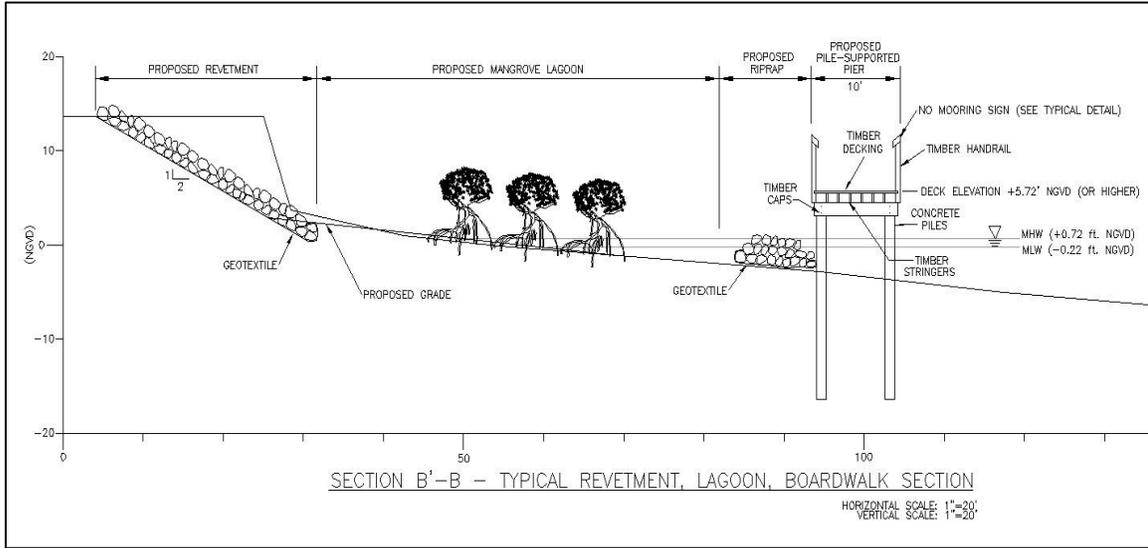
Figure 5 – Typical Section (Revetment, Sill, Boardwalk)

A fixed pier designed for pedestrian use only was included to provide access over water for observation and fishing opportunities. No vessel mooring would be permitted with accompanying signage being displayed from pier structures. Refer to Figure 4 for a general project layout. Figures 5 and 6 depict typical design sections for transitions from the boardwalk and sill to the revetment and bulkhead, respectively.

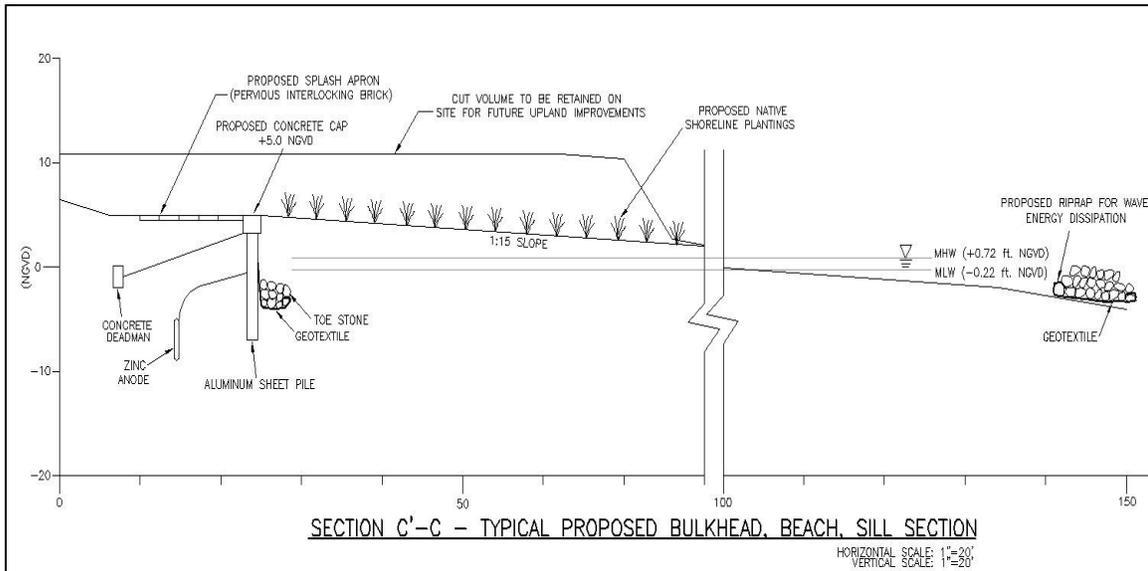
Figure 6 – Typical Section (Bulkhead, Sill)

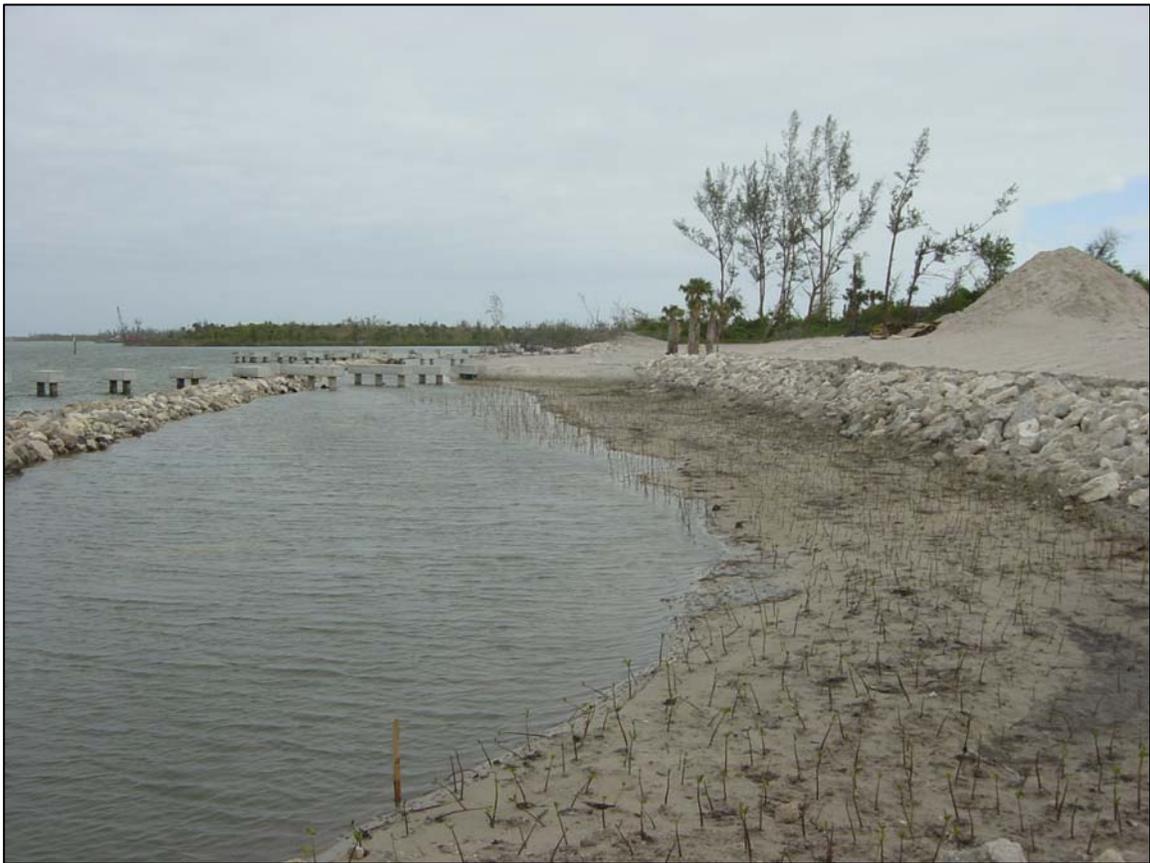
Figure 8 – Construction of Lagoon (Looking East Toward St. Lucie Inlet)

Project construction began in July 2005 and should be complete by April 2006. Field adjustments to the lagoon grading and sill gaps have been made to try to optimize water exchange and retain a minimum pool during low tide, while at the same time increasing accessibility to fish and shellfish. Figure 8 depicts the most recent construction progress photograph within the lagoon area. Note the partial construction of the boardwalk, with concrete piles and caps in place.
